Design and Access Statement including Heritage Report and Construction Method Statement

Date: 18-01-2024
Client: J Roberts
Project: Proposed Replacement Boundary Wall
Project Address: Lansdowne House, 11 Cross Street, Beverley, East Riding Of Yorkshire, HU17 9AX,

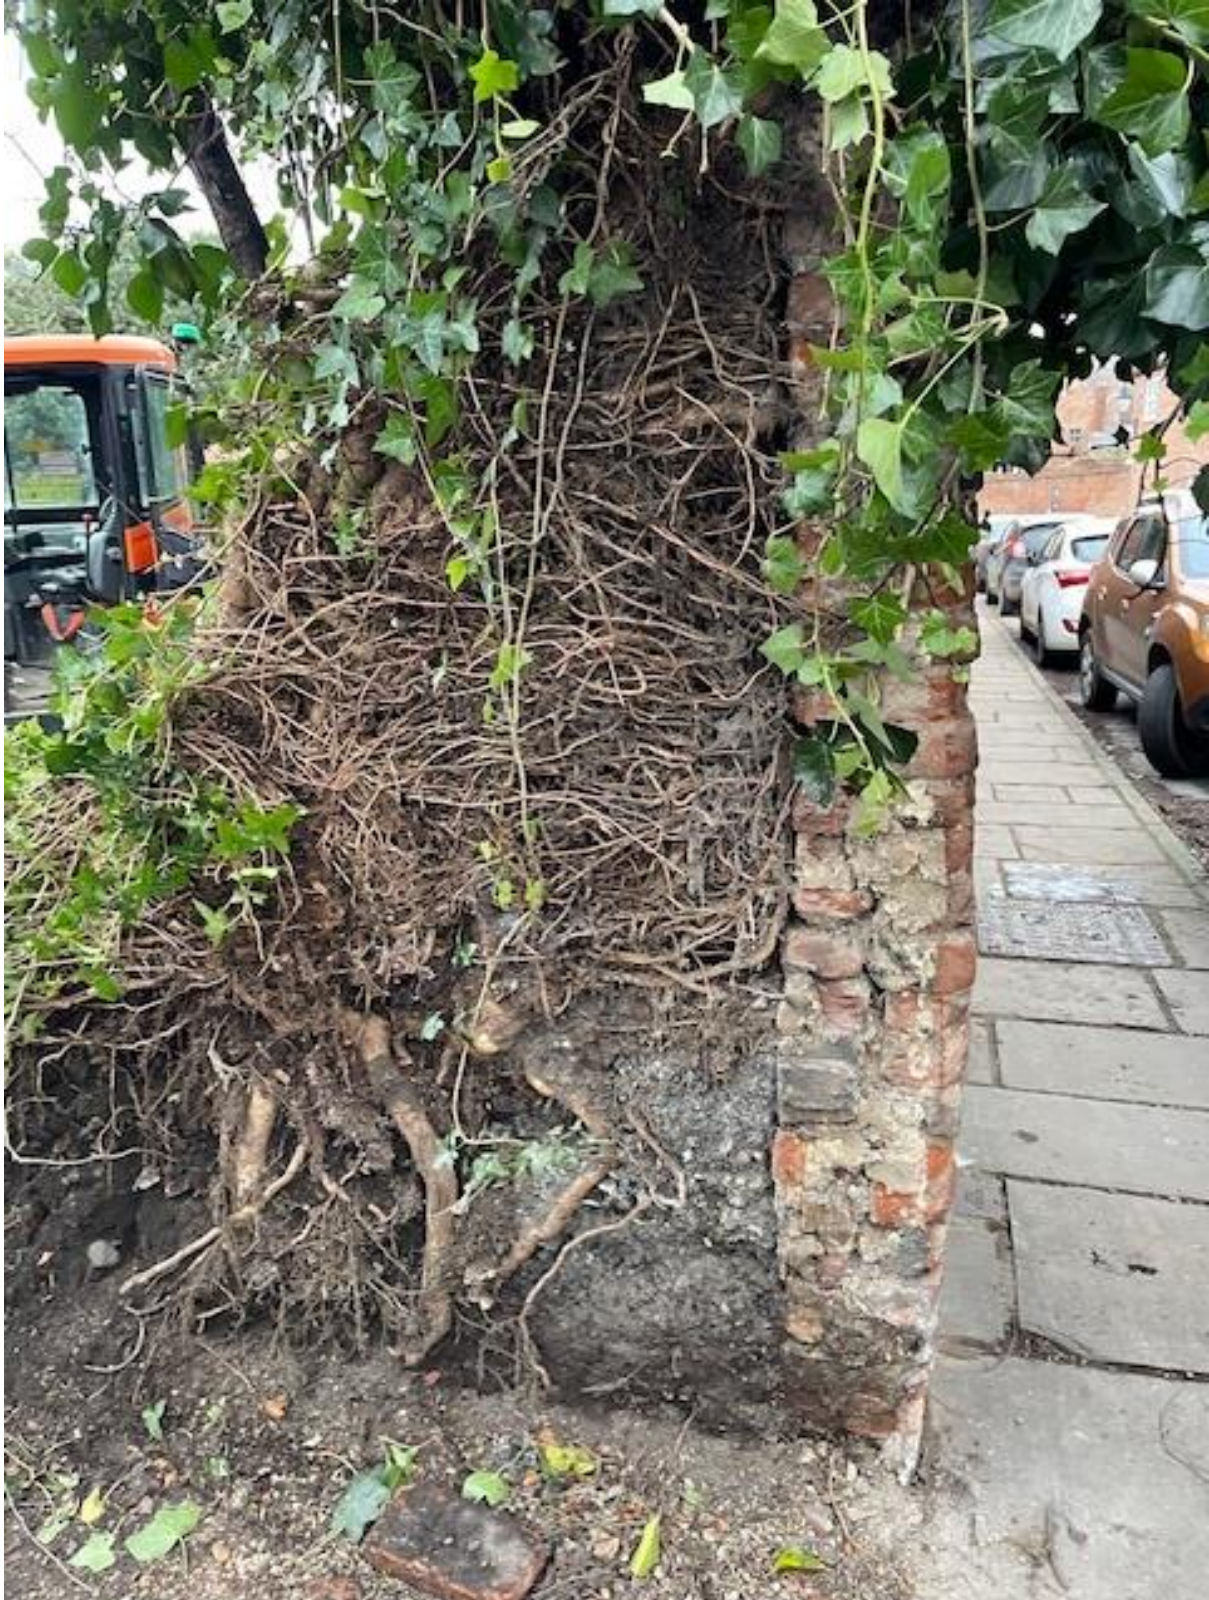
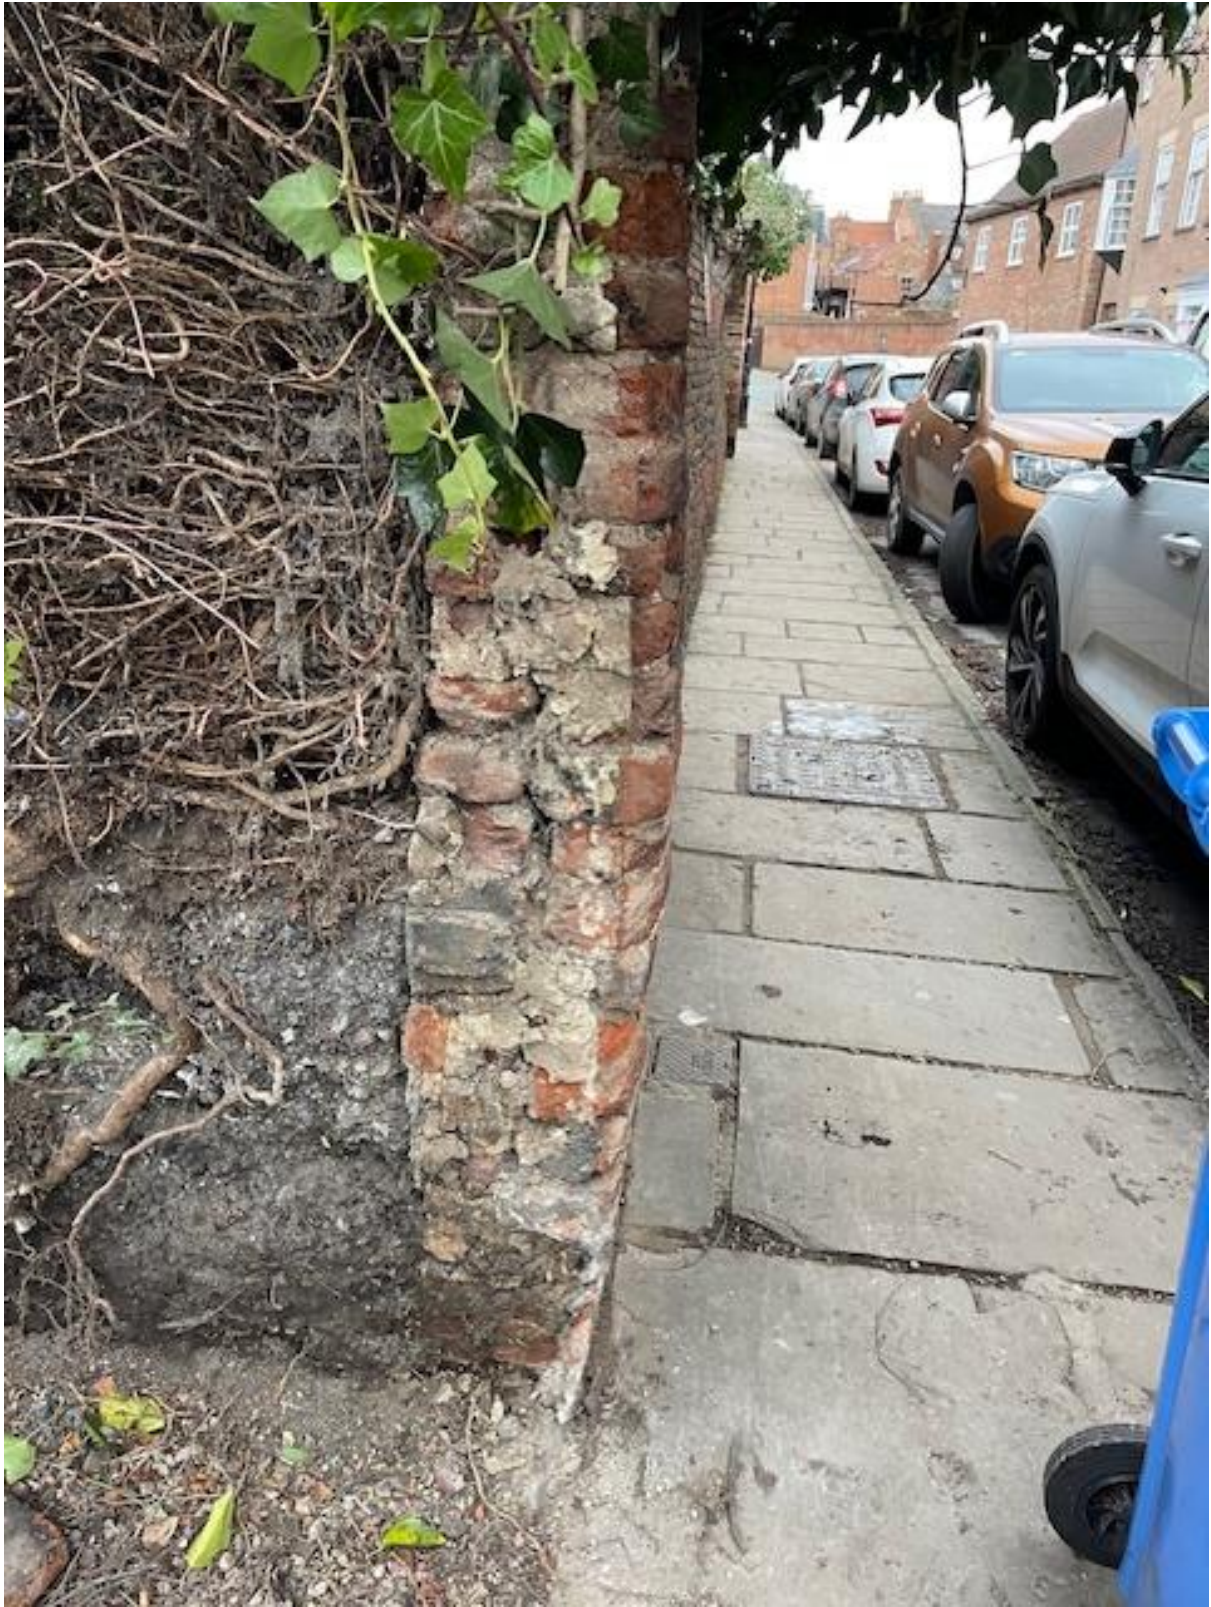
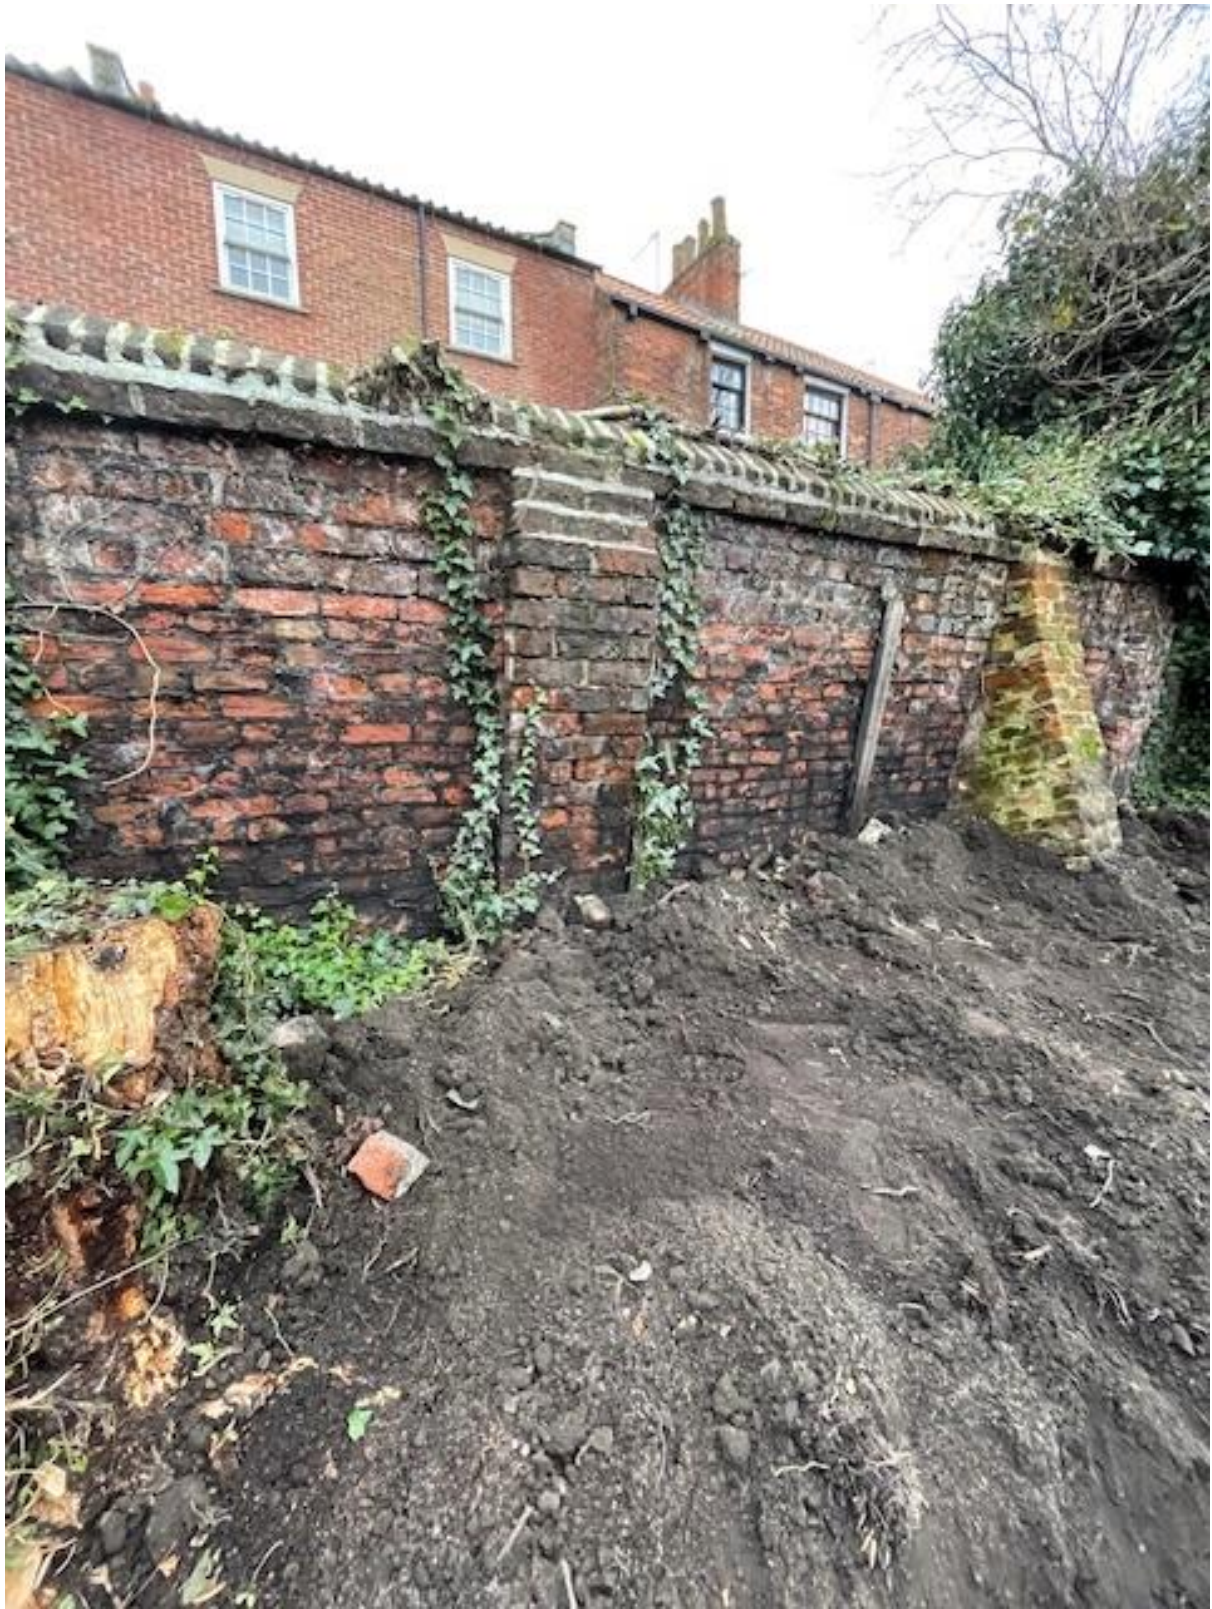
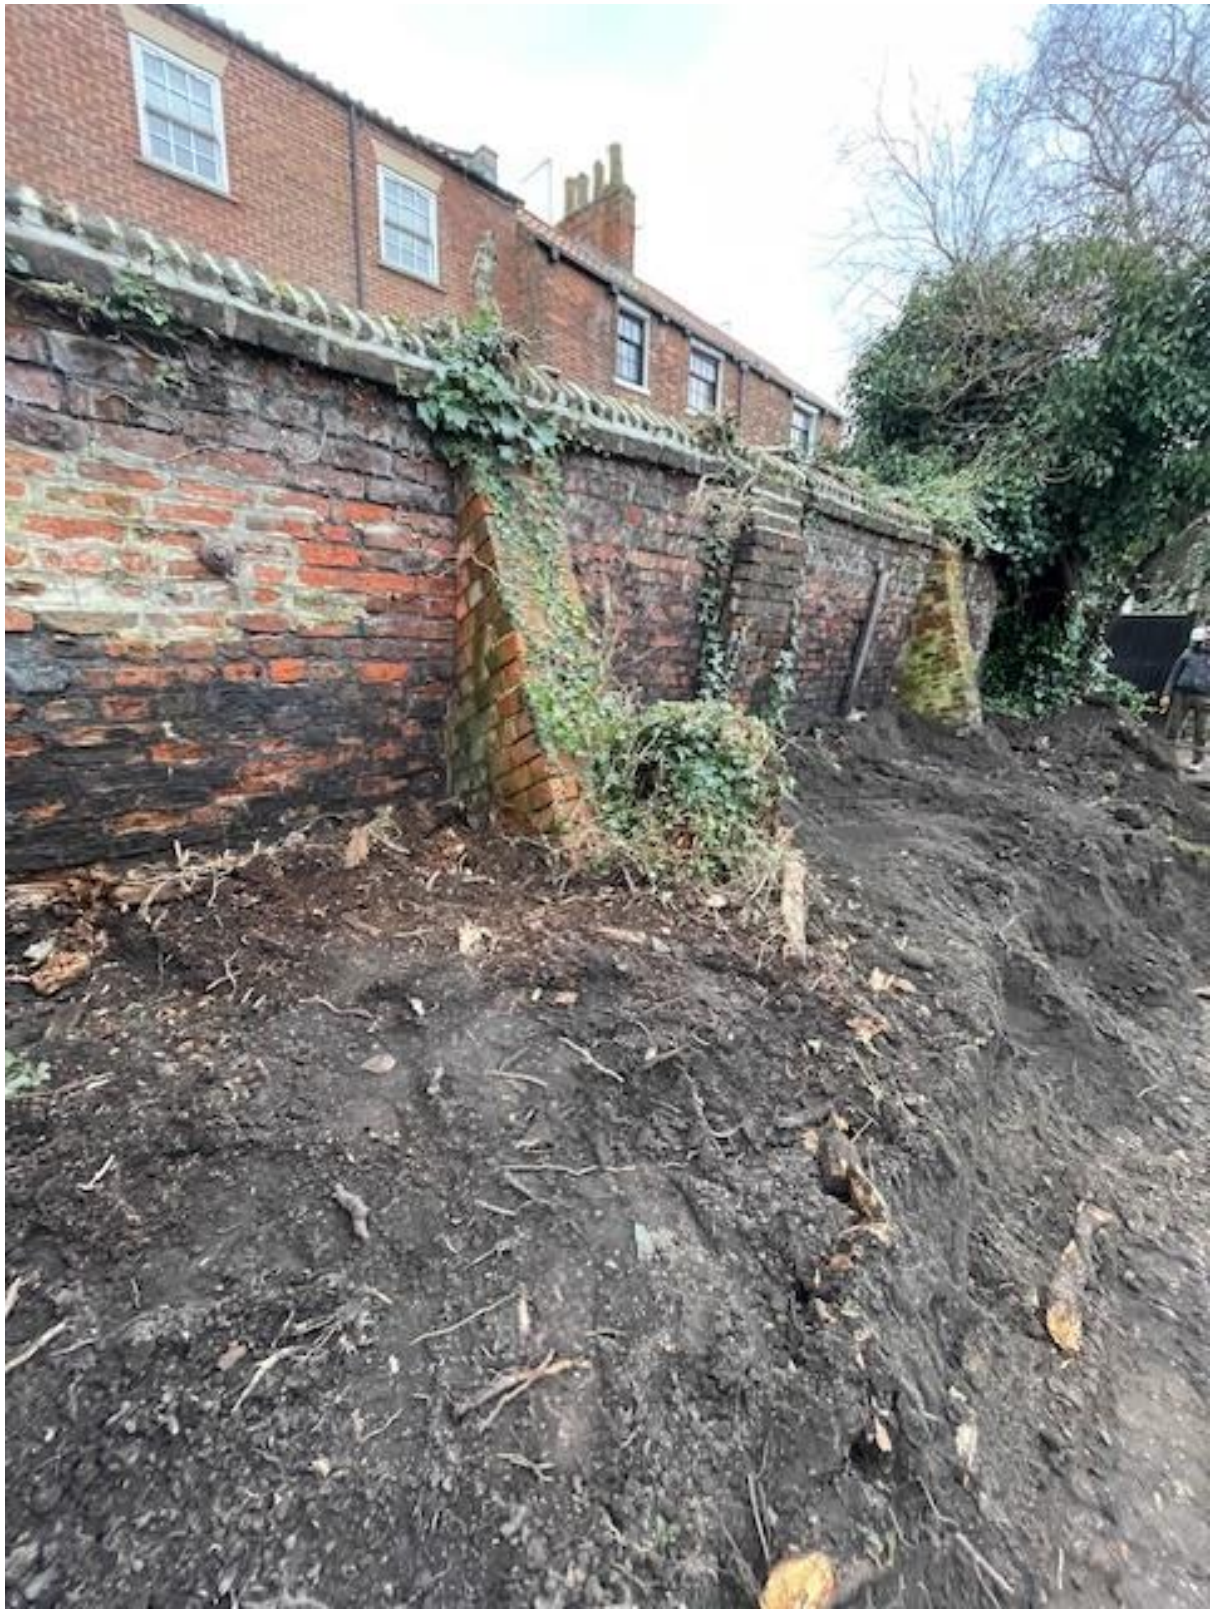
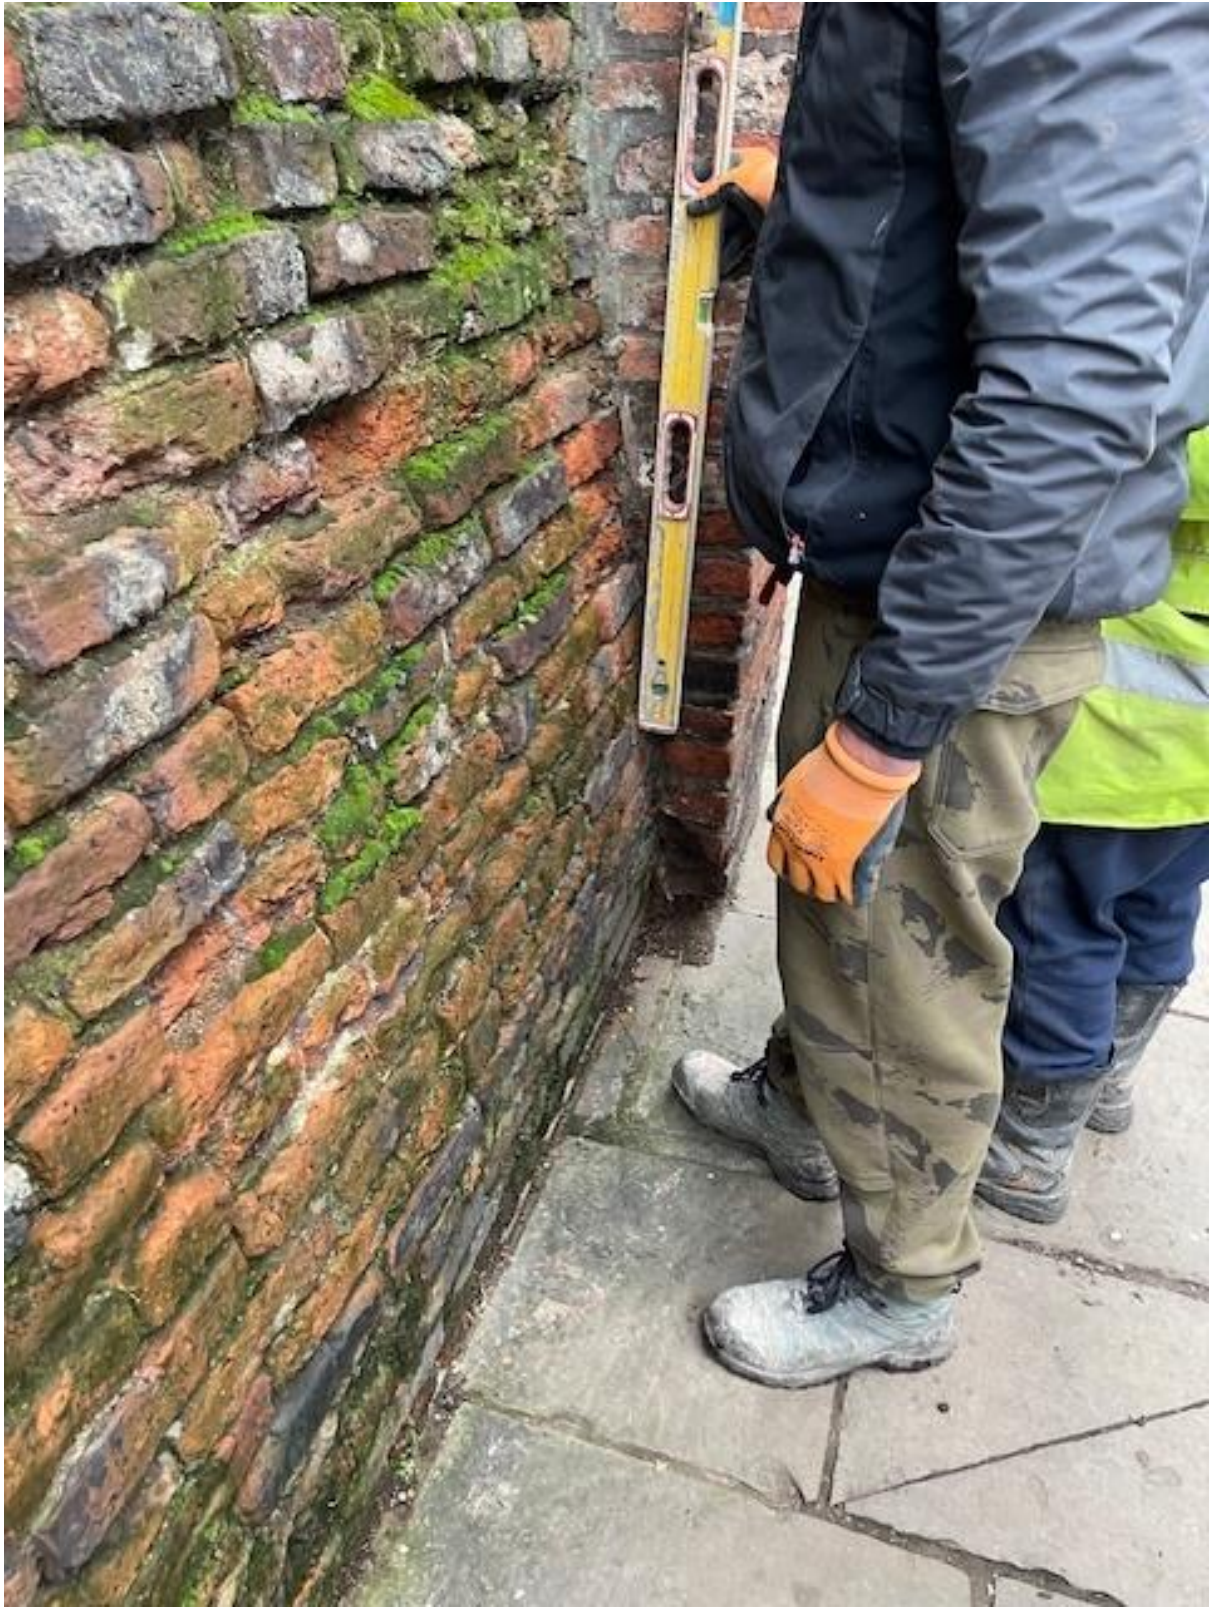
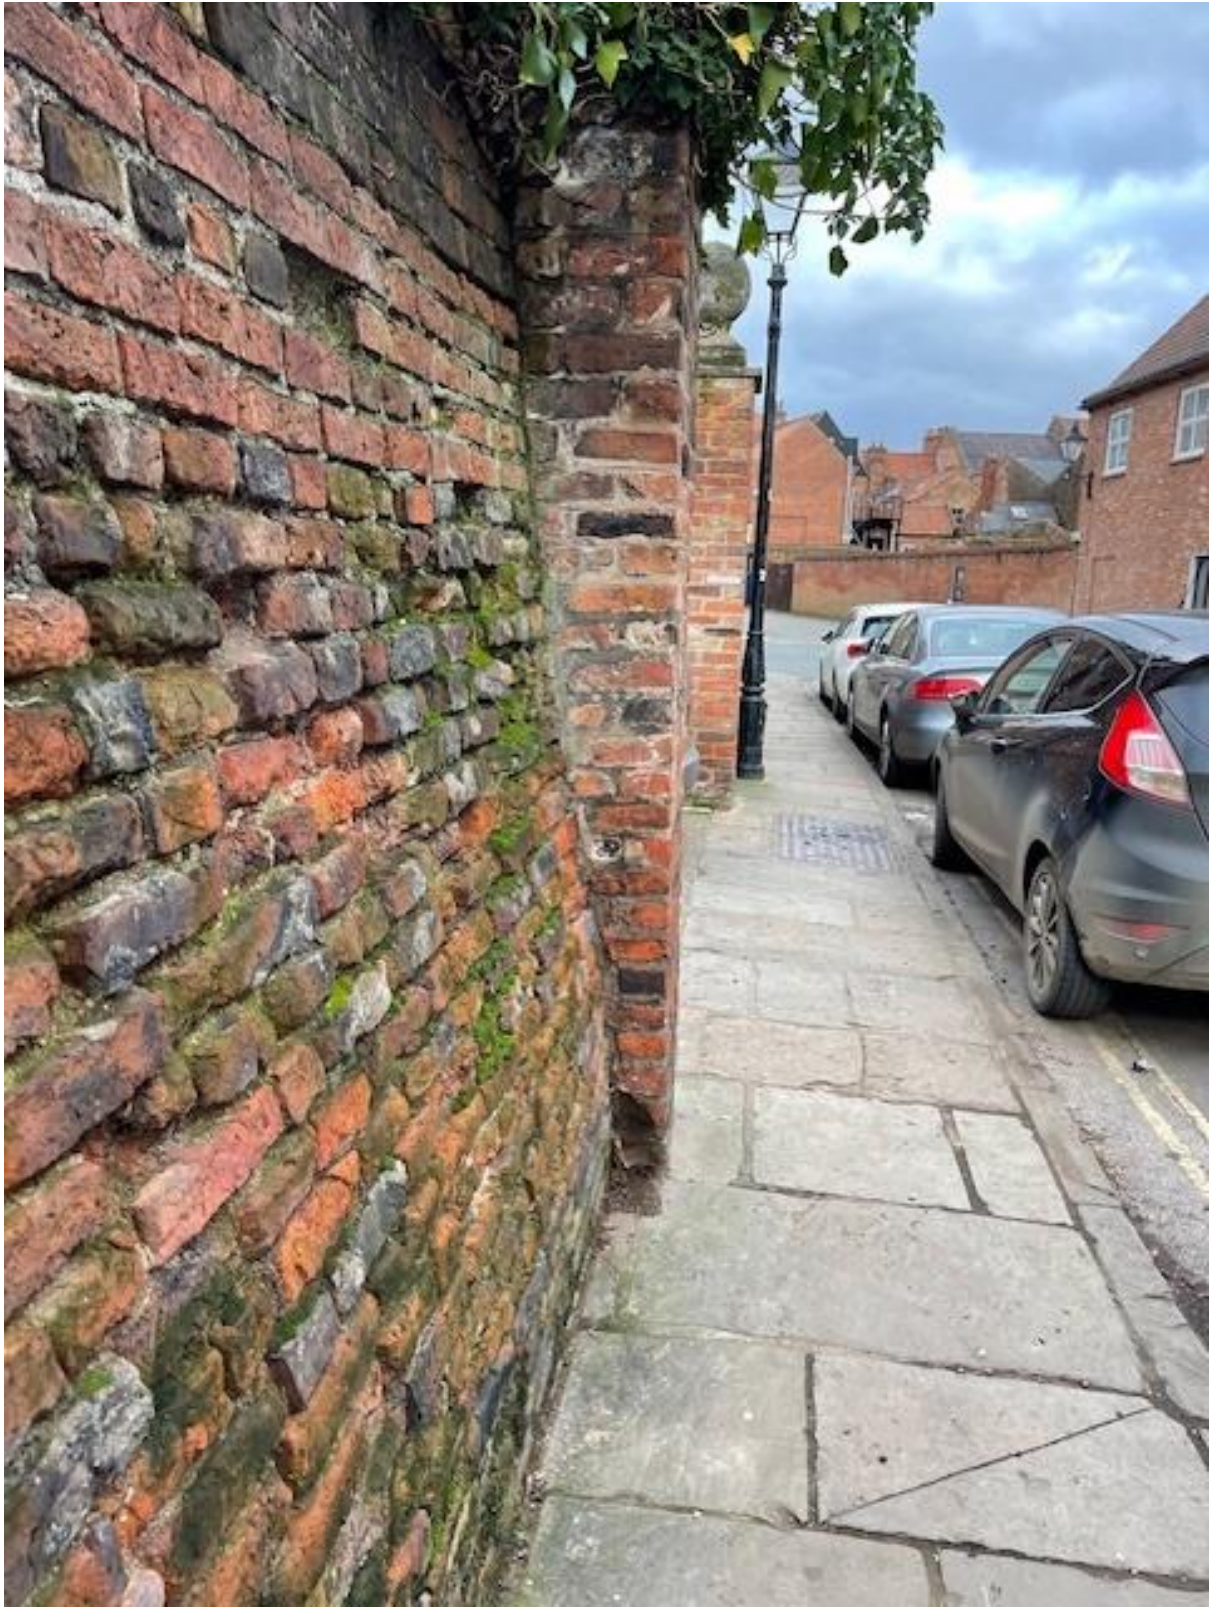
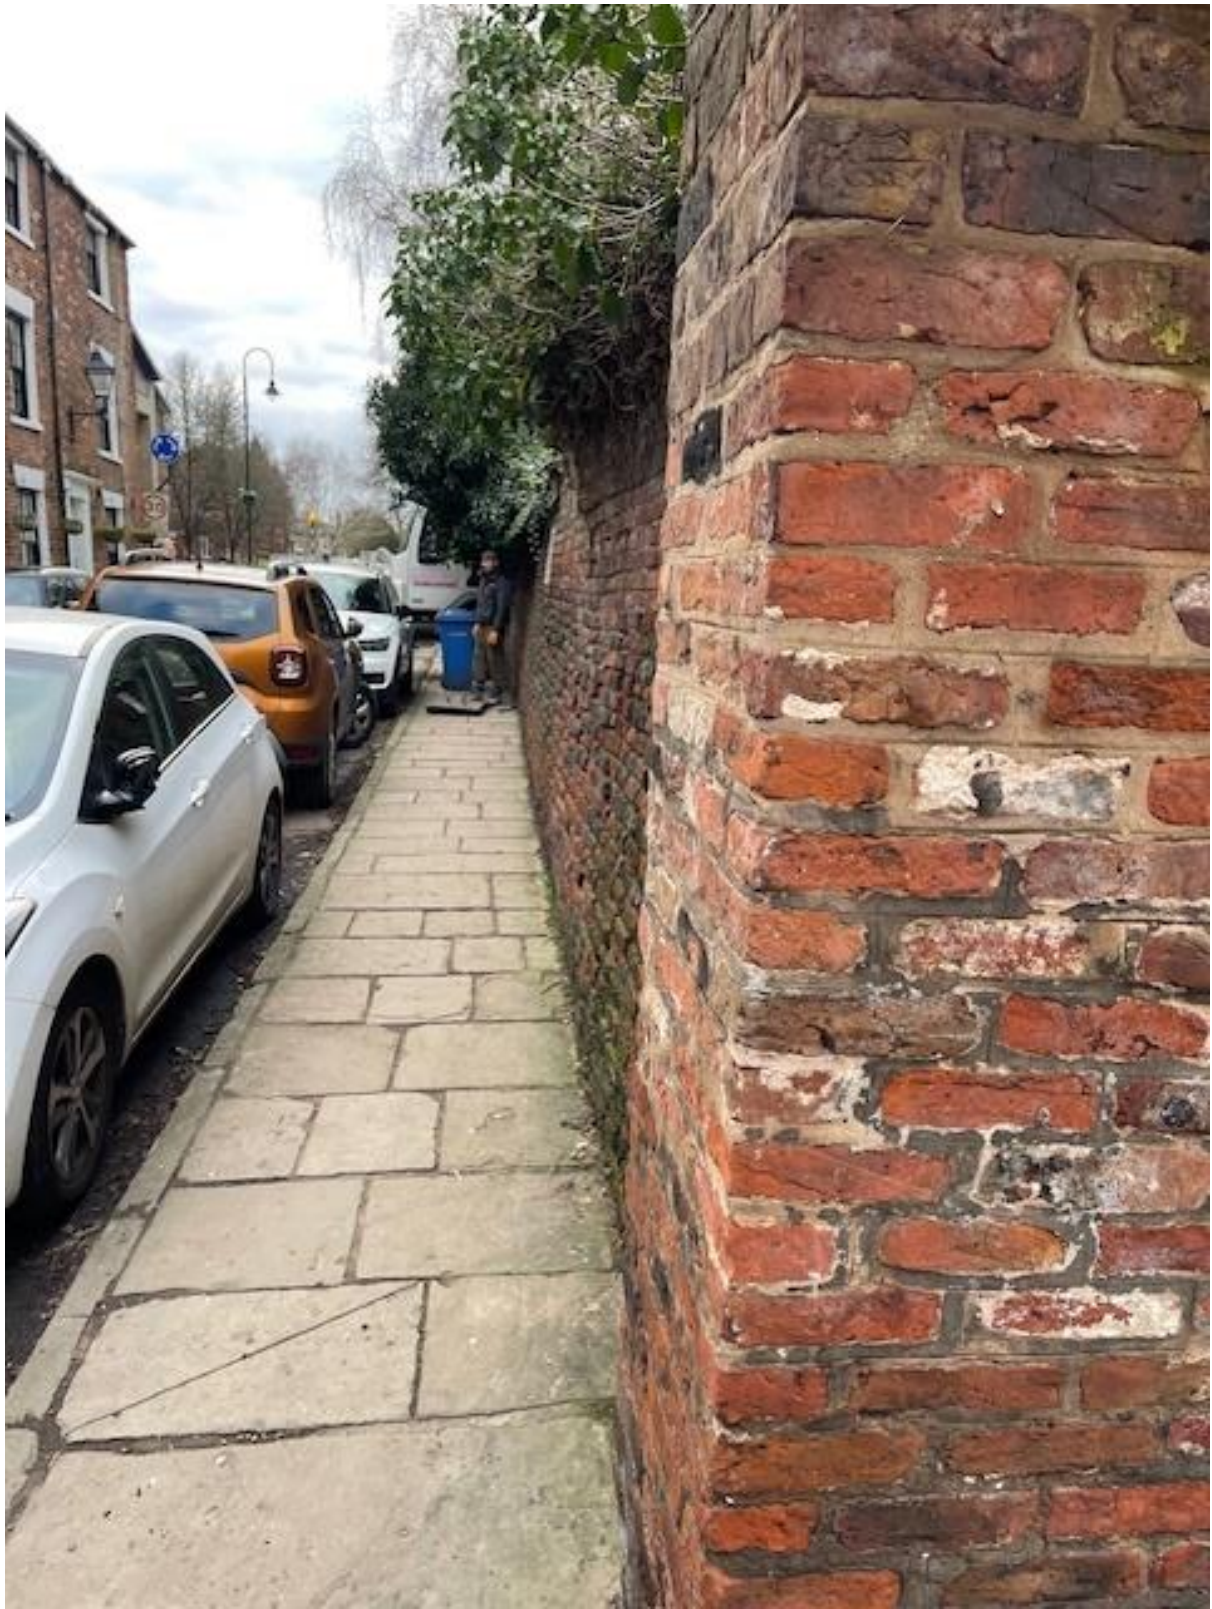
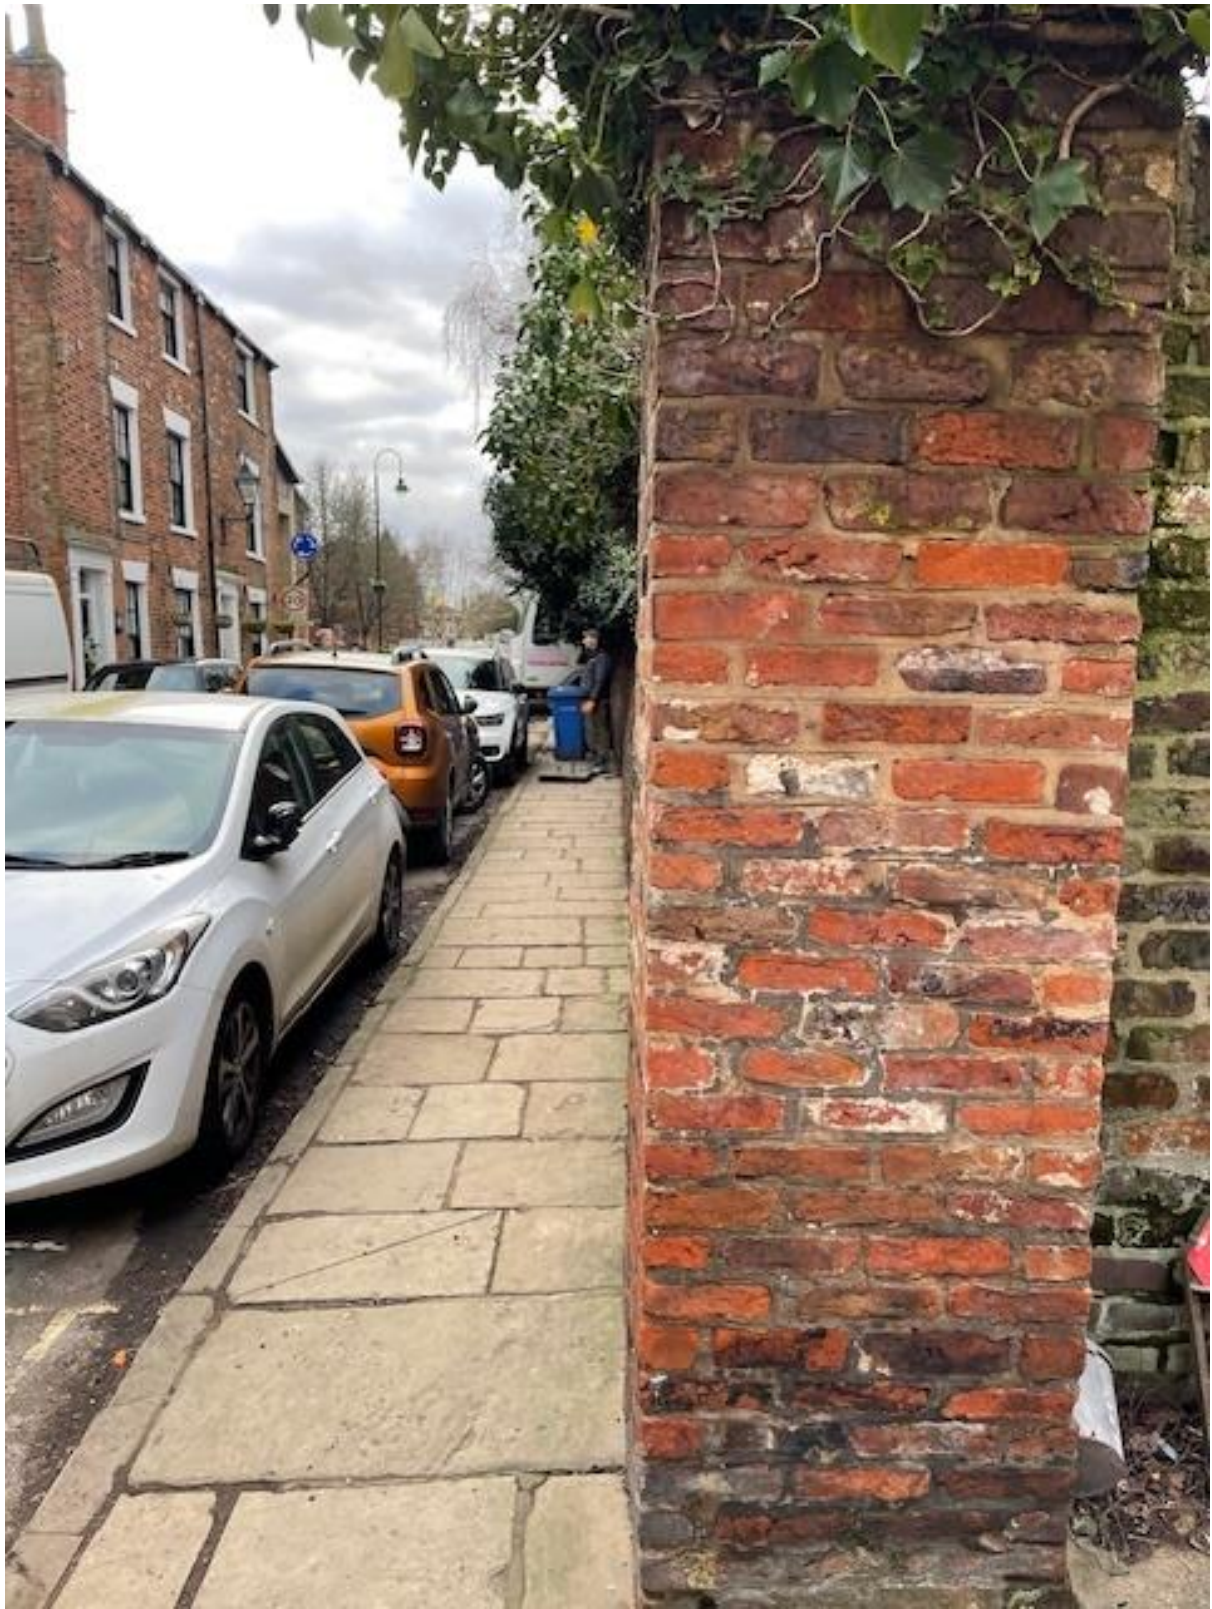
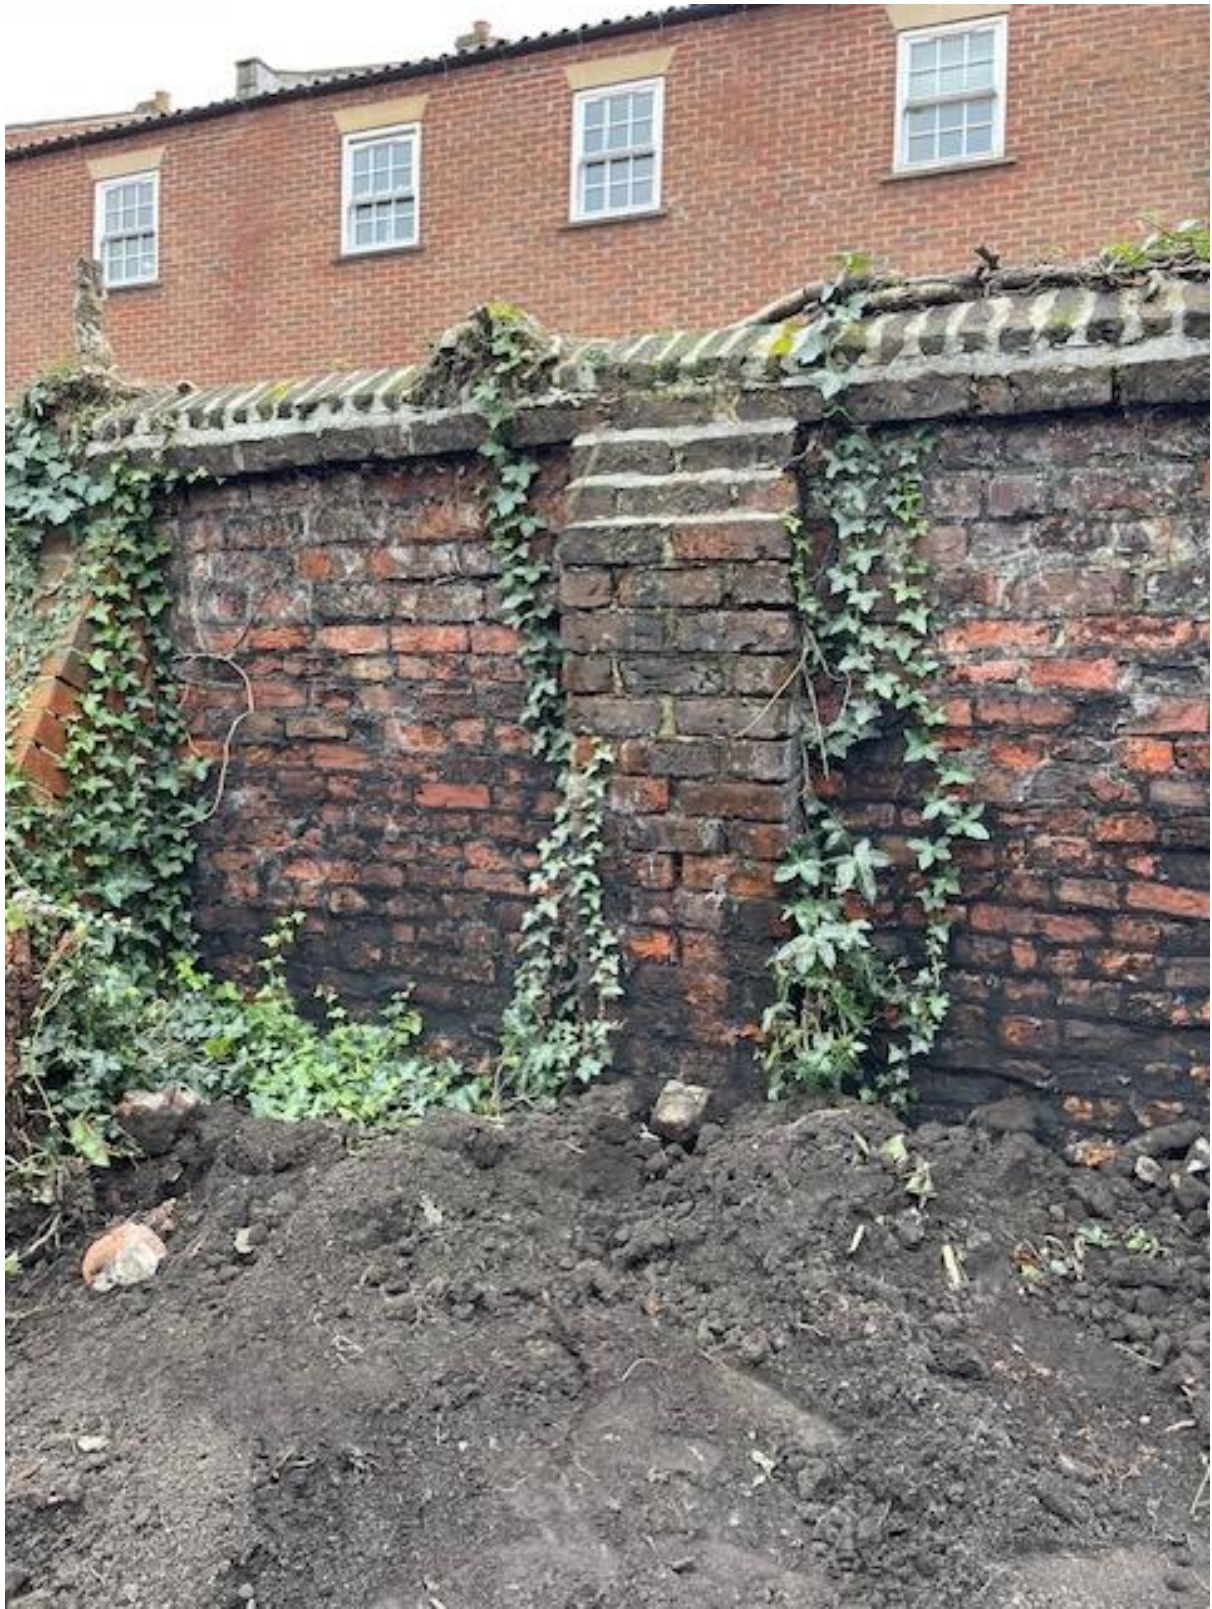
2.0 Existing Wall Photographs

2.1 Photographs taken Prior to demolition during site clearance.

- 2.1 The existing wall has been demolished to below ground level to what has been determined as a solid foundation for rebuilding of the wall.
- 2.2 The wall as it is, has been altered over its life and is comprised of 2" bricks mainly especially on the Well Lane Elevation with the upper courses being 3" bricks. 3" bricks have been used to patch and strengthen the wall at points of its life.

- 2.3 The 3" bricks make up the upper 5-8 courses of brickwork and patching and repairs along the length of the wall to the garden side.
- 2.4 The top of the wall was dressed in a saddleback brick capping which appears to correspond to a later addition to the wall and it is not clear what date these works took place as either an early 20th century addition or a later 20th century repair along with the buttresses.
