## **Arboricultural Impact Assessment**

### **& Method Statement:**

Land to rear of Sturt Avenue  
Camelsdale  
Haslemere  
Chichester  
West Sussex  
GU27 3SJ

Ref: jwmb/rpt2/sturtavenue/AIAAMS

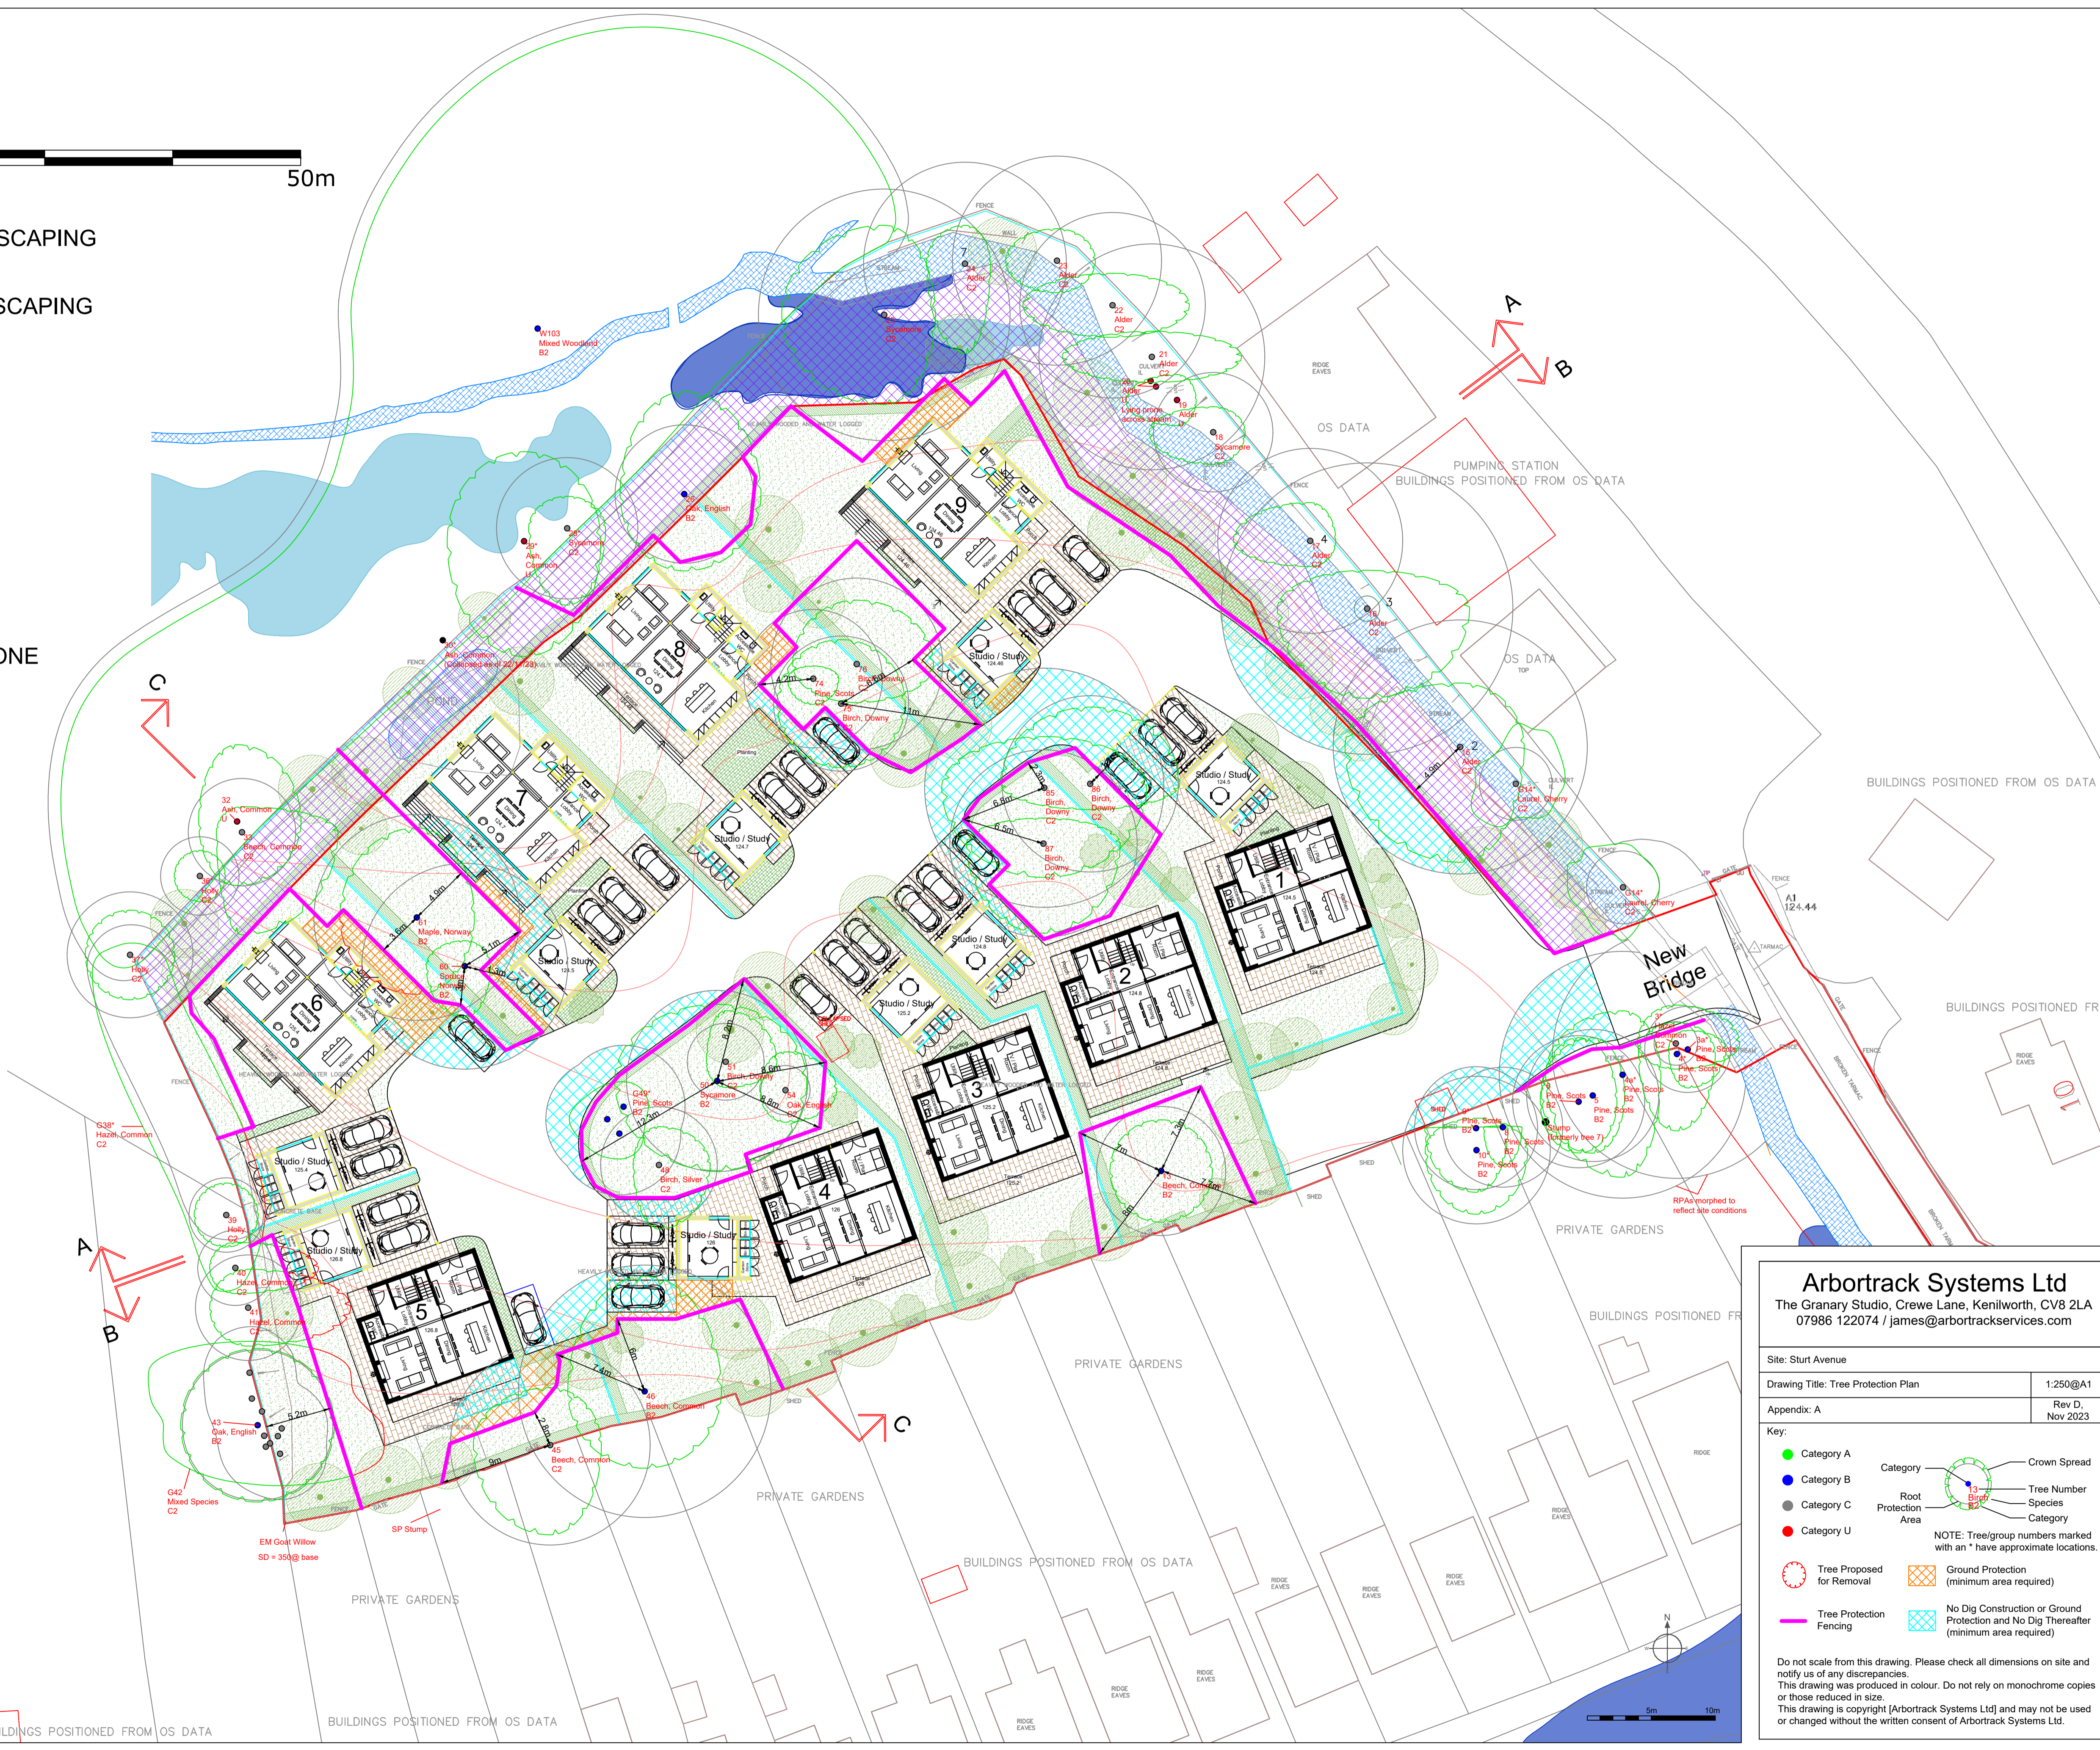
Site: Sturt Avenue  
 Drawing Title: Tree Protection Plan 1:250@A1  
 Appendix: A Rev D, Nov 2023

2.3.1 The TPB must be comprised of a vertical and horizontal scaffold framework, braced to resist impacts, with vertical tubes spaced at a maximum level of 3m. On to this, weldmesh panels should be securely fixed with wire scaffold clamps: see section 6.2.2 and Figure 2 of BS5837:2012 (Appendix C). Hardboard or marine ply sheets can be used as an alternative to weldmesh panels, but these must be fixed firmly to the framework. The location of the TPB is shown in Appendix A.

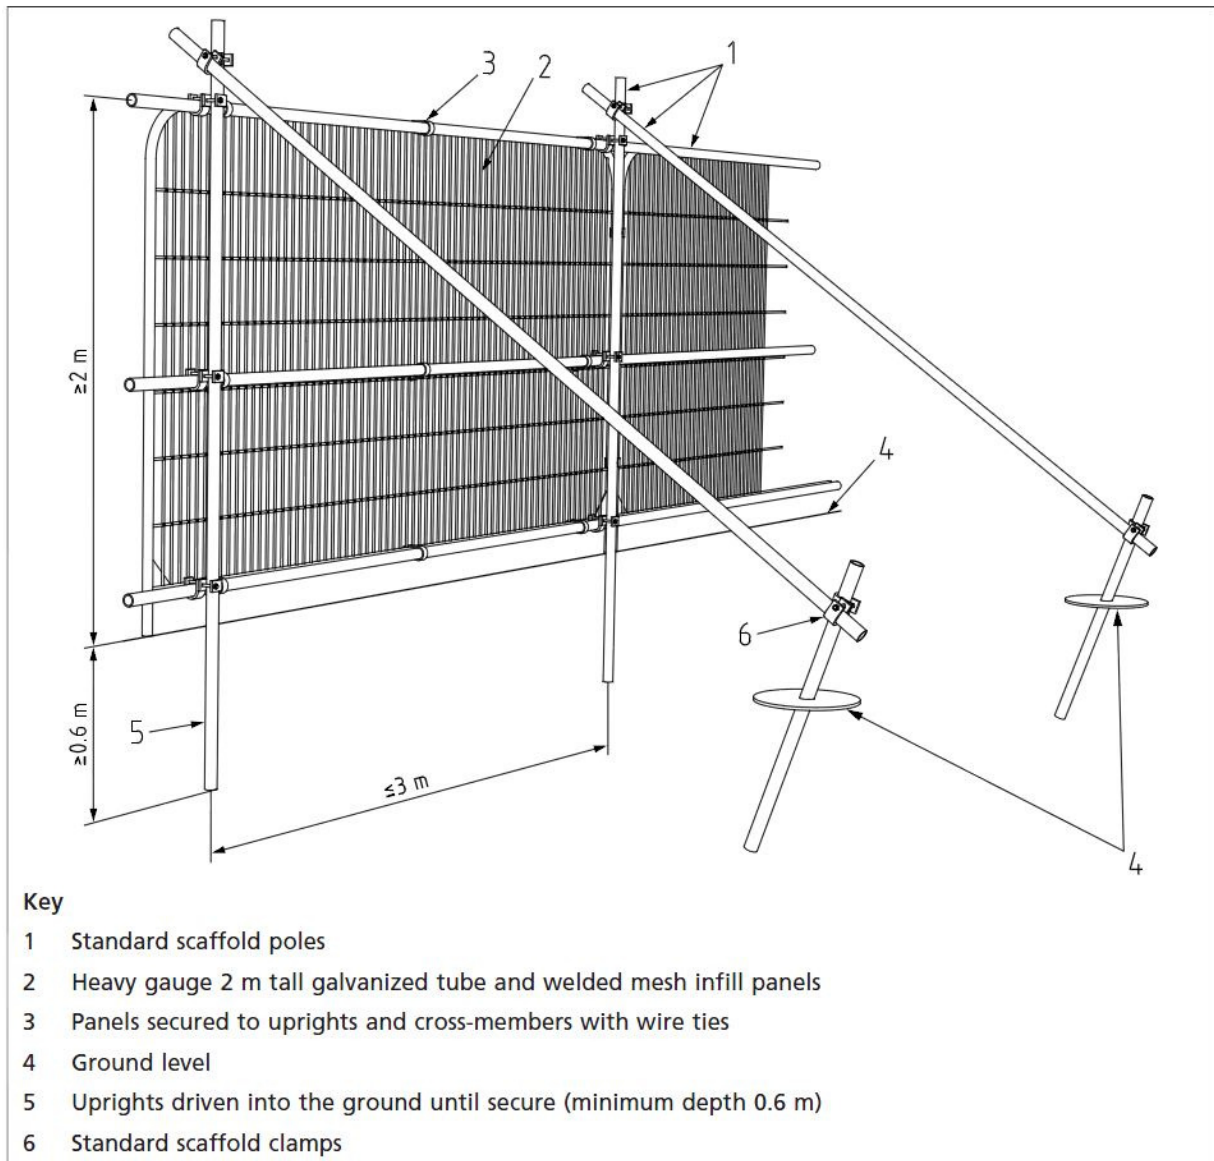
Appendix C Tree Protective Fencing Detail (from BS5837:2012)

Figure 2 Default specification for protective barrier

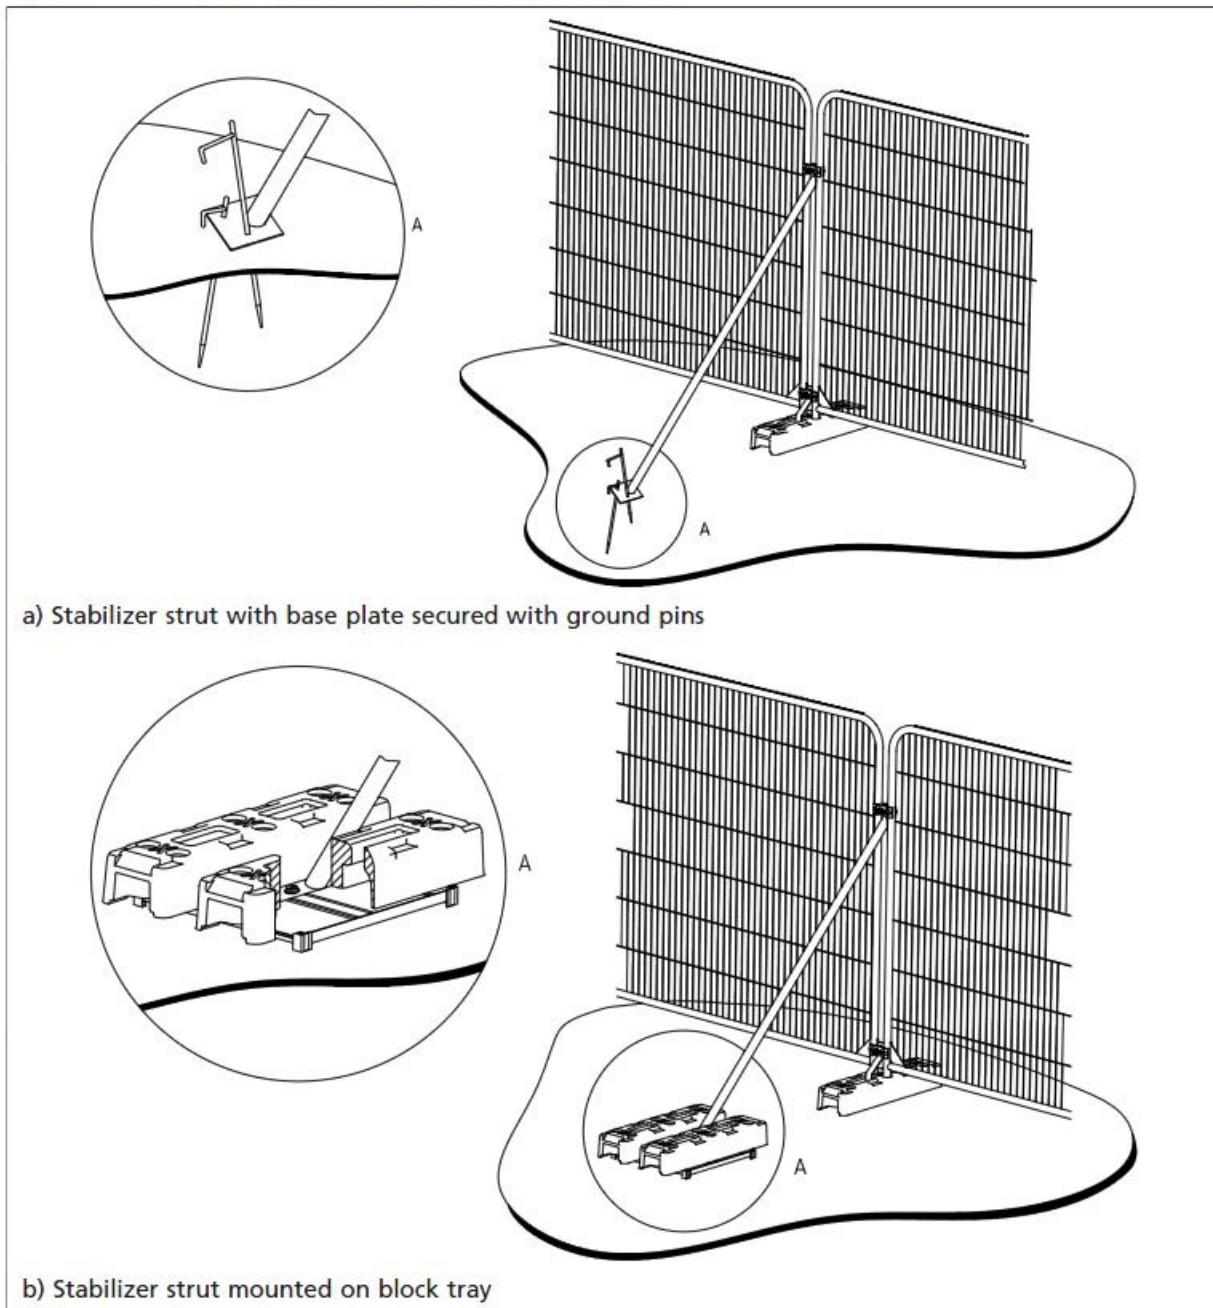
Figure 3 Examples of above-ground stabilizing systems

a) Stabilizer strut with base plate secured with ground pins

b) Stabilizer strut mounted on block tray

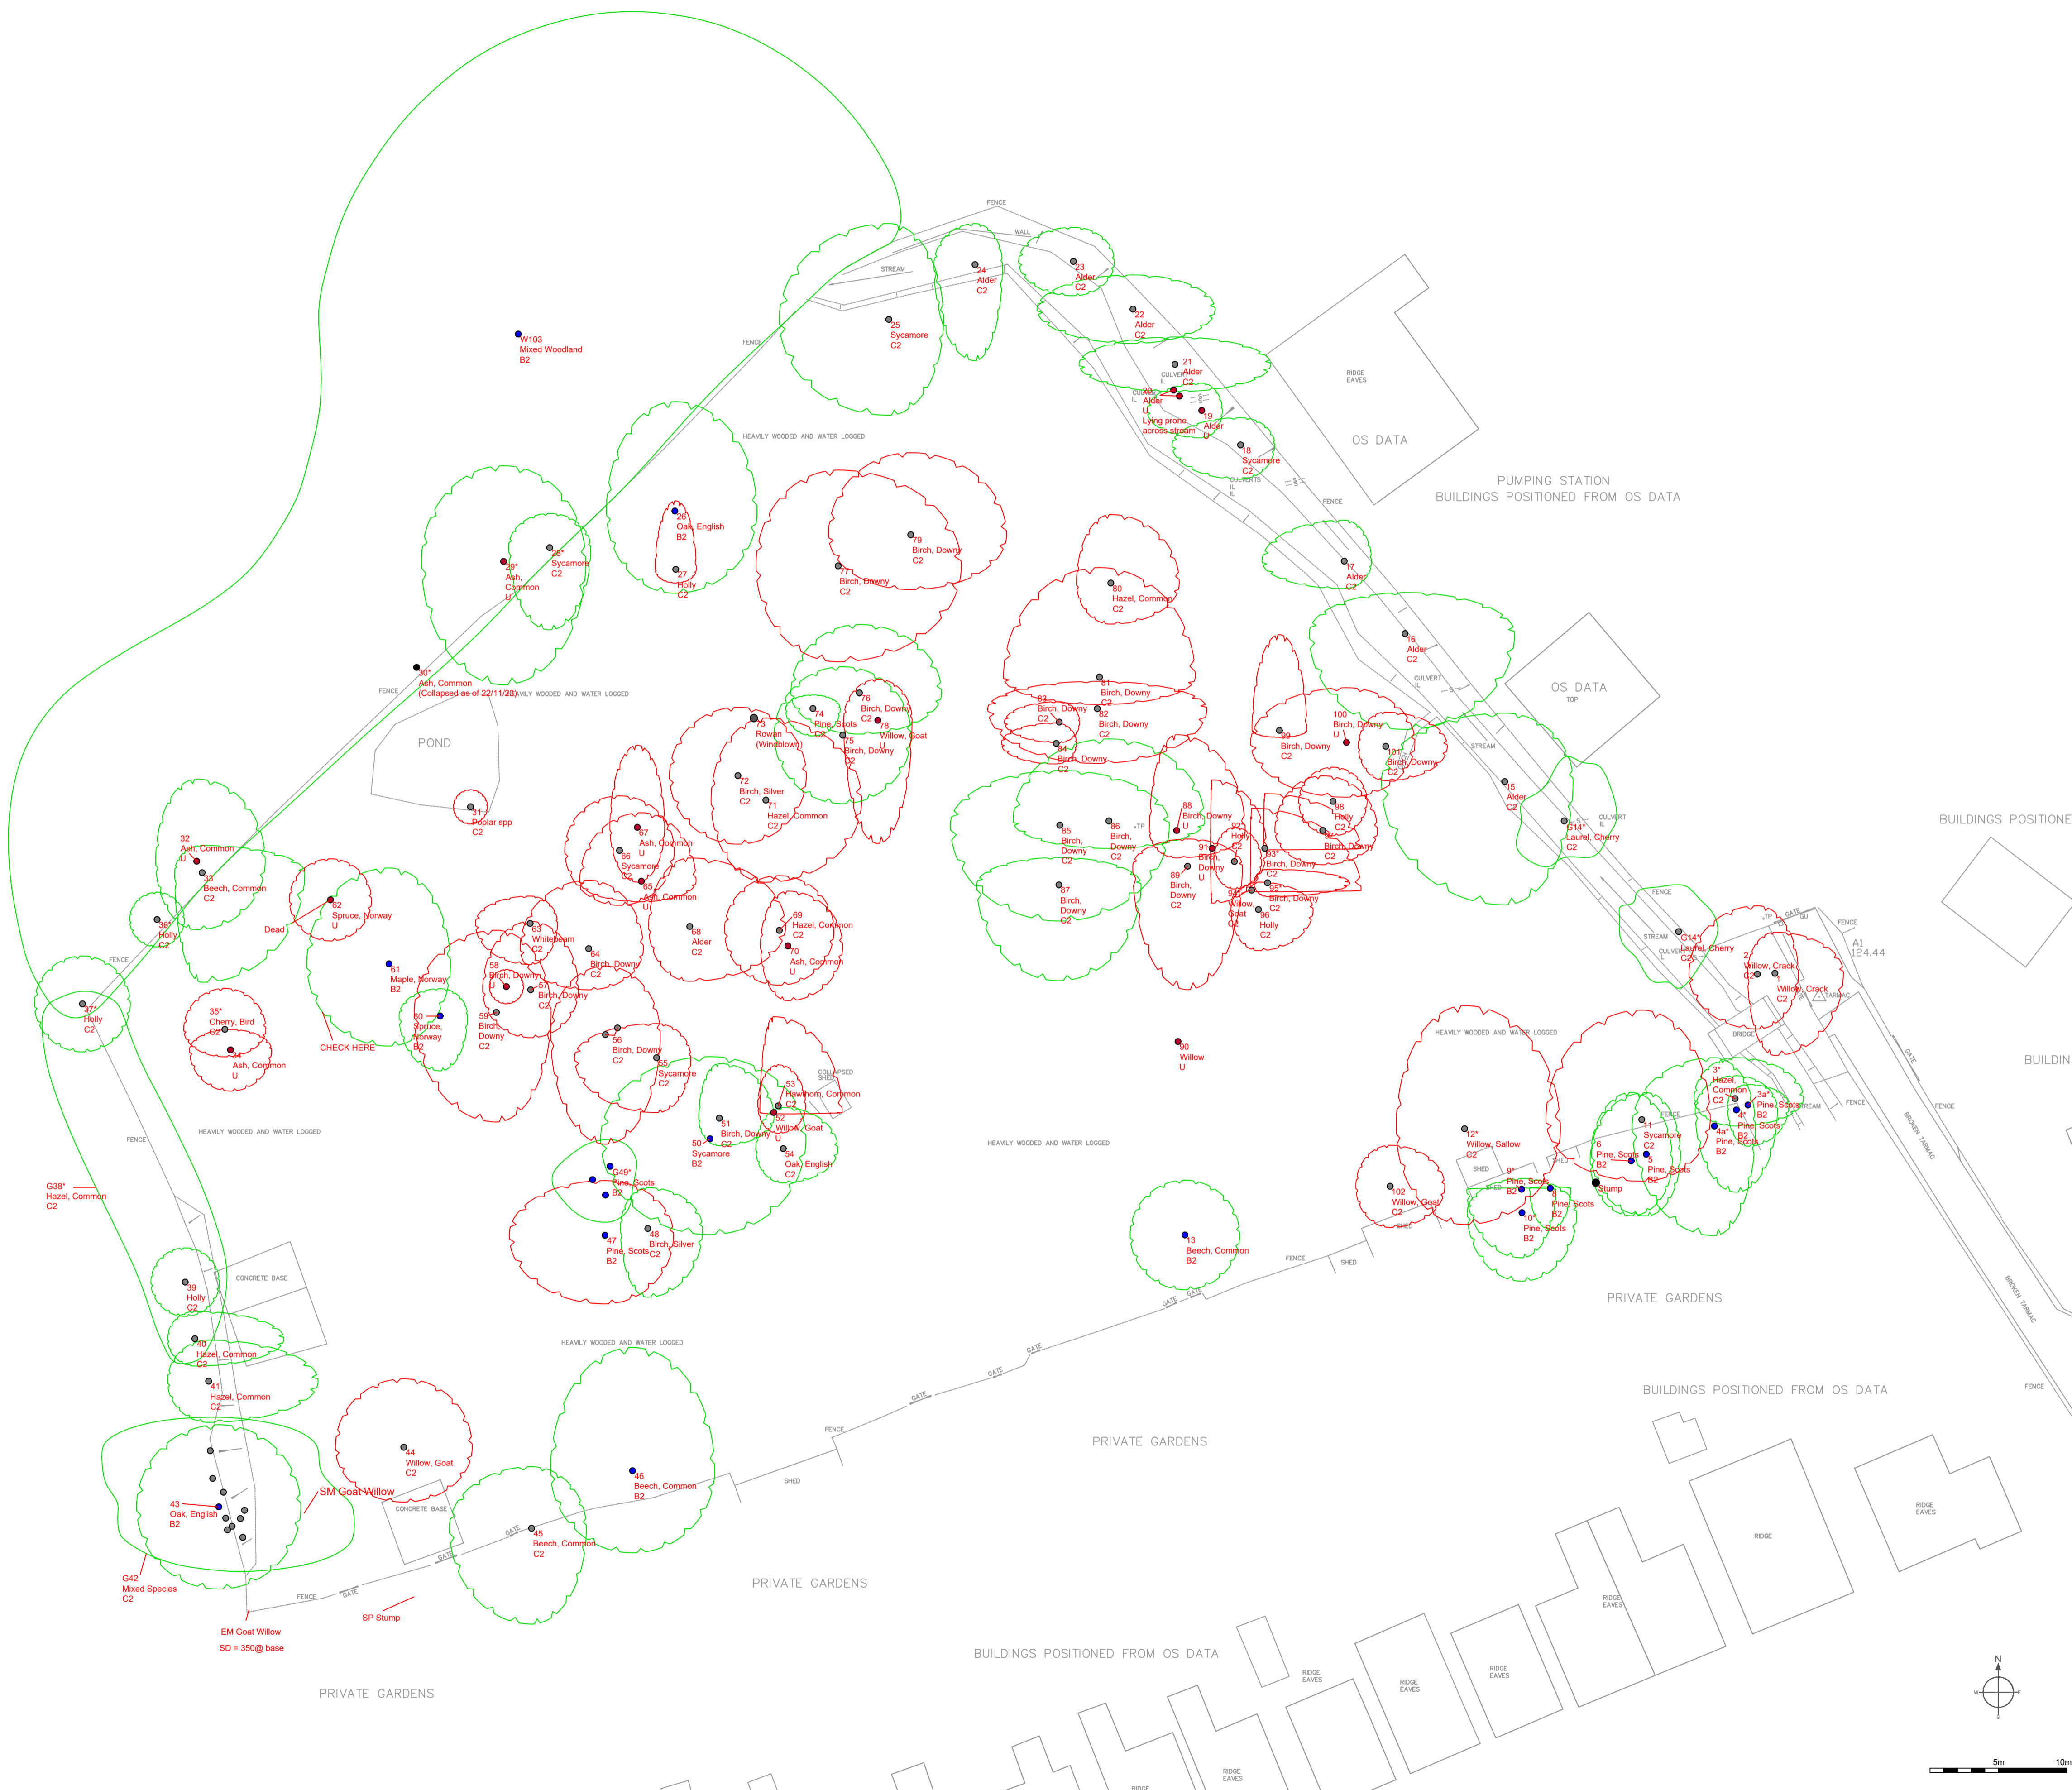
Site: Sturt Avenue  
 Drawing Title: Tree Constraints Plan (Trees for Removal) 1:250@A1  
 Appendix: F Rev B, Nov 2023
