PROPOSED HOUSES, FORMER DEXTER PAINTS
GANNOW LANE, BURNLEY, BB12 6JG
PRELIMINARY RISK ASSESSMENT (DESK STUDY) – Amended 25.02.2022

A residential development is proposed. The objective is to carry out a Preliminary Risk Assessment (PRA) to consider contamination, landfill, geotechnical and coal mining issues. This is an amended version of our previous report following a change in design.

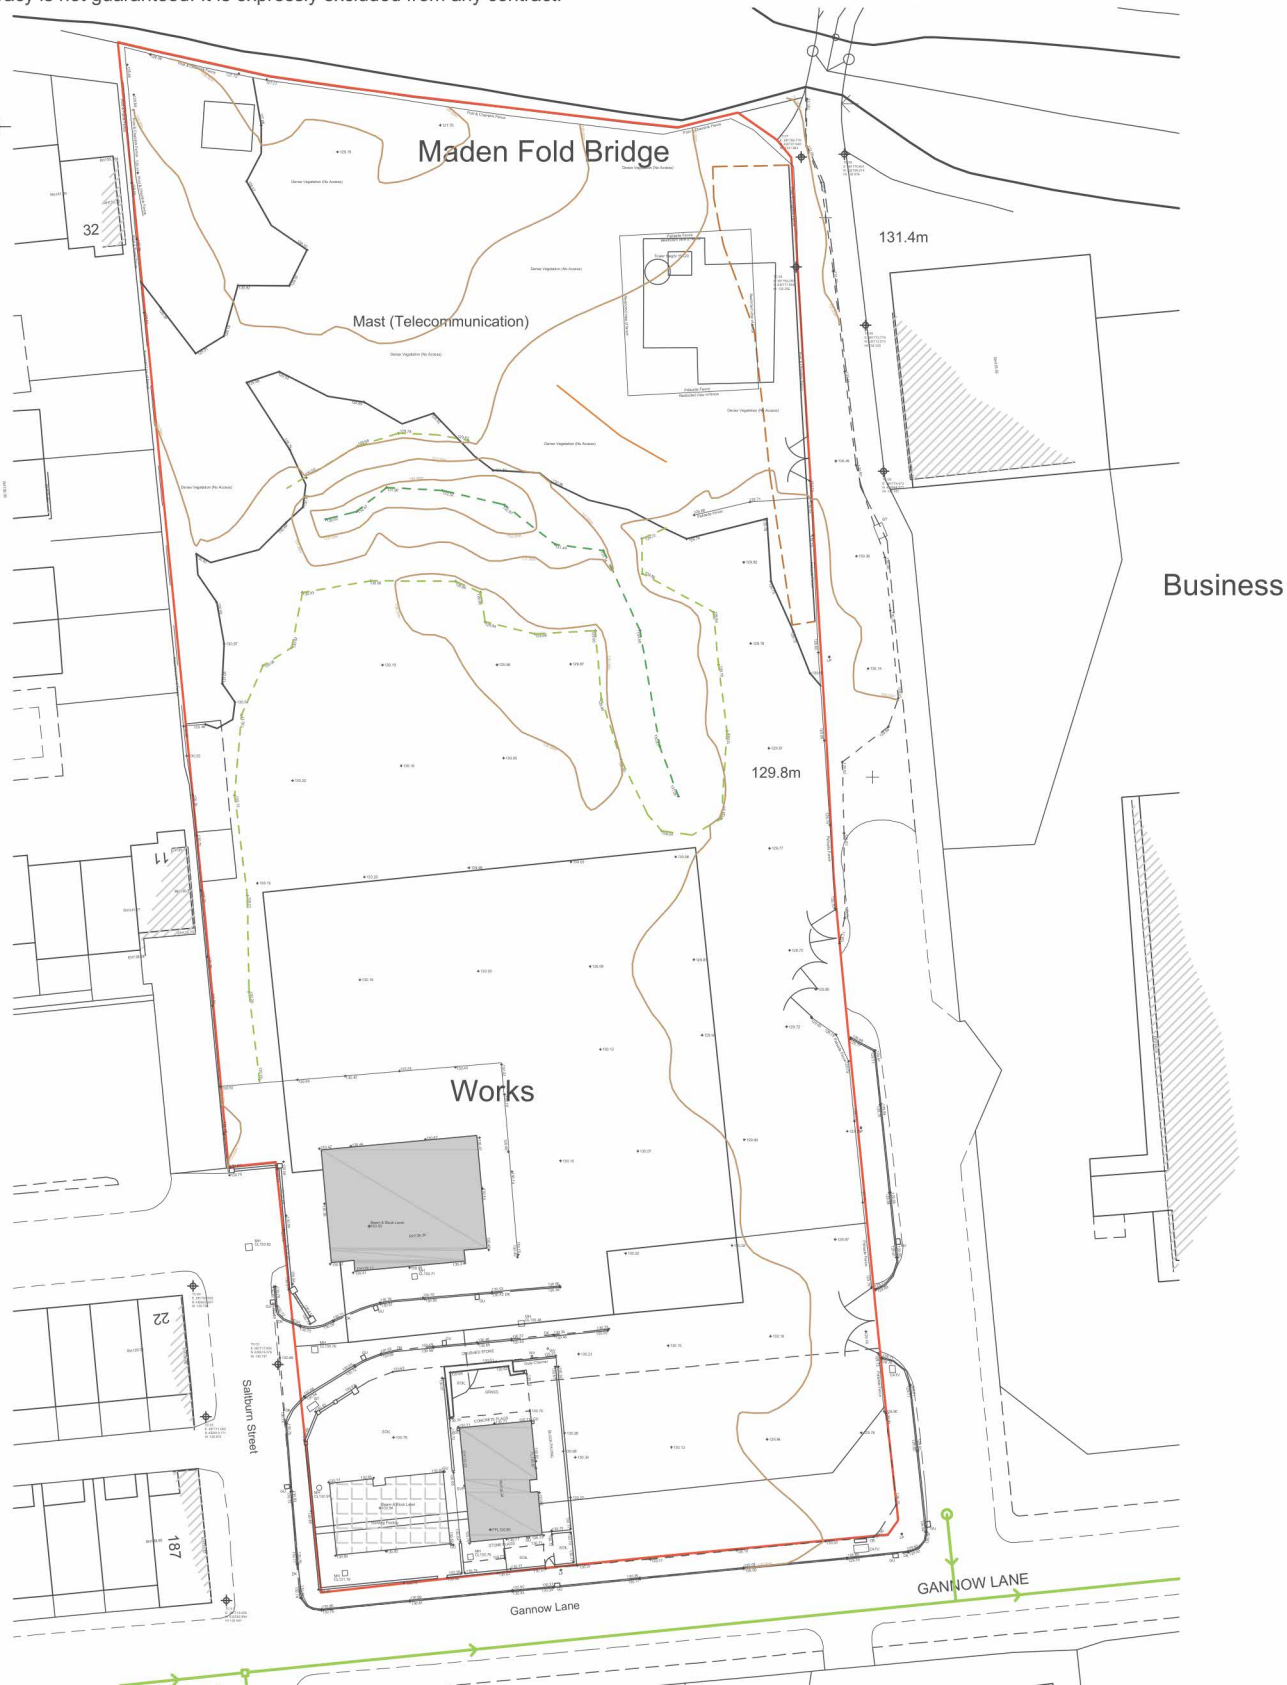
EXISTING SITE PLAN

Site: Former Dexter
Paints, Unit 15, Gannow Lane, Burnley

The site, a rectangular plot 135 by 60m, is located to the north of Gannow Lane in Burnley, and at OS Grid Reference 381740, 432670. The site, inspected on 16/4/20 by Mr M Whitaker, mostly comprised a vacant site. A berm, across the north of the site, split the north (overgrown with a telecom mast at the northeast corner), from the rest of the site. The centre of the site was vacant, mostly surfaced with hardcore/rubble, with piles of fly-tipped material and building materials. At the southwest were two modern bungalows, with the foundations for a third in place. In recent years the south of the site was used for car sales, with a small office, now demolished. A former, demolished, building at the south/middle was occupied by a paint manufacturer. The site slopes down to the north.
