# ARBORICULTURAL IMPACT ASSESSMENT

(INC. TREE SURVEY TO BS 5837:2012)

CLIENT - Uppingham School  
PROJECT - Meadhurst  
DOC. REF - P1845-MEAD-AIA01 V2  
PLANNING REF - n/a  
CREATION DATE - 29/01/2024

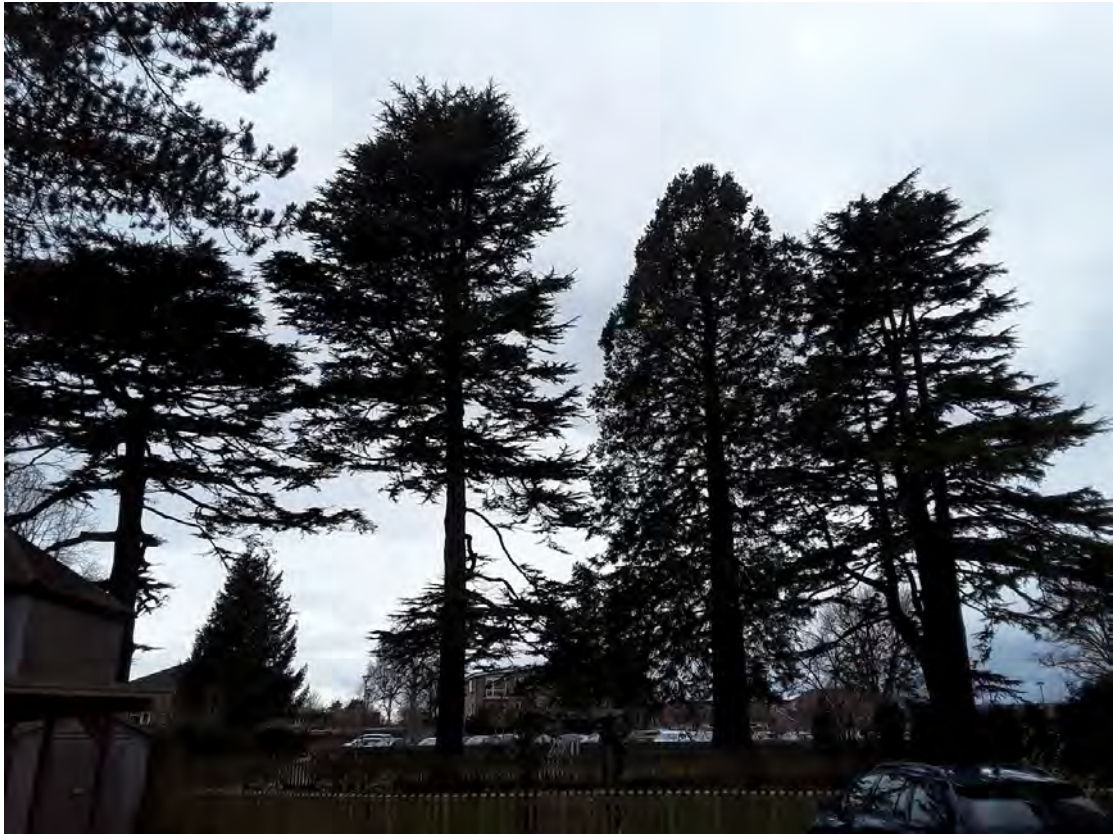
*Figure 2 – Looking westwards at T34-T36, all Cat. 'A' trees.*

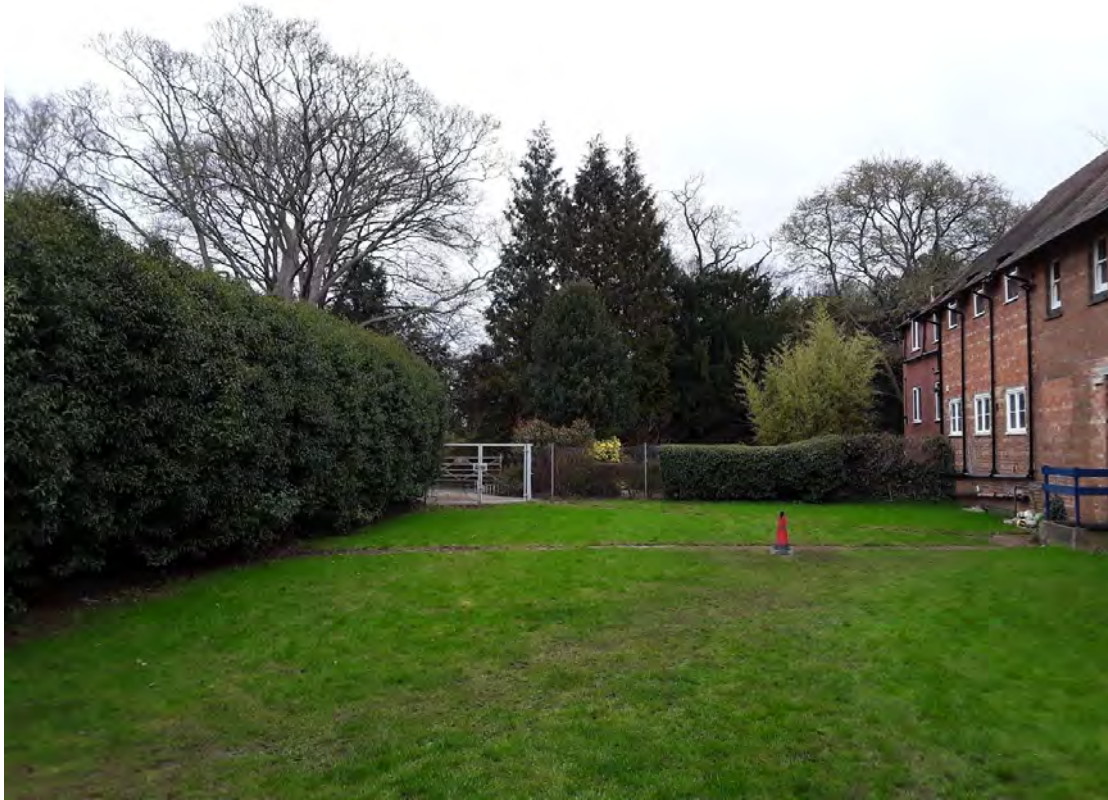
*Figure 3 – Looking northwards with H3 to the left of the photo and the existing building to the right.*

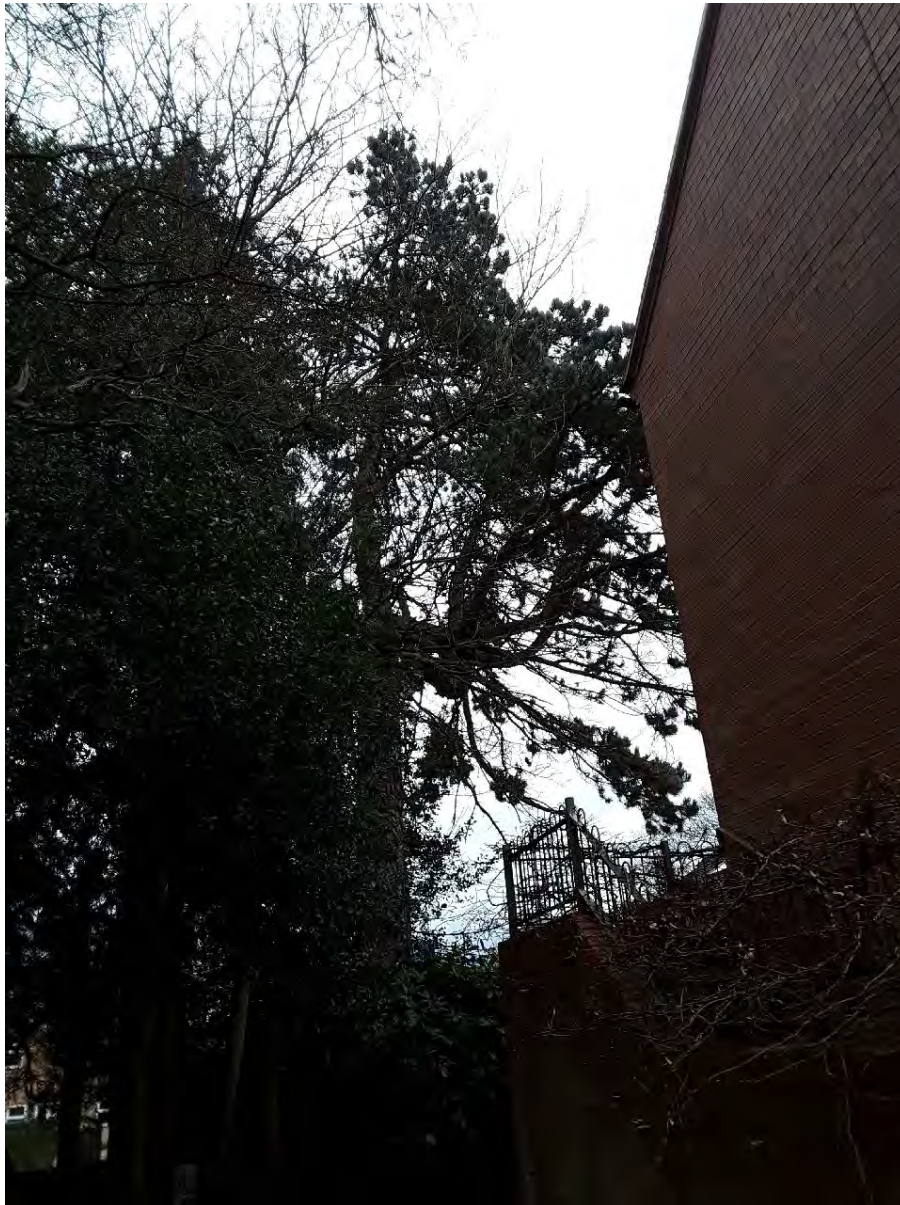
*Figure 5 – T28.*

T27		Ilex spp. (Holly)	16	3 / 3 / 3 / 3	1.5	170	Semi-Mature	Good	Good	Estimated height used.				Good	2.0	13.1	B3
T28	1 3 9 1	Pinus nigra (Austrian pine)	21	4.5 / 9.5 / 9 / 5.5	5	790	Mature	Good	Good	Estimated northern and southern crown. Southern canopy consisting of significant size lateral scaffold limb that overhangs adjacent building, unable to assess branch union but no obvious signs of defect or cause for concern. Moderate amount of minor size deadwood predominantly in mid to bottom of crown with a low to moderate risk of harm posed.				Good	9.5	282.3	A3
T29		Sequoia giganteum (Giant redwood)	3	0.5 / 0.5 / 0.5 / 0.5		70	Young	Good	Good				Transplant to elsewhere in school site.	Moderate	0.8	2.2	C3
T30		Sequoia giganteum (Giant redwood)	3	0.5 / 0.5 / 0.5 / 0.5		70	Young	Good	Good				Transplant to elsewhere in school site.	Moderate	0.8	2.2	C3
T31		Sequoia giganteum (Giant redwood)	3	0.5 / 0.5 / 0.5 / 0.5		70	Young	Good	Good				Transplant to elsewhere in school site.	Moderate	0.8	2.2	C3

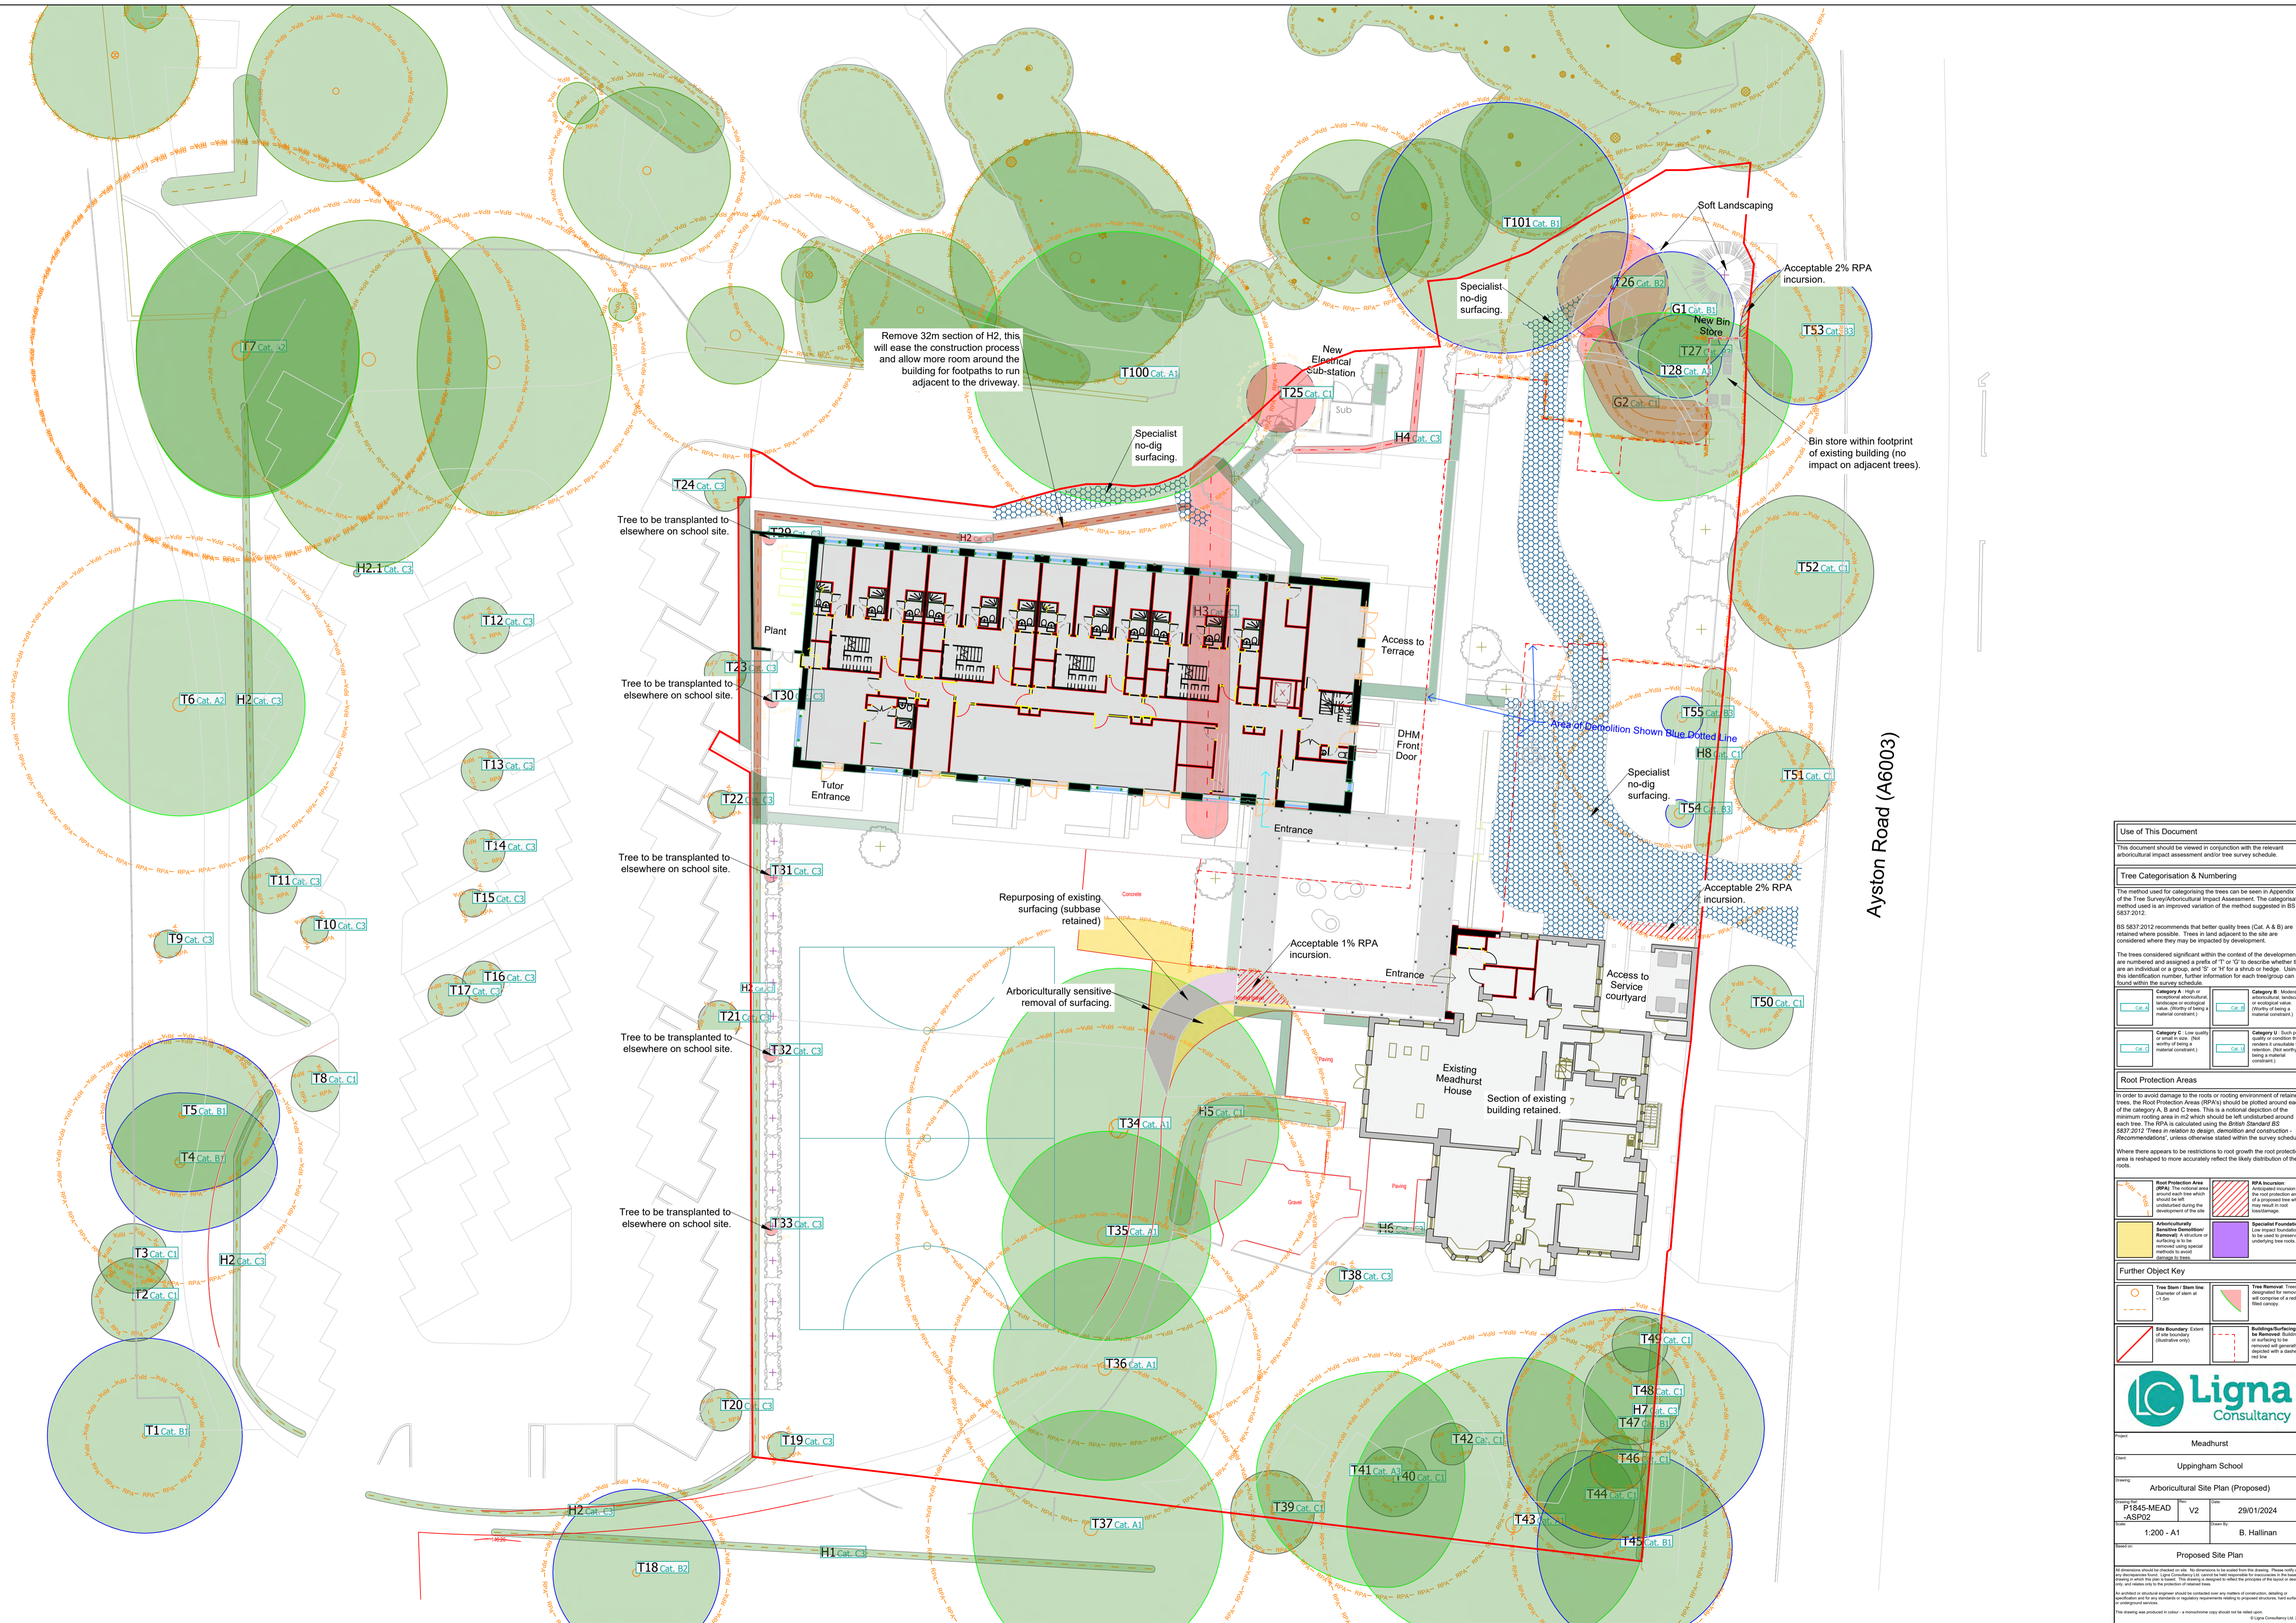
## ARB. SITE PLAN (PROPOSED)

Tree to be transplanted to elsewhere on school site.

Appendix	Document
1	Tree Survey
2	Site Photos
3	Arboricultural Site Plan (Existing) (P1845-MEAD-ASP01)
4	Arboricultural Site Plan (Proposed) (P1845-MEAD-ASP02)
