DORMER CONSTRUCTION

To achieve minimum U Value of 0.28W/m²K

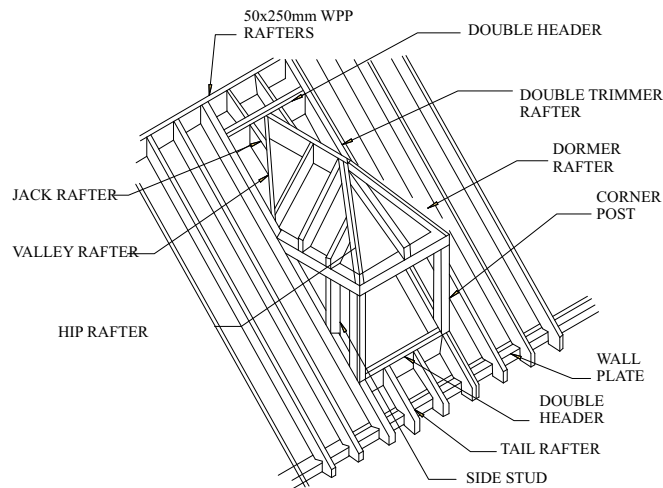
Structure to engineer's details and calculations. Render finish (to comply with BS EN 13914-1:2005) - applied in 3 coats at least 20mm thick to stainless steel render lath. Render should be finished onto an approved render stop. Render lath fixed to vertical 25 x 50mm preservative treated battens to provide vented and drained cavity, fixed to breathable membrane (having a vapour resistance of not more than 0.6 MNs/g) and 12mm thick W.B.P external quality plywood sheathing (or other approved). Ply fixed to treated timber frame studs constructed using 150mm x 50mm head and sole plates and vertical studs (with noggins) at 400mm centres or to structural engineer's details and calculations. Insulation between and over studs; 100mm Kingspan ThermaWall TW55 plus VCL and 22mm Gyproc Thermaline Basic plasterboard with 3mm light weight skim of finishing plaster over.

All junctions to have water tight construction, seal all perimeter joints with tape internally and with silicon sealant externally. Dormer walls built off existing masonry walls to have galvanised mild steel straps placed at 900 centres. Dormer cheeks within 1m of the boundary to be lined externally with 12.5mm Supalux and 12.5mm Gyproc FireLine board internally to achieve 1/2 hour fire resistance from both sides

Construct ceiling using sw joists at 400mm centres, finished internally with 12.5mm plasterboard and min 3mm thistle multi-finish plaster. Provide polythene vapour barrier between insulation and plasterboard. TYVEK breathable roofing felt. 100mm Kingspan ThermaWall TW55 between ceiling joists plus VCL and 22mm Gyproc Thermaline Basic plasterboard with 3mm light weight skim of finishing plaster over.

Restraint strapping -100mm x 50mm wall plate strapped down to walls. Ceiling joists and rafters to be strapped to walls and gable walls, straps built into cavity, across at least 3 timbers with noggins. All straps to be 1000 x 30 x 5mm galvanized straps or other approved to BSEN 845-1 at 2m centres

PITCHED ROOF INSULATION WHERE CEILING FOLLOWS RAFTER LINE
 Insulate between the rafters using two layers of Kingspan K7 rigid phenolic board (50mm layers) - no void ventilation is required - use Tyvek roofing felt throughout. Ceiling to be 12.5mm plasterboard and skim..

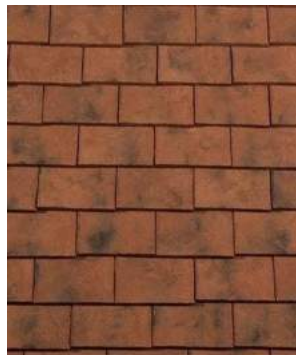
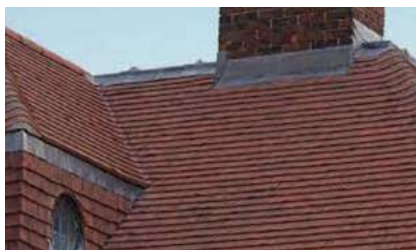
ROSEMARY CLAY CRAFTSMAN TILE

Colour - Hawkhurst with matching clay valley tiles
