Wonham Barton, Wonham

Design and Access Statement

In support of listed building consent for internal and external works to the existing farmhouse

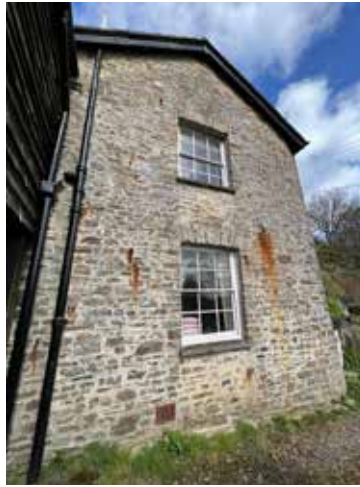
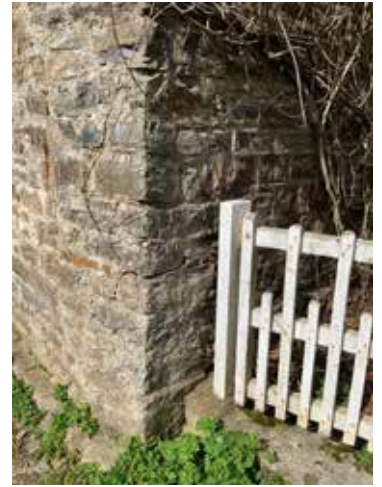
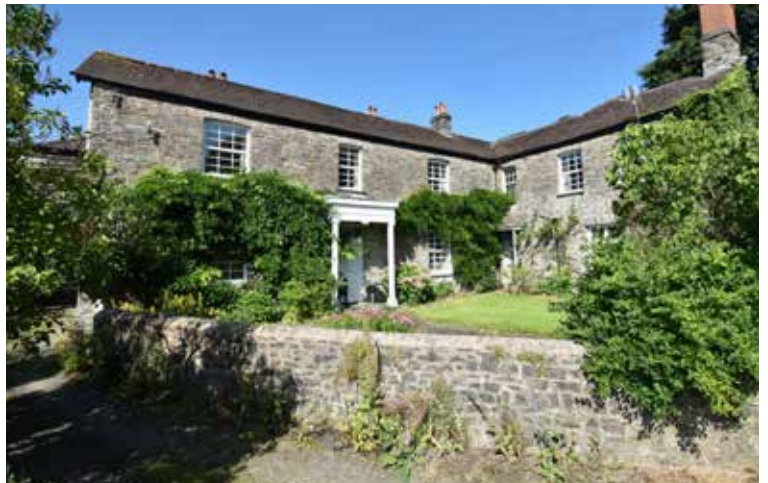
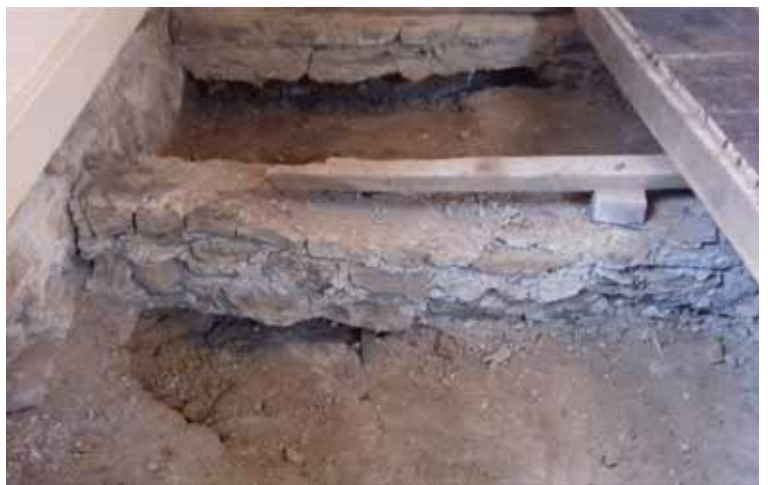
The southern gable end of the farmhouse has suffered with subsidence, and it appears that the corner of the building has settled. This settlement has resulted in multiple cracks in the stone, internally and externally in both the gable and front elevation. A majority of the cracking is of structural concern as it has resulted in building in the wall, dropped lintels and open joints in the face of the wall.

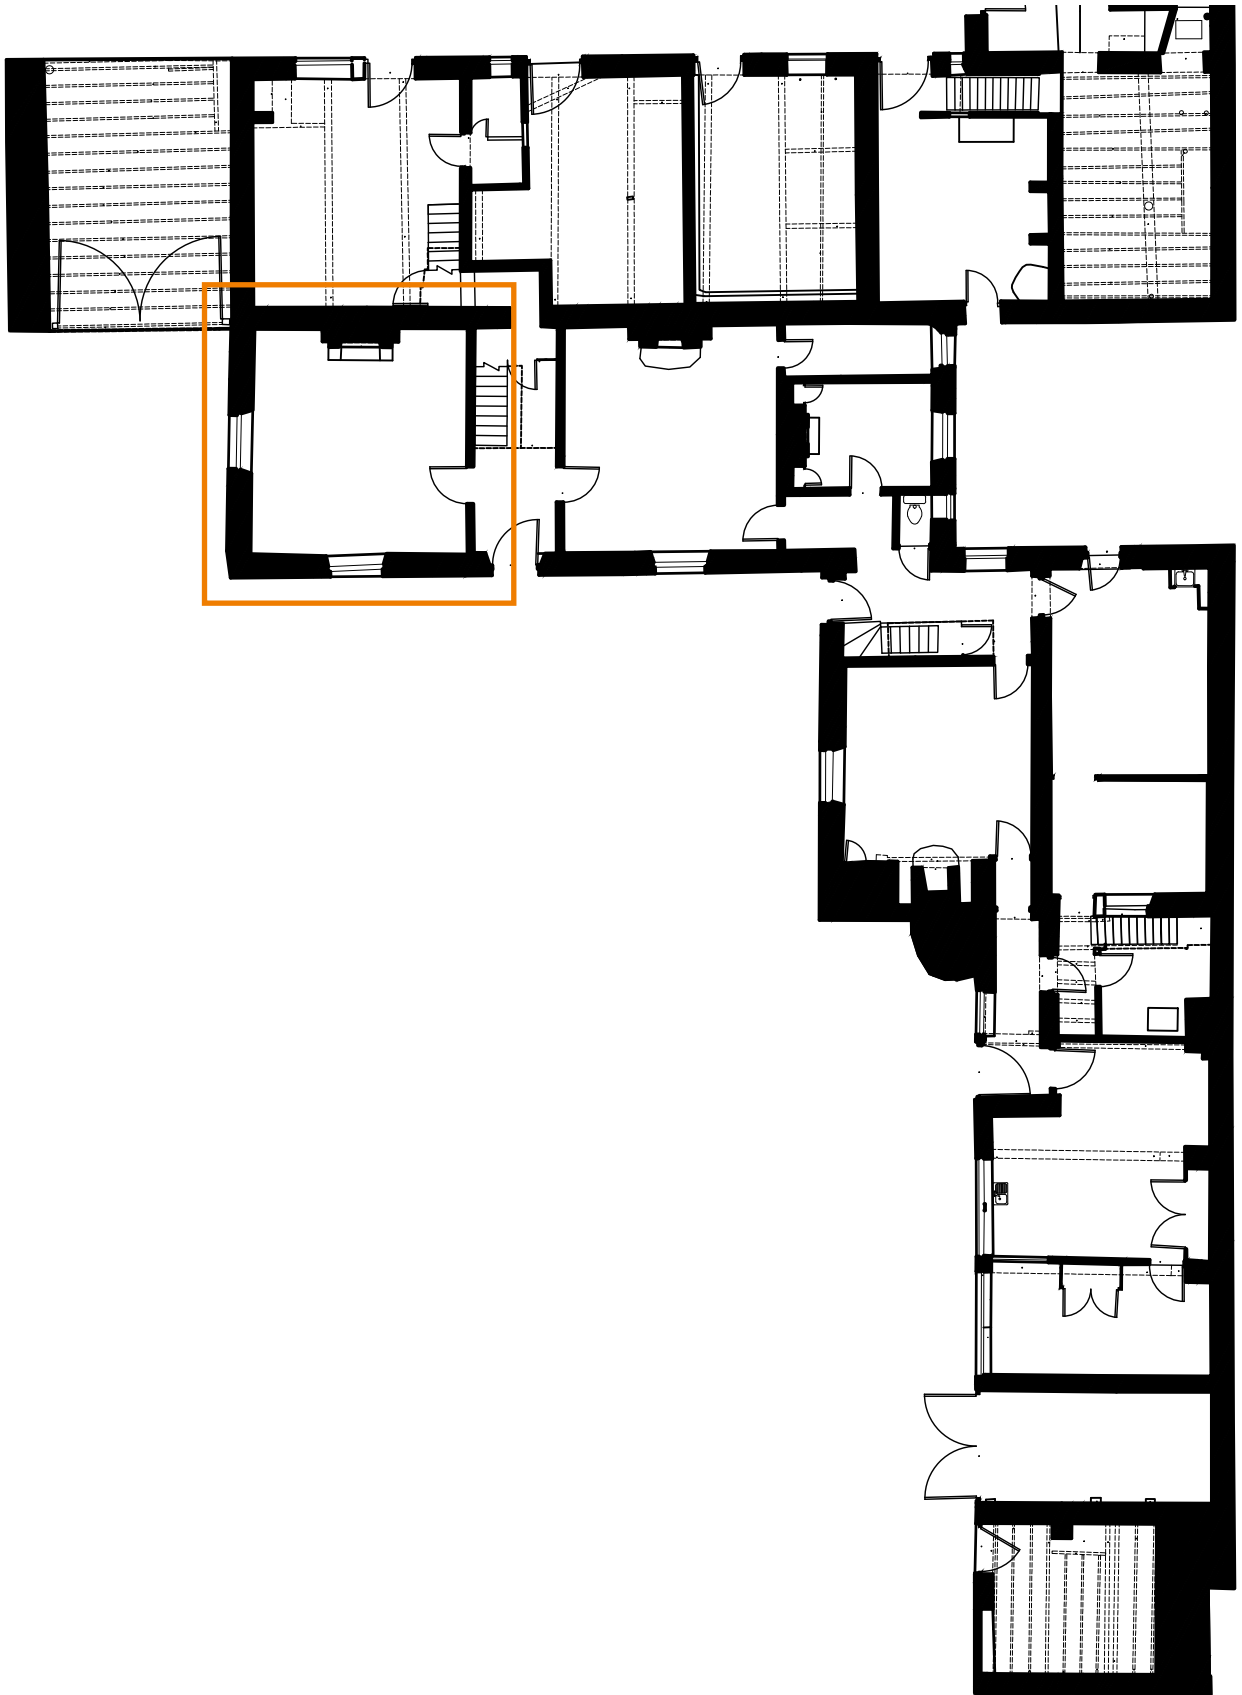
Existing ground floor plan

The plan form is single depth L shape. The main element comprises of two principal rooms and a centrally positioned entrance. The southern most of these rooms is the living room to which this application relates.

The return wing to the right is complete with a separate entrance.
