Design and Access Statement & Impact Assessment

**Roof Replacement, repointing and infilling of window
at
1-2 Main Street, Shalstone, MK18 5LX**

Date: 17.02.2024
Issue No: Two (2)
Written by: Nick Mullineux BSc (Hons) MRICS

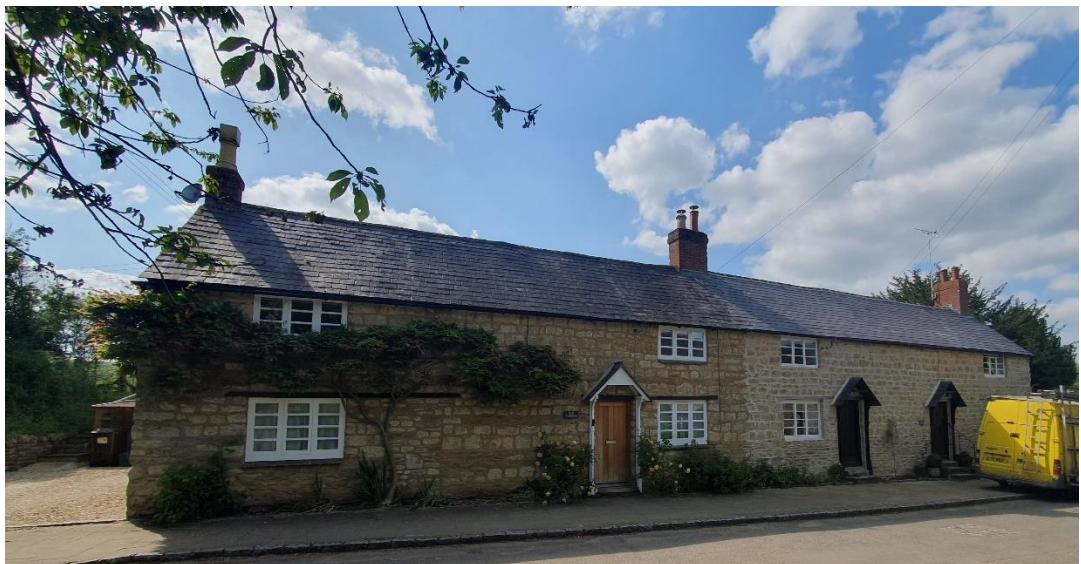
Image 1 – Front Elevation of 1-2 Main Street, Shalstone

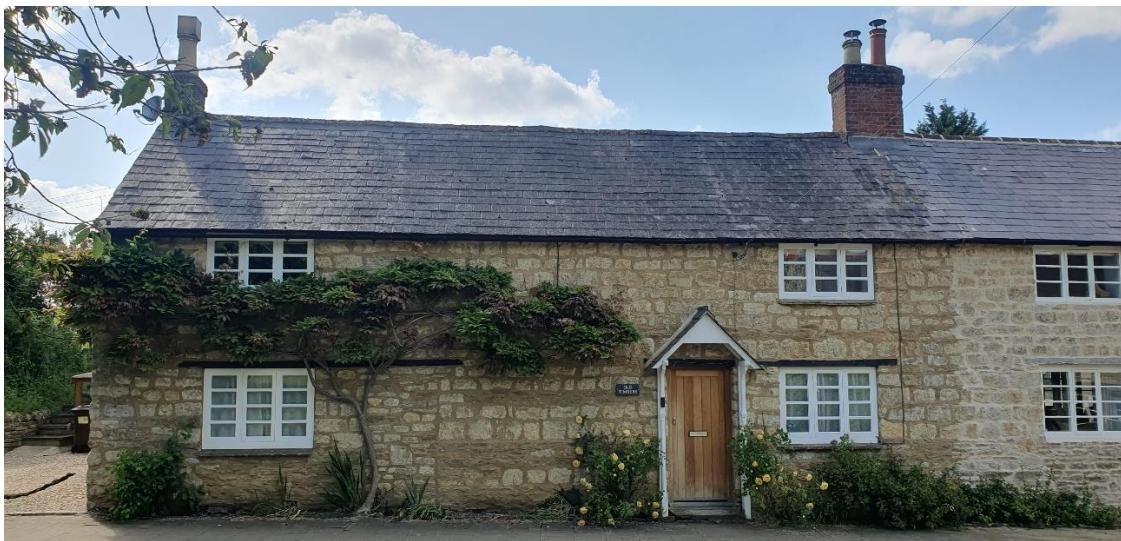
Image 2 – Photo showing the front elevation of No 1-2. Existing slate roof is to remain.

As noted in the images below, the front elevation of No 1 and 2, already includes a Welsh slate finish. However, the rear elevation was at some point altered to a clay pantile roof. The proposal is to carefully remove the existing clay pantiles, and replace them with a blue clay pantiled roof. The slates proposed are to match those recently installed and approved under condition 5 of the Listed Building Consent obtained for No 3 and 4. This replacement work will provide a sensitive and appropriate alteration to the building which reinstates this section of roof back to its original form. The ridge tiles will be carefully removed, set aside and reused. If new ridge tiles are needed, where existing are beyond repair, these will be re-provided to match existing.

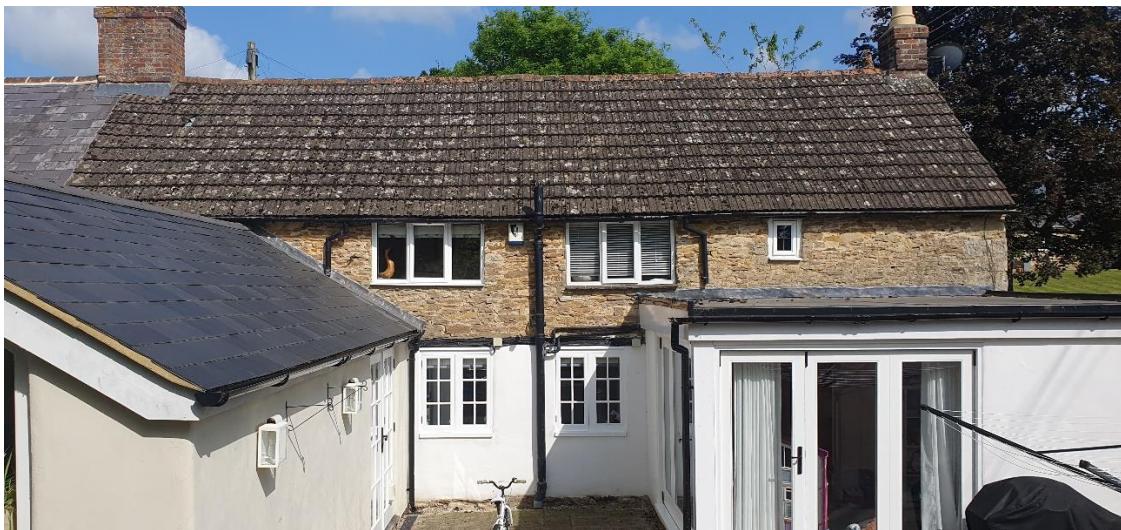
Image 3 – Photo showing the rear (West) elevation of No 1-2. Existing clay pantile roof to be removed and replaced with reclaimed purple Welsh slate to match that installed on No 3-4.

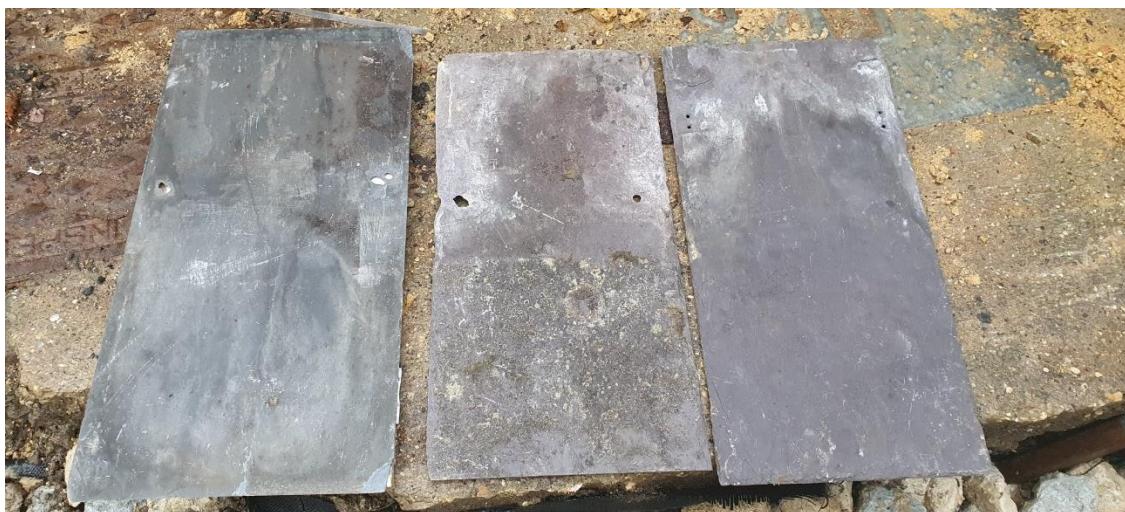
Image 3 – The slate colours which were considered as part of the application for No 3-4.
left: sample blue/ grey slate, middle: sample purple slate, right: existing slate.

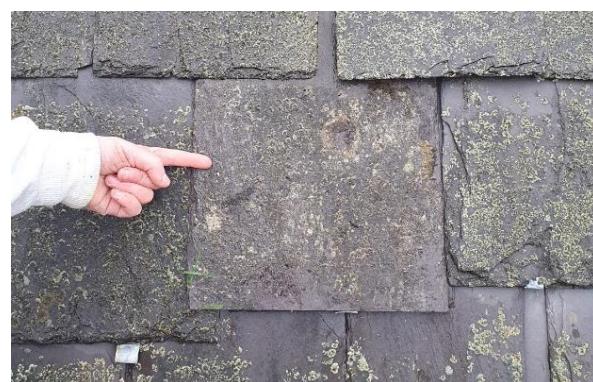
Image 4 - The sample purple slate was slotted into the roof of No 3-4 as part of its condition discharge requirement and provided a comparison of the replacement slates with the existing.

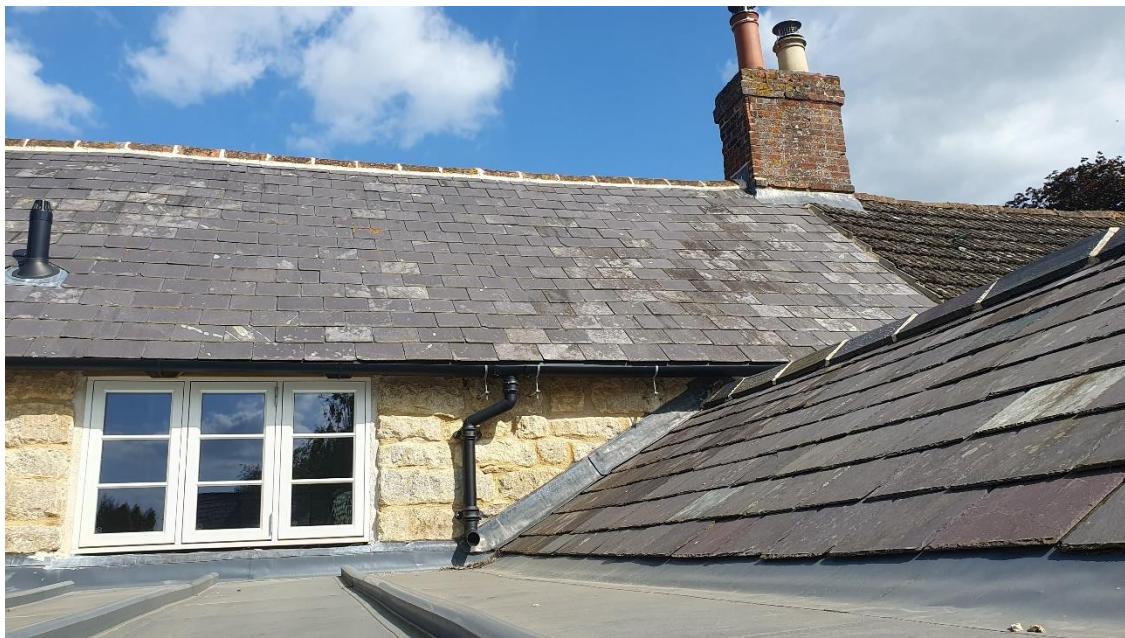
Image 5 – Final slate roof installation completed for No 3-4. This slate will continue to the right, as part of replacing the clay pantile roof tiles of No 1-2.

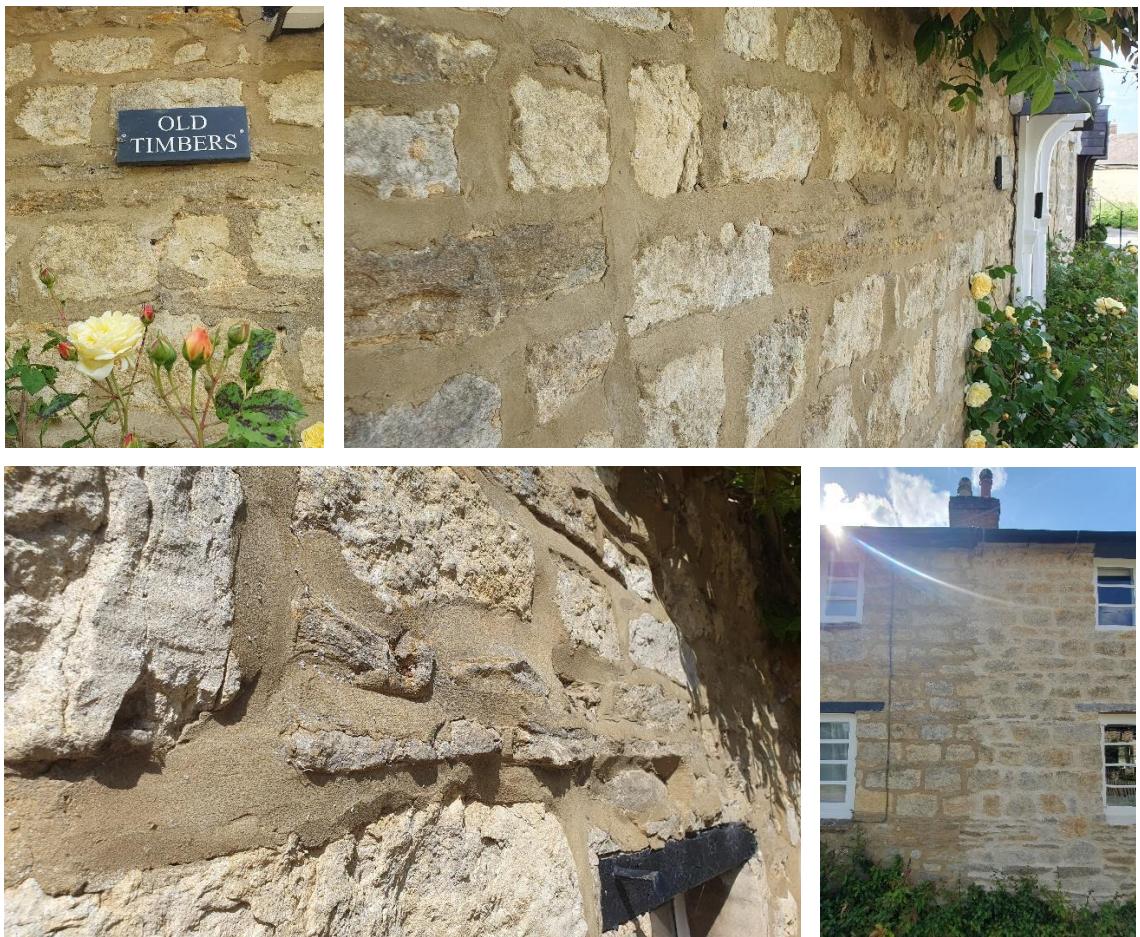
Image 6 – Photos showing the condition of the existing mortar, which is to be raked out and replaced with a new lime mortar.

The existing cement based mortar is inconsistent and does not allow the existing stone rubble walls to breathe. Additionally the strength of the cement mortar may in time promote the early erosion of the limestone rubble walls, and is to be replaced with a new lime mortar to match the mix applied to, and approved under condition for No 3-4 in 2022.

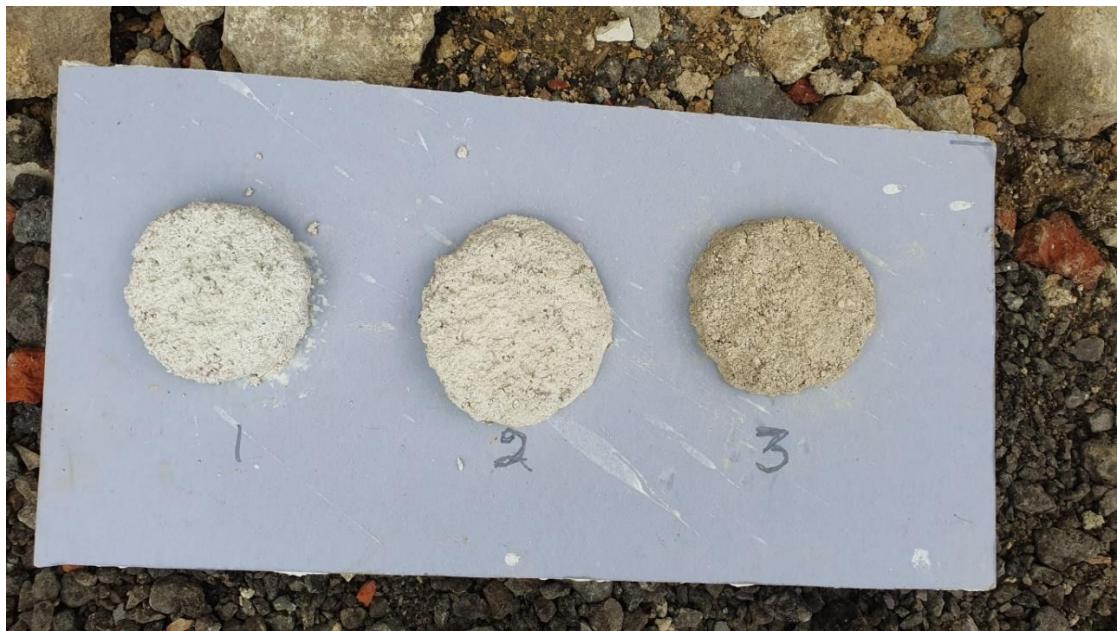
Mix 1 – 1 part lime, 4 parts Duns Tew sharp sand

Mix 2 – 1 part lime, 3 parts Duns Tew sharp sand, 1 parts builder's sand

Mix 3 – 1 part lime, 2 parts Duns Tew sharp sand, 2 parts builder's sand

All lime is NHL 3.5.

Samples of mortar were mixed including the creation of mortar ‘biscuits’ plus small sample areas within the stone itself.

The samples completed are as noted below:

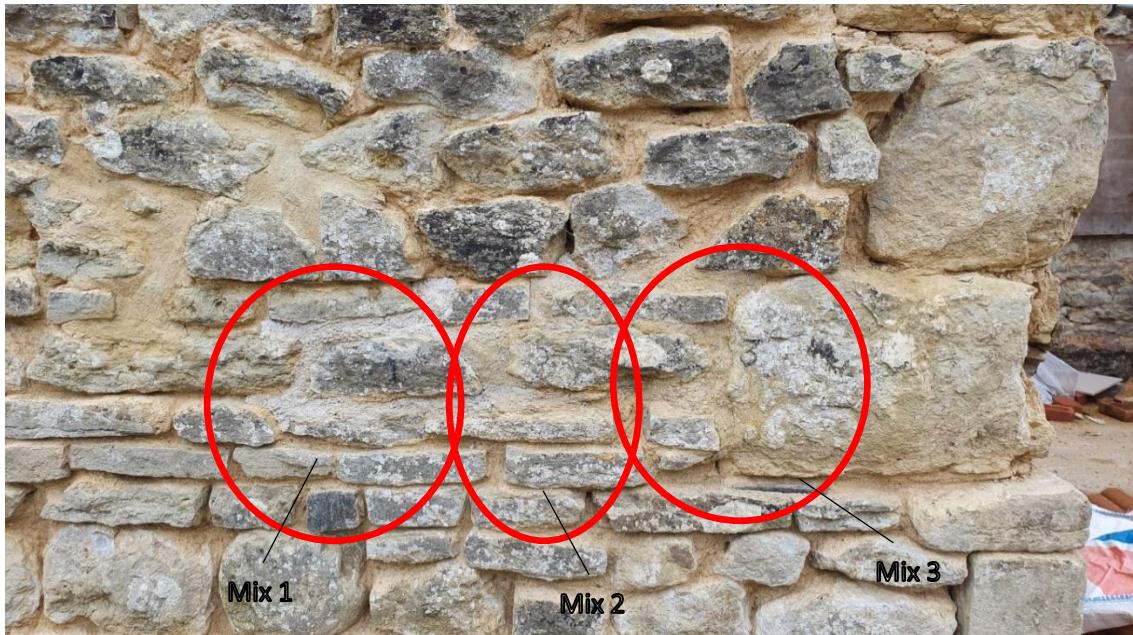
These mixes were applied to small areas to the existing stone walls as the image below.

From the above, and once the mortar had dried out and become much lighter, the best match is considered to be mix 3 – the darkest of the mixes. This has the best colour match to the existing mortar, as evidenced in the below close up photo. Mix 3 is therefore issued for approval.

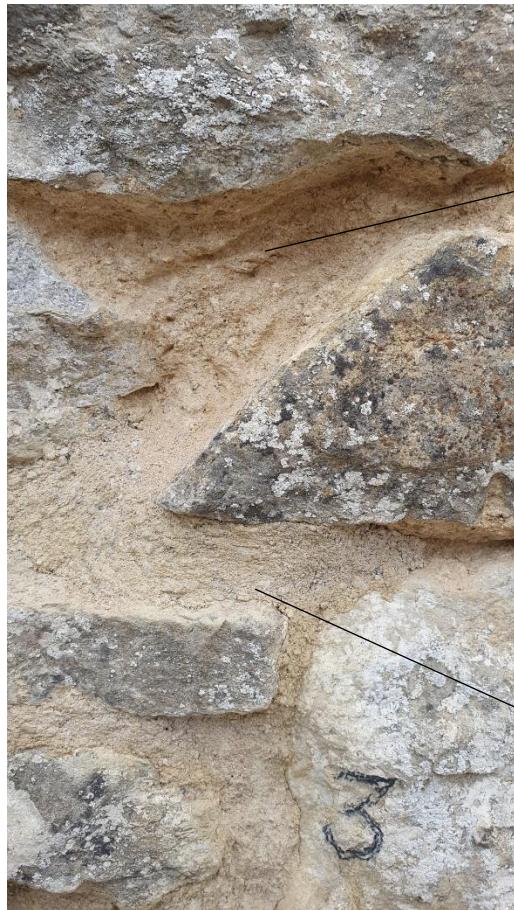
Existing mortar colour when facing mortar is raked out.

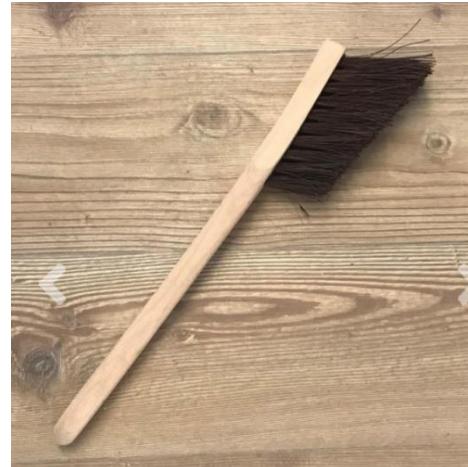
Mix 3 colour

The mix has been brushed with a churn brush to bring some of the sharps to the surface and to avoid a smooth finish.

Accordingly the proposed mortar mix to be used for No 1-2 is Mix 3 – 1 part lime, 2 parts Duns Tew sharp sand, 2 parts builder's sand

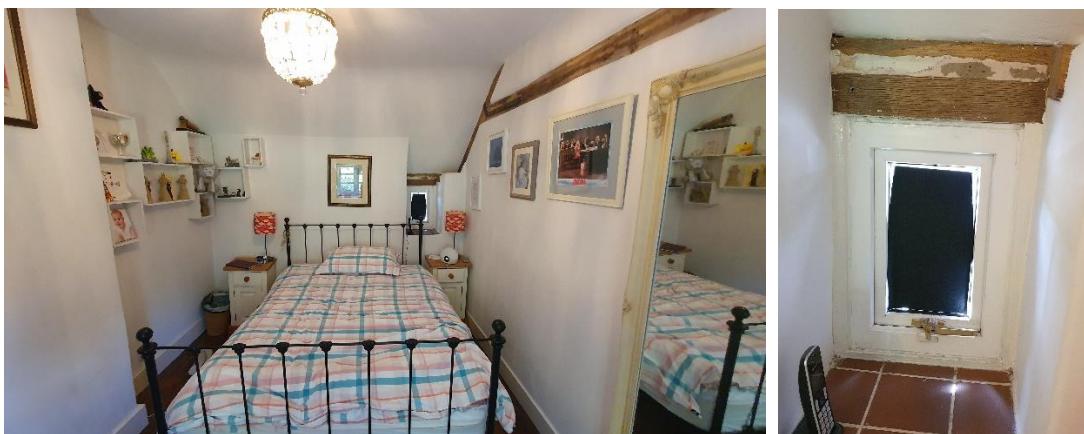
Image 7 - Internal view of window to be infilled. Note, the main window to this bedroom is on the front elevation and will provide both daylight and ventilation to the room. The window is not original, is not present on any of the other mirroring cottages, of No 2, 3 or 4, and can be infilled without causing harm to the historic value of the cottage.

The window in question which is to be infilled is as below.

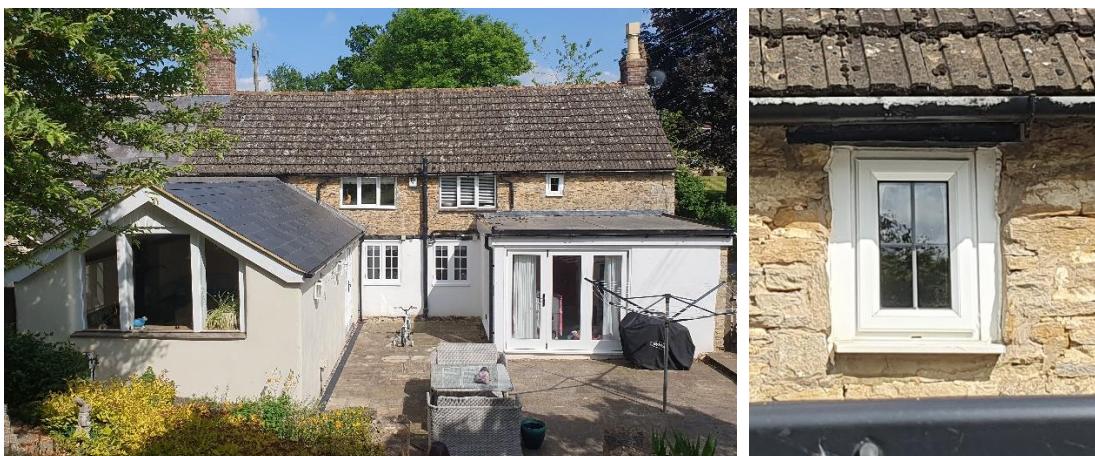
Image 8 – External view showing the location of the existing uPVC window which is proposed to be infilled.

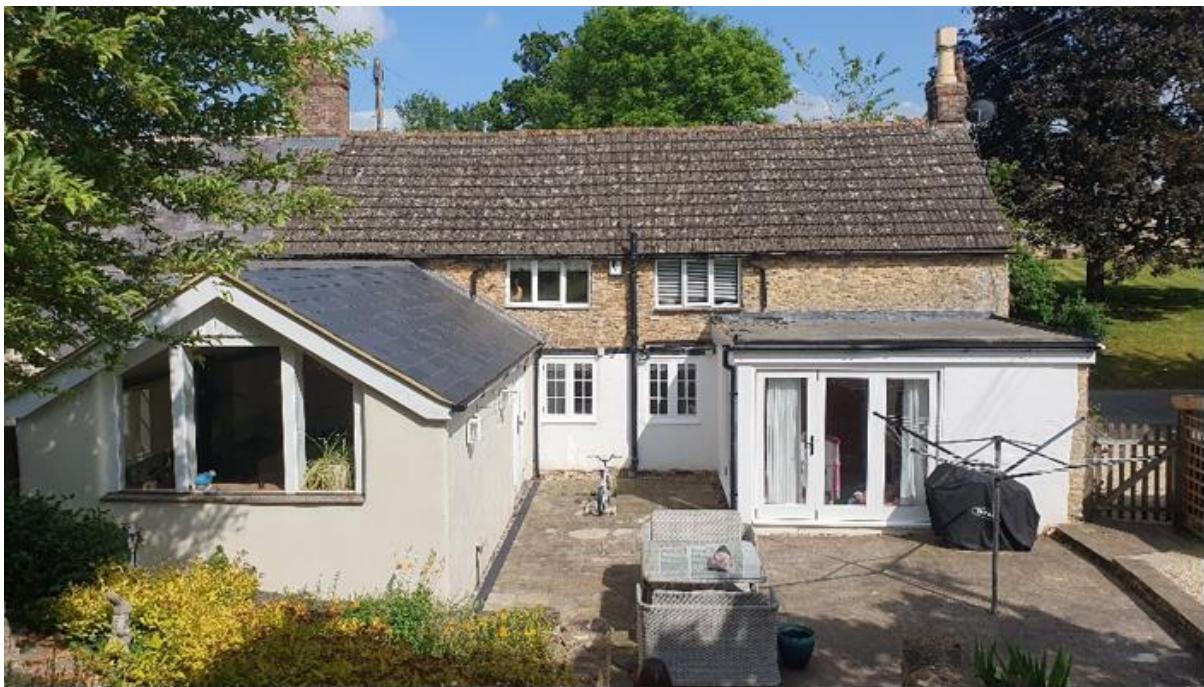
Image 9 – View of the proposed external elevation photoshopped to show the view of the rear window with the window infilled with a matching limestone. This window will be repointed as part of the main repointing. The timber lintel above the window will also be removed.

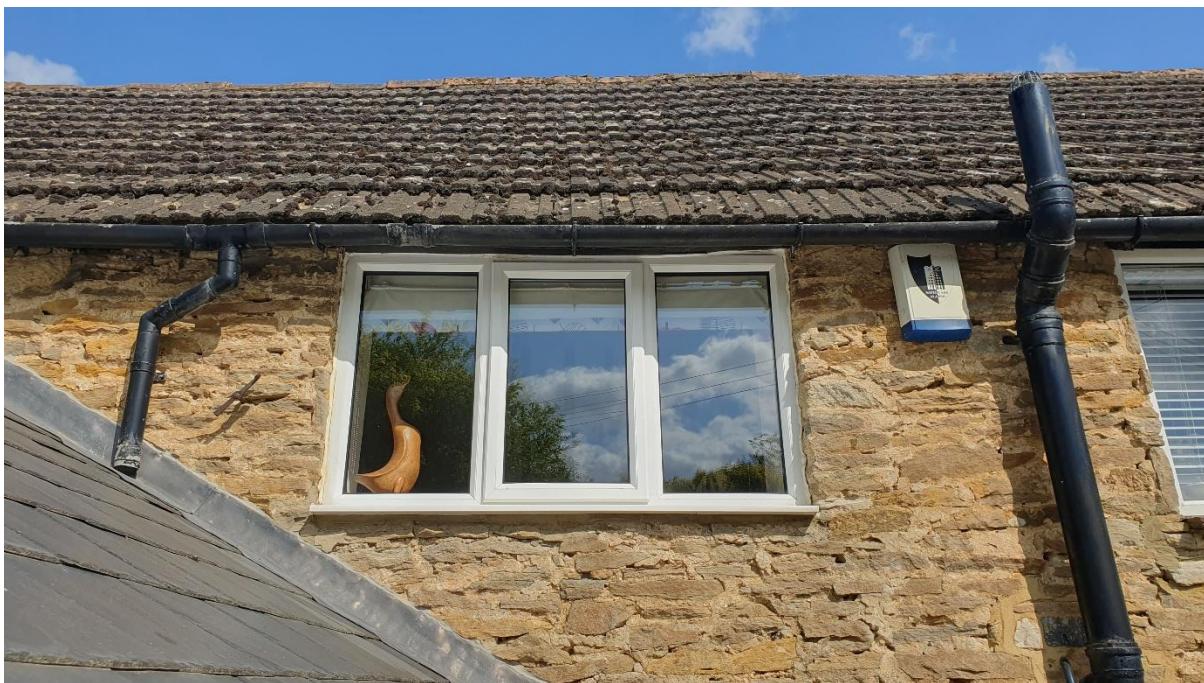
Image 10 – Existing window to No 2

The existing rear windows are original window openings but the windows themselves are modern double glazed uPVC windows, circa 20 years old. This proposal seeks to alter the windows to be building regulations compliant, insulated timber casement windows. The windows proposed are as noted below.

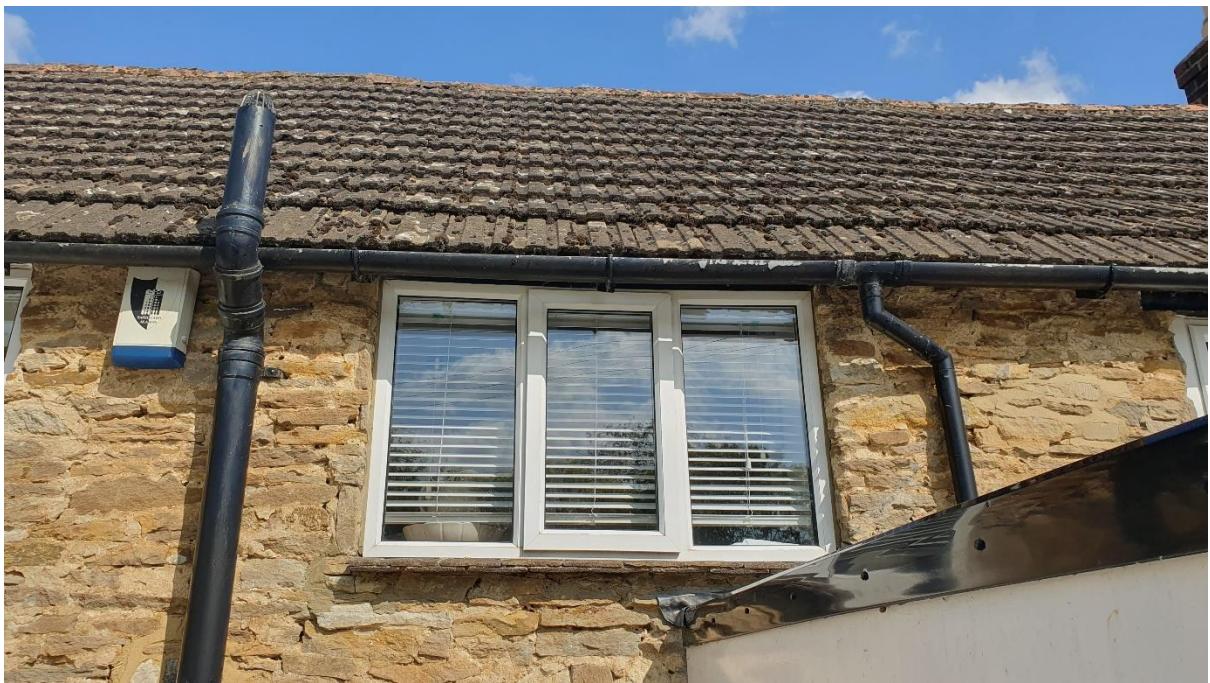
Image 11 – Existing window to No 1

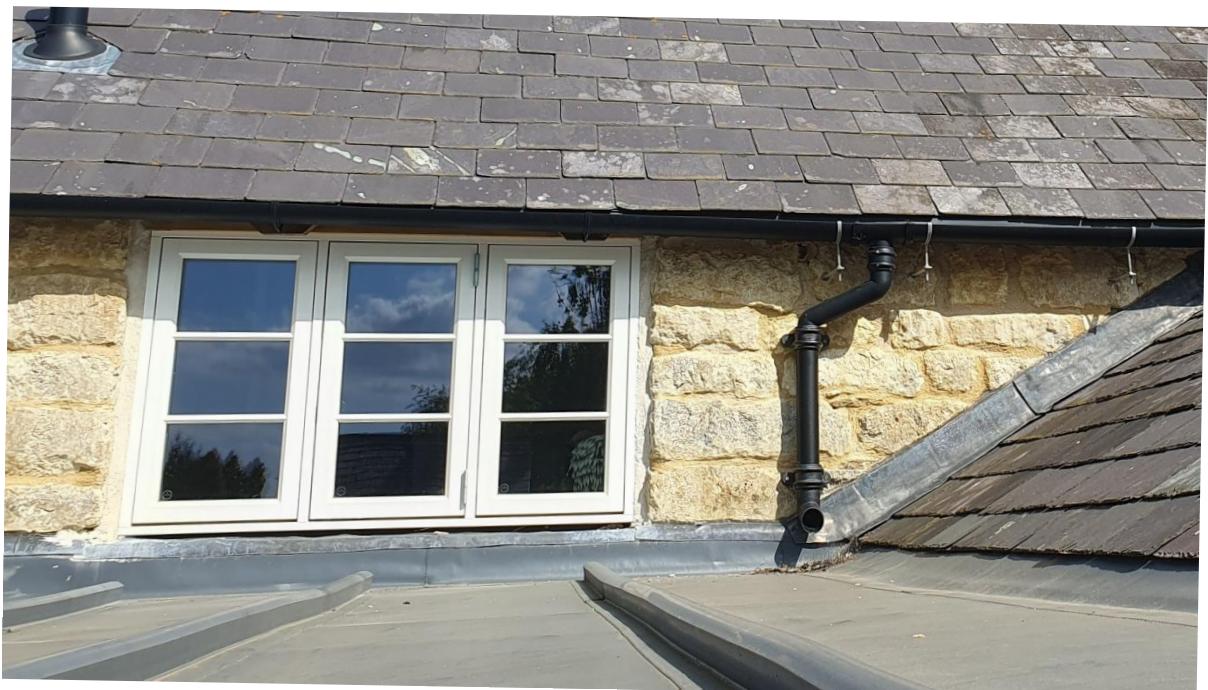
Image 12 – Proposed Replacement casement window to be fitted within existing opening.
