Client: National Trust
 Job Title: Thorrington Hall
 Drawing Title: Typical Timber Frame Repair Details
 Scale: NTS Drawn By: A1 ET Date: Nov 2023
 Job Number: 689221 Drawing Number: 04 Status: Preliminary

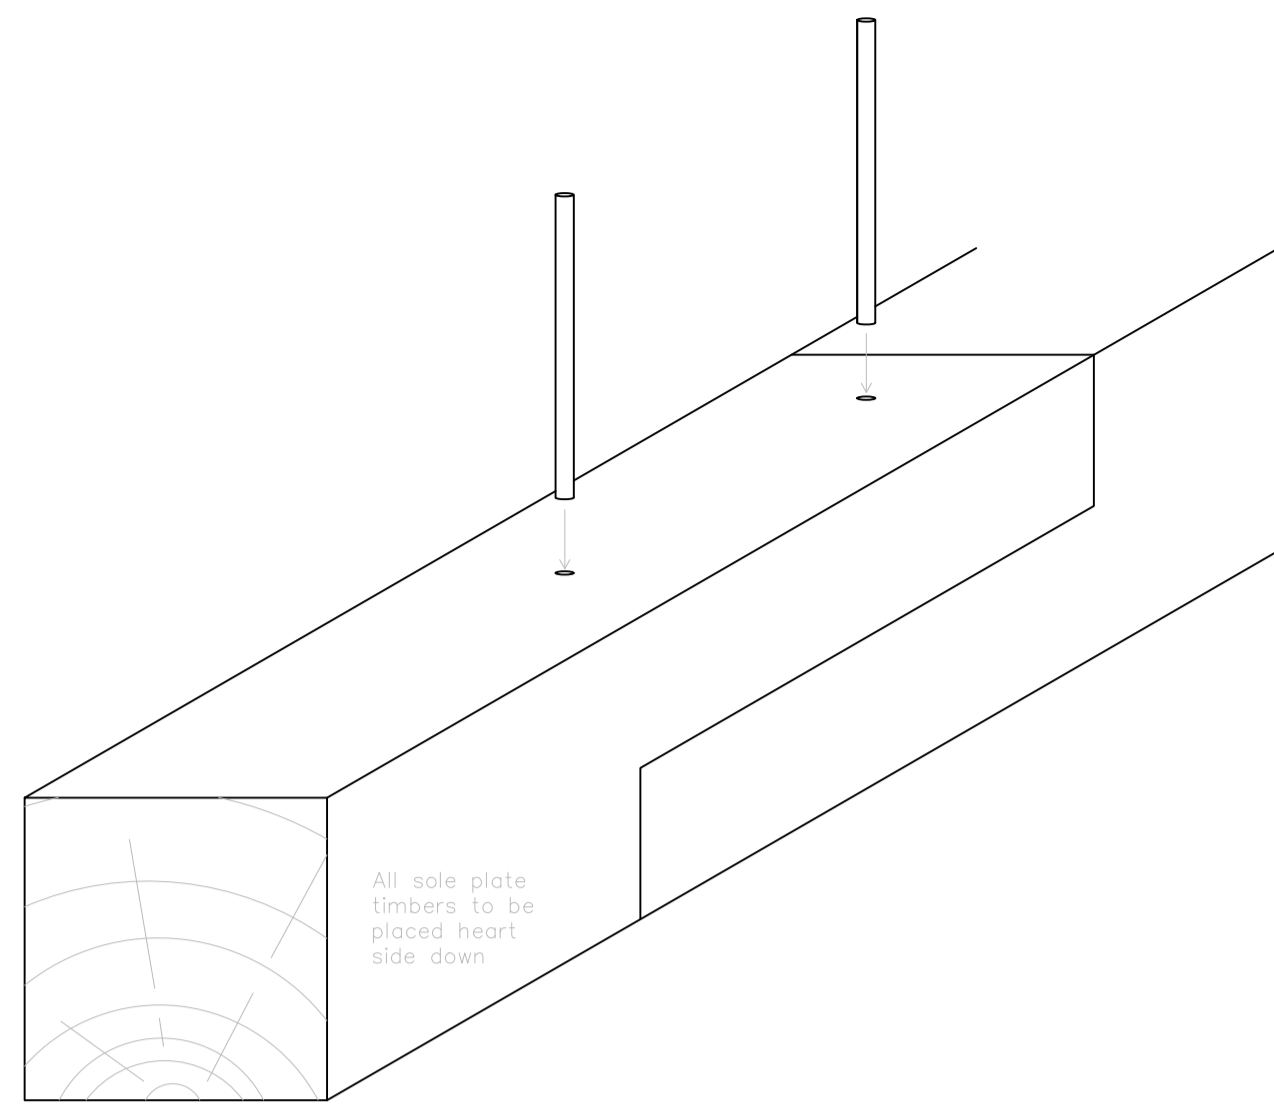
Scissor Joint Repair
1:10
This should be used in preference to the Scarf Joint Repair, for all repairs where possible. As the eight faces of the joint help to resist lateral movement.

Stainless Steel (M10)m coach screw or bolted, countersunk and pelleted.

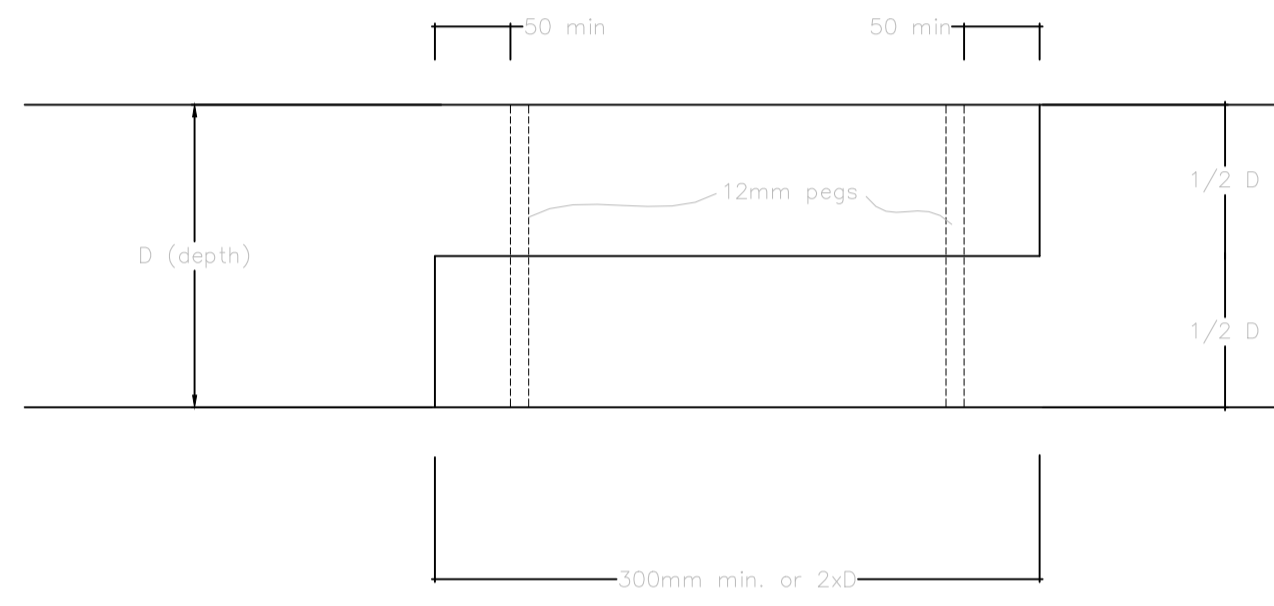
Scarf Joint Repair
1:10

Stainless Steel (M10)m coach screw or bolted, countersunk and pelleted.

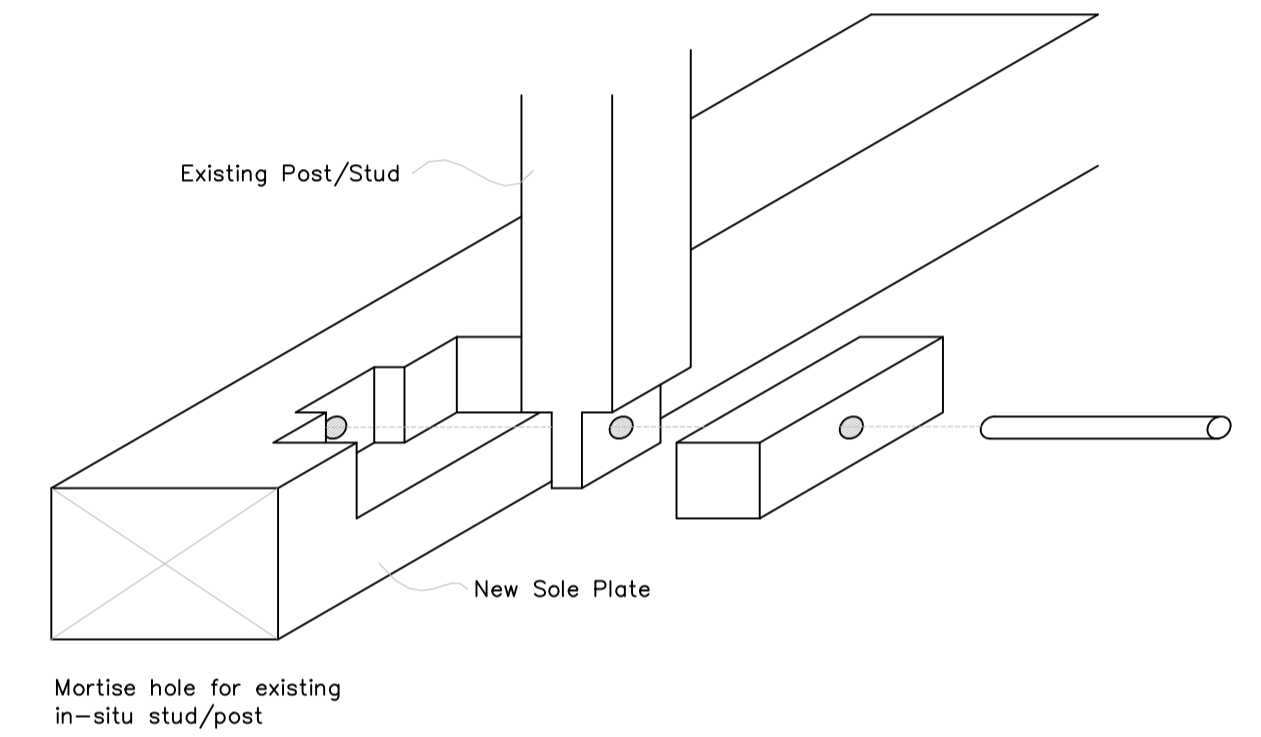
Splayed horizontal cuts to throw water clear if the timber is exposed to the elements.
Stainless Steel (M10)m coach screw or bolted, countersunk and pelleted.
