# WEST CROSS HOUSE, THE STREET, UPPER FARRINGTON

## Heritage, Design and Access Statement

West Cross House,  
The Street,  
Upper Farringdon  
Alton  
Hampshire  
GU34 3DT

January 2024

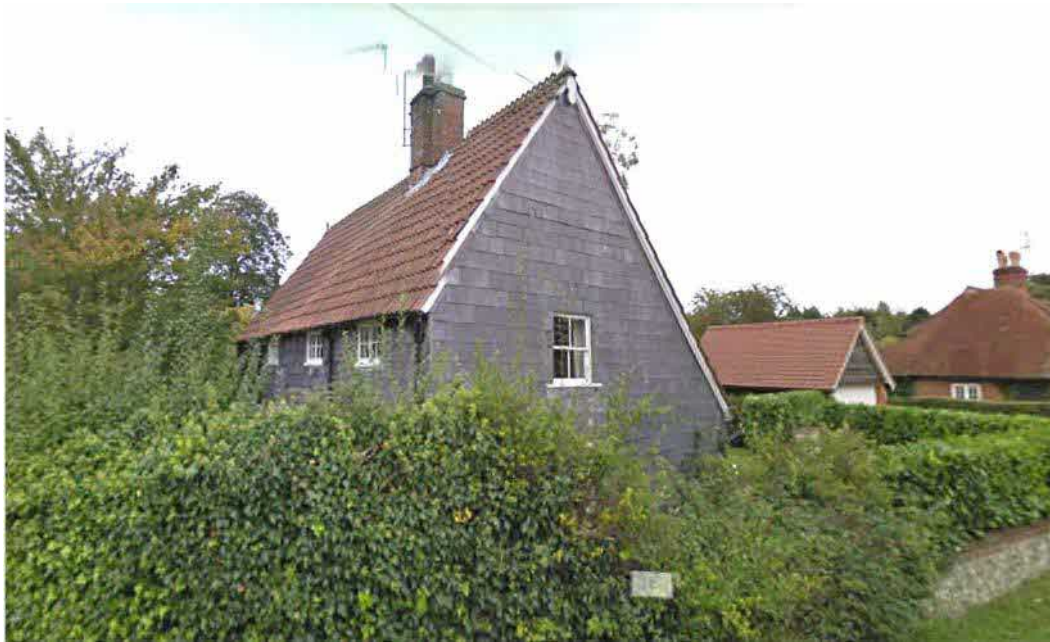
Figure 1 West Cross House prior to the removal of the slate hanging to the west and south elevations. © Google Maps

1.4 West Cross House is a two-storey timber-framed building with a modern two-storey extension to the rear. When listed the front, west and southern elevations were slate-hung see Figure 1. The slates were removed in 2012 to expose the timber-framing on the west and south elevations see Figures 2, 3 and 4. The north elevation has some exposed framing at low level but the majority of the elevation is tile-hung. The gabled roof is of double-Roman clay tiles, see Plans 3 to 5 in Appendix 2.

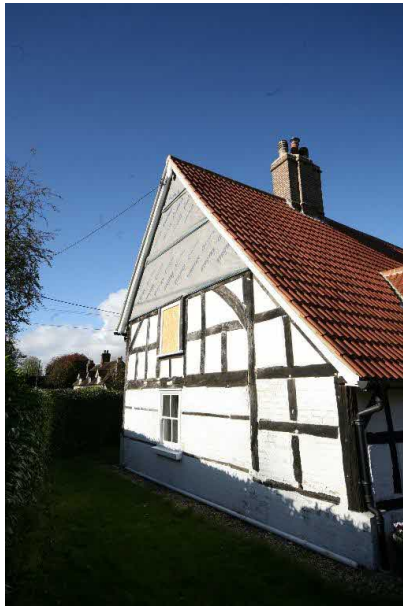
Figure 3 Southern Elevation with slate tiles removed and temporary measures in place.

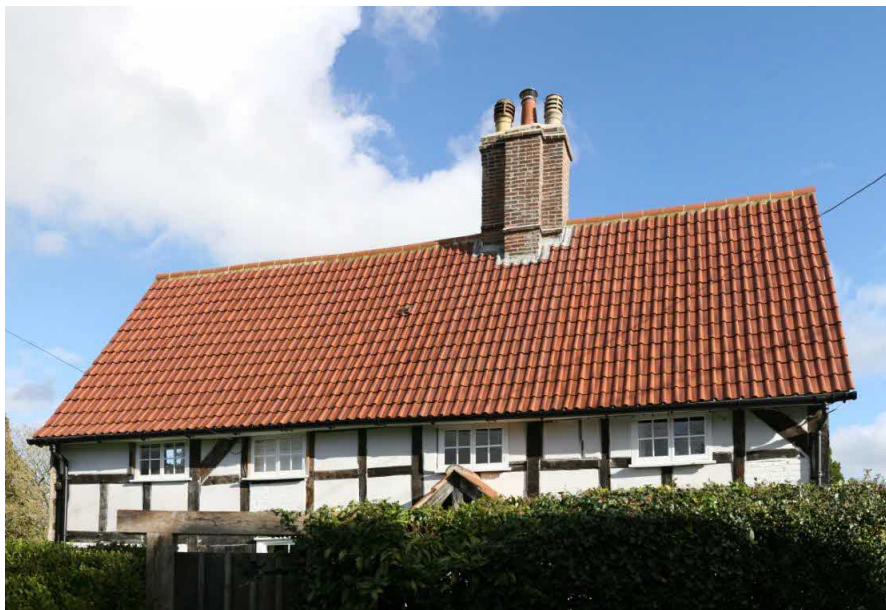
Figure 4 Western Elevation with slate tiles removed.

1.2 West Cross House is a two-storey timber-framed building with a modern two-storey extension to the rear. Due to the ingress of rainwater causing damage to the fabric of the building the proposal is to install wall hung handmade clay tiles to the upper apex of the southern elevation to prevent the ingress of rainwater and protect the building and prevent further damage. This elevation was previously tiled with grey slate tiles installed in Victorian times, see Figure 1. This is noted in the listing given below. The slate tiles were removed in 2012 see Figure 2 and 3. As will be seen from Figure 4 the northern elevation is tiled with clay tiles within the apex.

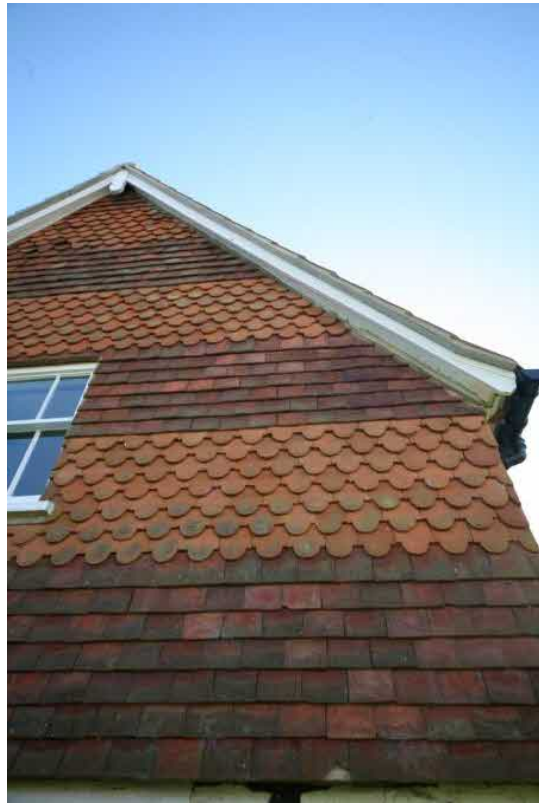
Figure 6 Northern Elevation tile detail.

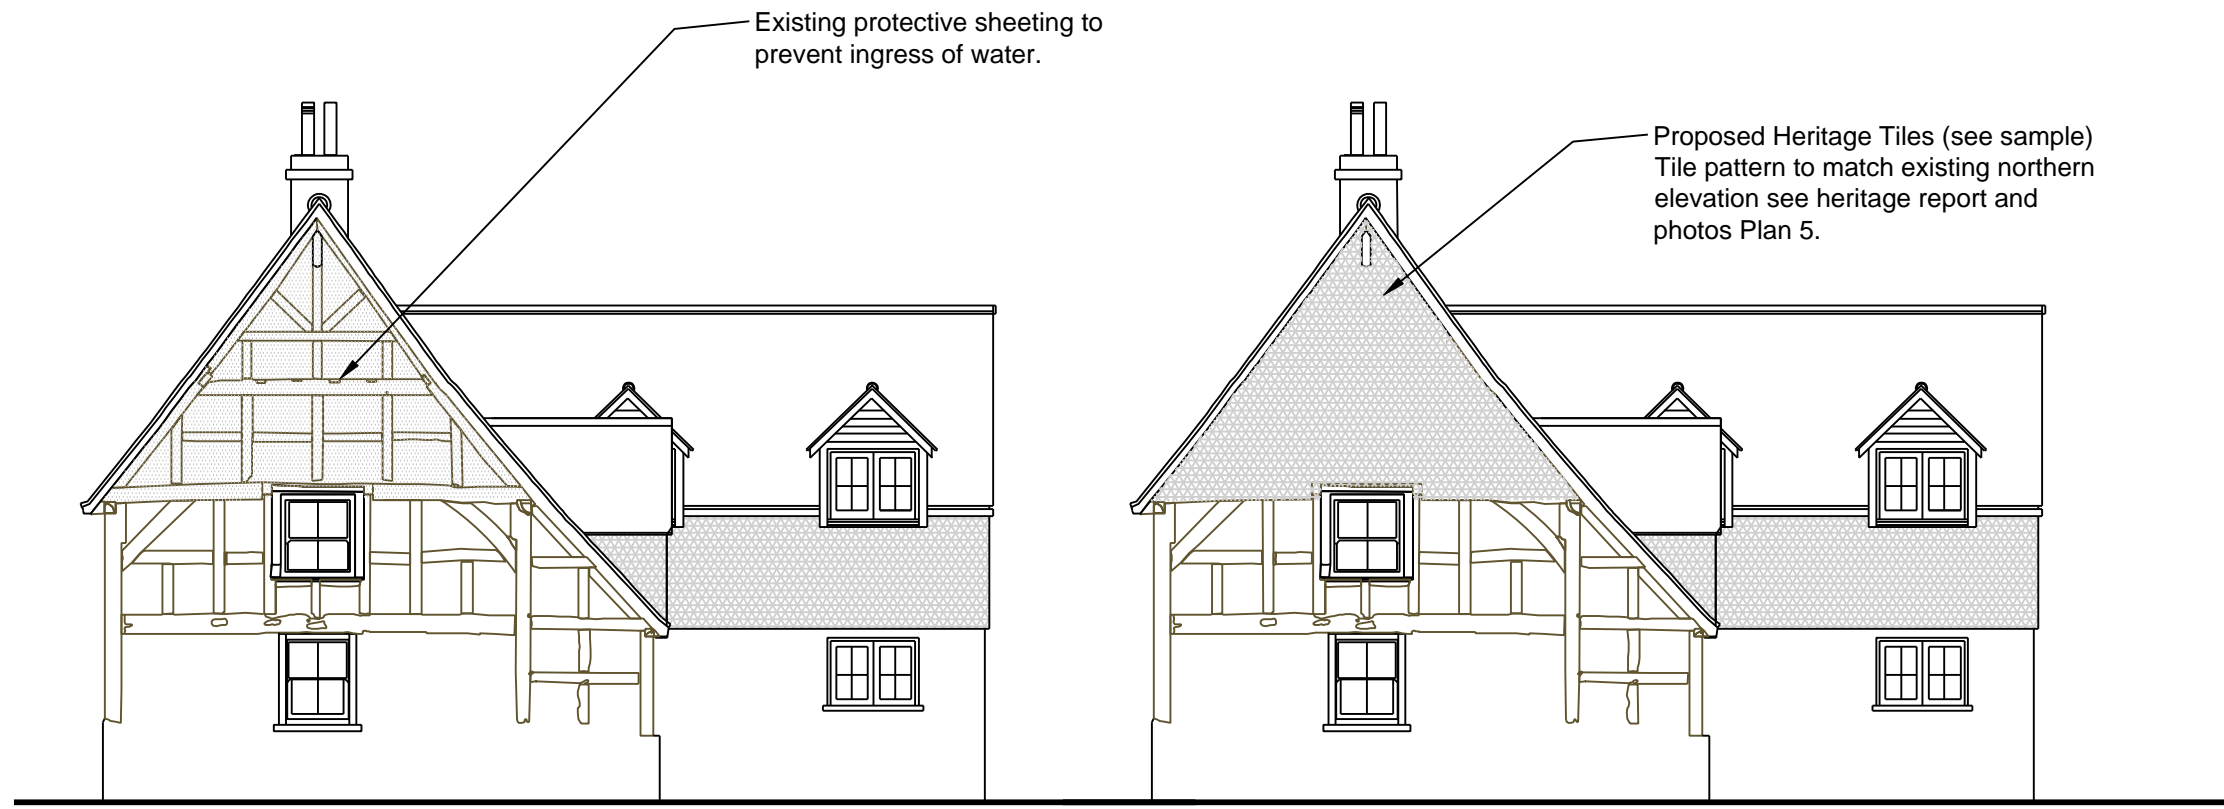
Plan 4: South Elevation Proposed

*Southern Elevation- Existing*

*Southern Elevation- Proposed*

3.4. The proposed tiles are to be secured onto a system of double battens, which will allow air to circulate behind the tiles so preserving the timber structure and historical interest. The battens are to be attached using stainless steel screws. The tiles are handmade and reflect the existing tile hanging on the northern elevation and in part the eastern elevation and so are in keeping with the historical interest and of the period.
