## Proposed bat and bird mitigation and enhancement measures - Crossways Farm SPBW Jan 2024

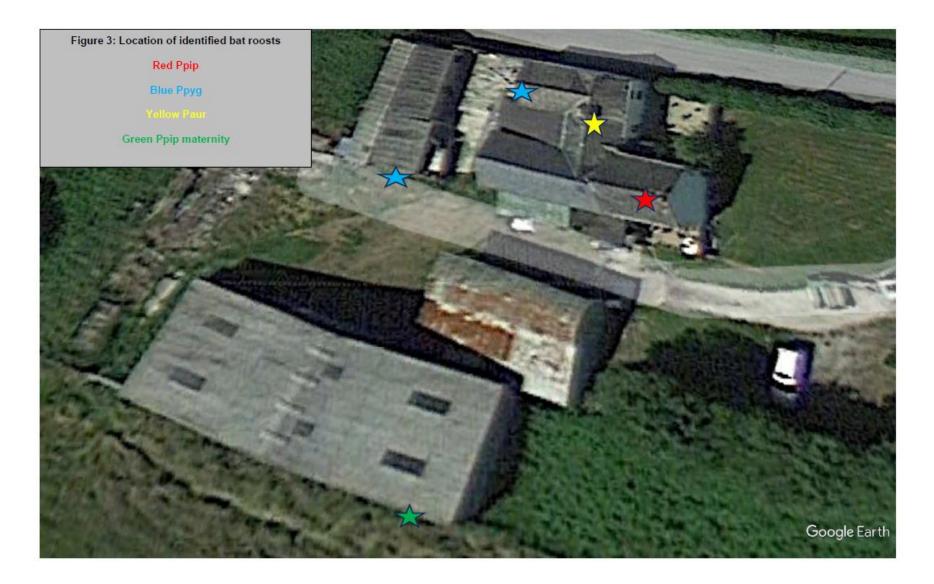
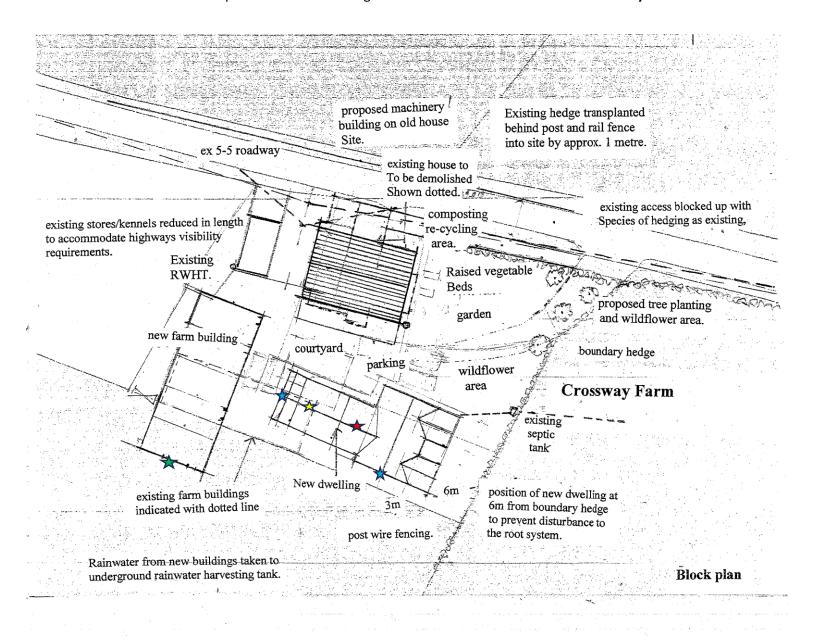
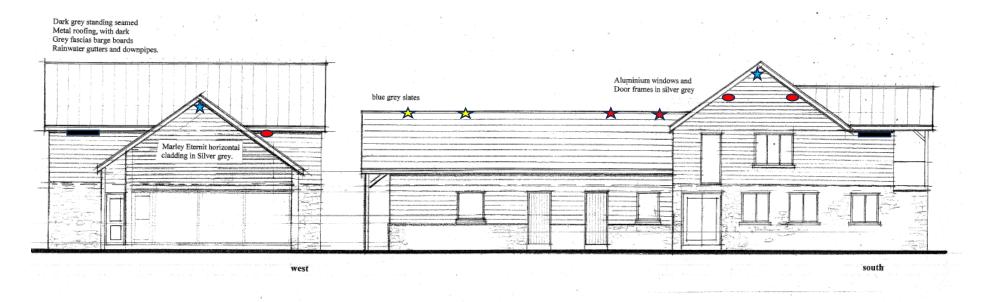
Ridge slates for bat access to ridge channel void roost. Four in total to compensate for loss of two ridge roosts on the house, and further enhance.

Built-in bat boxes to compensate for loss of fascia roost on house and barn cladding roost. To consist of one set of two boxes side-by-side in each of three locations as marked. Set within fabric of building with small access slot open to exterior and short wooden "landing strip" beneath opening.

Propose using Greenwood Ecohabitats half & half bat boxes. (Very cost effective compared with alternatives). Others can be used such as "woodcrete" boxes from Habibat or the Blue and Green company.

These measures will provide a similar range of features ad roost opportunities including all-important aspects and elevation heights. All other recommendations as set out in Appendix 3 of the survey and mitigation report should be followed, including a search of the databases held by the local Biological Recording Centre – Please advise (we can arrange this for the client).

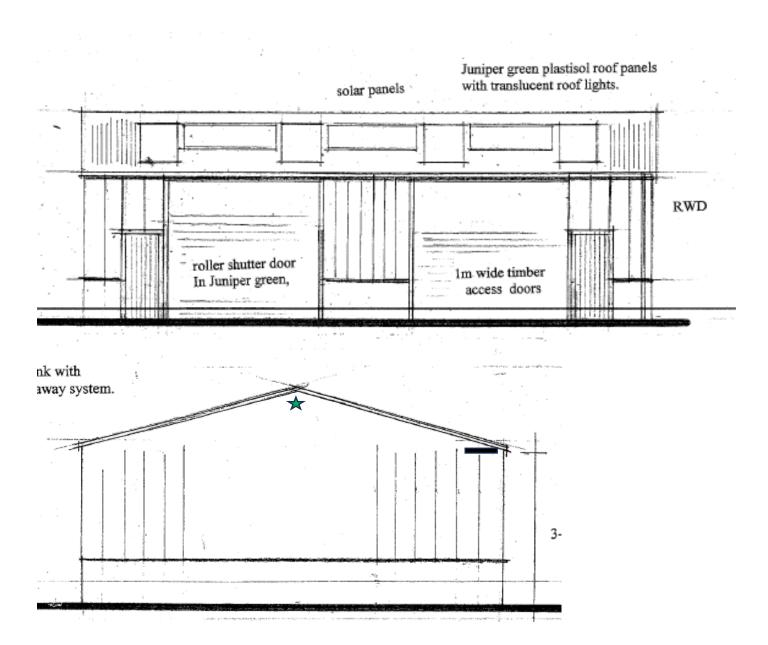
The barn should have an opportunity created for barn swallows to be able to access the interior and nesting ledges built of timber incorporated and added to the internal framework to perpetuate their nesting opportunity. Exterior bird nesting boxes are indicated.

House martin nest forms (three) attached to exterior of structures as indicated.

House sparrow nesting terraces (three) as indicated.

A lighting scheme will be requested. Follow the protocols of not illuminating any of the bat box and roosting features. We understand that security is important to the clients so will not here recommend the avoidance of floodlighting, but a dark zone should be retained that will enable flight access to each of the roosting features even when yard and security lighting is active.
