WOODSIDE HOTEL AND CONFERENCE CENTRE, KENILWORTH, WARWICKSHIRE

Assessment of Significance

BUILT HERITAGE ASSESSMENT OF SIGNIFICANCE

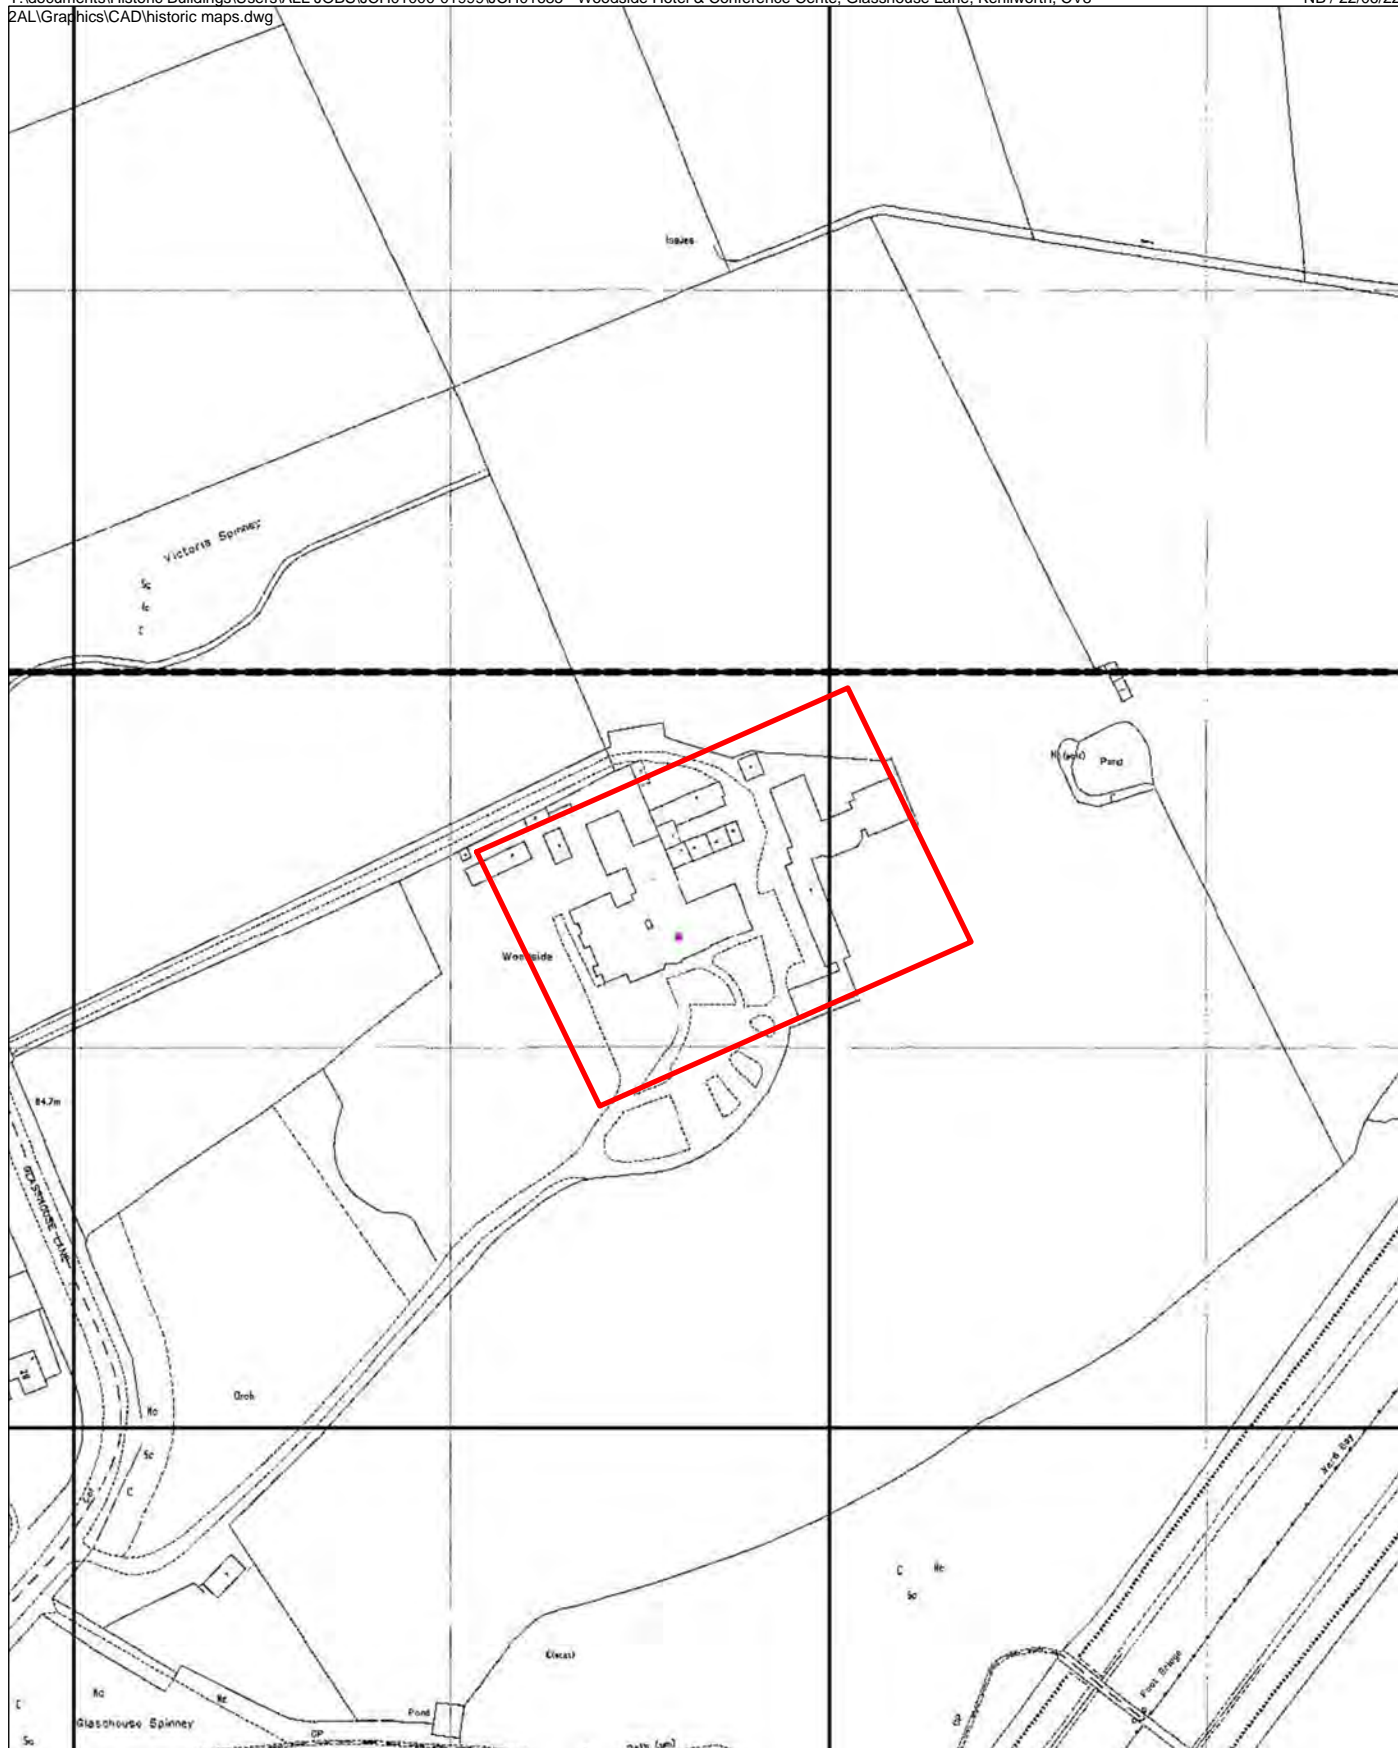
Figure 6

1992 Ordnance Survey Map

- 3.9 By 1992 (Fig.6), mapping shows further substantial changes to the footprint of Woodside. This comprises a small extension to the north-western corner of the rear of the original building. A considerably larger rear extension is now seen to the north-eastern corner which extends some distance north and now links up to the former stabling. The earlier linear building to the immediate east of Woodside has now been consumed into the wider footprint with a further extension to the east of the original property, built along the building line of the early twentieth century changes to Woodside. Extensive changes are seen to the wider surrounds with further new development to the east connecting up the earlier post-war development. Allied to these changes is the conversion of the near surrounds of the Woodside front elevation to extensive car parking.

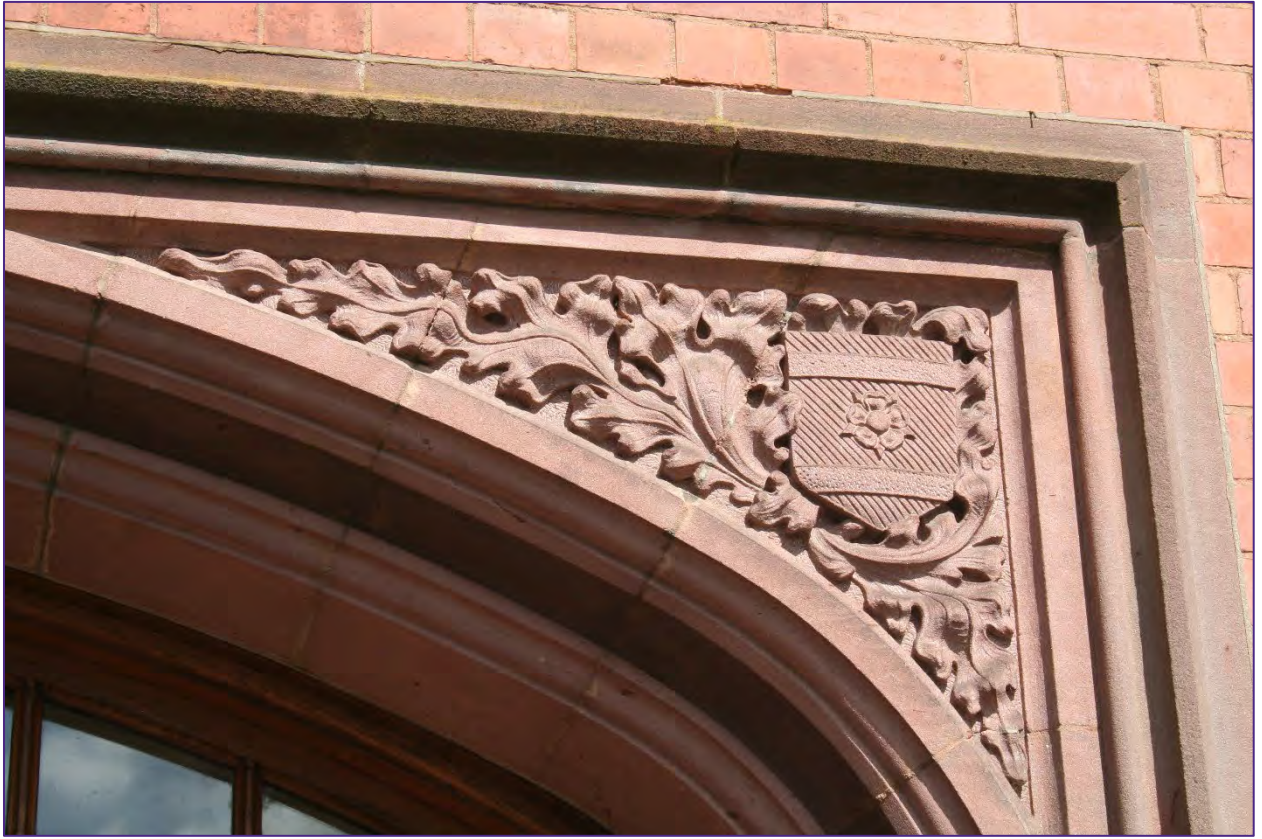
Plate 11: Three-centred sandstone doorcase with labelled drip mould, coats of arms and floriolate designs.

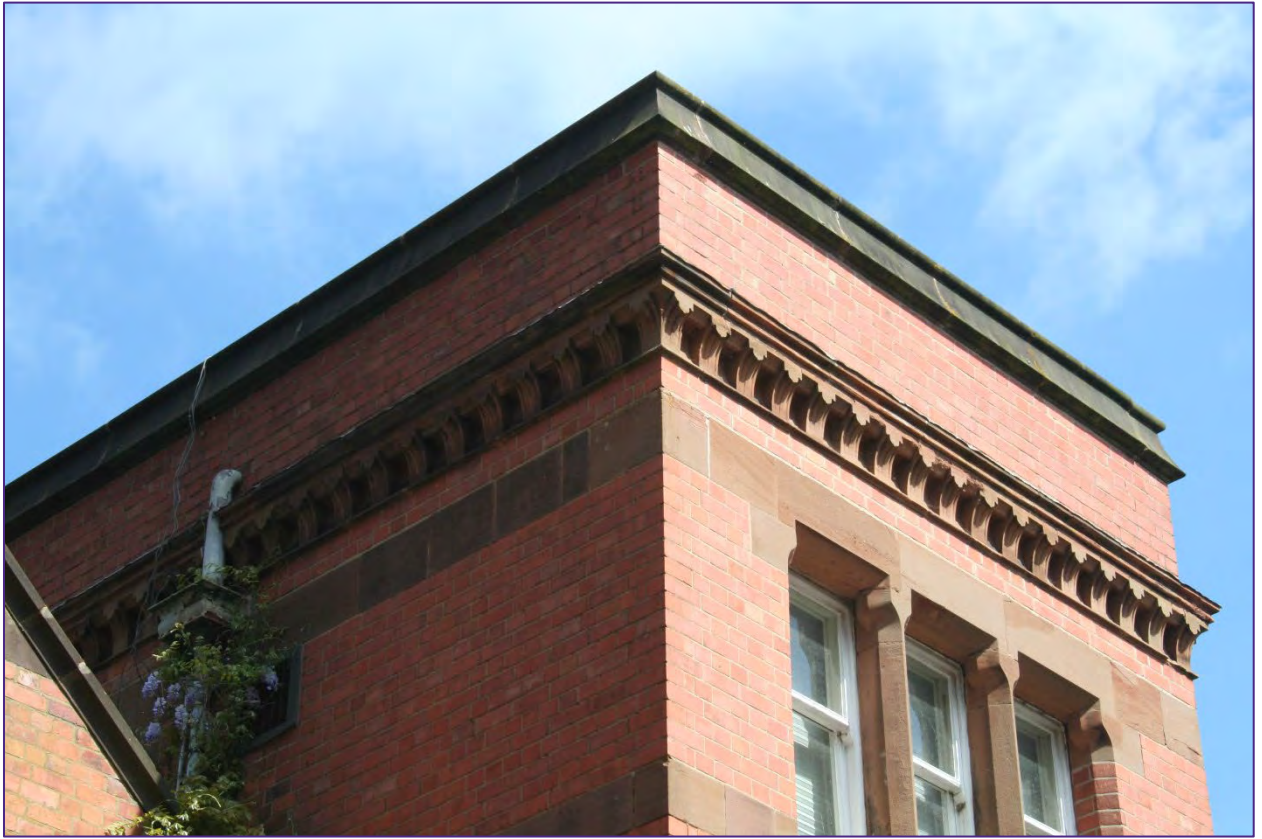
Plate 12: Second floor of entrance tower with sandstone detailing and parapet.

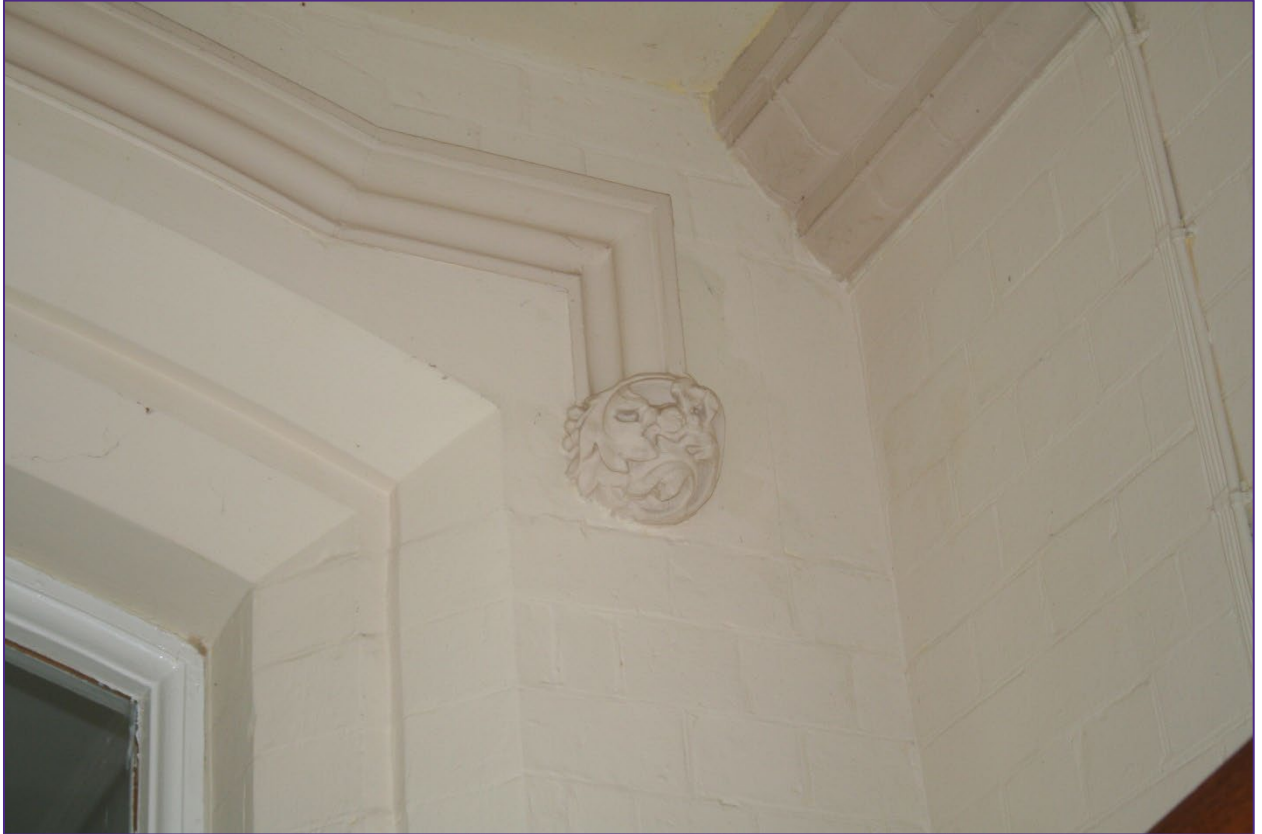
Plate 13: Hoodmould with headstops on original nineteenth century entrance into Woodside.

which existed over the original front door with foliate headstops at either end. Elsewhere brick corncicing is noted around the roof of the porch.

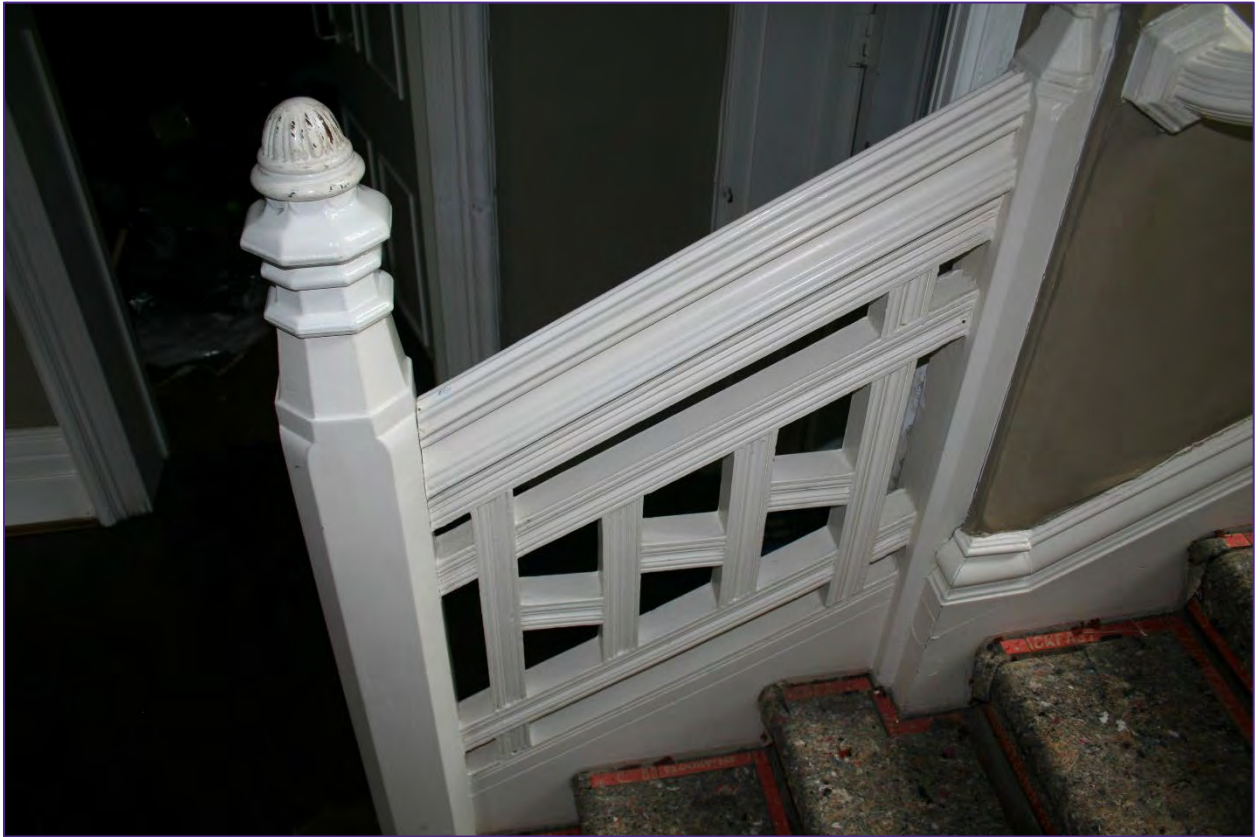
Plate 20: Timberwork on staircase.

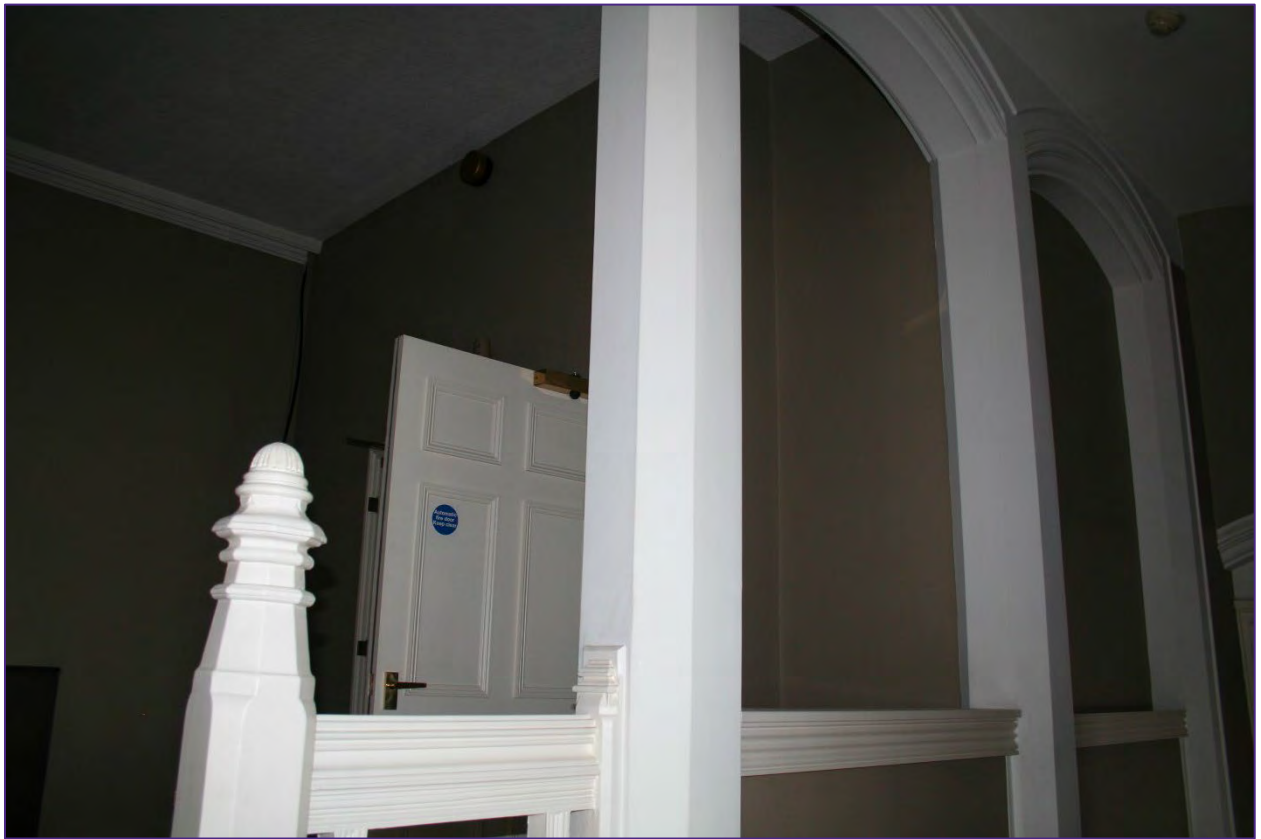
Plate 22: Arcading of upper landing.

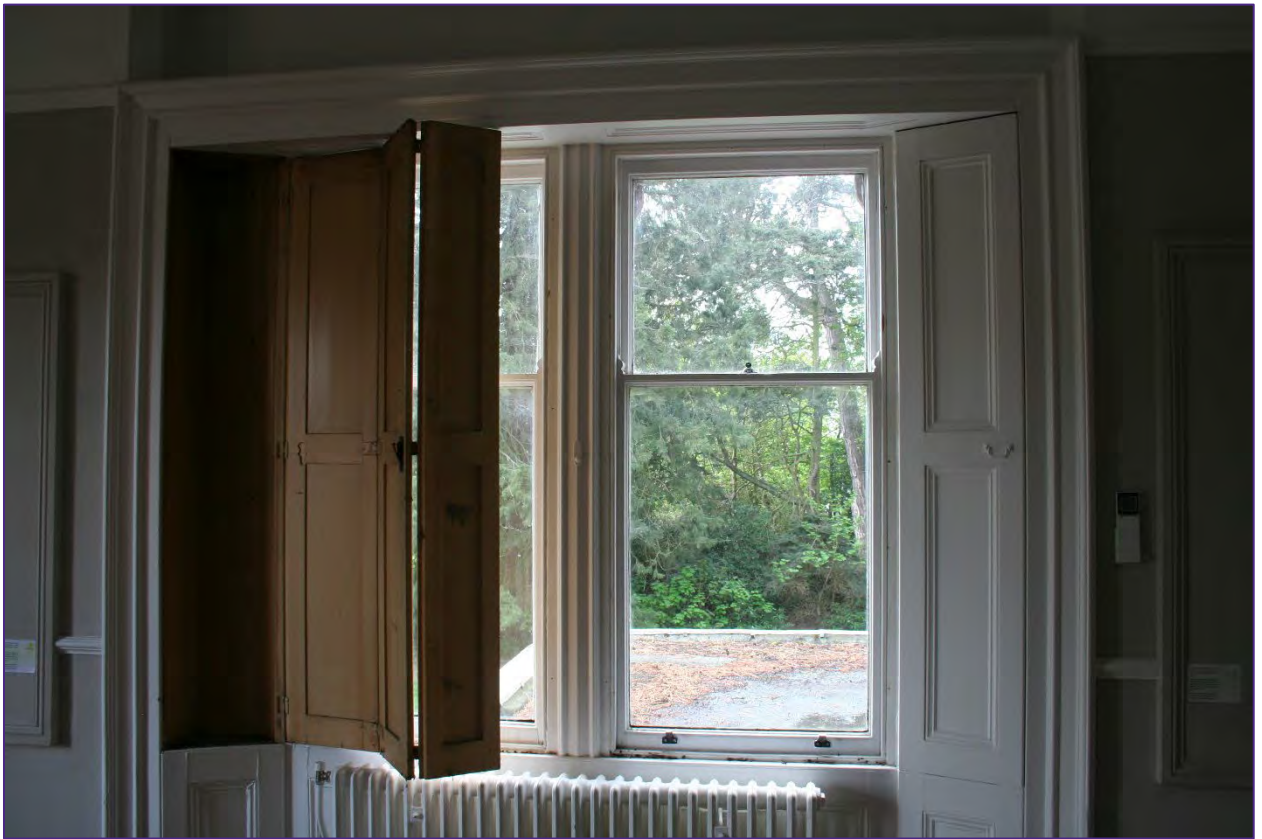
Plate 26: Timber panelling, shutter boxing and shutters in bedroom.
