01 As Proposed typical cross section of upper rafters  
Scale 1:5 @ A1

02 As Proposed part section of Roof 5. Repairs proposed the same for Roof 6  
Scale 1:10 @ A1

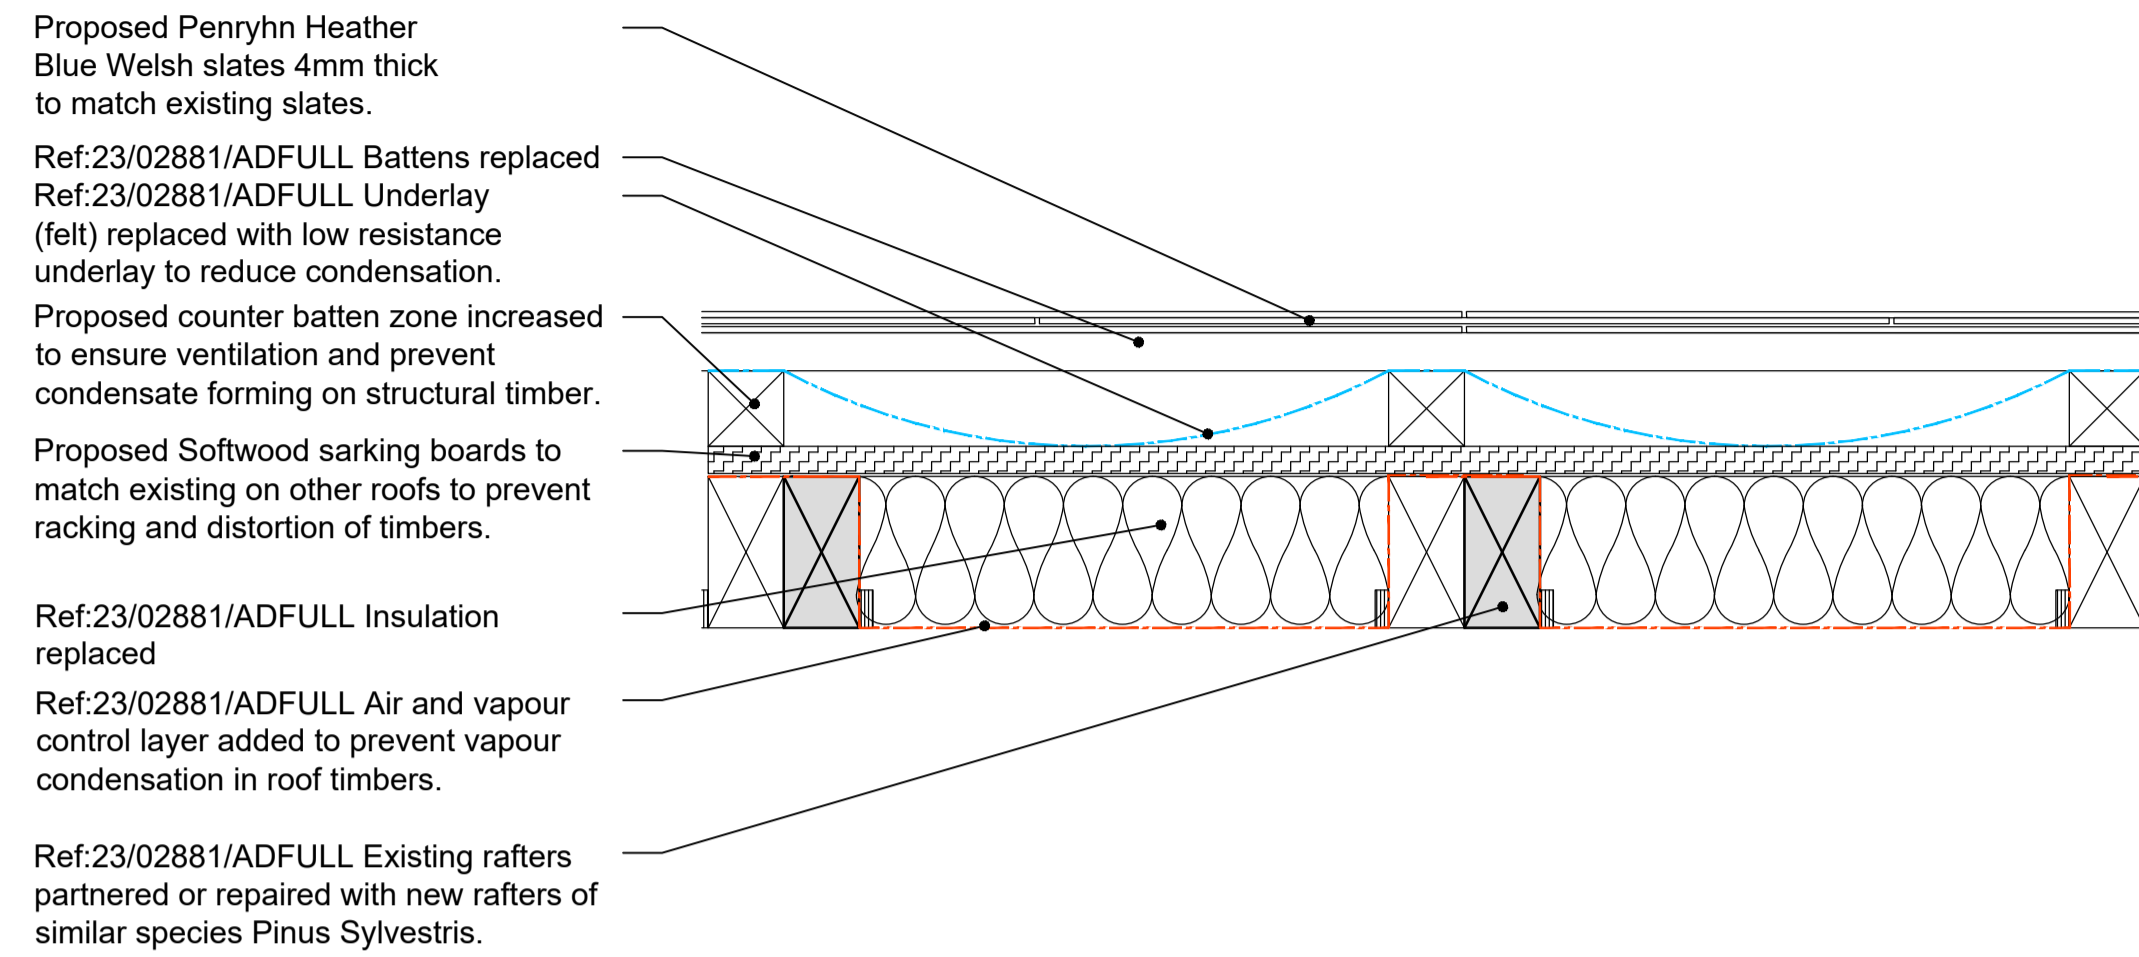
Ref:23/02881/ADFULL Existing ridge replaced with Pinus Sylvestris ridge to support the ridge ventilator with existing ridge tile above.

Proposed Penryhn Heather Blue Welsh slates 4mm thick to match existing slates.

Proposed timber noggins in timber to match existing and brackets to fix rafters

Proposed steel beams to reinforce existing timber purlins, concealed in ceiling zone.

Proposed counter batten zone increased to ensure ventilation and prevent condensate forming on structural timber.

Proposed racking board, Pinus Sylvestris to match existing. To prevent twisting of timbers.

Ref:23/02881/ADFULL Facade refurbished with Portland stone coping on lead DPC

Ref:23/02881/ADFULL Facade refurbished leaning parapet reinforced / rebuilt to structural engineer's documentation

Ref:23/02881/ADFULL Parapet render repaired.

Ref:23/02881/ADFULL Existing gutter exposed to allow repair and replacement of roof timbers. Warm ventilated lead gutter to lead sheet association standards, to prevent condensation on roof timbers and underside lead corrosion.

Ref:23/02881/ADFULL Existing roof exposed to allow repair and replacement of roof timbers. Warm ventilated roof design to prevent condensation on roof timbers.

Ref:23/02881/ADFULL Existing facade refurbished with lime render and paint finish.

Ref:23/02881/ADFULL Condition 9 Existing window frames to be refurbished and upgraded with slimline heritage double glazed panels, according to method statement.
