REPORT ON A PHASE 2 GROUND INVESTIGATION AND CONTAMINATION ASSESSMENT FOR A PROPOSED MIXED-USE DEVELOPMENT AT FORMER CHAMBERS BUS DEPOT, CHURCH SQUARE, BURES, SUFFOLK, CO8 5AB

Report No: 212945B

June 2022

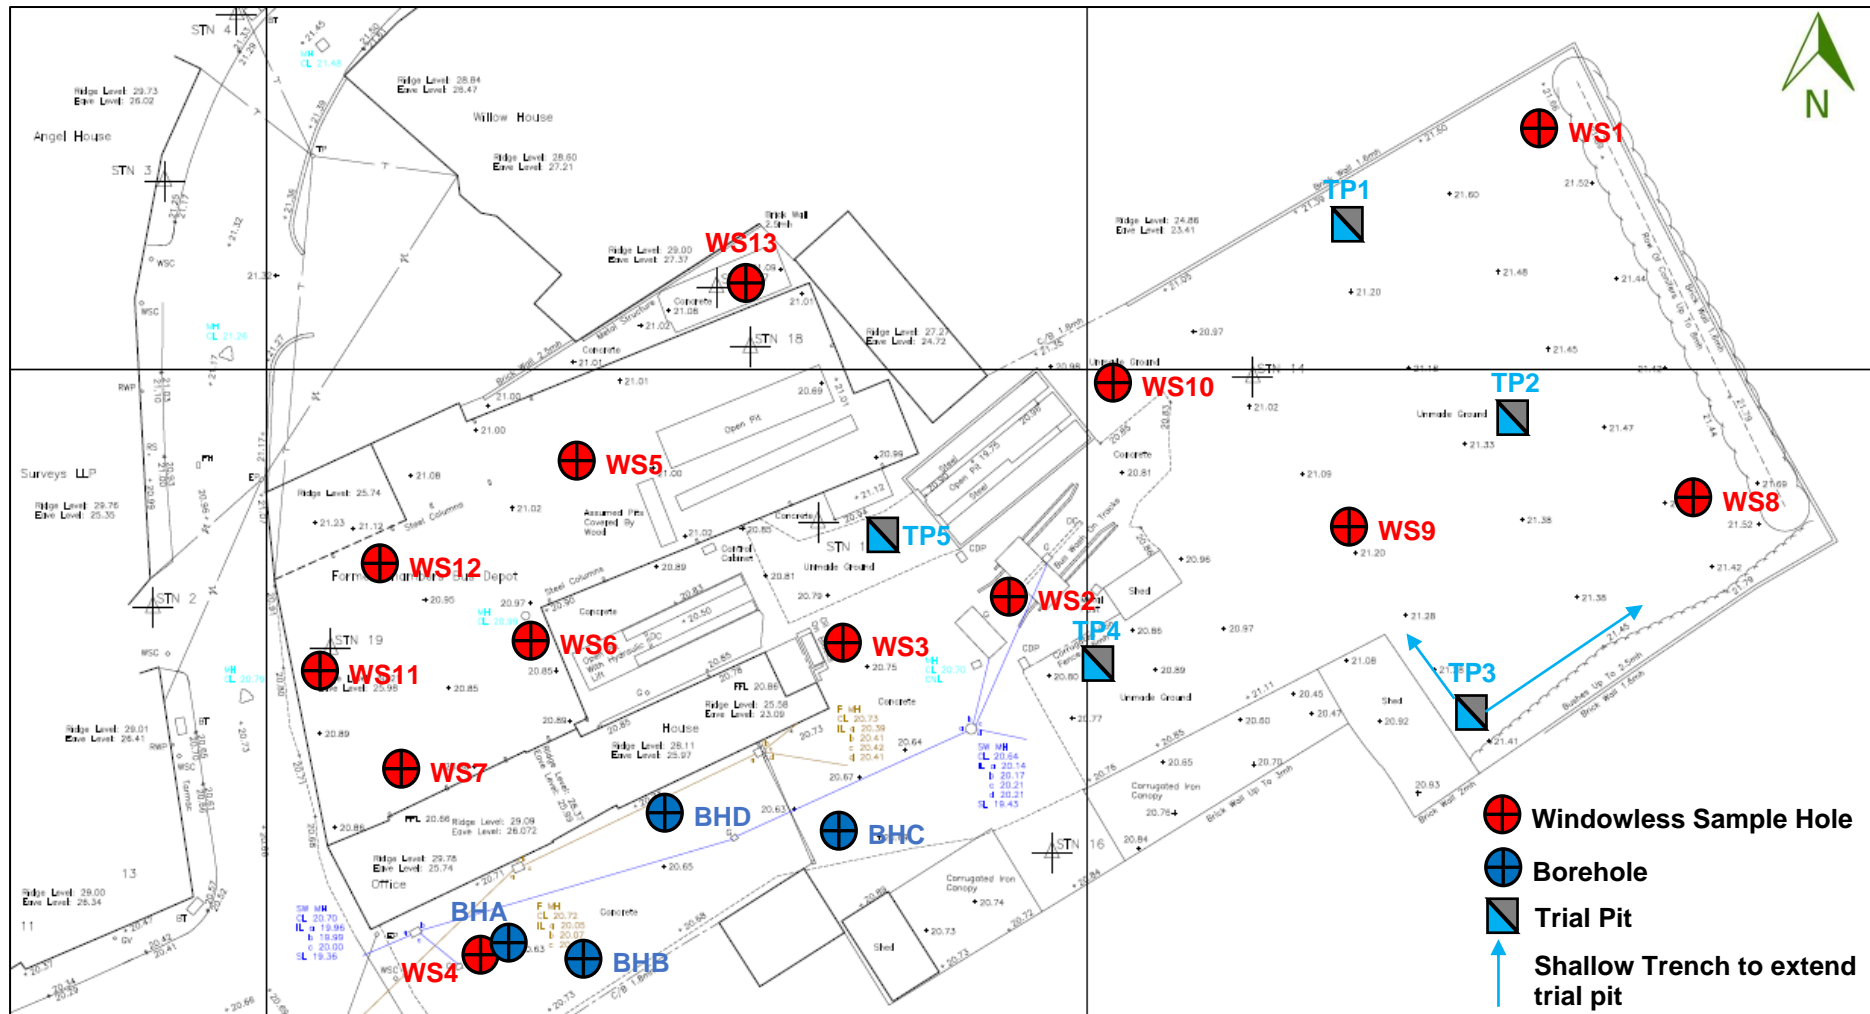
Figure 3	Exploratory Hole Plan
Date	June 2022
Not to Scale

Extract from Randall Surveys Existing Site Layout Drawing No: 16449/OG/1 dated June 2021

- 5.2 The second phase of investigation included four boreholes (BHA to BHD) drilled to 6.0m depth by light cable percussive methods with installation of groundwater monitoring points in each of the four boreholes. The installations comprised a slotted pipe with pea gravel surround below 2m depth. The upper 2m of the installation comprised a plain pipe with a bentonite surround and a lockable cover was concreted in flush with the existing ground surface. The boreholes were located in the south west of the site between Knowle House and the site boundaries but some of the positions were restricted by the presence of buildings. Full details of the ground conditions and the installations are given on the relevant borehole logs of Appendix (iii) and the location of the boreholes is shown on Figure 3, Appendix (i).

south of the existing bus wash in an area thought to have been an inspection pit. TP4 was of limited depth due to the presence of concrete slabs associated with an older bus wash structure. TP5 was located adjacent to the plinth for the former above ground tank outside the rear of the bus garage. The trial pit logs are included in Appendix (iv) and their location is shown on Figure 3, Appendix (i).
