**Proposed roof plan**

**Project:** Proposed alterations & refurbishment at Old Rectory, Tostock  
**Client:** Mr & Mrs Bowyer

**Drwg:** 23 1860 17 **Revision:** -  
**Date:** Feb 2024 **Scale:** 1:100 @A2

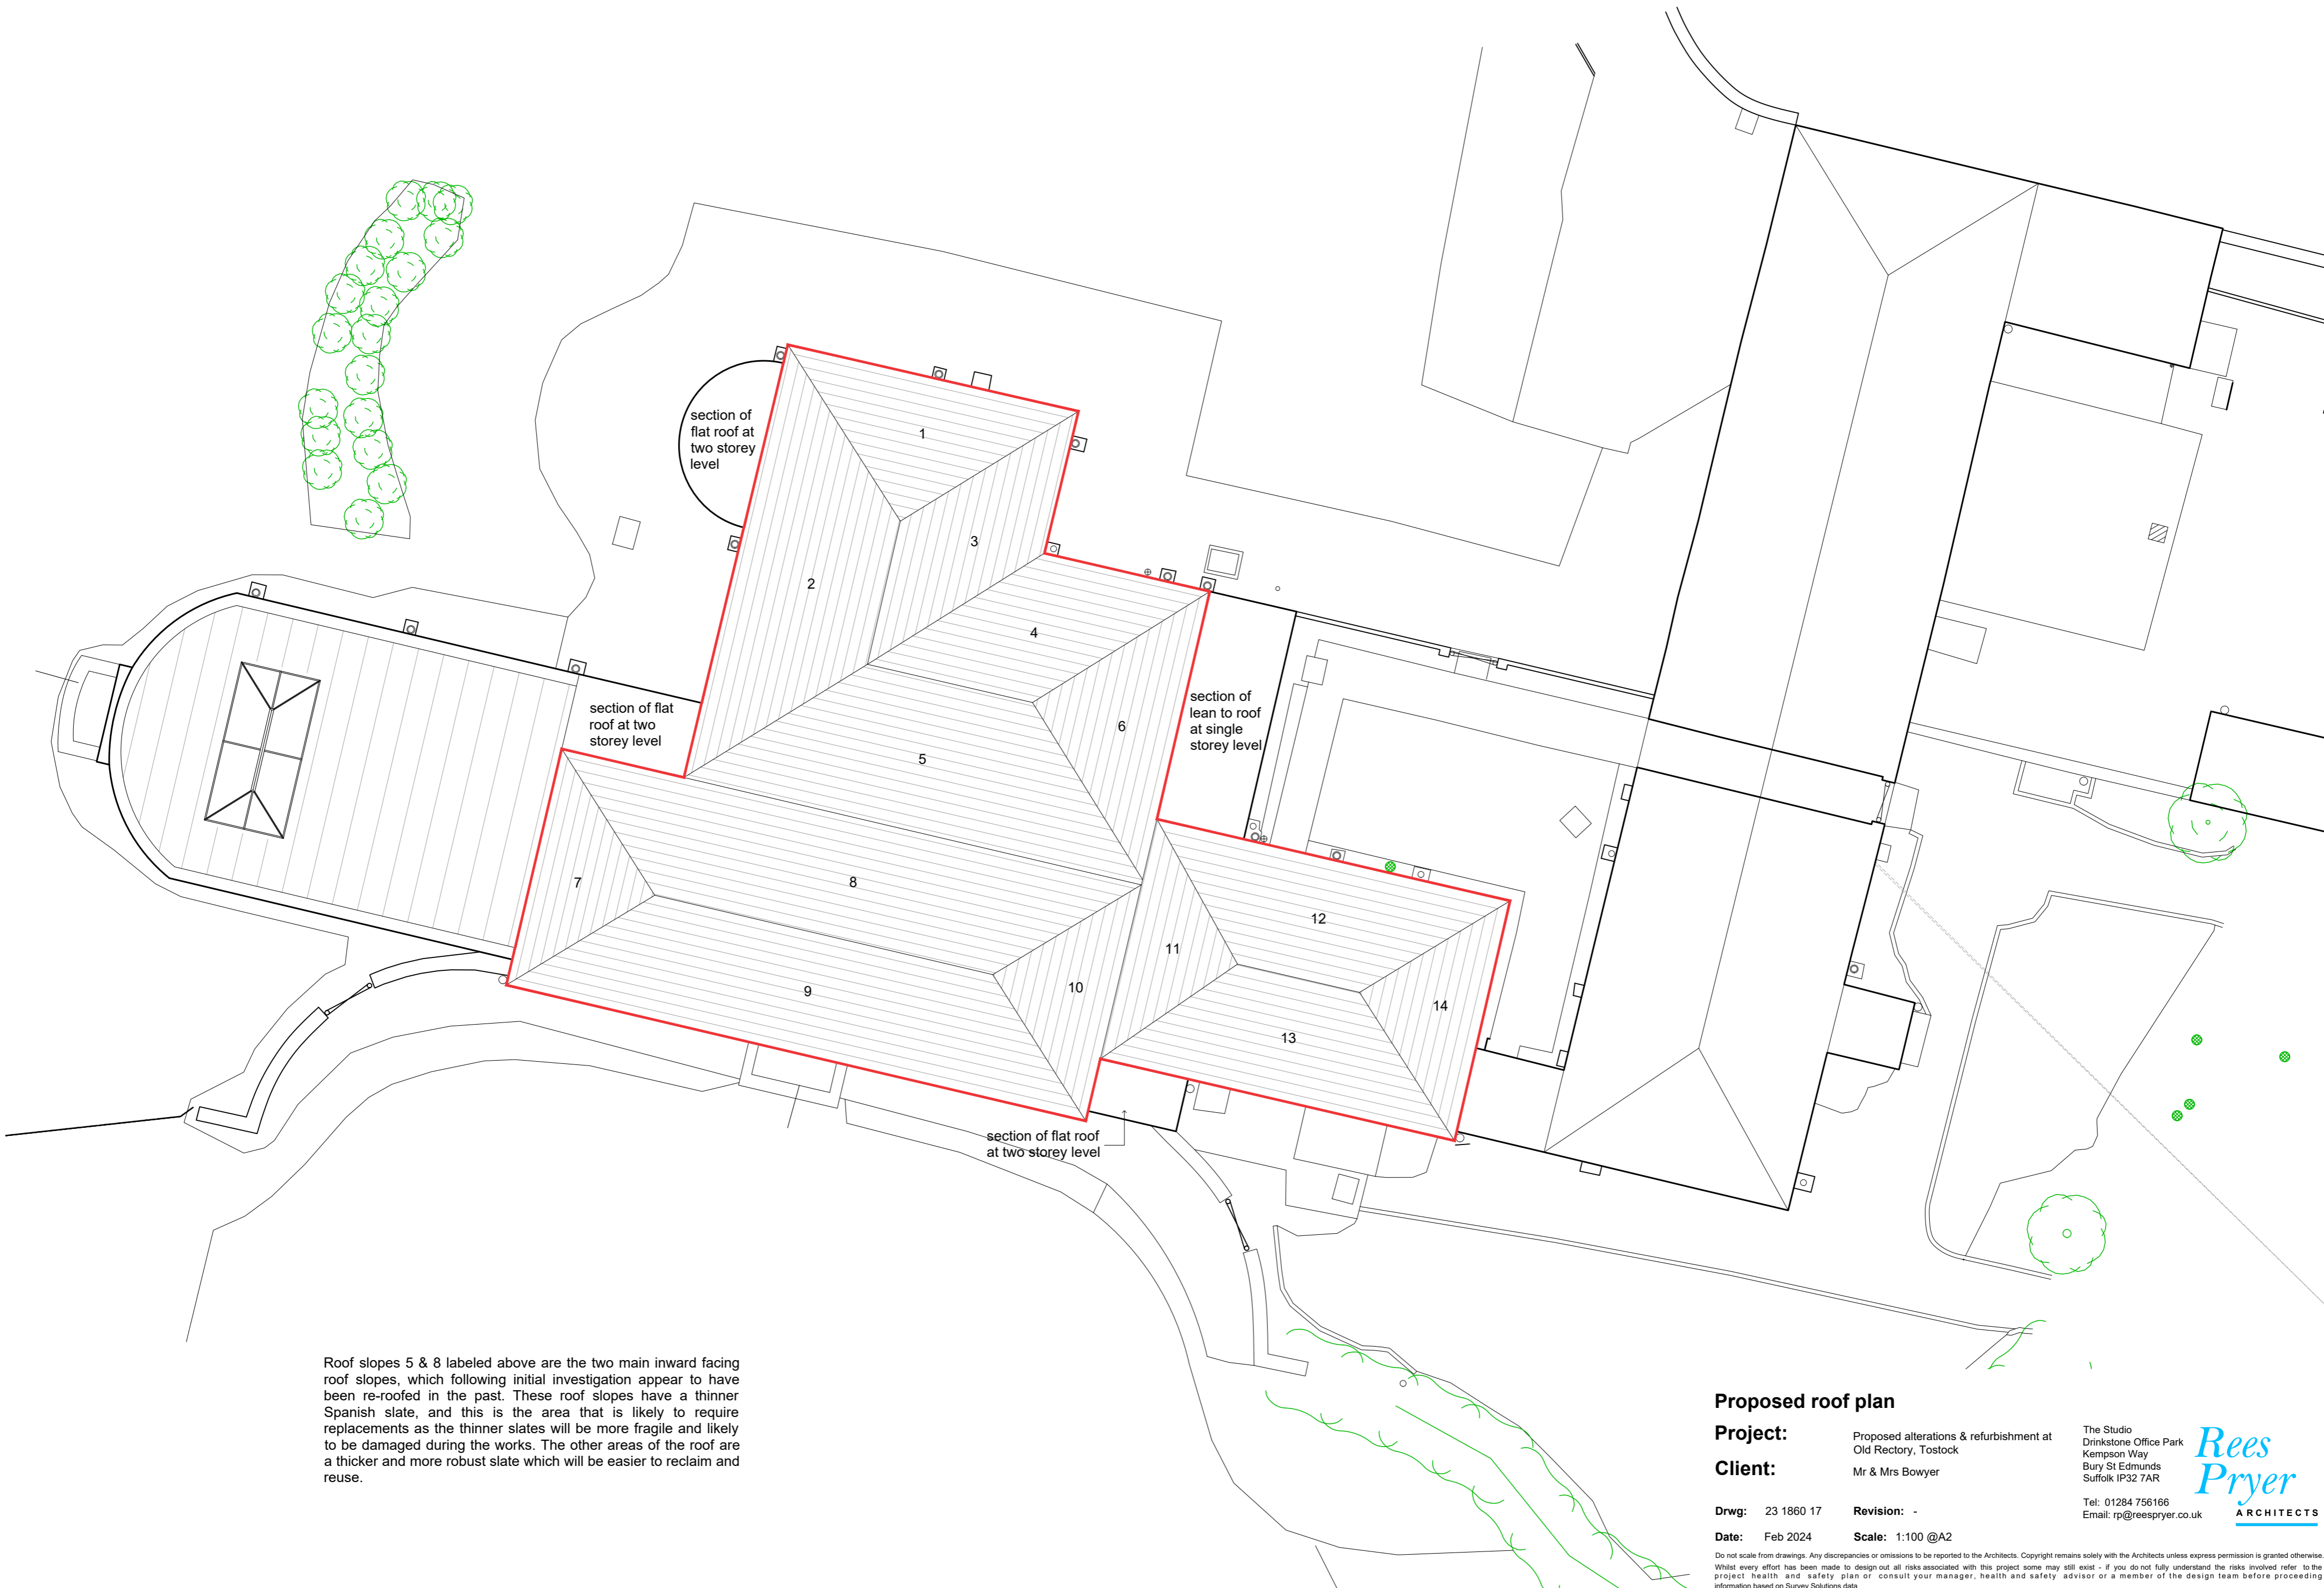
Roof slopes 5 & 8 labeled above are the two main inward facing roof slopes, which following initial investigation appear to have been re-roofed in the past. These roof slopes have a thinner Spanish slate, and this is the area that is likely to require replacements as the thinner slates will be more fragile and likely to be damaged during the works. The other areas of the roof are a thicker and more robust slate which will be easier to reclaim and reuse.
