Report No. BC/MB/02.24.02.

## Coal Mining Risk Assessment: Land at Block B, Sparks House, Western Industrial Estate, Caerphilly.

Creazione Fitness Village.

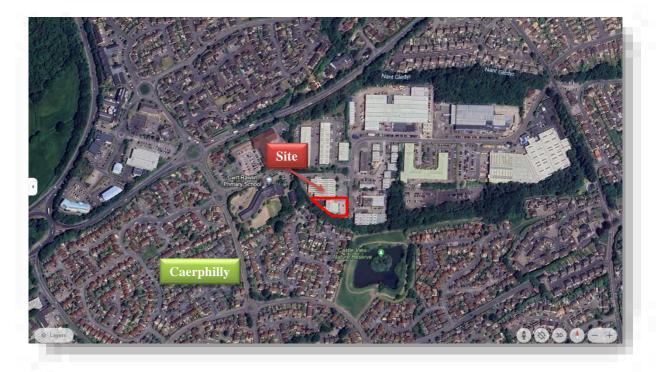
Figure 1
Aerial View of Site
(Google Earth Pro)

The plot of land that is the subject of this report, 'the Site' is located at Sparks House on the Western Industrial Estate, which is in the south-western quarter of Caerphilly approximately 1.6 miles south-west of the commercial centre of Caerphilly. The Site is situated at the south-west edge of the industrial estate, adjacent to a mixed residential area that includes a school and nature reserve area (see Figure 1 and *General Location Plan, drawing no. BC/MB/02.24.02.01*). The Site is presently occupied by Creazione Fitness Village, a dance, fitness and gym facility with car parking space, it is roughly triangular in outline and occupies an area of approximately 0.53 hectares. The Site is at an approximate elevation of 100m aod.
