## **DESIGN AND ACCESS STATEMENT**

### **Renovations at Poole Barton, Barton Close, Cheriton Fitzpaine, Crediton, Devon, EX17 4JB**

### **Design and Access Statement and Supporting Information for Listed Building Consent Application**

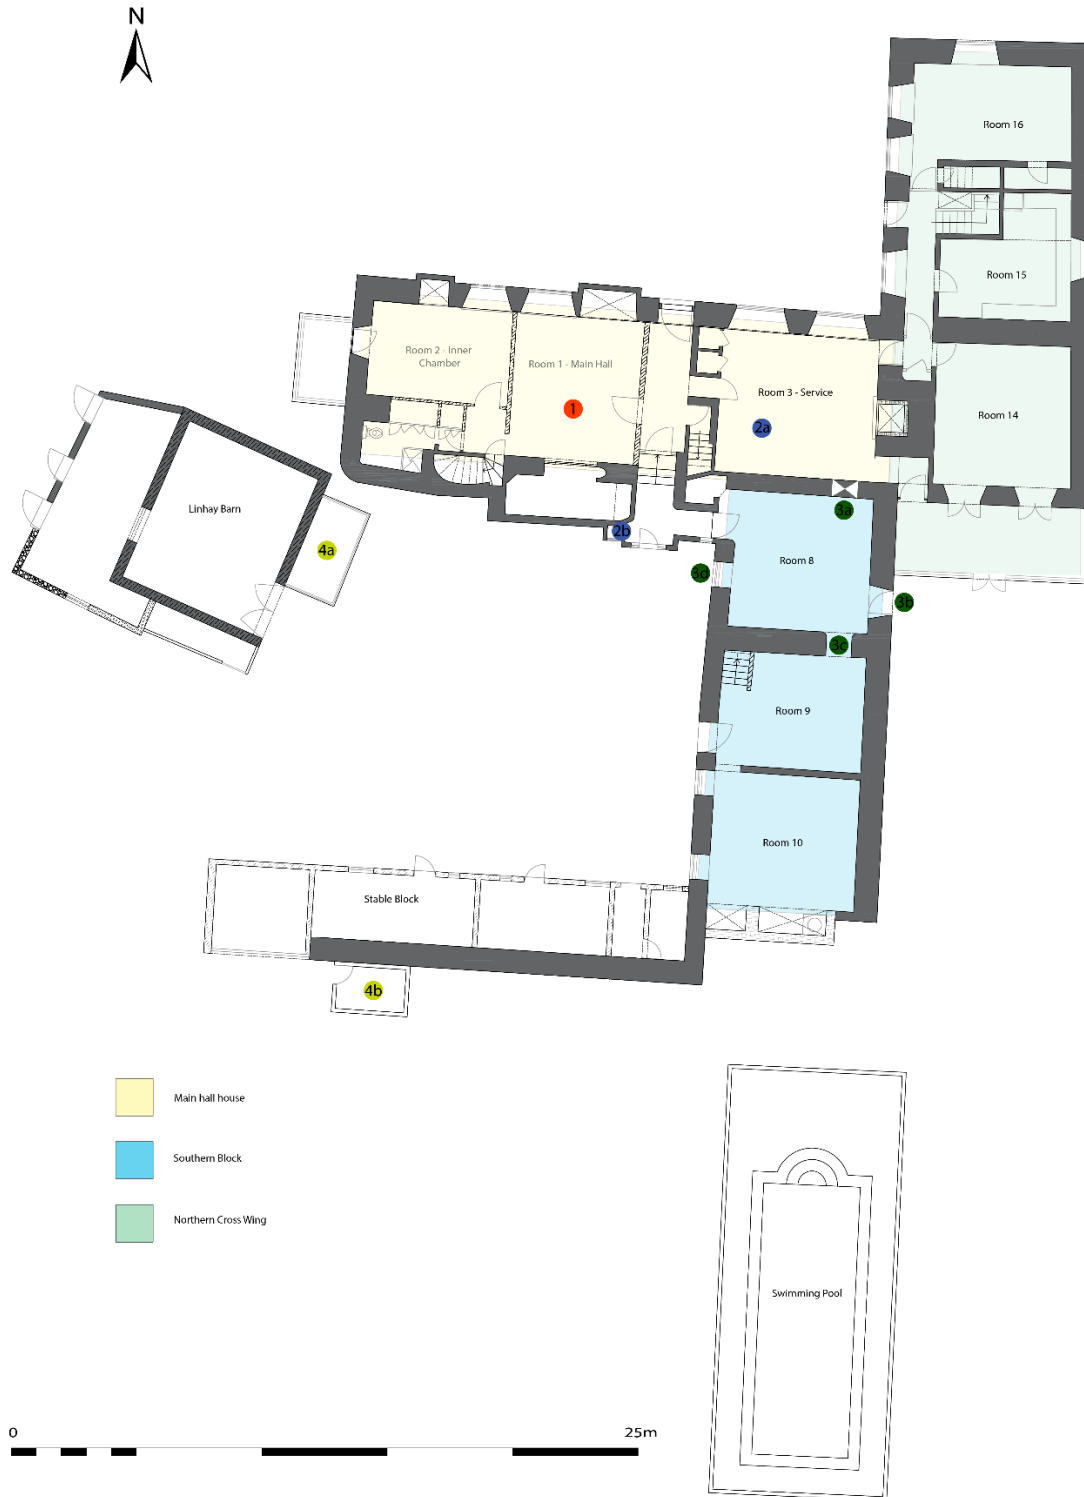
<i>Plan No.</i> 1	<i>Plan Title</i> Ground Floor Plan

**4. EXISTING FLOOR PLANS OF POOLE BARTON AND LOCATION OF PROPOSED WORKS**

The change of use of Room 3 will require upgrade of the drainage system to allow for the flow to an open drain in the back porch (Fig. 1, **2b**). This will require the drain in this location to be covered or moved (Photo. 4). With regard to the drainage, the plan is for it to be capped but this may require an internal vent; the installation of which will be guided by building control. If this is possible there would be no change to the fabric of the building and no changes externally.

The proposal to reinstate a previous doorway opening between Room 8 and Room 3 (Fig. 1, **3a**). The Heritage Assessment has effectively demonstrated that a doorway once existed between these two rooms which functioned to link the main hall house with the southern block/wing (Photo. 5). The woodwork and joinery present within a wall cavity in this location suggests that this doorway was filled in during the 20th century (Photo. 6). The opening of this cavity, including the installation of the new door is therefore not anticipated to result in any impact to historic fabric of high significance in this location. The replacement door will be made from pine to match the historic 6-panel doors within Room 3 (Fig. 1).

Replacement of the current ledge/brace door along the east of Room 8 with door of same design but of oak rather than pine (Fig. 1, **3b**). The current door, which includes a

A new door to be installed into the existing historic frame (Photo. 8) between Room 8 and Room 9 (Fig. 1, **3c**). The proposals are for this door to be of the same material and type as **3b**, but without the addition of a central window cavity. Reinstatement of this door will function to converting Room 8 to a liveable space and put the room to use rather than the current state of degradation to the room. All three doors within Room 8 will be manufactured by the client by hand. The client has prior experience in construction of such doors and will be designed in-line with the provided example (Photo. 9).

The installation of a new windowpane on the western side of Room 8 (Fig. 1, **3d**). The window would be installed within the existing frame which is likely contemporary with the fabric of this part of the building (17th century). The casements within this frame are proposed to match that of the first-floor window above. The frame in **3d** is currently covered from the outside with polycarbonate and no historic window glass in present (Photo. 10). It is proposed that the new pane will be of similar 12mm double glazing, providing benefits to insulation and energy efficiency of the space.

The greenhouse located along what was originally eastern side of what is likely to be a 18th to 19th century linhay barn abuts a section of 20th century corrugated metal wall (Fig. 1, **4a**). Its removal will therefore not be at risk of impacting upon any historic fabric (Photo. 11).

The other greenhouse proposed for removal (Fig. 1, **4b**), although not forming part of the curtilage Listing of the property itself, abuts a cob wall proven by historic mapping to be older than that of 1839 Cheriton Fitzpaine Title Map (ISCA, 2024, 24). However, its careful removal is anticipated to result in minimal impact to the historic fabric of the section of cob wall. Its removal will provide the added benefit of providing an insight into the preservation and structural condition of the section of cob walling that the lean-to greenhouse currently prevents observation of (Photo. 12).

- 3.3. It is the client's intention to carry out all works to Room 8 themselves.
- 3.4. Following removal of the greenhouse, and also during the summer of 2024, the schedule is to replace the existing external door in Room 8 (Fig. 1, **3b**) as this relates to a security issue within the house. Overall, this work is anticipated to take no longer than a few days.
- 3.5. Following this, the proposal is to reinstate the former doorway between Rooms 3 and 8 and install the new door (Fig. 1, **3a**). This would function to link the main hall house with the southern wing of the house. This would likely take no less than a week to complete.
- 3.6. Following this, the client will install the door in the existing doorframe between Rooms 8 and 9 (Fig. 1, **3c**) and conduct the work to the window (Fig. 1, **3d**).

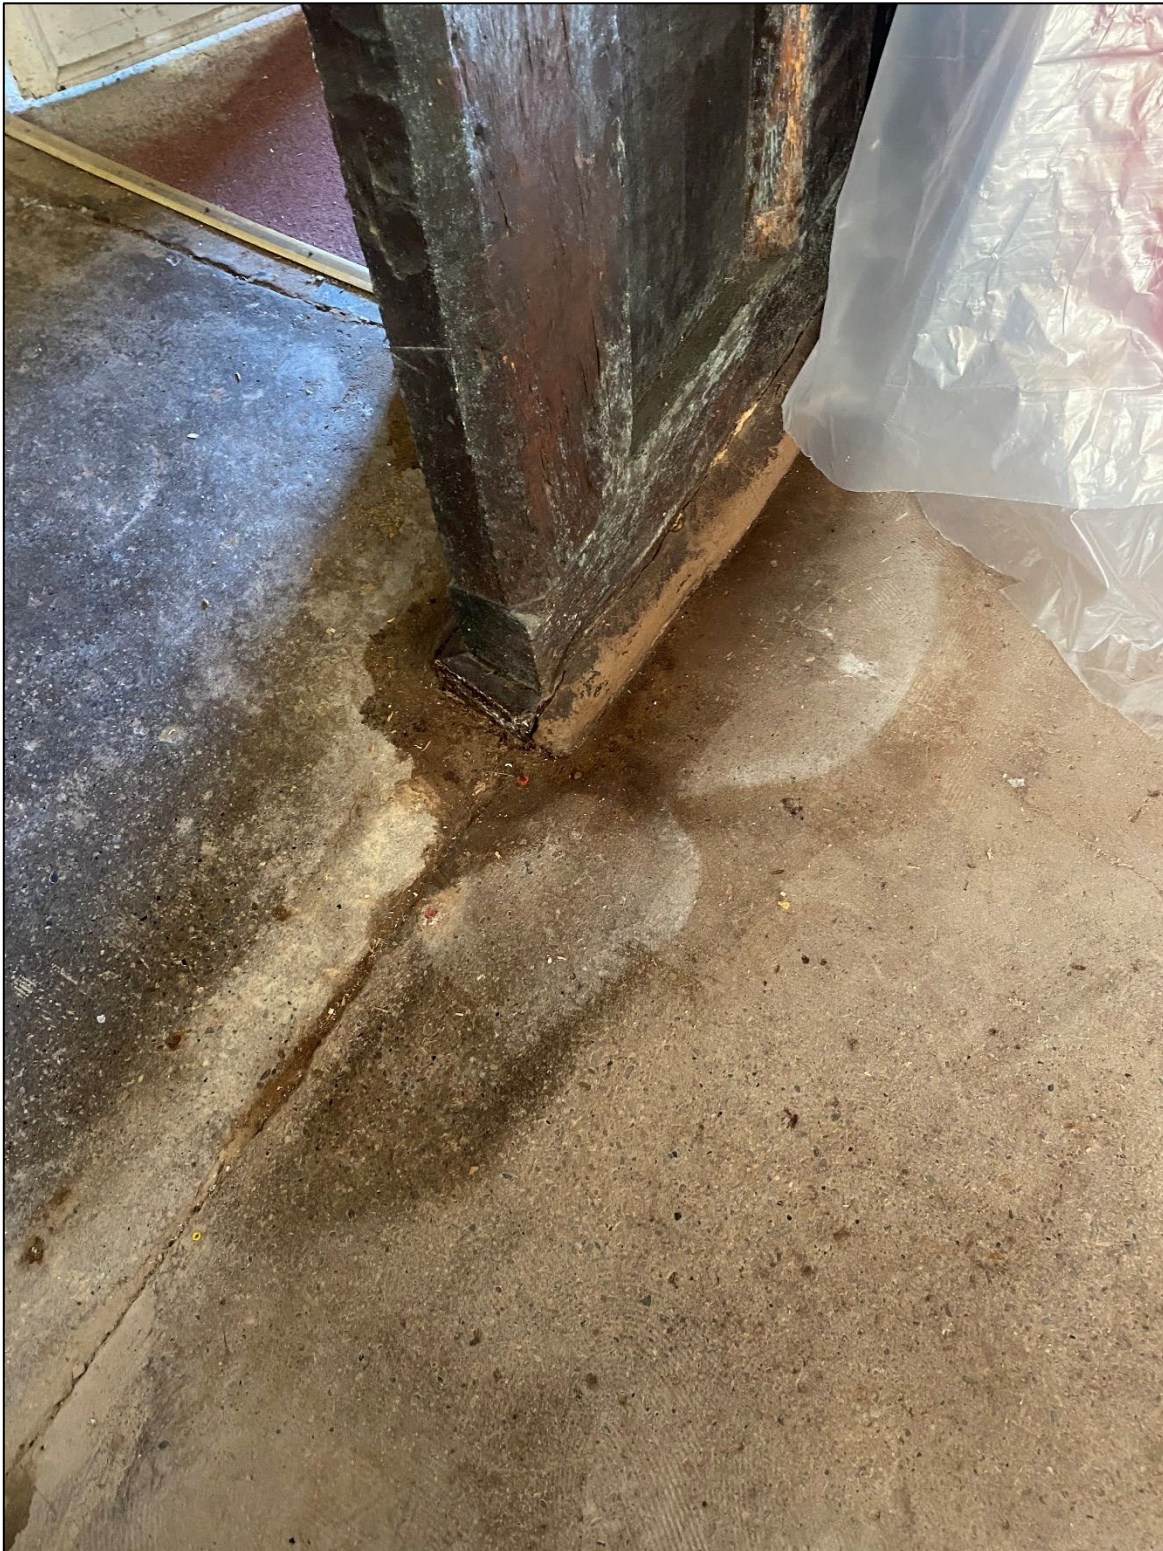
**Photo 1:** Damp coming through the modern concrete floor against the base of a 15th century oak plank-and-muntin screen (Fig. 1, 1)

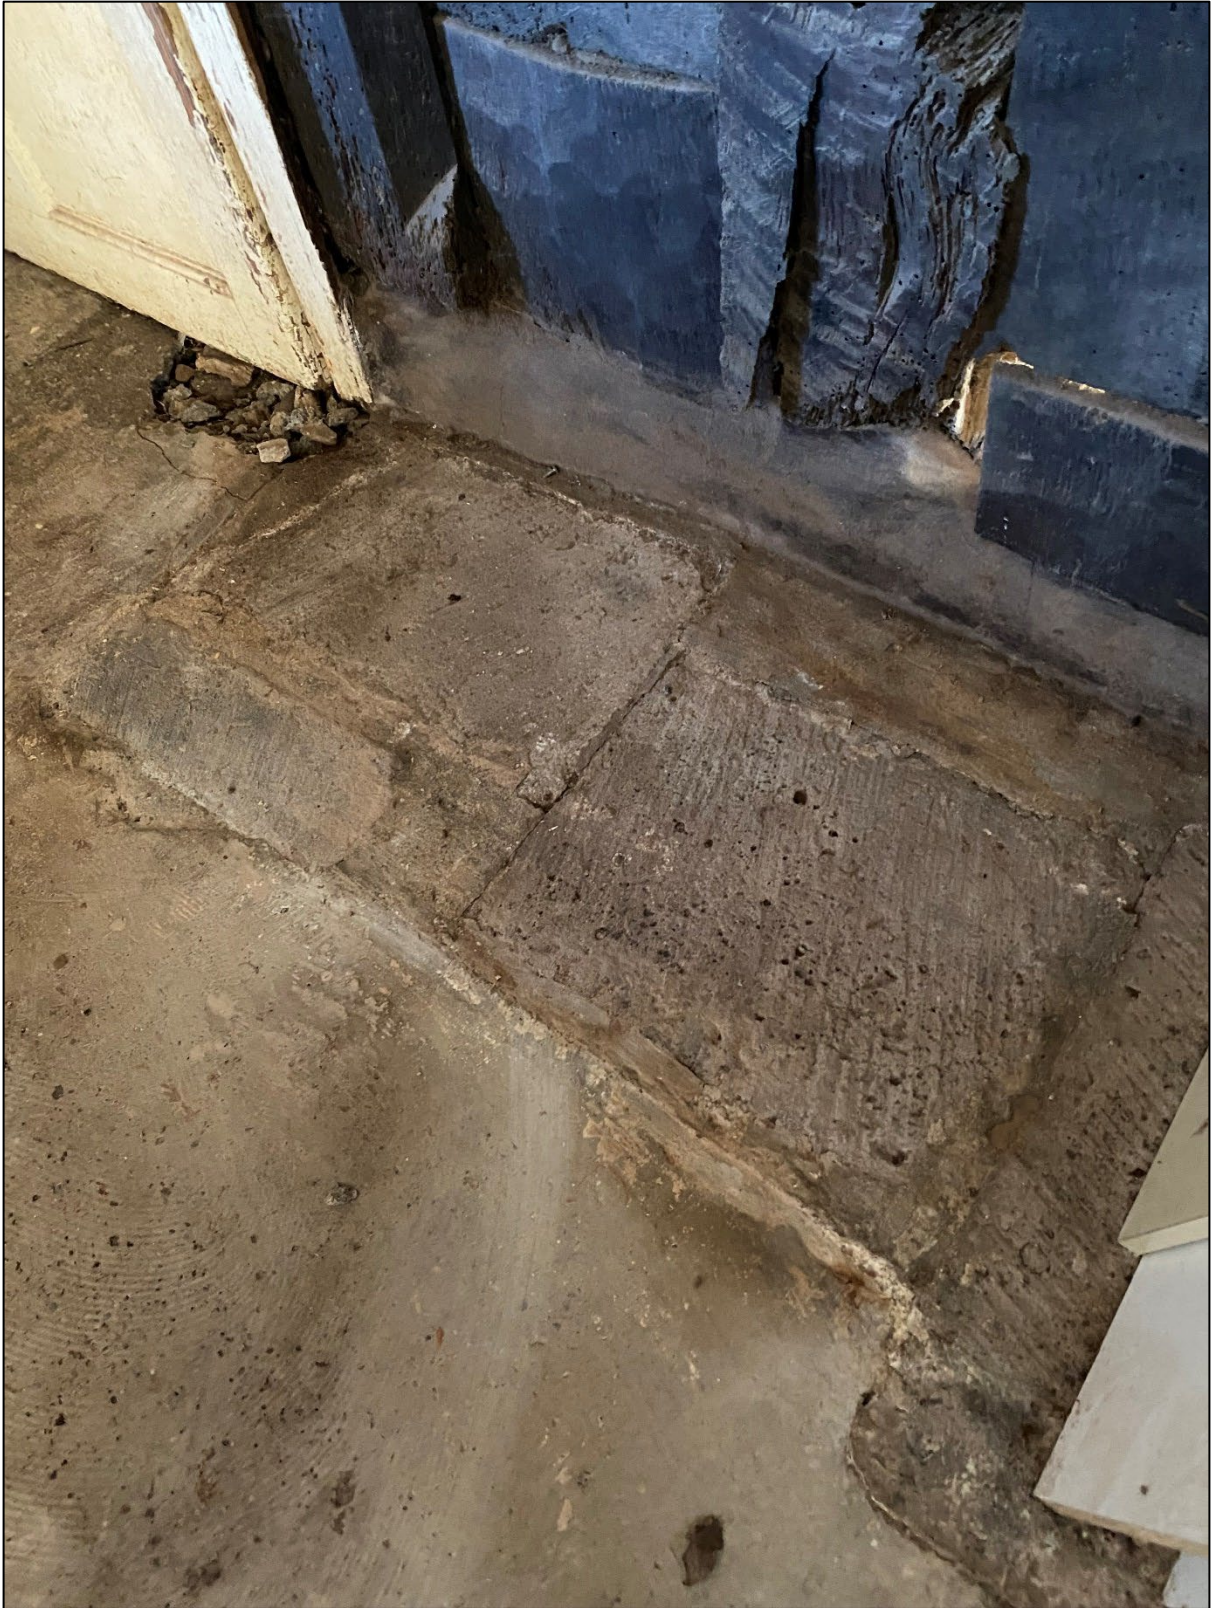
**Photo 2:** Historic Flagstone flooring in the south west corner of Room 1. To be left *in-situ* without impact (Fig. 1, 1)

Historic flagstones (0.5m<sup>2</sup> in total) located in the south western corner of Room 1, and on the same level as the modern concrete flooring are present (Photo. 2). These historic flagstones, likely dating to either the 15th or the 16th century, will be left *in-situ* and will not be impacted by the proposed works to the floor.

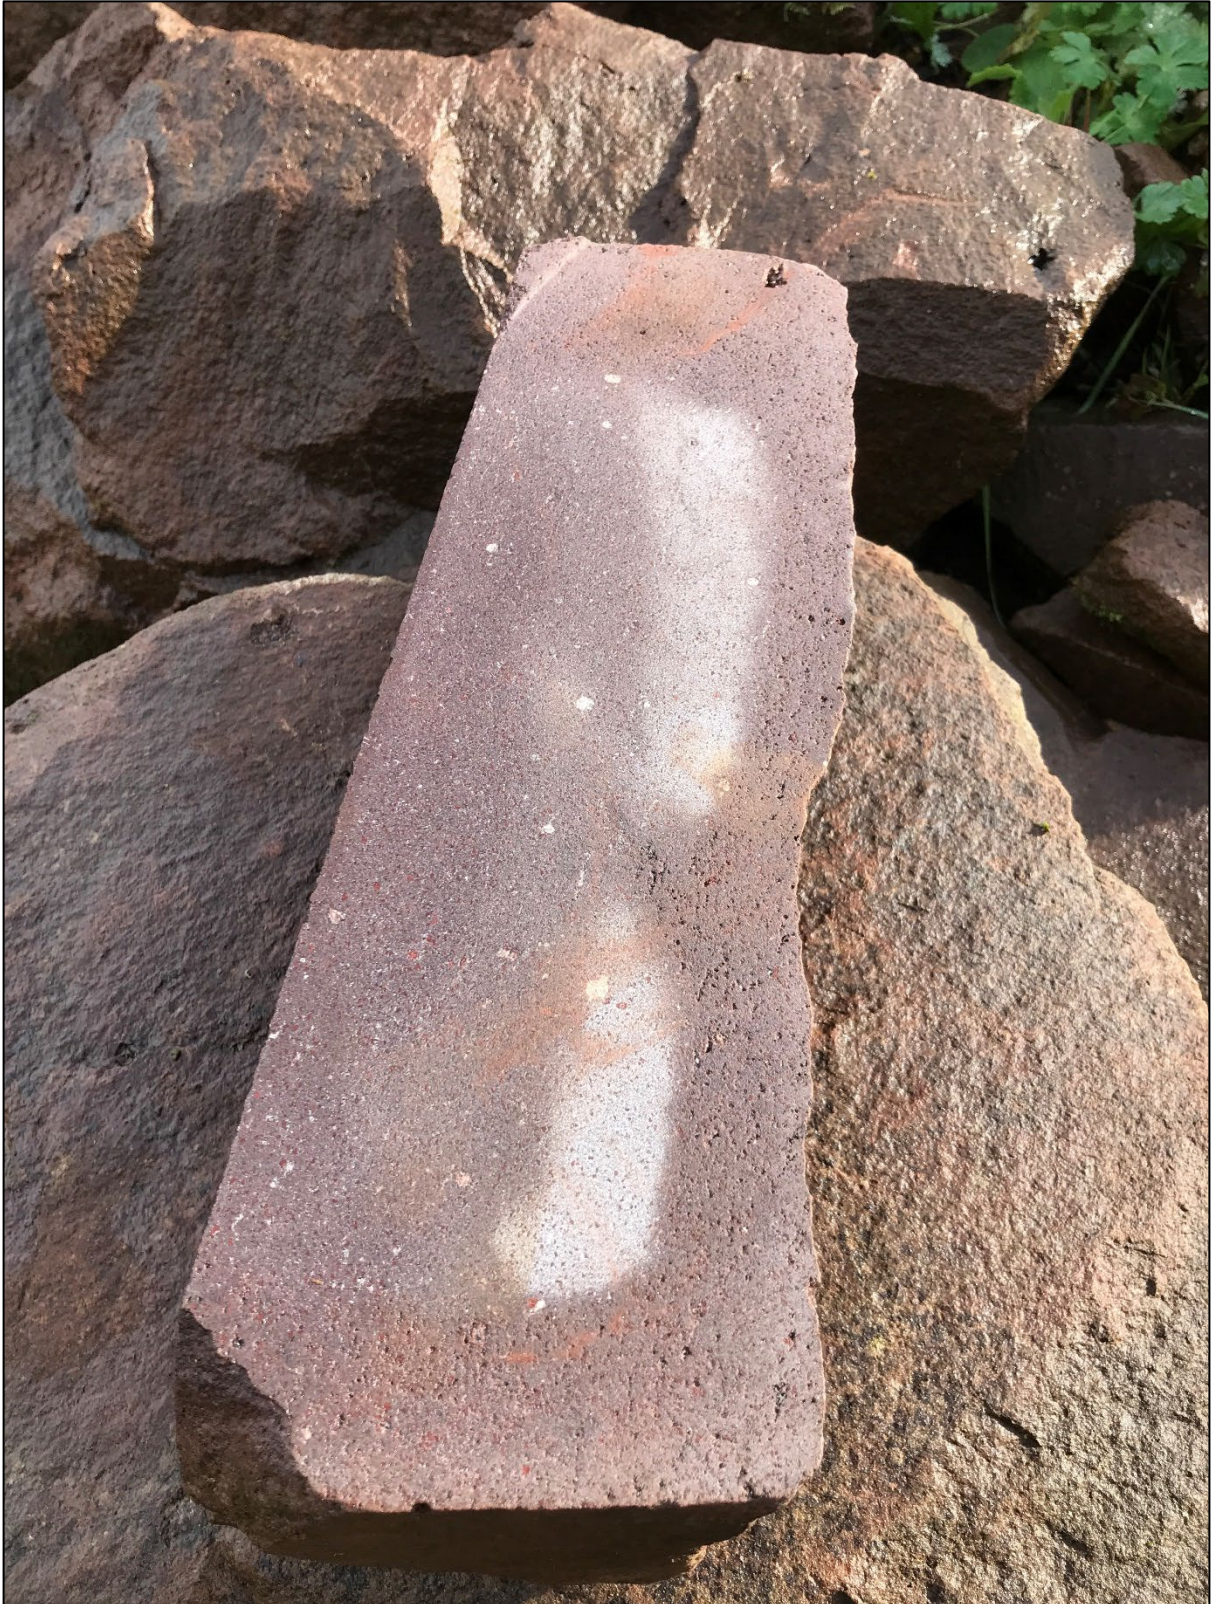
**Photo 3:** The new floor within Room 1 will utilise volcanic flagstones sourced from a local quarry. These would be consistent with existing in-situ historic flagstones (Fig. 1, 1)

The proposal is to replace the current concrete flooring with volcanic flagstones sourced from the local Knowle Quarry (Photo. 3). Sizing would be as per the historic flagstones *in-situ*.

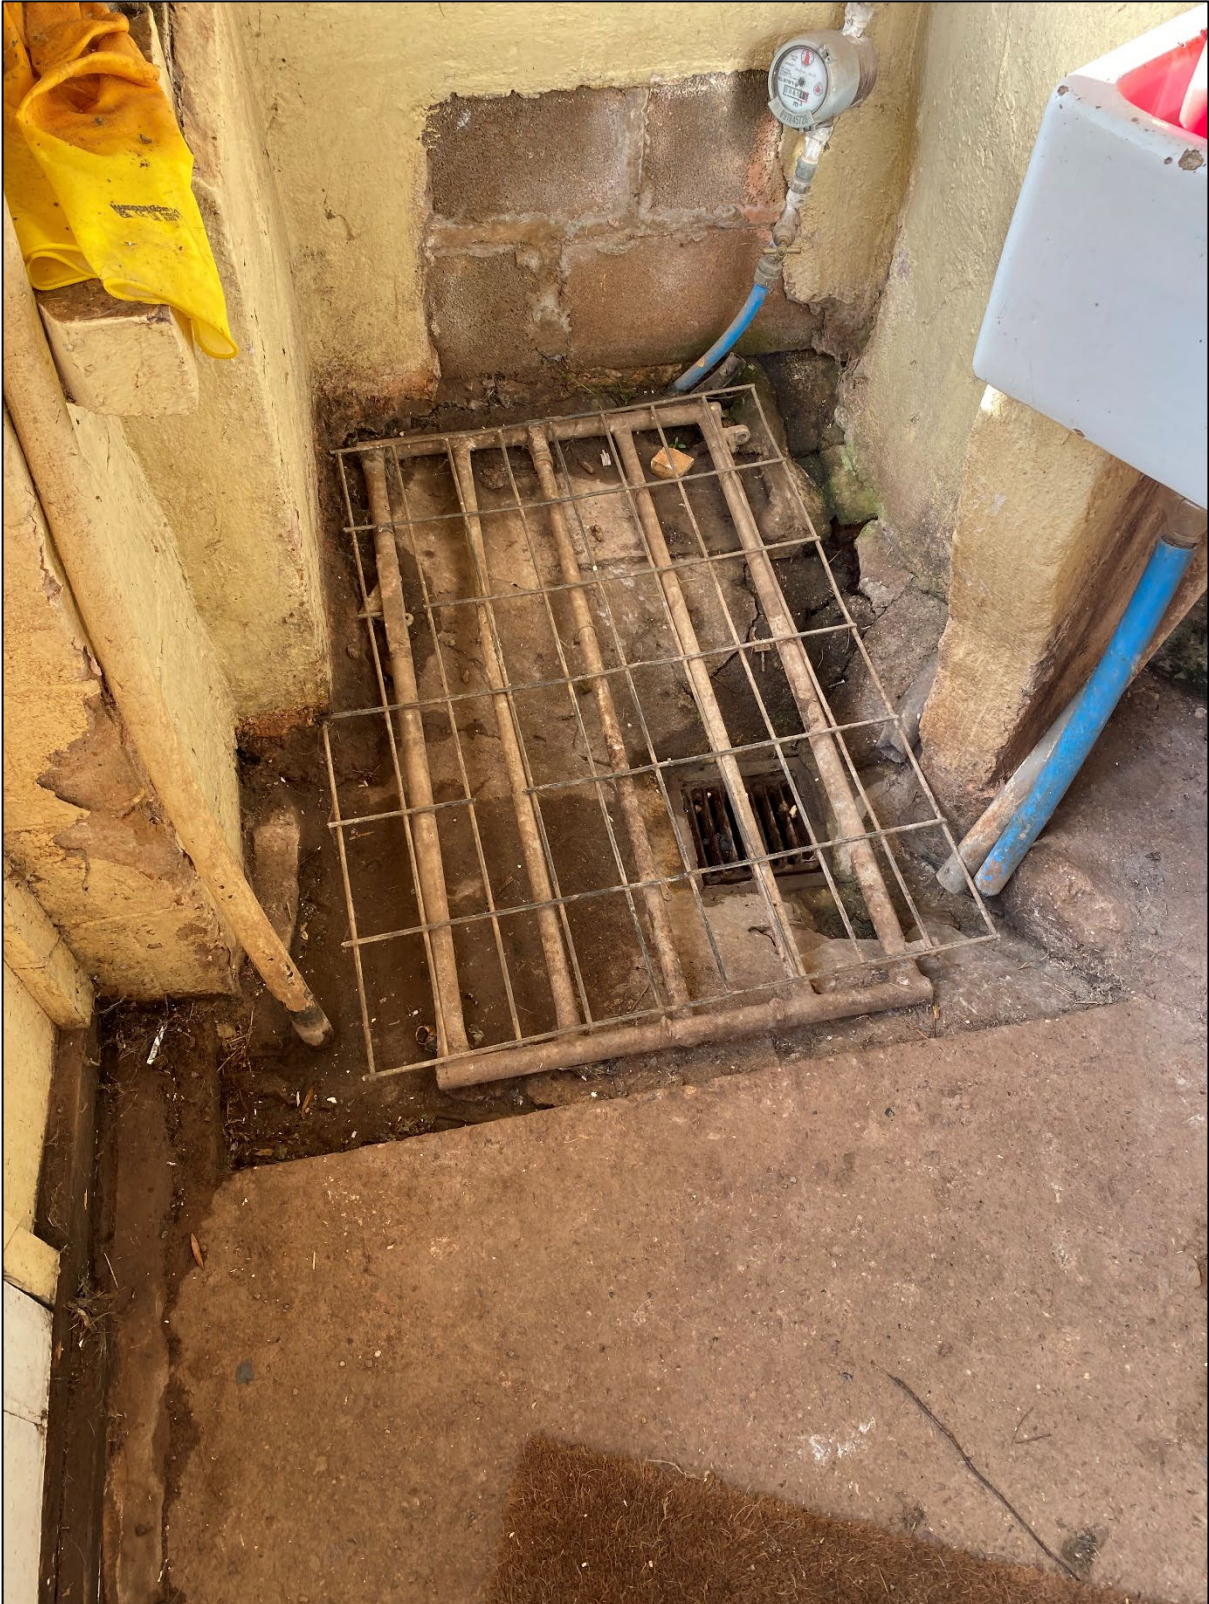
**Photo 4:** Drain within the rear porch to be covered or moved (Fig. 1, 2b)

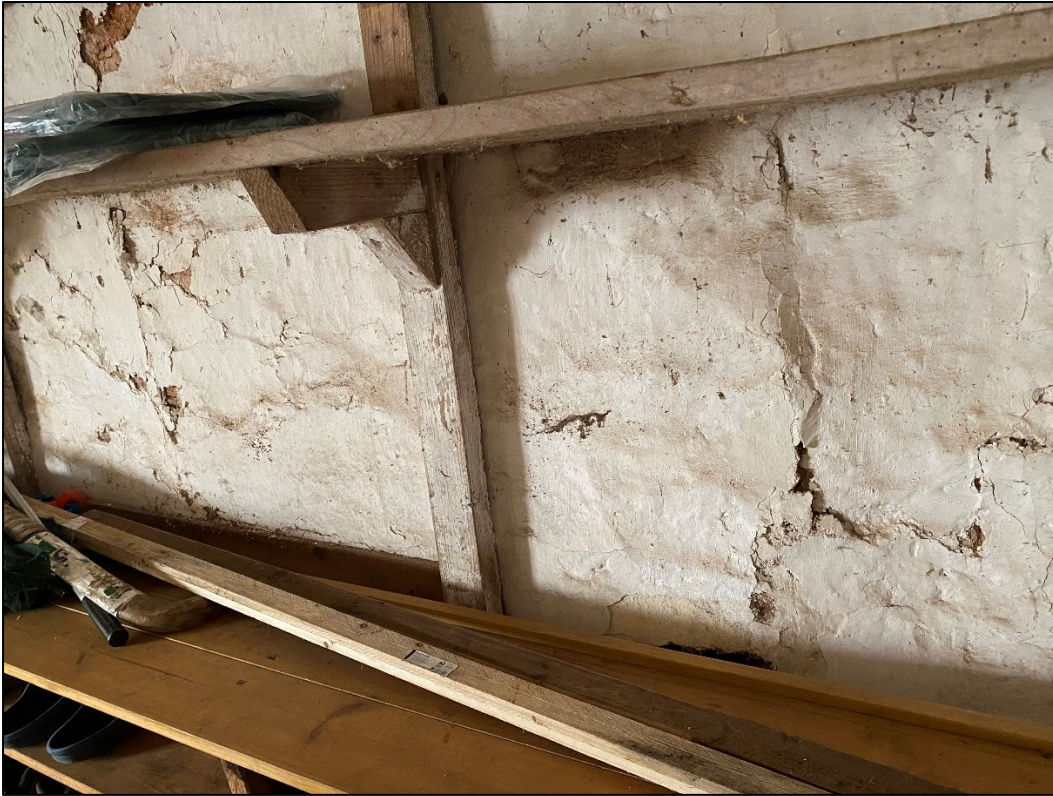
**Photo 5:** Former doorway outline to be reinstated between Rooms 8 and 3 (Fig. 1, 3a)

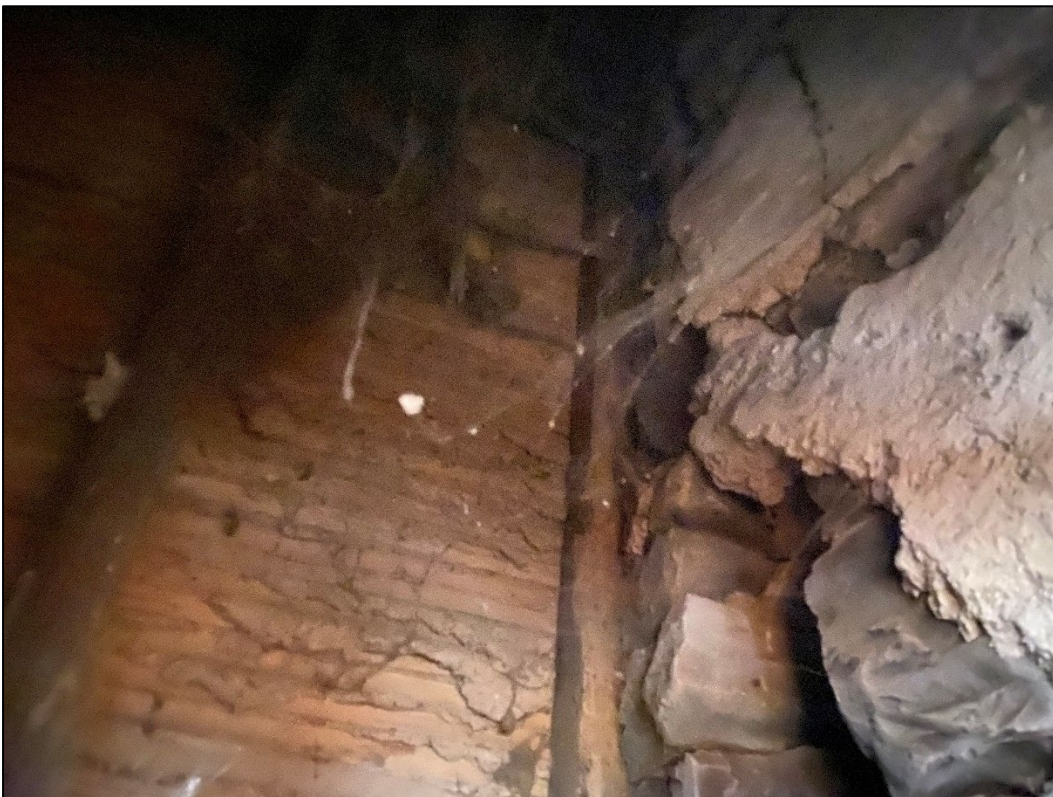
**Photo 6:** Cavity in the location of former doorway to be reinstated between Rooms 8 and 3 containing modern (20th century) woodwork (Fig. 1, 3a)

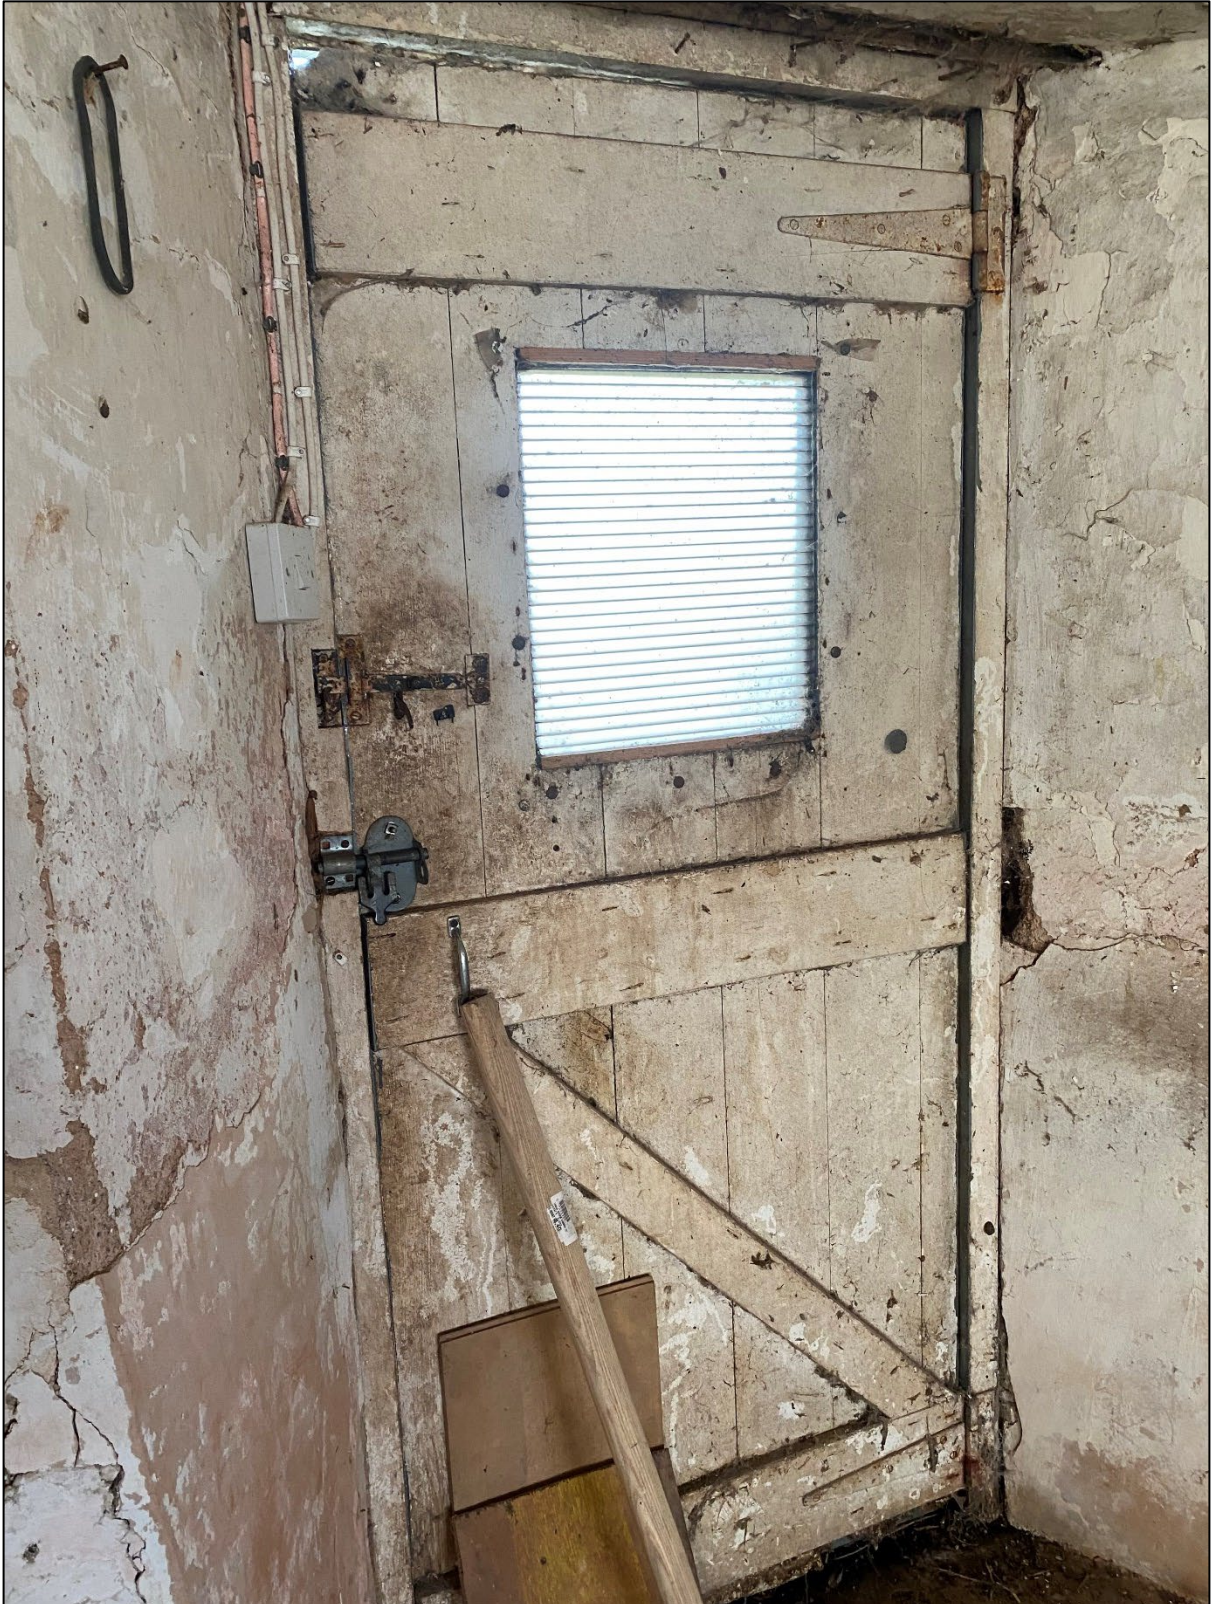
**Photo 7:** Pine door to be replaced with oak door of the same type on the eastern side of Room 8 (Fig. 1, 3b)

polycarbonate windowpane, is likely to be late 19th to 20th century in date and is a replacement of an earlier door set into the external cob wall (Photo. 7). Its reinstatement/replacement in oak is more in keeping with the historic doorways throughout the house and likely to be more in keeping with the original door. The proposal is to use 12mm double glazing within the new door which will provide more insulation and energy efficiency to this part of the house.

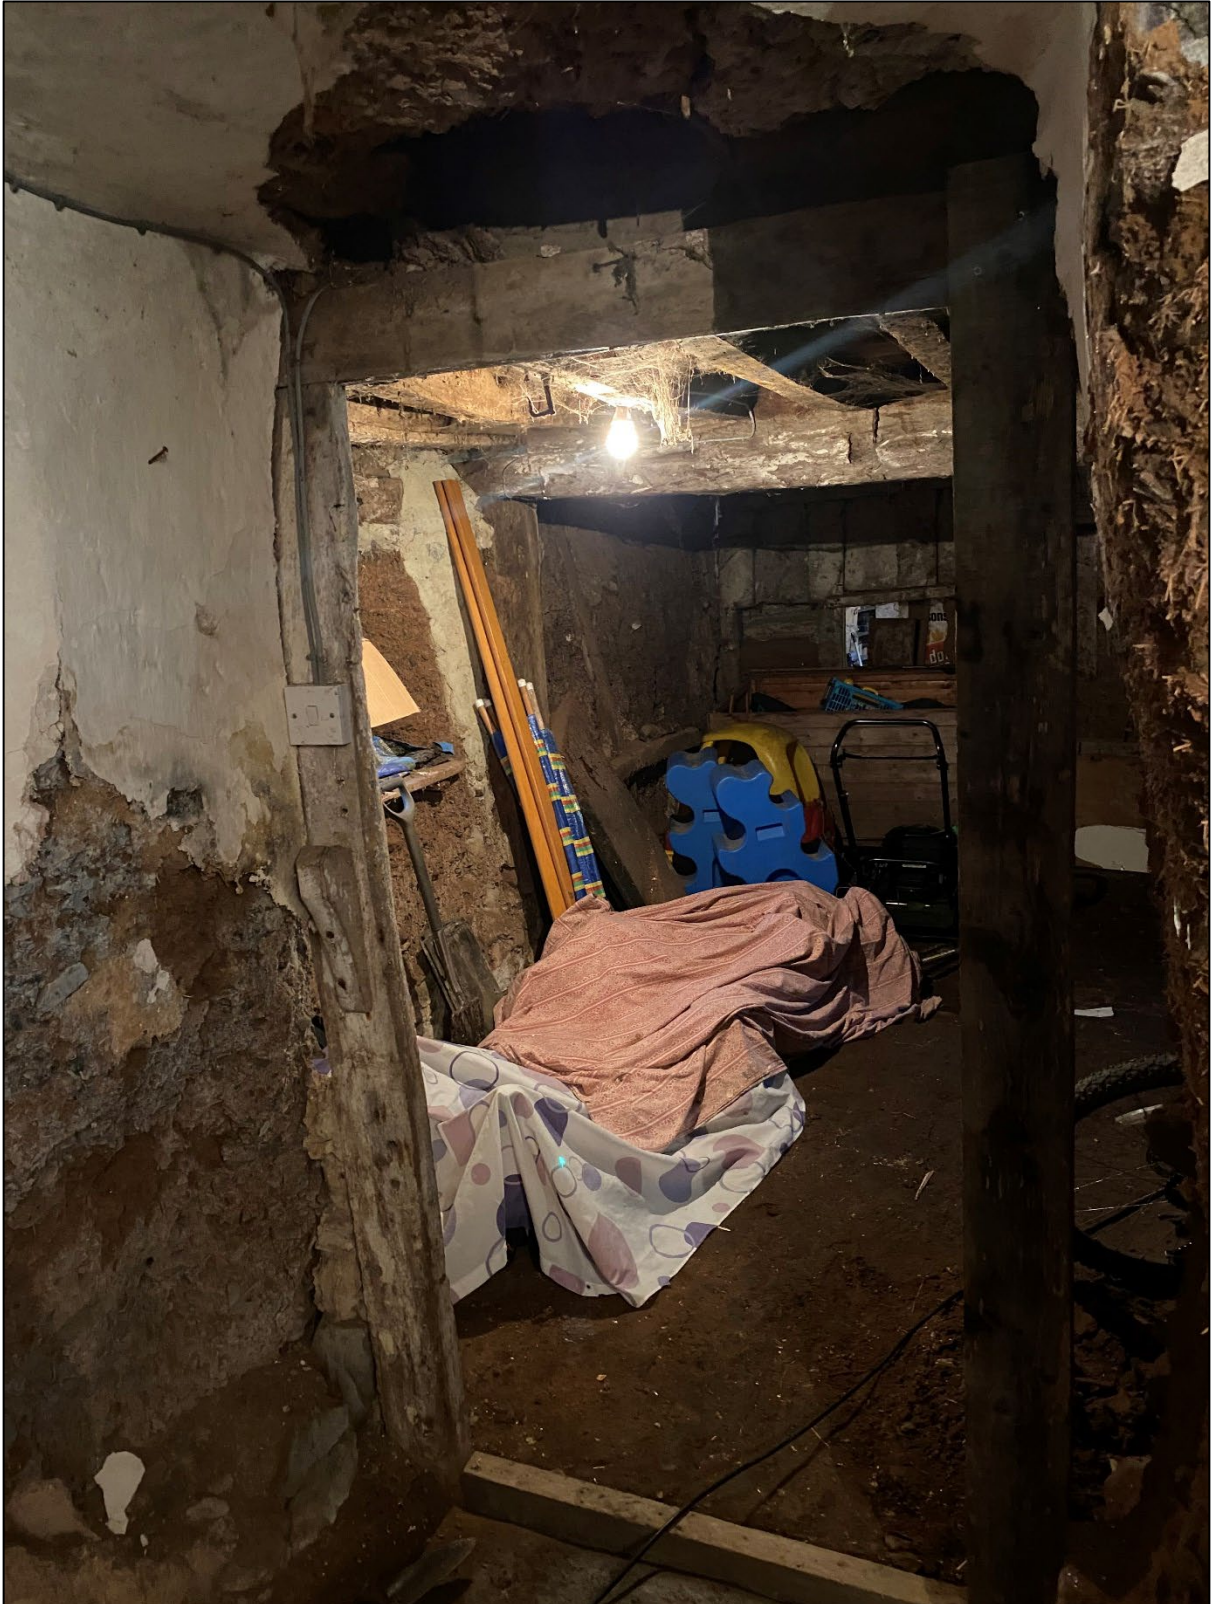
**Photo 8:** Existing oak doorframe between Rooms 8 and 9. The doorway is to be reinstated using a door respectful to the heritage of the house (Fig. 1, 3c)

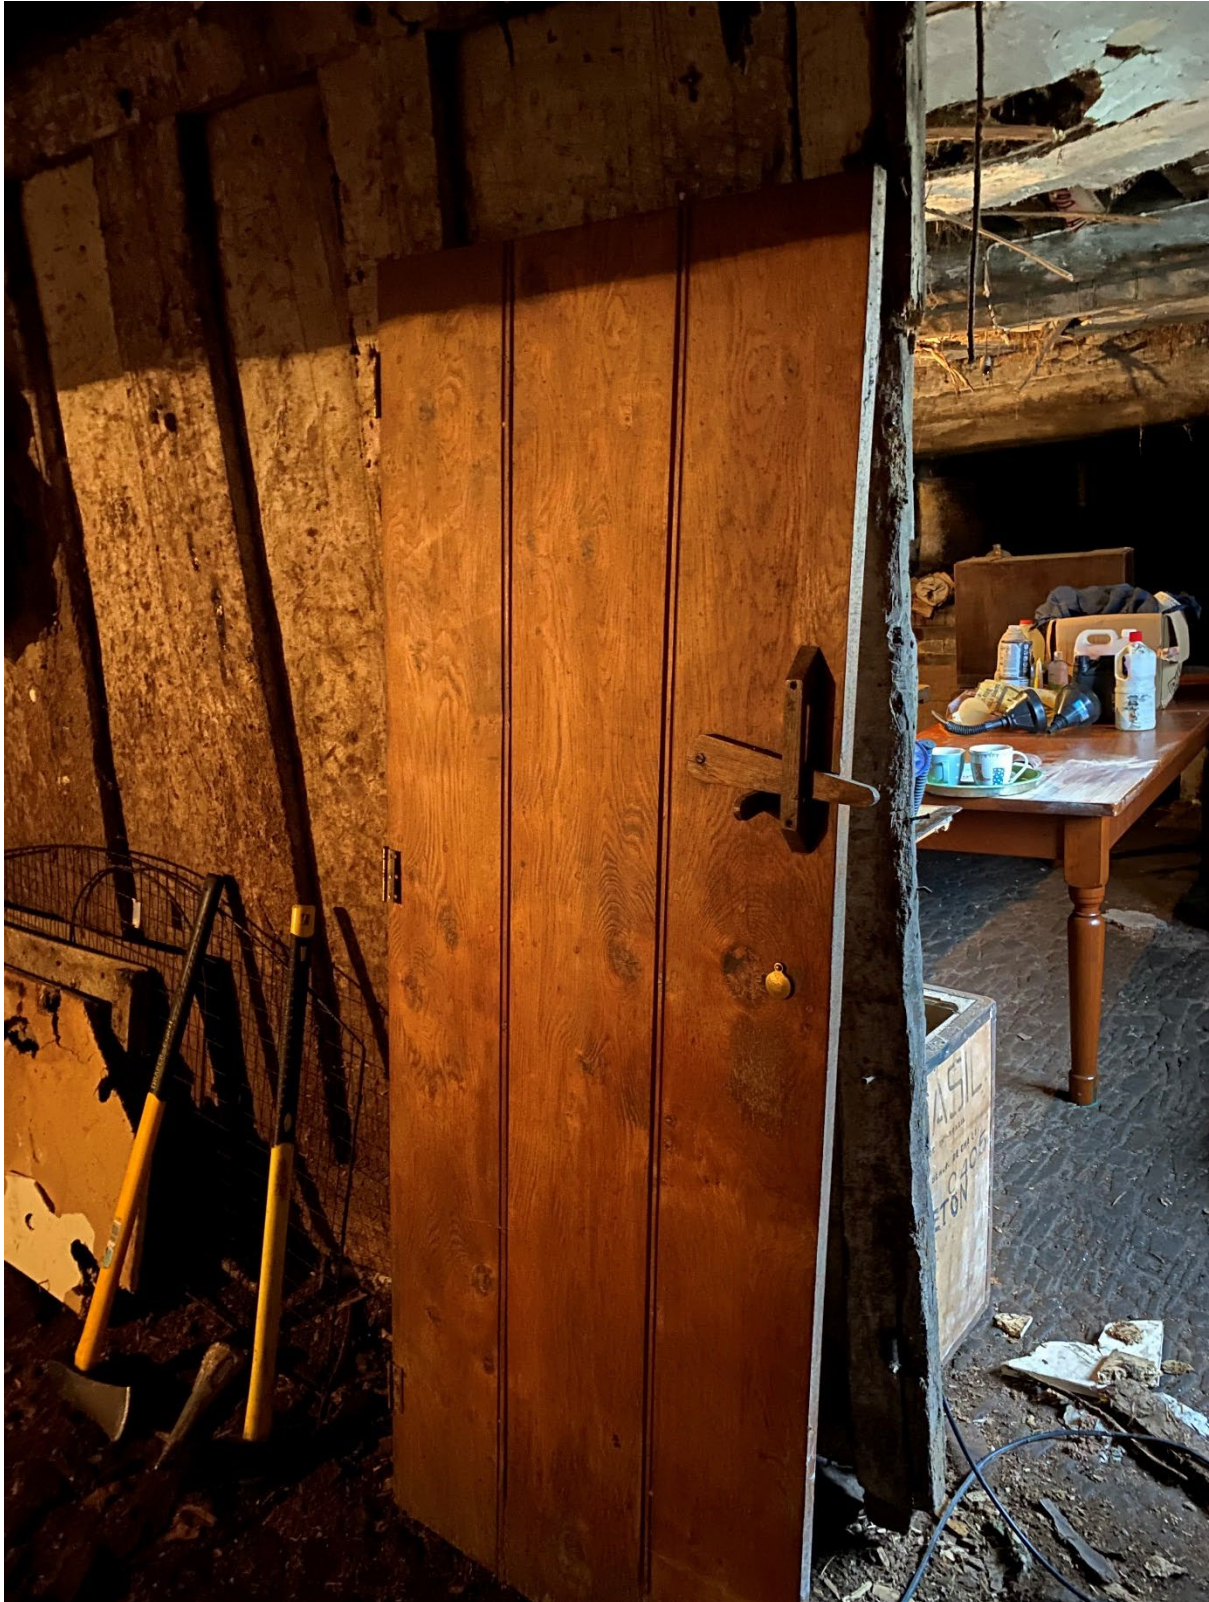
**Photo 9:** Example of the 3-panel door to be installed within Room 8

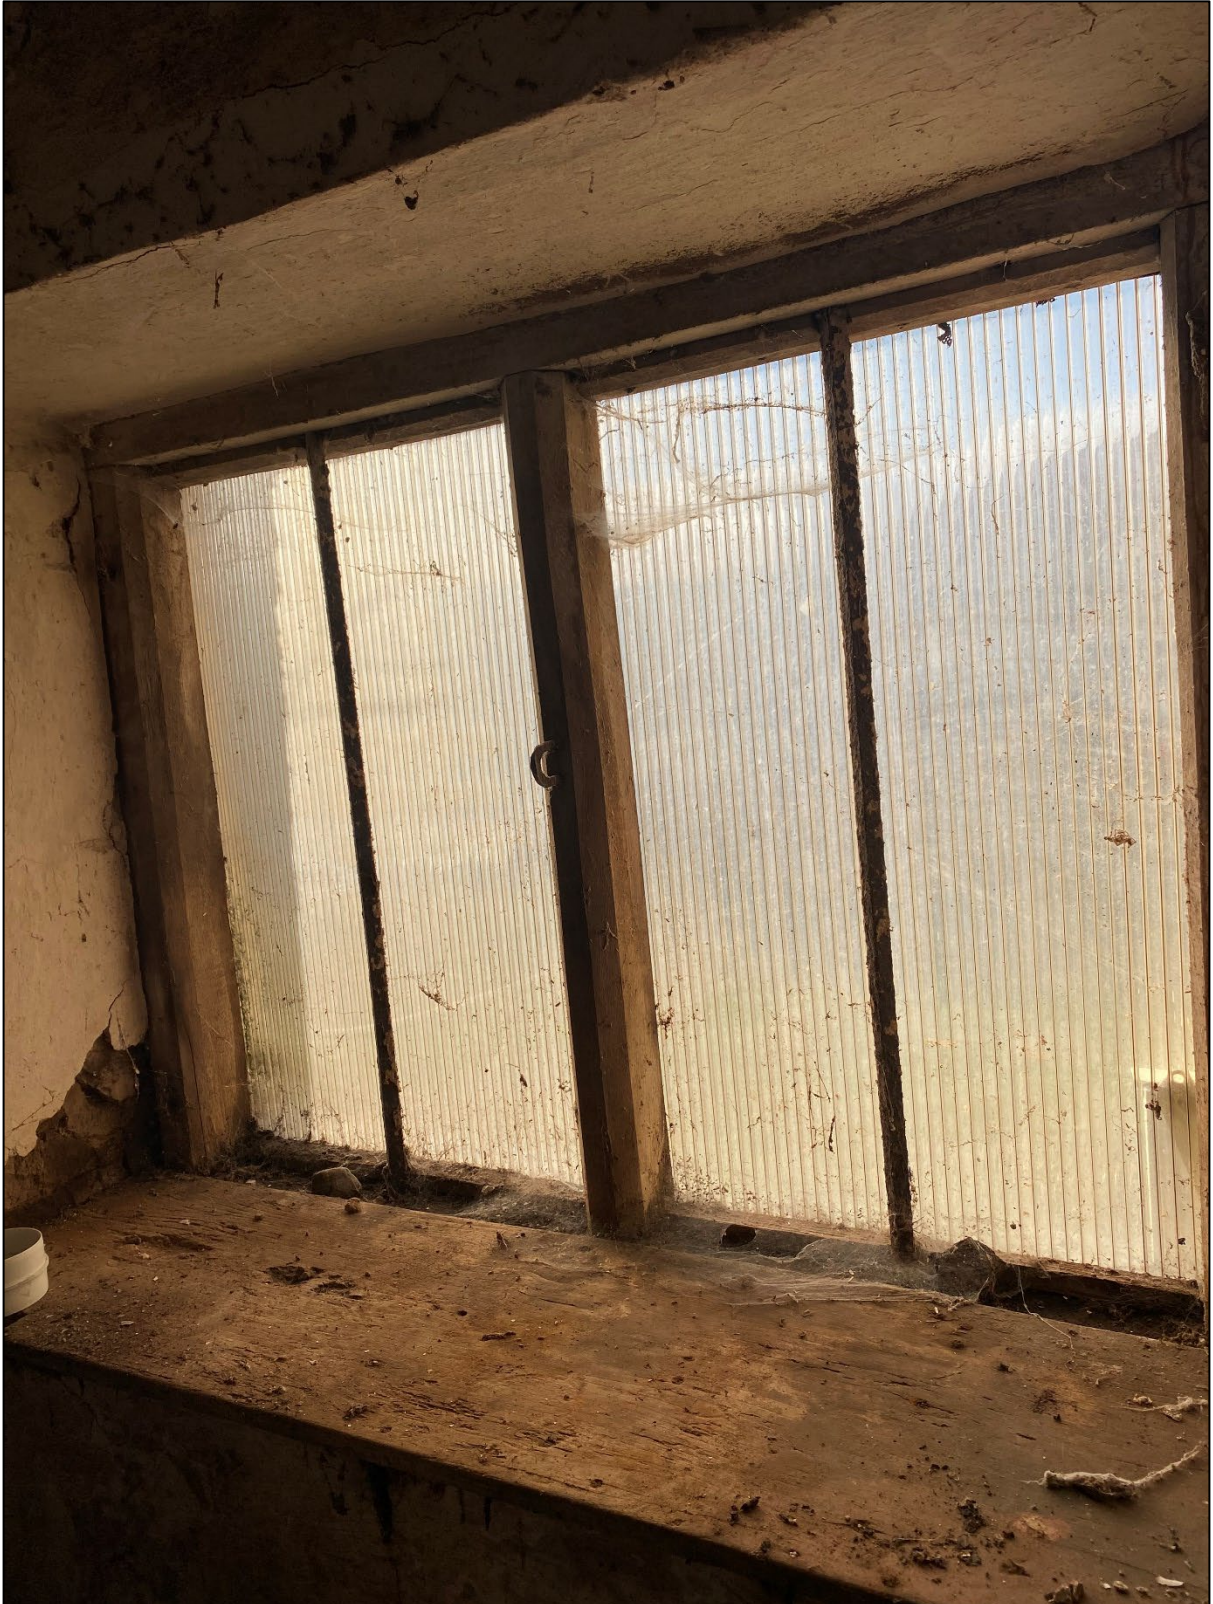
**Photo 10:** Historic window frame and ledge in Room 8 to be left in-situ, polycarbonate pane to be replaced with 12mm double glazing to provide warmth to the room and create a liveable space (Fig. 1, 3d)

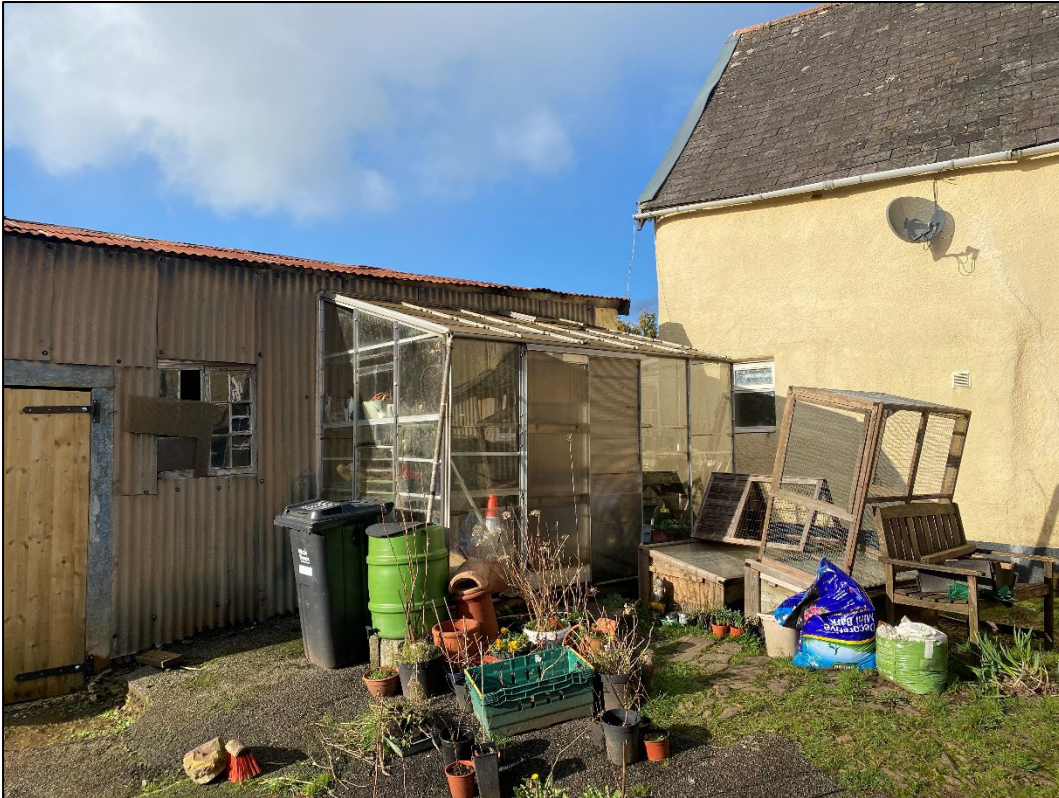
**Photo 11:** Modern lean-to greenhouse to be removed along the route of a 20th century corrugated metal wall (Fig. 1, 4a)

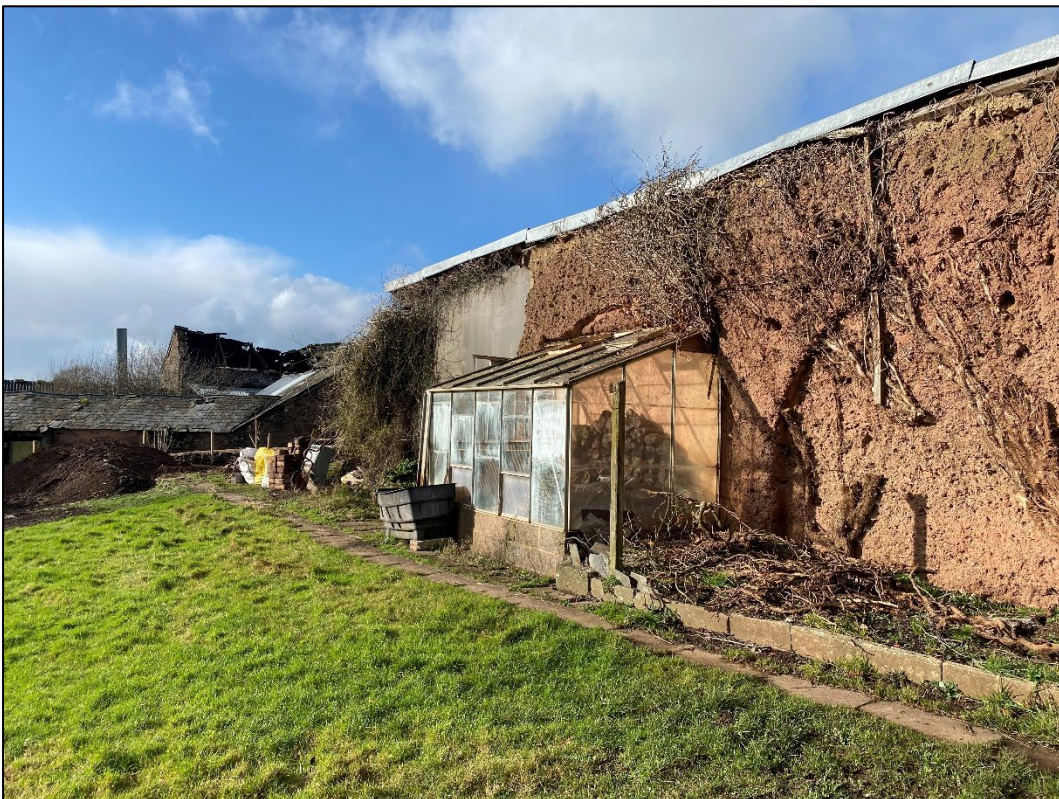
**Photo 12:** Modern lean-to greenhouse to be removed along the route of a curtilage cob wall (formally walled garden) (Fig. 1, 4b)
