OLD TIMBERS, THE POUND, COOKHAM, BERKSHIRE

HERITAGE STATEMENT

PROJECT: Old Timbers, The Pound, Cookham, Berkshire

DOCUMENT TITLE: Heritage Statement

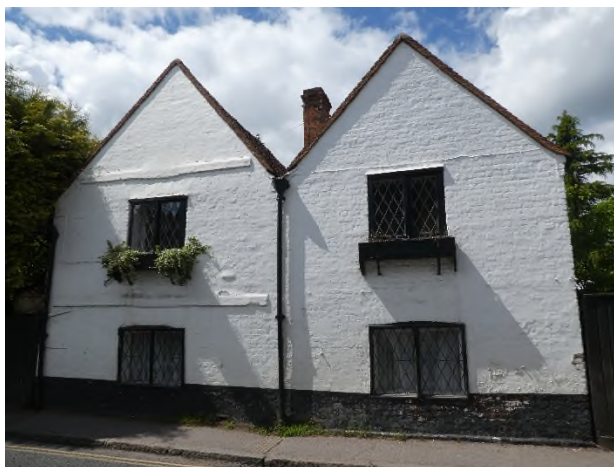
Figure 1: Front elevation of Old Timbers

- 3.2.4 Externally, the brickwork is obscured by paint finishes. There are two platband features with a smooth finish on the front elevation (**figure 1**). These don't appear to be brick. The insertion of 20th century windows on the ground floor of the front elevation appears to have included a slight enlargement of the original window openings. The original window opening on the ground floor has a segmental arched brick head. The side elevation appears to be generally Flemish bond and abuts the brick refronting of Phase 1 where there is a straight joint (see **figure 19**).

3.2.8 The exterior of Phase 3 is characterised by white painted brick (**figure 1**). The brickwork appears to be generally Flemish bond. There is a plain projecting brick band along the eaves on the side elevation. Phase 3 includes the extension of the north-east side of the Phase 1 timber framed structure. This may have been to create additional space but also to balance the front elevation with a smaller but similarly proportioned gable end elevation to Phase 2. The brickwork on the north-east elevation appears to extend to include the outshut with catslide roof to the rear. There is no apparent straight joint in the brickwork on the north-east elevation.

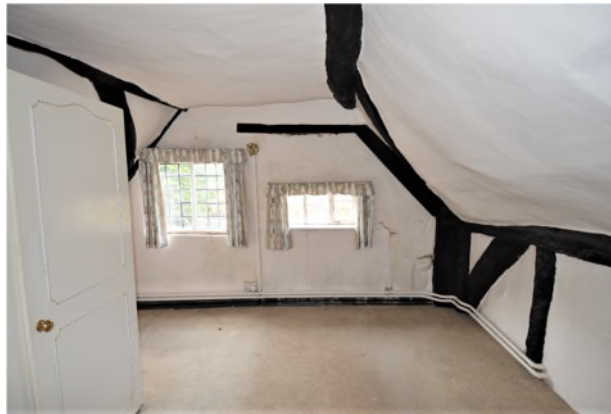
Figure 11: South-west gable end frame with curved windbrace to left of photo

- 3.2.1 The Phase 1 house is a 2-bay timber framed structure that lies to the rear of the two brick phases of development and is aligned parallel to the road. The roof structure includes what appear to be clapsed purlins. The two gable end trusses have been altered, including cut tie

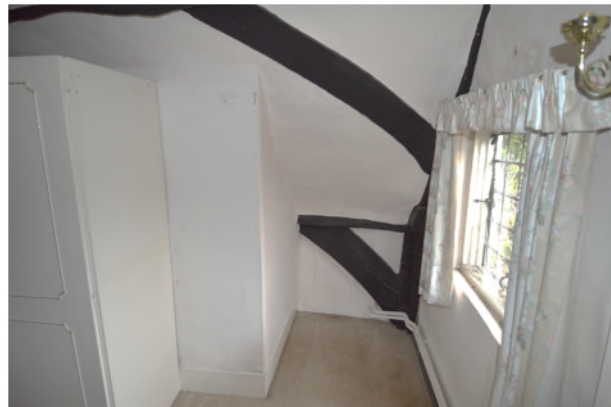
Figure 12: Curved head brace in the south corner of Phase 1

beams and the central truss is largely obscured by finishes. Both bays include curved windbraces. Part of the wall frame is visible and includes a curved head brace associated with the southern principal post. The curved windbraces and head brace are indicative of a 16th century date. There is a later chimney with what appears to be a blocked fireplace located on the south-west side of bedroom 3. The date of insertion of the chimney is currently unclear. If there was originally a chimney stack in this position you would expect there to be a chimney bay, i.e. a truss on each side. The partition between bedroom 3 and the landing is a later insertion.

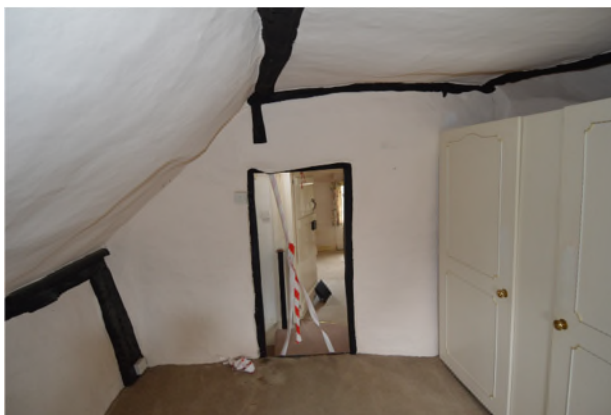
Figure 13: Central truss

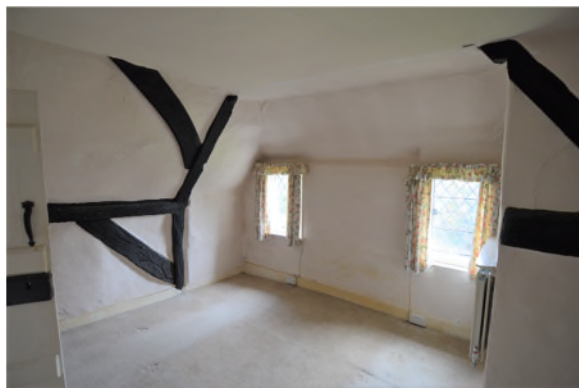
Figure 14: Cut tie beam associated with the Phase 3 extension

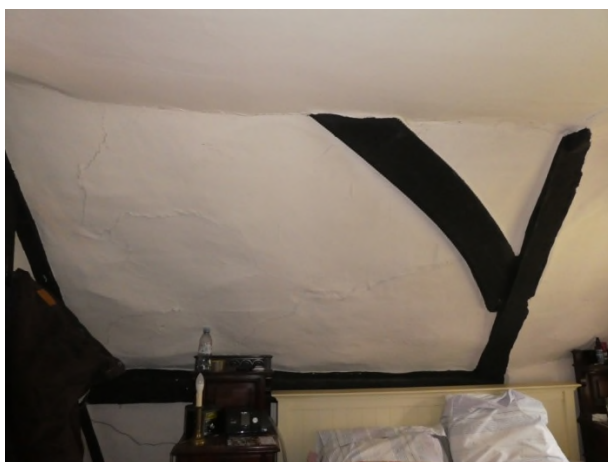
Figure 15: Curved windbrace in the northern corner of Phase 1

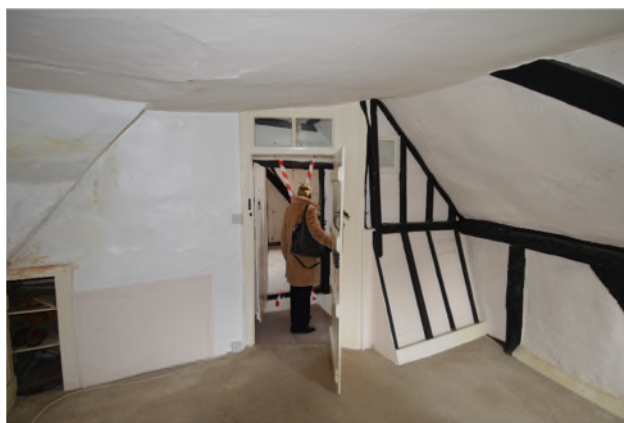
Figure 16: South-west side of bedroom 3 showing the position of the chimney breast (left) and later partition (right)

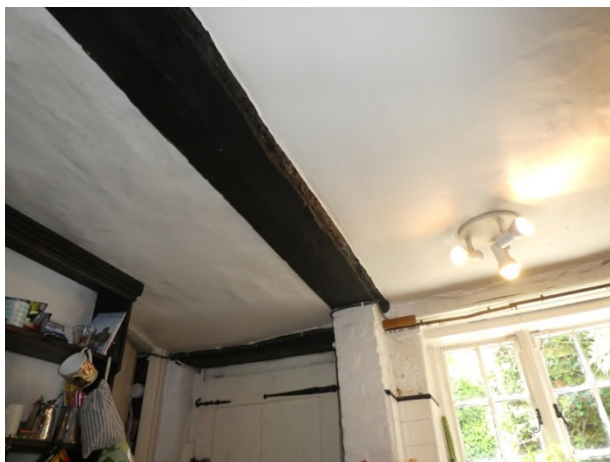
Figure 17: Axial beam in the south-west ground floor bay of Phase 1

3.2.2 The evidence for the early origins of the house is more ephemeral on the ground floor. There is an axial beam with no chamfers in the south-west bay. To the rear of this bay there is a sole plate over a plinth and a post and to the front (behind the stairs) there is a timber sole plate over a plinth. There is evidence for a door opening in this location as suggested by the curved finish on the truncated section of sole plate. This may be a Phase 1 door opening rather than later. An axial partition wall marks the line of a corresponding beam in the north-eastern bay. A beam on the north-west side of the sitting room marks the position of the original south-east wall frame of the Phase 1 building.

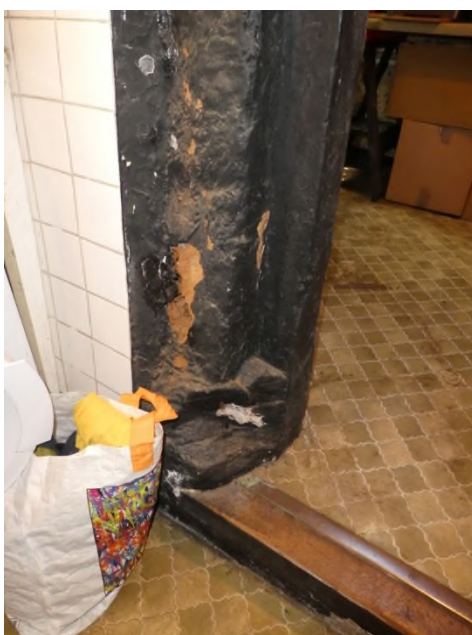
Figure 18: Sole plate and post in the opening between the front and rear kitchen

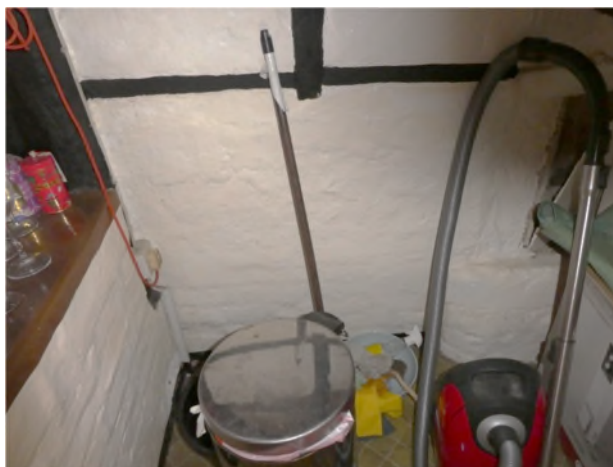
Figure 19: Position of a former door opening on the south-east side of Phase 1 (under the stairs in the kitchen)

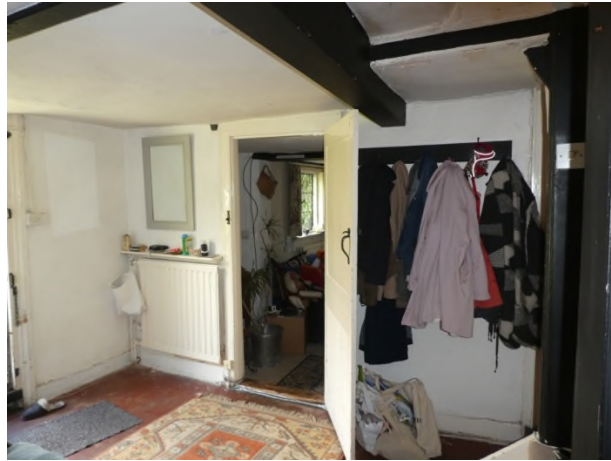
Figure 20: Partition wall on the south-east side of the entrance hall from the garden marks the probable position of an axial beam

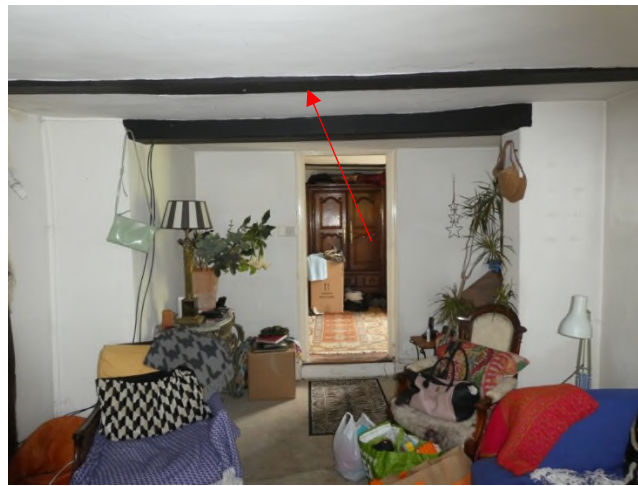
Figure 21: Beam in the living room that defines the south-east side of the north-east bay of Phase 1

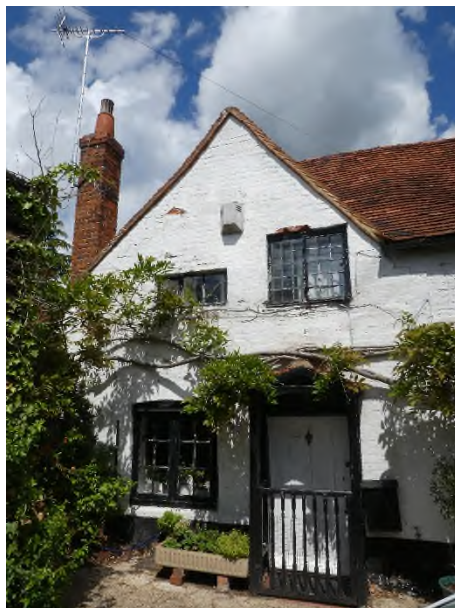
Figure 22: Brick refronting of the south-west gable end of Phase 1

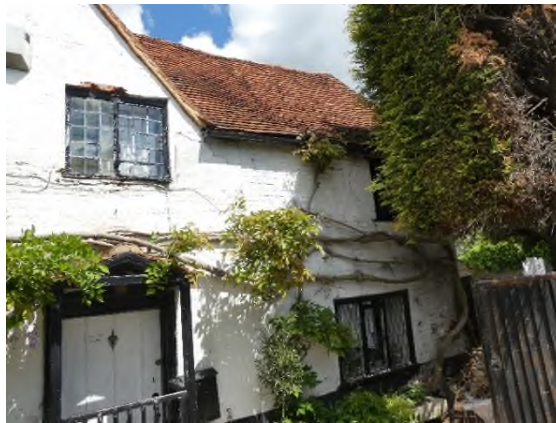
Figure 23: Side elevation of Phase 2

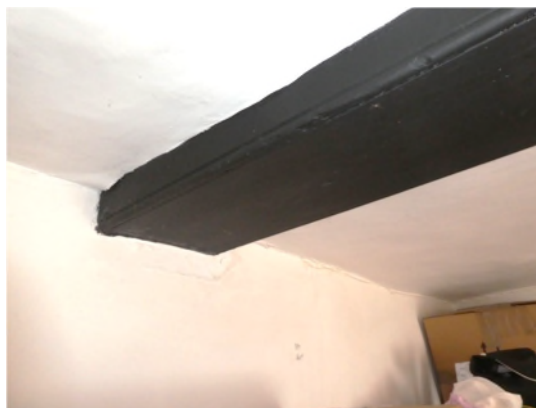
Figure 24: Boxed in beam in the dining room

- 3.2.5 On the ground floor there is limited evidence for a construction date for Phase 2. The axial beam in the dining room is boxed in and the plank and batten door with trapezoidal battens and beads along the edge of regularly sized planks is of late 19th to early 20th century date. The window and frame on the front elevation is a relatively modern 20th century replacement. The window on the side elevation is a later insertion, probably early 20th century, which incorporates a late 19th century iron casement with a catch and back plate and a tulip handle. There is a brick hearth which has been preserved within the concrete floor. This indicates a fireplace in this room in the past.

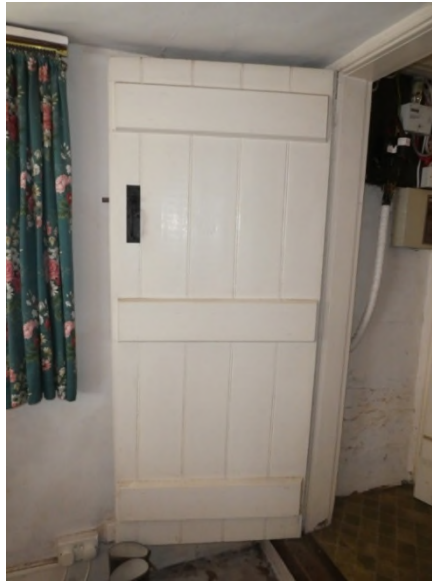
Figure 25: Late 19th to early 20th century plank and batten door to the dining room from the kitchen

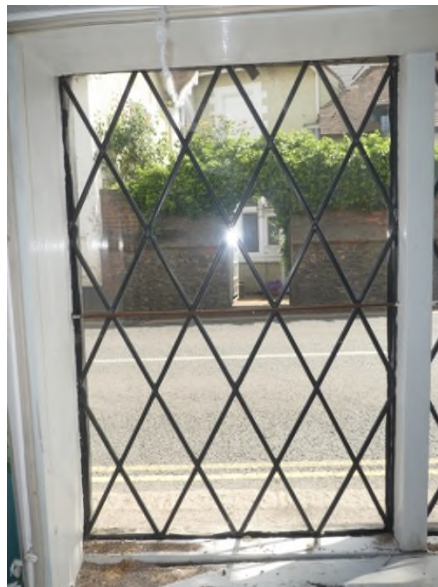
Figure 26: Modern window on the south-east side of the dining room

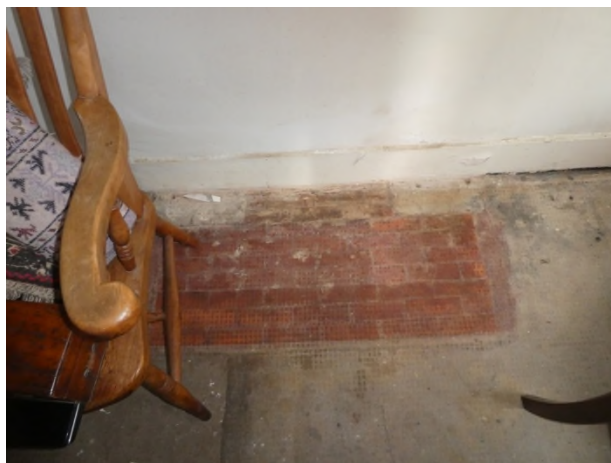
Figure 27: Evidence for a brick hearth in front of the chimney breast in the dining room

- 4.9.2 **Insertion of a wood burning stove in the dining room** – The depth of the fireplace is relatively shallow which suggests a later alteration. The flue has been checked and it would be possible to insert a liner for a wood burning stove in a manner that would not adversely impact on the fabric of the building, including allowing ventilation of the flue.

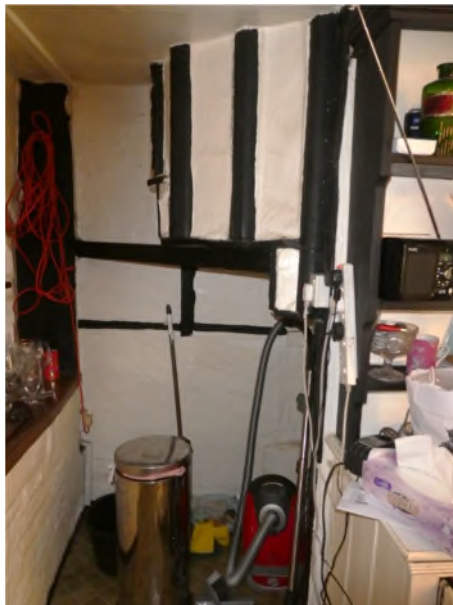
Figure 28: Stair enclosure in the kitchen

- 3.2.6 The first floor is accessed by a staircase within the footprint of the Phase 1 house. This is a straight flight with winder stair that has a thick coating of multiple layers of paint on the underside of the treads and risers. The partition for the winder section at the top of the stairs is characterised by studs painted black. None of these elements are particularly diagnostic for dating purposes but the stair is of some age, possibly 19th century.

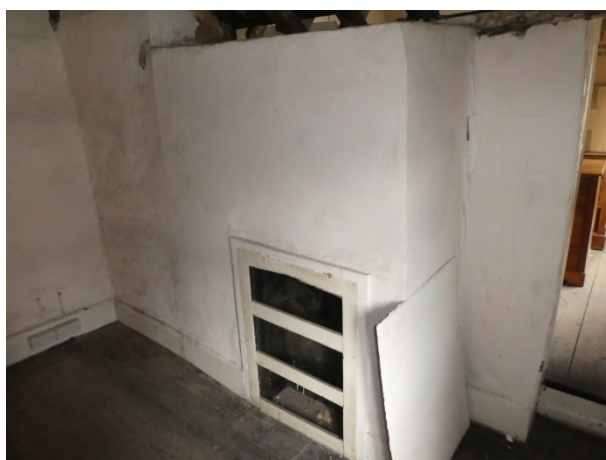
Figure 29: Fireplace in bedroom 1

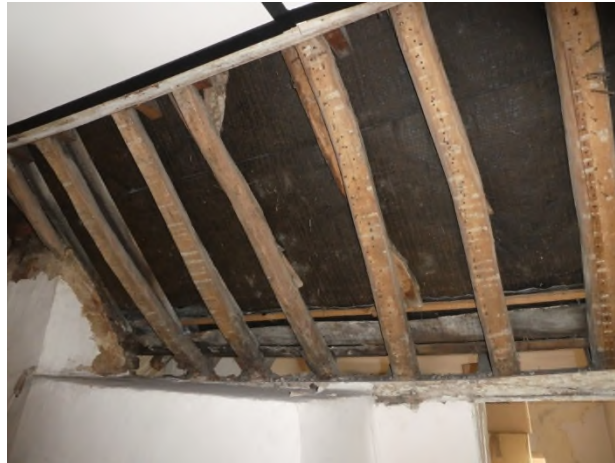
Figure 30: Exposed rafters above the chimney breast in bedroom 1

- 3.2.7 The door into the first floor room is of a design, including door furniture, that is consistent with a 19th century date. The room includes a chimney breast with fireplace. There is no evidence for a main stack, although the later rafters in Phase 3 are suggestive of a main stack being removed. The current stack is narrow and appear to have only one flue. The flue for the first floor fireplace in bedroom 1 is assumed to traverse across to the brick flue in the northern corner of the room. The exposed rafters are irregular and roughly square in section. There is a diagonal rafter visible below the later ceiling level which is a form of windbrace and is indicative of an 18th century date. The windows on the front and side elevations are 20th century.

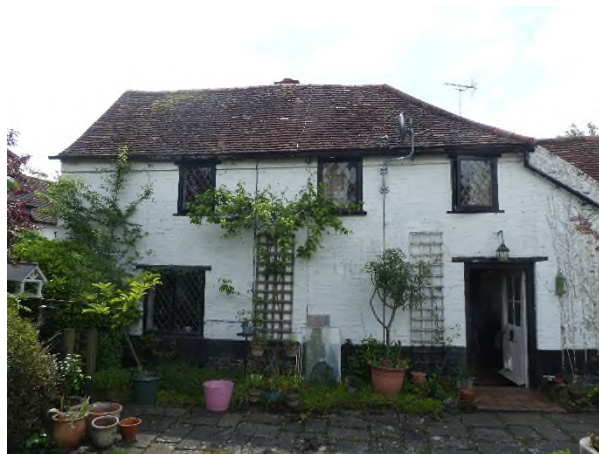
Figure 31: North-east side elevation of Phase 3

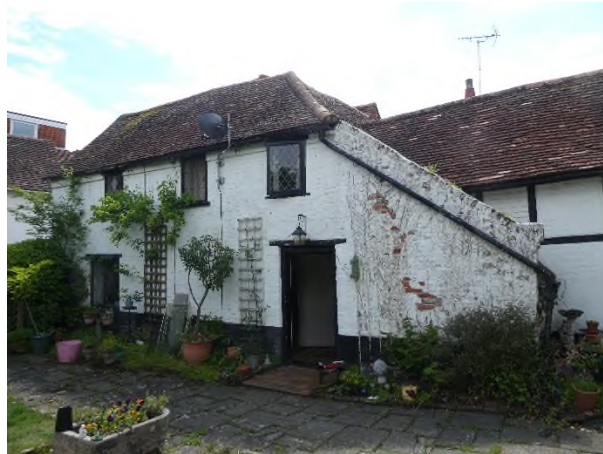
Figure 32: Parapeted outshut to the rear of Phase 3

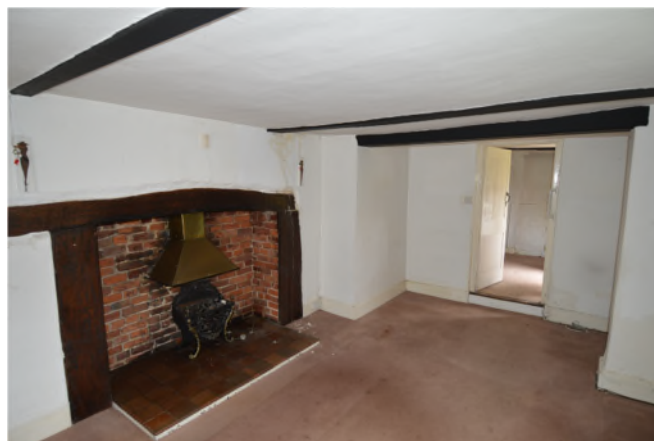
Figure 34: Brick fireplace with timber lintel

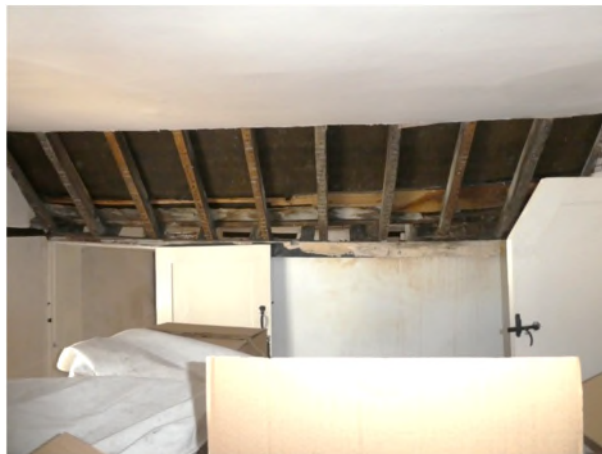
Figure 35: Exposed common rafters in bedroom 2

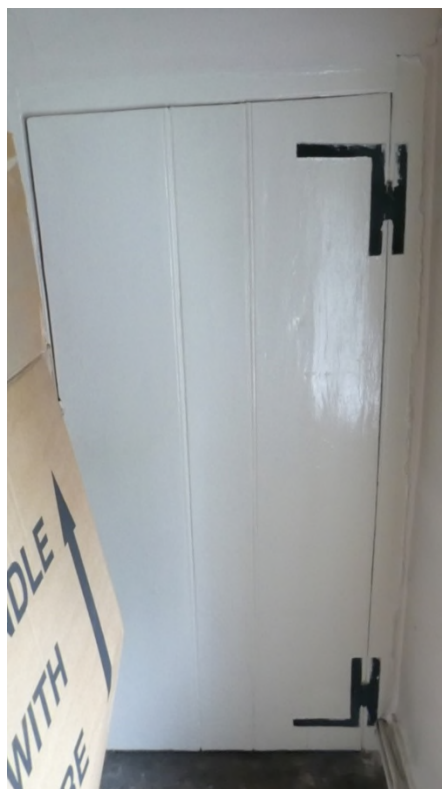
Figure 36: 18th to early 19th century cupboard door in the northern corner of bedroom 2

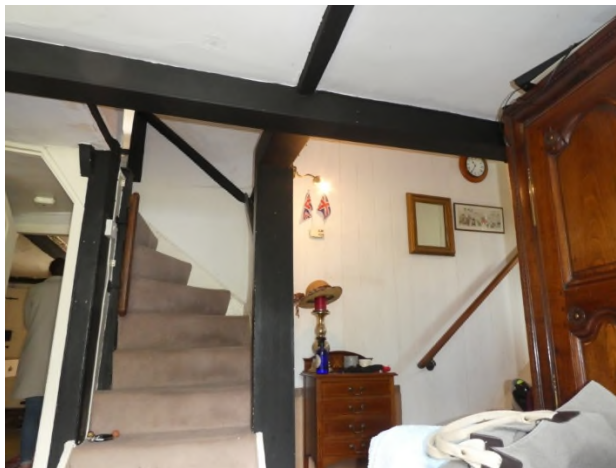
Figure 37: 20th century beams and posts in the entrance hall

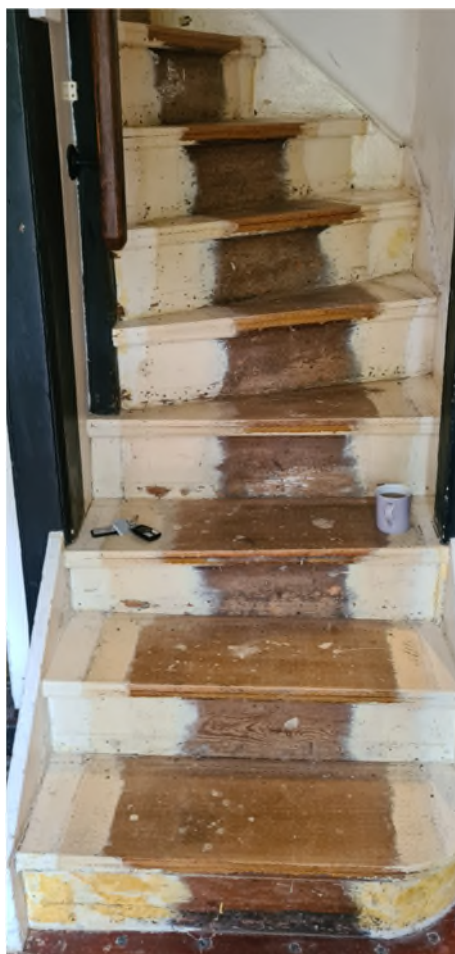
Figure 38: Staircase in the entrance hall

earlier stair of which the upper winder section remains. The character of the stairs (following removal of the carpet) suggests an 18th century date and may be associated with Phase 2 or Phase 3. There are 19th century doors to an understairs cupboard. The south-west side of the outshut element to the rear can be observed in the kitchen. This side of the outshut is clad with weatherboard with a door frame that is concealed behind an early 20th century cupboard.

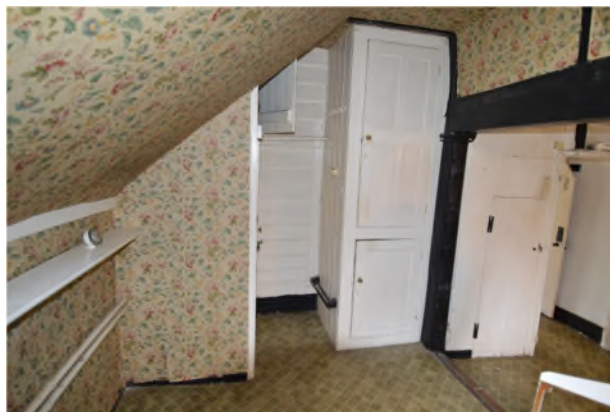
Figure 39: Weatherboard finish on the south-west side of the Phase 3 outshut

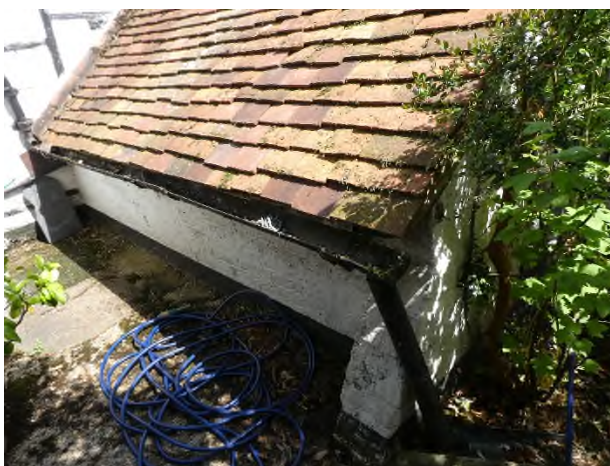
Figure 40: Brick outshut with a catslide roof to the rear of Old Timbers

3.2.12 Phase 4 is interpreted as the brick outshut with a catslide roof to the south-west of the Phase 3 outshut. The interior includes a relatively large corner fireplace with 20th century (modern) finishes, an early 20th century cupboard and a first half of the 20th century casement window. Intriguingly, there is a section of sole plate below the south-west window. This is visually dislocated by the corner fireplace but perhaps relates to the Phase 1 building (?).

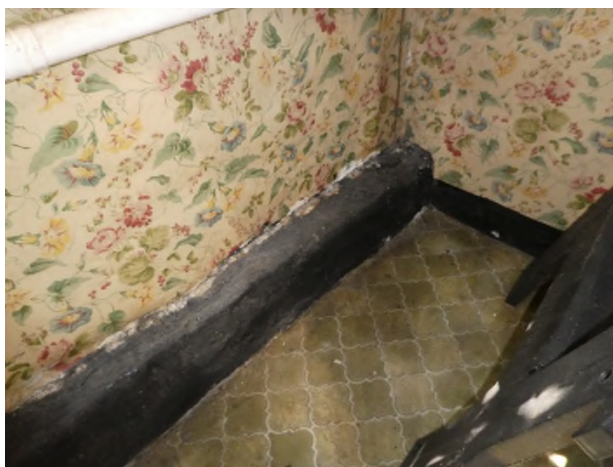
Figure 41: Sole plate on the south-western side of Phase 4

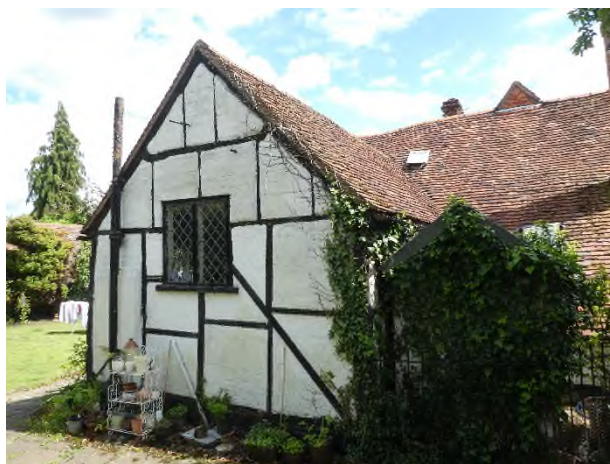
Figure 42: North-west gable end elevation of Phase 5

3.2.13 Phase 5 is a single storey rear extension over a cellar. The exterior is characterised by an irregular square panel; frame of slender scantling and a gable end truss with principal posts and a queen strut type roof truss with clasped purlins. The timber panels are infilled with brick painted white.

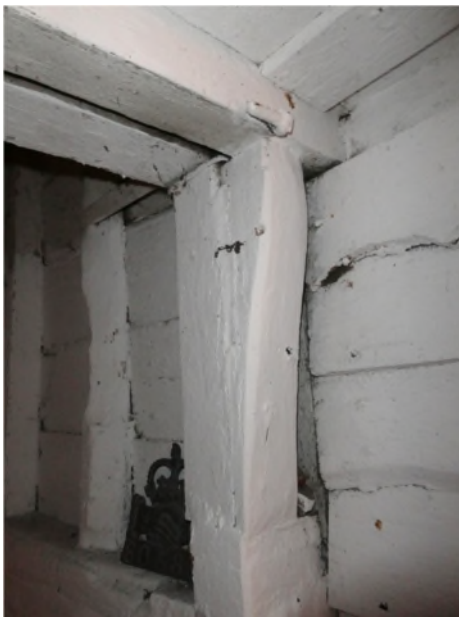
Figure 43: Reused timbers in the cellar

3.2.14 The cellar is accessed from the kitchen through a 19th century (possibly early 20th century) plank and batten door. There is an apparently blocked door opening with steps on the Phase 3 outshut side of the cellar. The floor structure over includes a number of reused timbers such as a jowled post, a door frame with iron pintles and sections of wall plate. There is a central longitudinal beam that includes morticed along the soffit which suggests that the cellar may have been subdivided into two small spaces. The joists have a range of joints including soffit tenon and birdsmouth type joints.

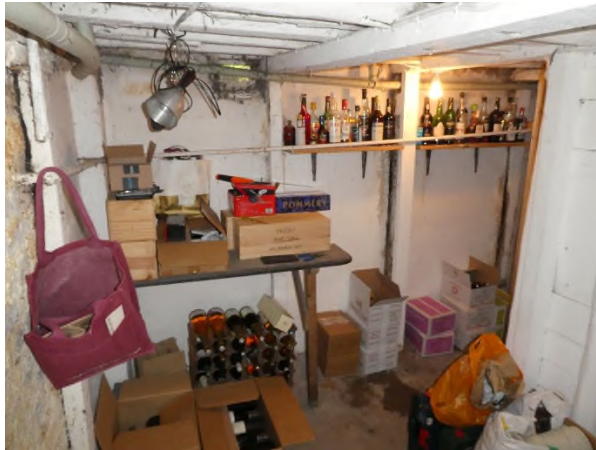
Figure 44: The cellar

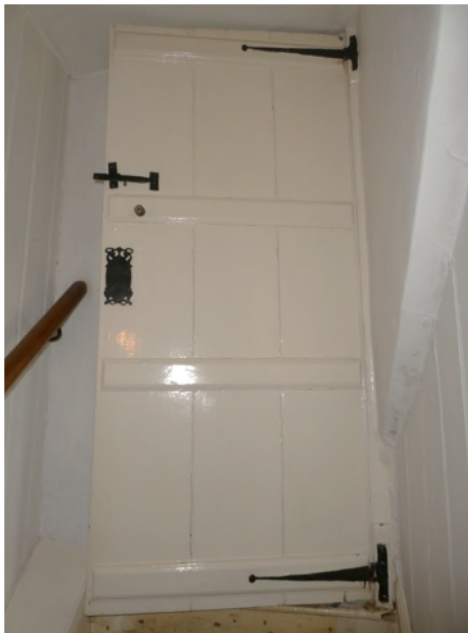
Figure 45: Plank and batten door to the room over the cellar

3.2.15 The floor above the cellar is accessed by stairs from the entrance hall. At the head of the stairs is an 18th century plank and batten door. The first floor room is currently a bathroom but does include what is possibly a late 18th or 19th century cupboard with H-hinges. The roof structure over includes a central truss with a collar and clasped purlins. There is a weatherboard and a lath and plaster finish on the north-west side of the truss. The sides of the roof structure, or skelting, are finished with lath and plaster. On the south-east side of the roof void there is evidence for rafters associated with the Phase 3 outshut and for diagonal rafters used in the Phase 5 roof structure.

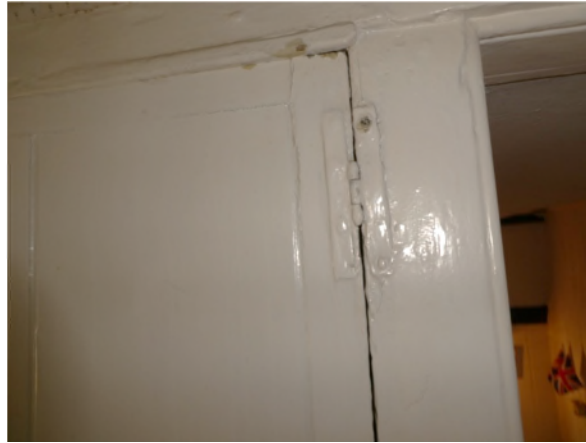
Figure 46: H-hinge to a late 18th to early 19th century cupboard in the bathroom

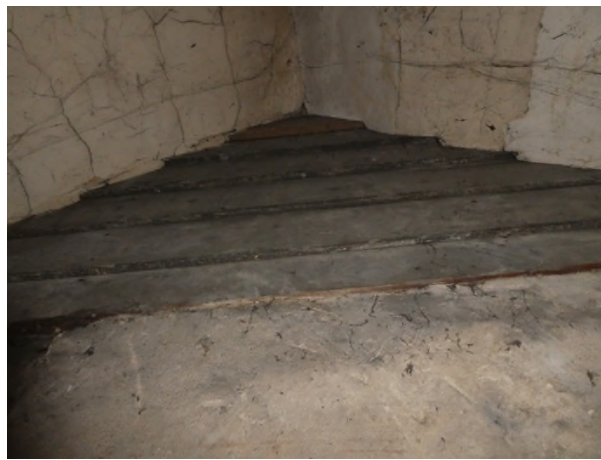
Figure 47: Weatherboard and plaster finishes to the central truss and skelting over the bathroom

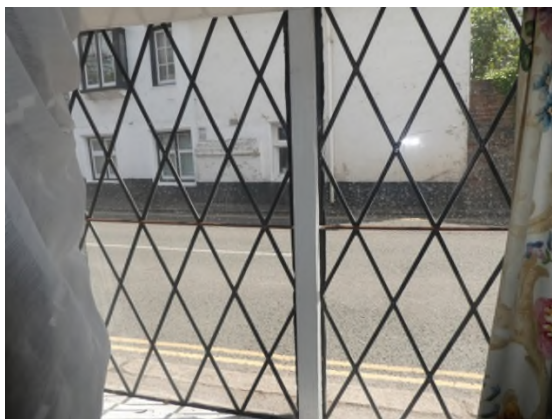
Figure 49: Modern window and frame in the dining room

4.2.1 The two ground floor windows are modern and include replacement frames and central mullions. The existing windows are of no heritage interest. The window in bedroom 1 includes a central mullion with mouldings which relates to an earlier window, possibly late 19th to early 20th century. It is proposed to retain the mullion and frame but to replace the modern leaded lights. The window in the proposed en-suite includes a frame with mouldings but the mullion is plain and is considered to be a modern replacement. The leaded lights are modern replacements. The approach here is to retain the frame but to replace the modern elements. The proposed windows will be conservation metal casements that will preserve the character of the front elevation of the listed building.

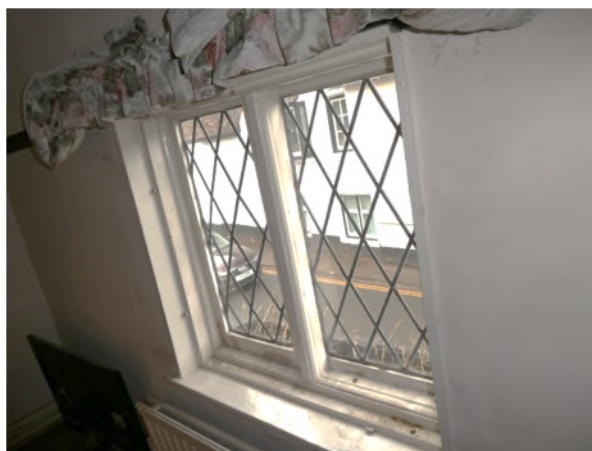
Figure 50: Modern leaded lights within an earlier frame in the bedroom

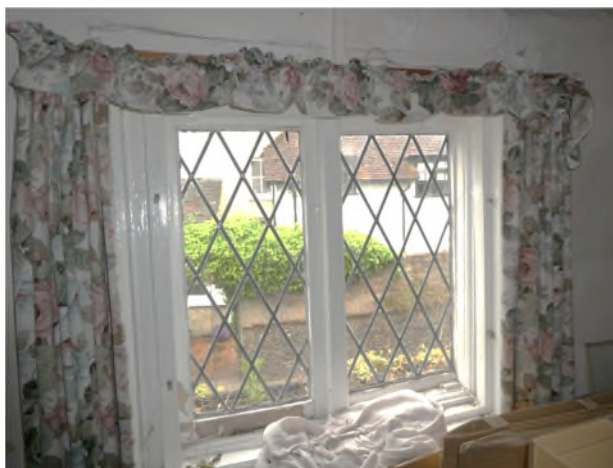
Figure 51: Window in the proposed en-suite on the first floor

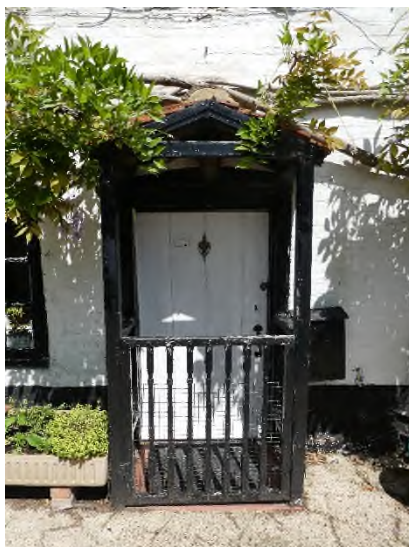
Figure 52: Existing porch on the south-west elevation

- 4.3.1 The porch on the south-west elevation is of machine sawn timber construction of slender section with a shallow pitched roof finished with clay tiles (the latter being inappropriate for the pitch). The ridge tiles are bedded in cement mortar. The existing porch is a poor quality 20th century feature that does not contribute positively to the significance or character of the listed building. The proposed flat hood on brackets is more in keeping with the character of the listed building which is substantially influenced by the 18th century changes.

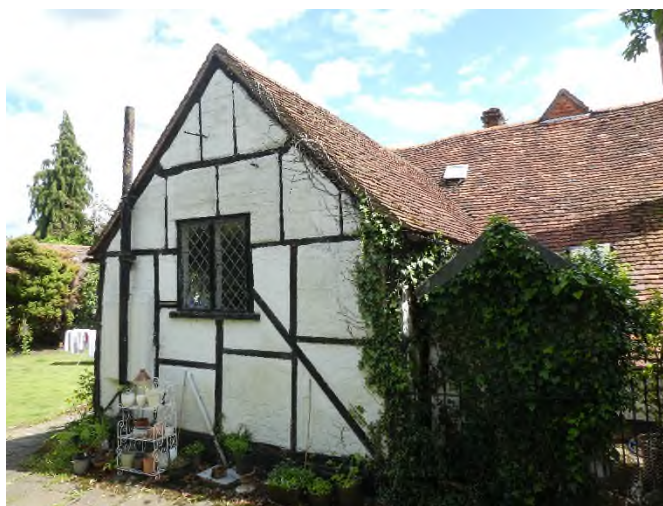
Figure 53: Rear elevation of the listed building showing the position of existing rooflights

4.4.1 There are two existing rooflights on the rear elevation: within the Phase 1 roof and in the catslide roof of Phase 4. The proposed rooflights would be conservation rooflights and would be positioned between the rafters where practicable, this will be particularly the case for the Phase 1 roof. In terms of visual impacts, the area of roof proposed for the new rooflights is relatively discreet and the level of any potential prominence on the rear aspect is mitigated by the flush design of the rooflights. The existing rooflights are fairly low key and do not overwhelm the character of the rear elevation. These will be replaced with more appropriate conservation rooflights.

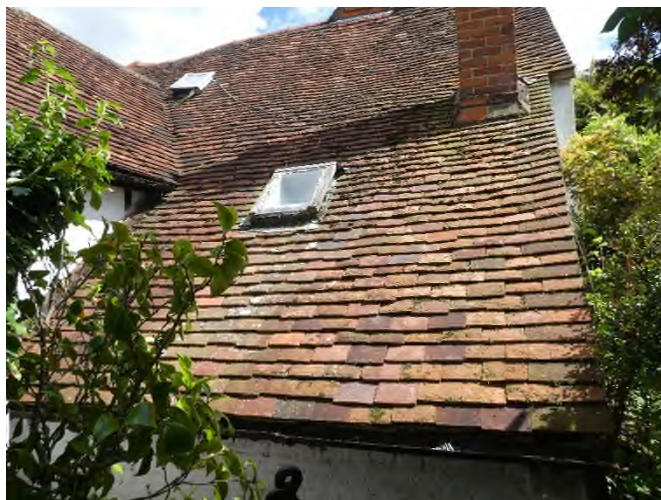
Figure 54: Existing rooflights to be replaced with more appropriate conservation rooflights

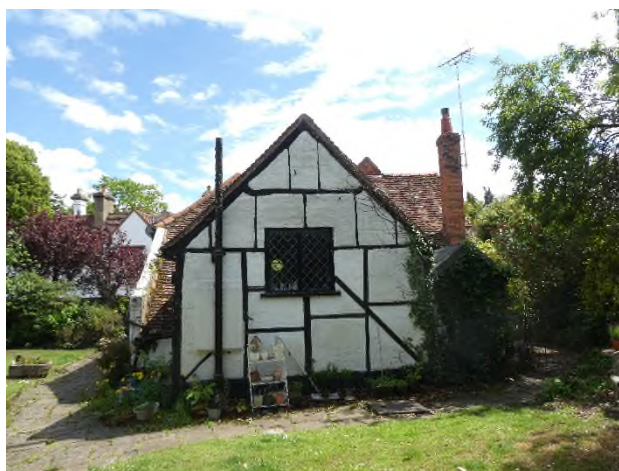
Figure 55: Gable end elevation of the Phase 5 extension

- 4.5.2 It is proposed to remove the central section of the gable end frame for access to the proposed extension. This will require the removal of a post and rails of slender section and some brick panels. The window, which is a later insertion, as demonstrated by the off-centre position and the truncated raking struts will be removed and retained on site to be displayed within the house. The remaining timber frame of the gable end elevation will be retained as an expressed feature. It is proposed to insert a small window within one of the panels on the side elevation. This window would be of appropriate size and would impact a small area of relatively late brickwork.

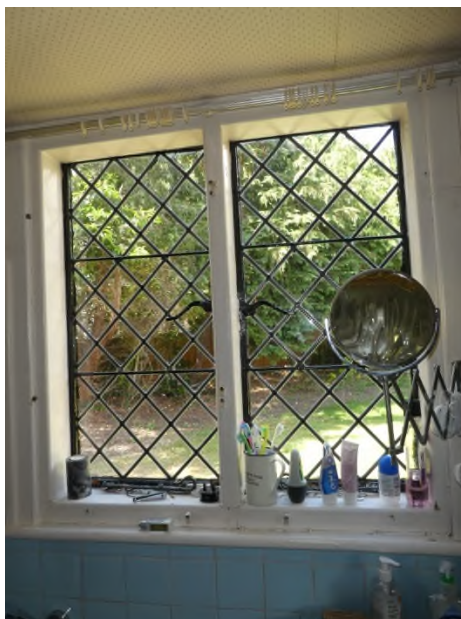
Figure 56: Late 19th to early 20th century leaded lights to be removed and retained on display within the building

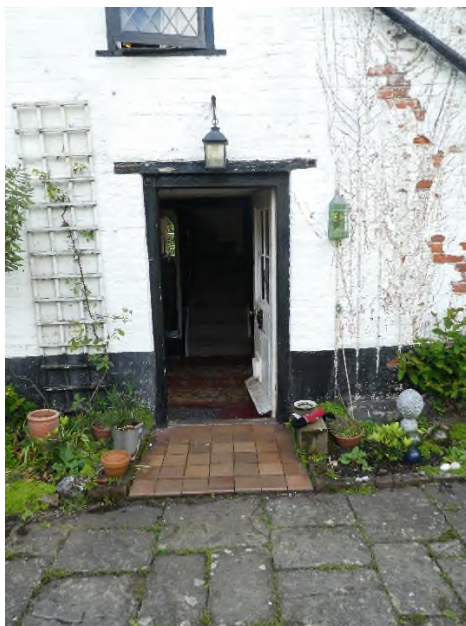
Figure 57: Existing door on the garden elevation

- 4.7.1 It is proposed to add a flat hood over the existing door to the garden on the north-east elevation. This door opening has a pegged frame, a slender timber lintel that is in poor condition and a 20th century part-glazed door. The proposed flat hood would be visually unobtrusive and would reflect the style of porch proposed for the south-west elevation. This style is in keeping with the character of the listed building which is substantially influenced by the 18th century changes.

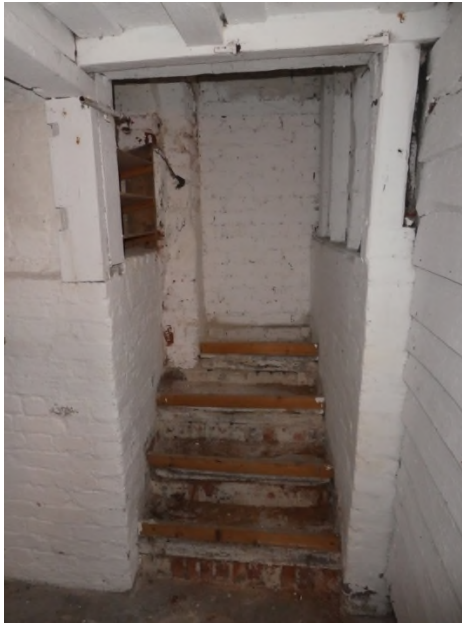
Figure 57: Steps leading to a blocked opening to the cellar from the entrance hall

- 4.9.3 **Opening up an infilled door to the cellar** – There is clear evidence for a blocked opening to the cellar, including steps. This arrangement may relate to early 19th century changes relating to the use of the building as cottages. The opening up of the infill will reinstate a historic circulation route and represents a heritage benefit.
