PROJECT
Underriver House - Kent

TITLE
Stables and Annex Floor Plans
Proposed

SIZE	SCALE	LAST REVISED	DRAWN	CHECKED
A1L	1:50@A1	11/03/24		
REV	SUITABILITY/REASON FOR ISSUE			
P03	Issued for Planning			
DRAWING NAME 241836-PUR-02-ZZ-DR-A-2001

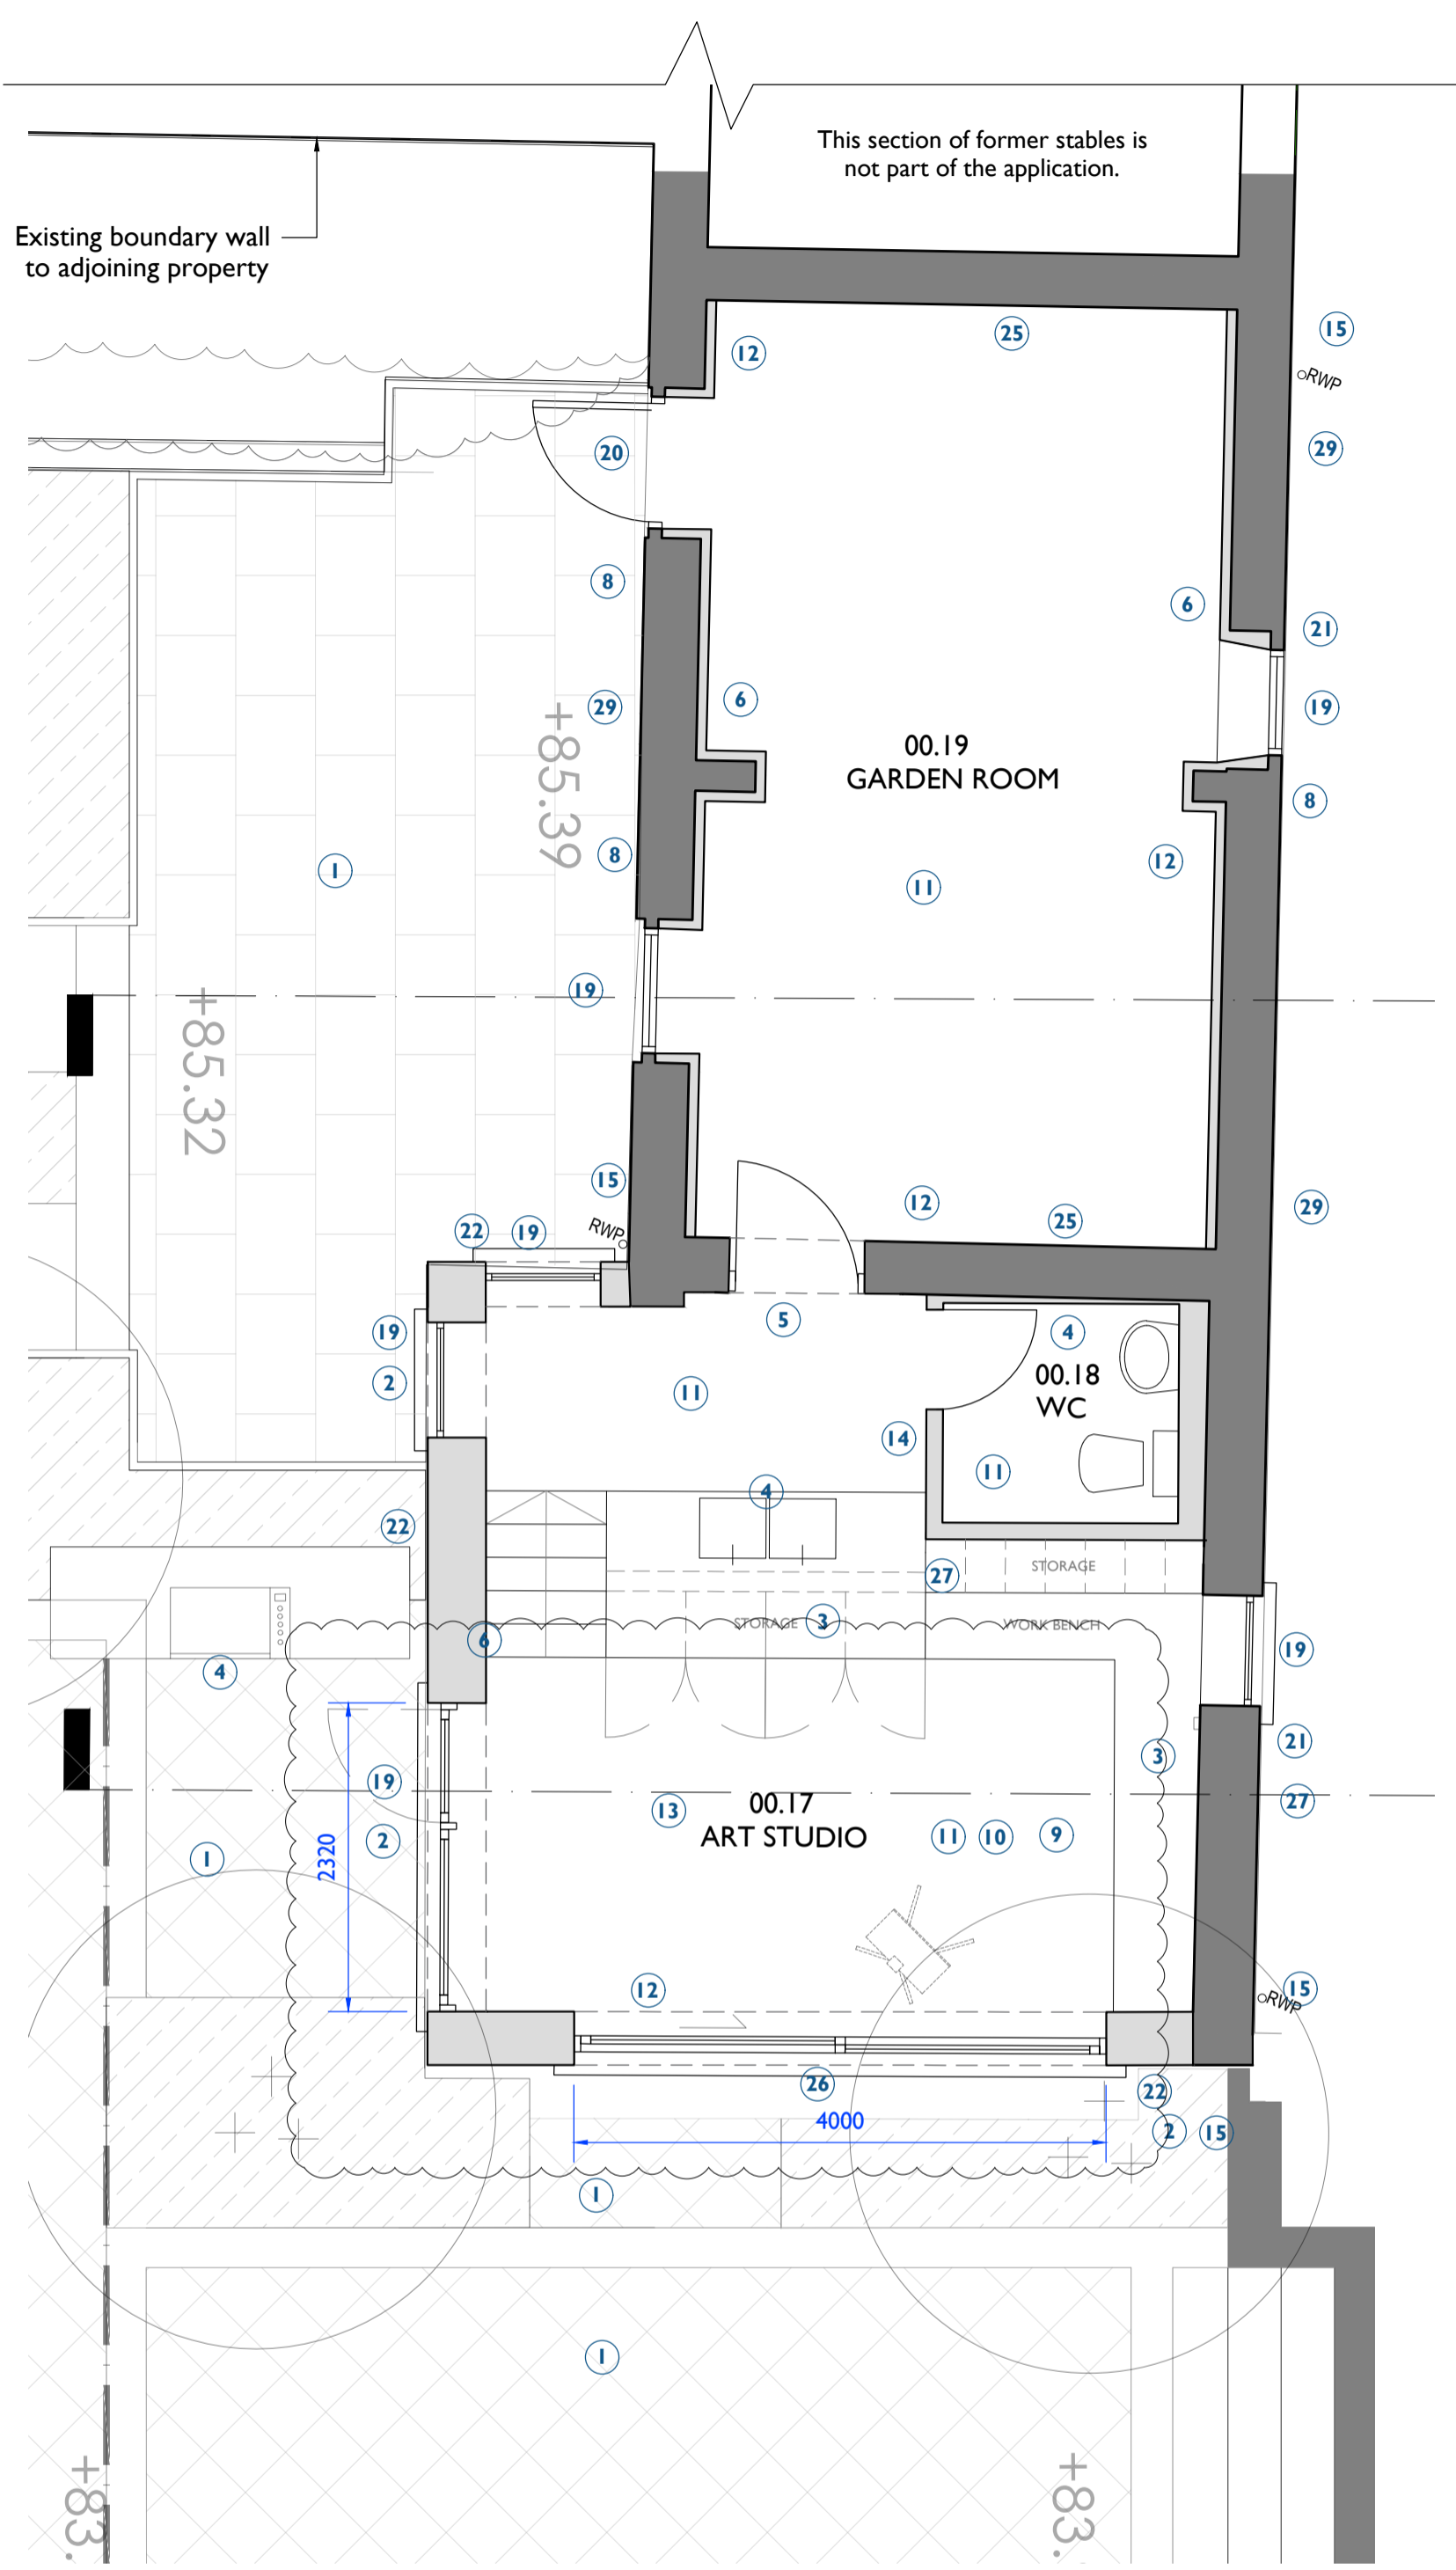
1 Existing Ground Floor Plan
2001 1:50@A1

- 1 Former Stables Building and Annex**
- 2 Re-landscaping garden:** New proposed landscape instated.
- 3 New external walls** finished in natural stone to match the existing stables building.

- 4 Joinery:** New joinery.
- 5 Modern kitchen and sanitary fittings and finishes:** New WC and kitchen fittings and finishes. See Design and Access Statement for design.

- 6 New Opening:** New doorway to stable with seasoned oak lintel. Allow for rebuilding localised area of stone wall.
- 7 Wall Linings:** Existing walls lined with plasterboard and insulation to improve thermal performance.

- 8 Roof Structure:** Existing modern timber roof structure replaced with new oak trusses and purlins. Existing modern softwood rafters replaced.
- 8 Timber Doors:** Painted ledged and braced timber barn doors on black painted hinges fixed externally to be used as external shutters.

- 9 Cornices and Skirtings:** New cornices and timber skirtings.
- 10 Proposed Floor Build Up:** New stone floor finishes laid on insulated concrete floor slab with integrated underfloor heating.

- 11 Proposed floor build up:** Proposed micro cement floor finish on screed over new concrete floor slab with integrated underfloor heating.
- 12 Electrical Services:** Existing electrical and lighting services replaced with new throughout.

- 13 Ceiling:** Existing plasterboard ceilings replaced with new. New plasterboard linings between new rafters in Garden Room.
- 14 Partitions:** New plasterboard lined stud partitions in Garden Room.

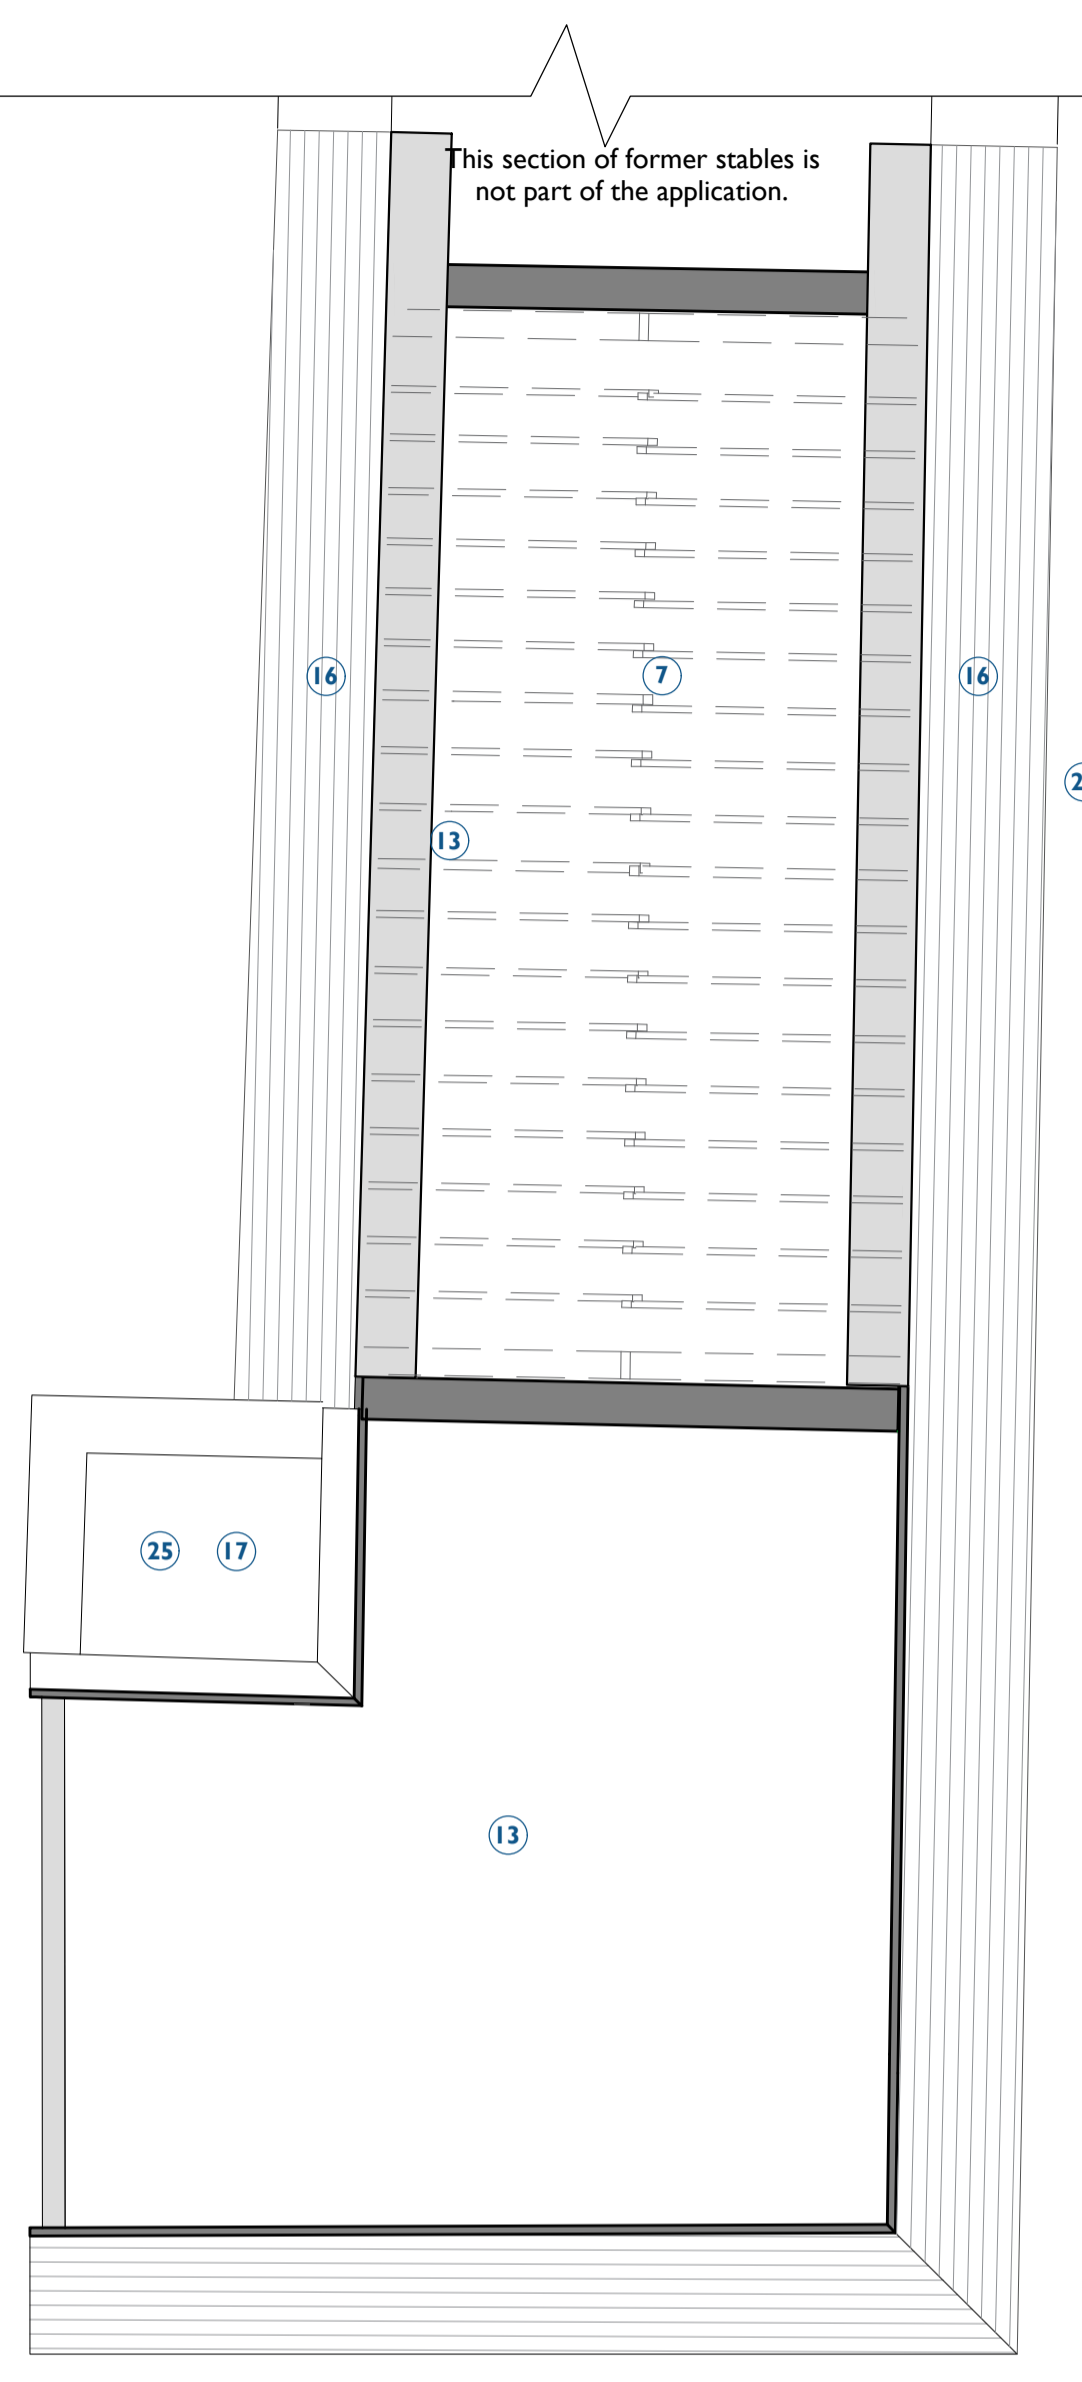
2 Existing Roof Space Plan
2001 1:50@A1

- 15 Rainwater Goods:** New black painted heritage range aluminium rainwater pipes and half round gutters.
- 16 Roofs:** Existing clay roof tiles carefully removed and reinstated to reconstructed roof structure. New clay tiles to match existing where necessary. Thermal insulation installed between timber rafters. All existing lead flashings and detailing to be replaced with new like for like.

- 17 Roofs:** New Leadwork and localised clay tiles repaired using salvaged tiles where possible.
- 18 Services:** Soil Vent Pipe terminating at tile vent within roof slope.

- 19 Windows/doors:** New painted timber framed double glazed windows/doors with hardwood reveals and sandstone lintels and cills.
- 20 Glazed Door:** Painted timber framed double glazed door within painted timber frame with sandstone lintel.

- 21 External Walls:** Existing ragstone walls repaired, made good and repointed in lime mortar following demolition works. All new work to match existing unless shown otherwise.

- 22 External Walls:** New ragstone wall to match existing stonework to former stables building.
- 23 Roof:** Salvaged Clay tiles to infill opening in roof where door frame is removed.

- 24 Roof:** New rafters framed and trimmed to receive black painted metal framed double glazed conservation rooflights. Roof tiles to be removed, salvaged and reinstated following structural alterations to roof.

- 25 Existing Wall Finish:** Exposed ragstone walls to be limewashed.
- 26 New painted timber framed double glazed windows/doors** installed in new natural stone wall with hardwood reveals and sandstone lintels and cills.

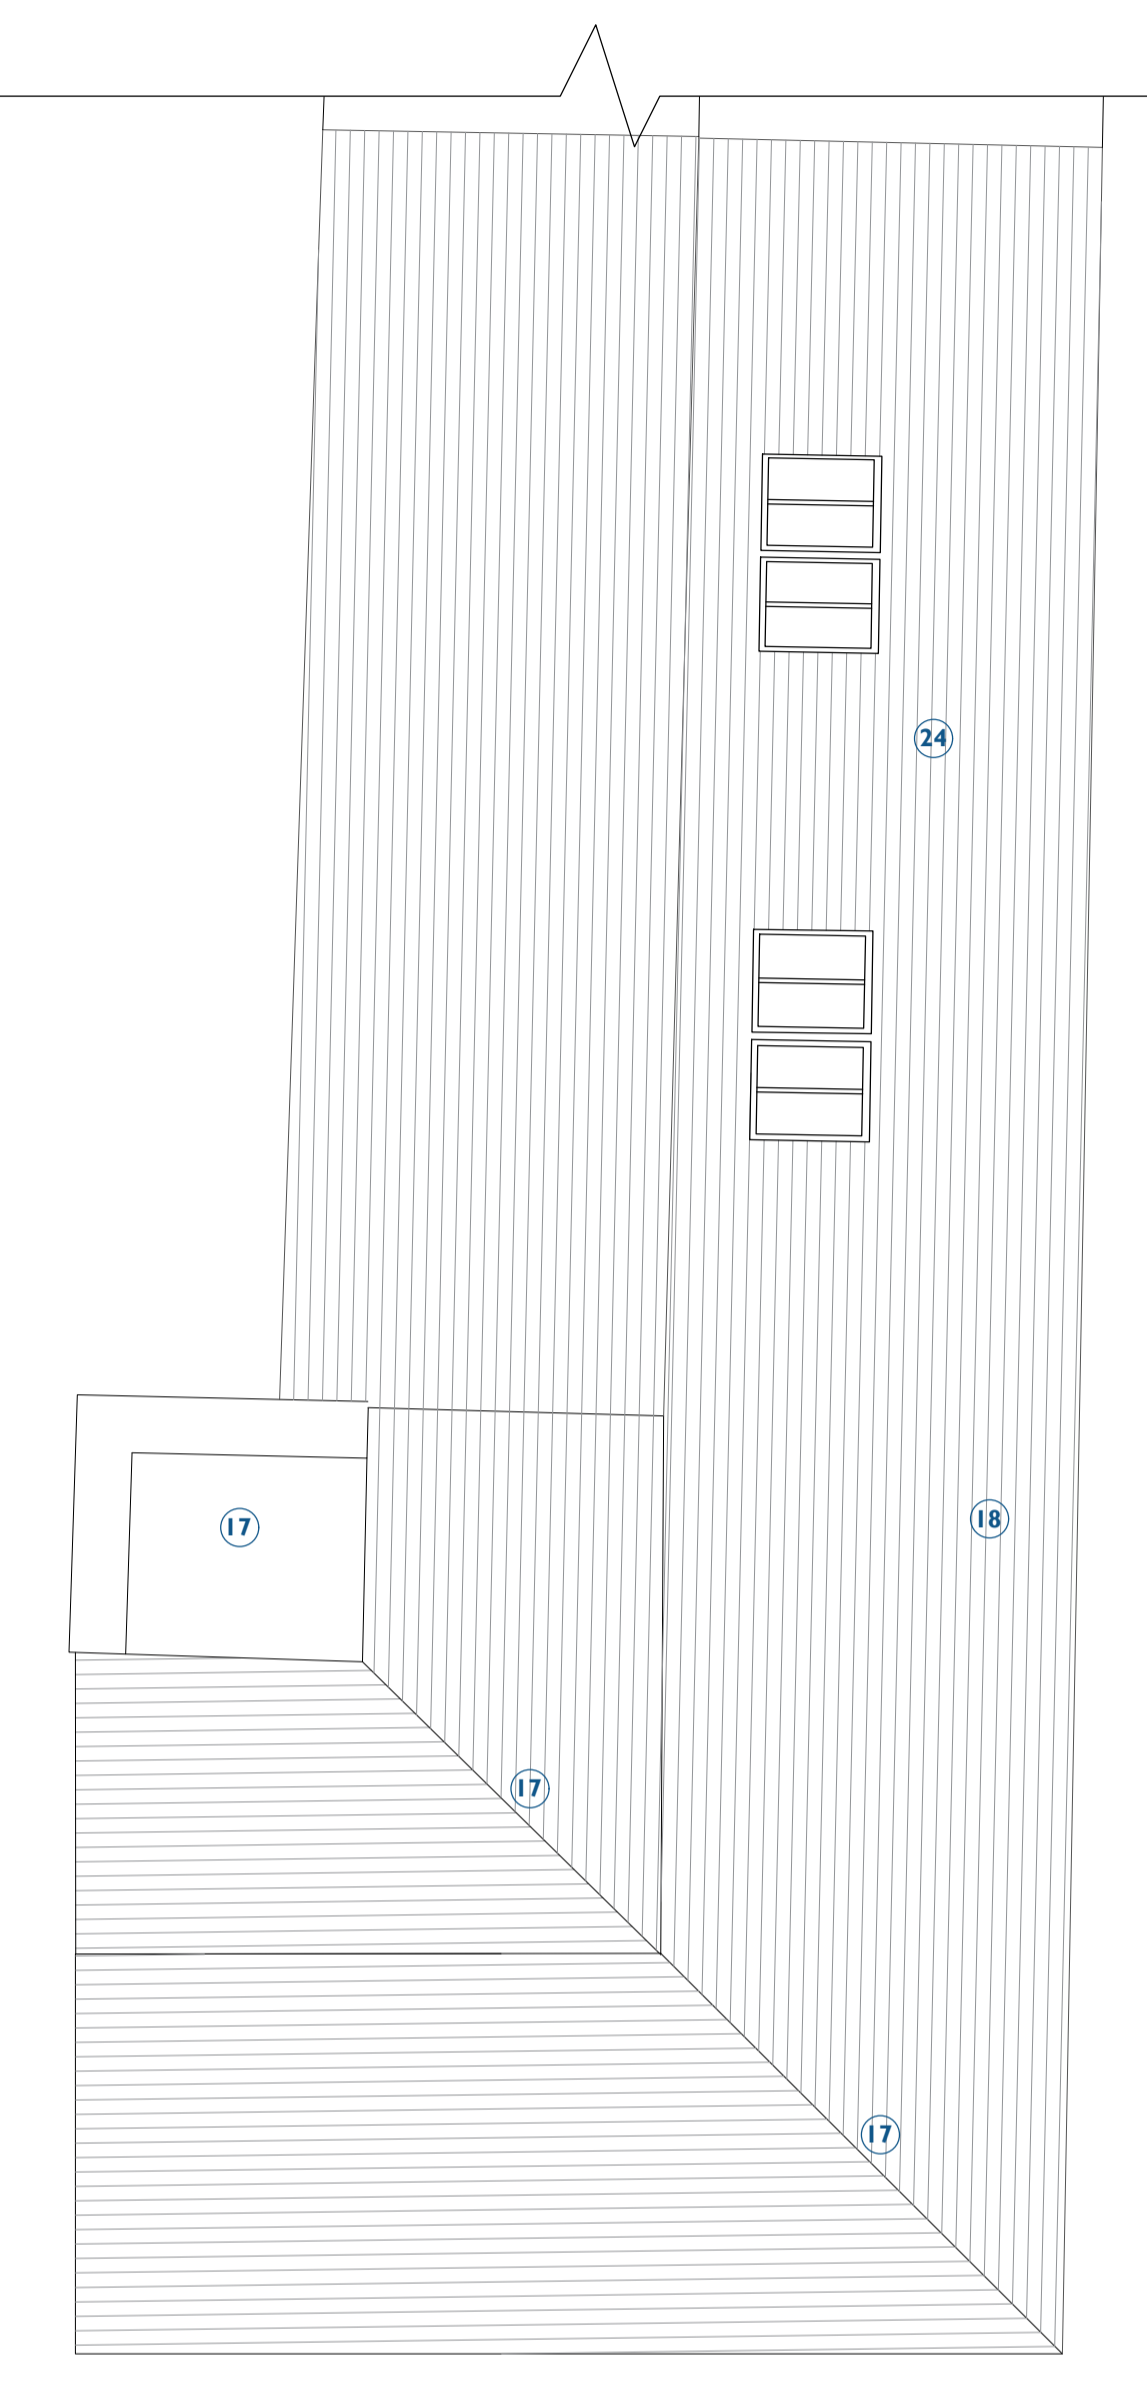
3 Existing Roof Plan
2001 1:50@A1

- 27 New retaining structure** to support existing external wall where internal floor levels are shown altered. Proposed French drain to run externally.
- 28 Existing walls** to be underpinned. Refer to Design and Access Statement for full structural strategy.
- 29 Existing stonework** to be repaired and repointed with lime mortar to match existing.
- 30 New Raised Roof Level** to allow for internal steel beam.
