CAMERON DARROCH ASSOCIATES

**SURFACE WATER DRAINAGE STRATEGY FOR
REDEVELOPMENT OF LAND AT 57 TOP DARTFORD
ROAD, HEXTABLE, KENT, BR8 7SG.**

DATE: March 2024

OUR REF: CDA-2601 v1.1

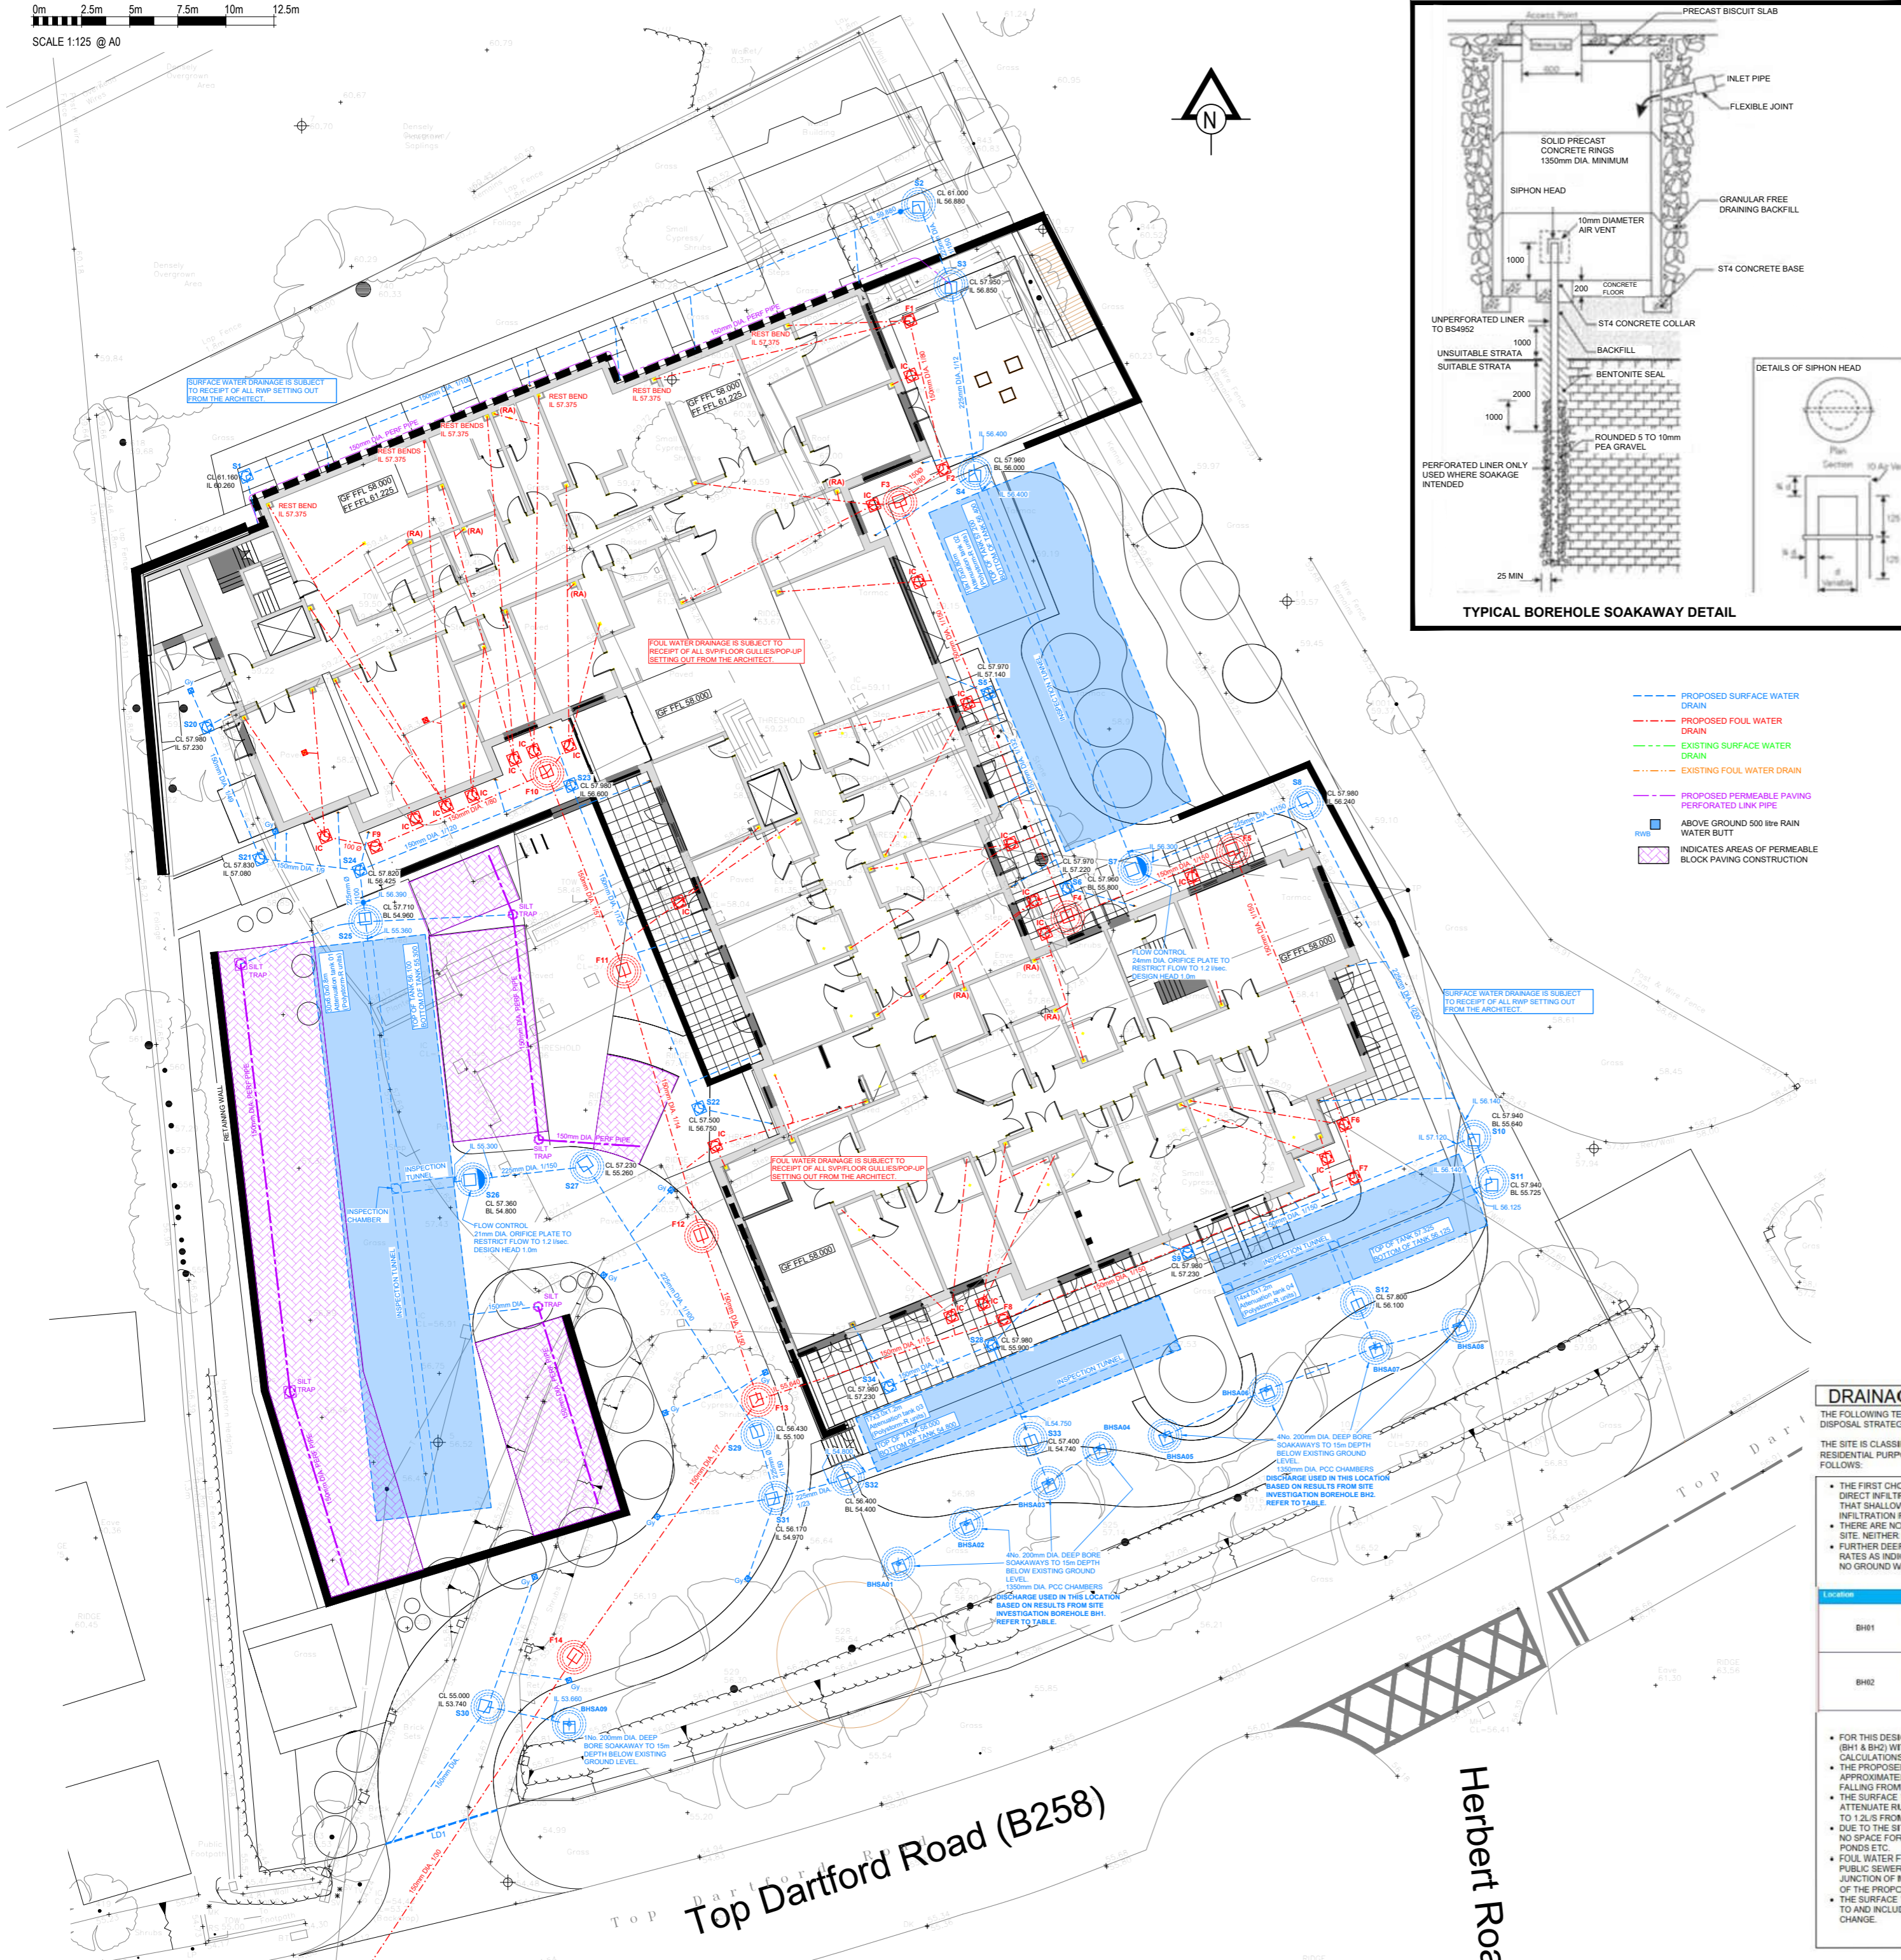
MANHOLE REF.	BASE INVERT LEVEL	CL	DEPTH	DI (MIN SIZE)	MIN COVER SIZE & GRADE
S1*	60.200	61.100	0.900	450mm DIA. POLYPROPYLENE	C250 (600x600)
S2*	56.800	61.000	4.200	1200mm DIA. PCC RINGS	C250 (600x600)
S3*	56.850	57.950	1.100	1200mm DIA. PCC RINGS	C250 (600x600)
S4*	56.900	57.800	0.900	1200mm DIA. PCC RINGS	C250 (600x600)
S5*	57.140	57.970	0.830	450mm DIA. POLYPROPYLENE	C250 (600x600)
S6*	57.220	57.970	0.750	450mm DIA. POLYPROPYLENE	C250 (600x600)
S7*	56.900	57.950	1.050	1200mm DIA. PCC RINGS	C250 (600x600)
S8*	56.240	57.980	1.740	1200mm DIA. PCC RINGS	C250 (600x600)
S9*	57.230	57.980	0.750	450mm DIA. POLYPROPYLENE	C250 (600x600)
S10	56.540	57.940	1.400	1200mm DIA. PCC RINGS	C250 (600x600)
S11	56.725	57.940	1.215	1200mm DIA. PCC RINGS	C250 (600x600)
S12	56.125	57.800	1.675	1200mm DIA. PCC RINGS	C250 (600x600)
S20*	57.220	57.900	0.750	450mm DIA. POLYPROPYLENE	C250 (600x600)
S21*	57.080	57.830	0.750	450mm DIA. POLYPROPYLENE	C250 (600x600)

- LD1 - ACO M1000 LINEAR DRAINAGE CHANNEL (OR SIMILAR APPROVED) WITH INTERNAL FALL & D400 GRATING.
- IC - 450mm DIA. POLYPROPYLENE LEVEL INVERT INSPECTION CHAMBER WITH 600x600mm RECESSED COVER & FRAME WHERE REQUIRED TO ACCEPT SURROUNDING FINISHES. IL 57.130 UNLESS NOTED OTHERWISE.
- RE - RODDING EYE. 600mm DP. UNLESS NOTED OTHERWISE.
- (RA) - RODDABLE ACCESS TO SVP ABOVE FLOOR LEVEL.

- PROPOSED SURFACE WATER DRAIN
- PROPOSED FOUL WATER DRAIN
- EXISTING SURFACE WATER DRAIN
- EXISTING FOUL WATER DRAIN
- PROPOSED PERMEABLE PAVING PERFORATED LINK PIPE
- ABOVE GROUND 500 litre RAIN WATER BUTT
- INDICATES AREAS OF PERMEABLE BLOCK PAVING CONSTRUCTION

DRAINAGE STRATEGY

- THE FIRST CHOICE FOR SURFACE WATER IS ATTENUATION WITH DIRECT INFILTRATION, HOWEVER SITE INVESTIGATIONS IDENTIFIED THAT SHALLOW INFILTRATION WAS NOT FEASIBLE DUE TO POOR INFILTRATION RATES ACHIEVED.
- THERE ARE NO WATERCOURSES WITHIN CLOSE PROXIMITY OF THE SITE, NEITHER IS THERE A SURFACE WATER SEWER.
- FURTHER DEEP BORE INVESTIGATION FOUND GOOD INFILTRATION RATES AS INDICATED BELOW, DRILLINGS CONTINUED TO 30.0M AND NO GROUND WATER WAS ENCOUNTERED:

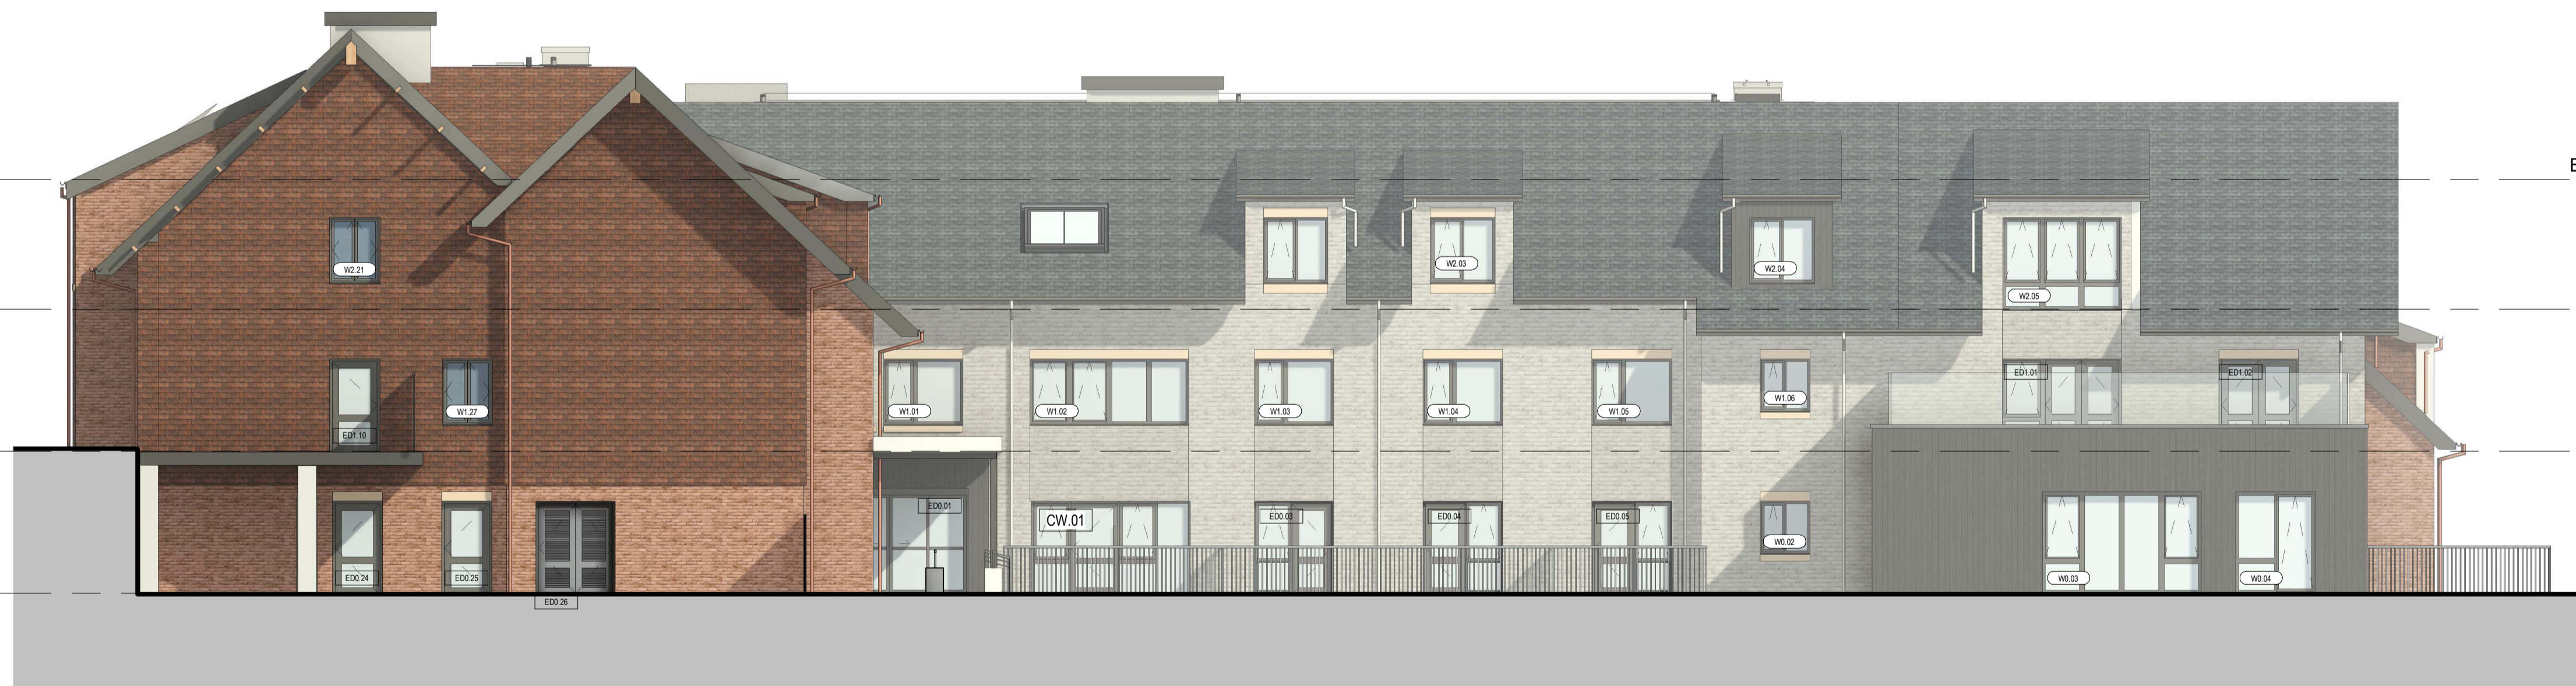
W West Elevation
 1 : 100

- Key:**
-   Red Clay Hanging tiles
 -   Red Multi-Brick
 -   Pale Brick work
 -   Black Timber style Cladding
 -   Grey Clay Hanging tiles

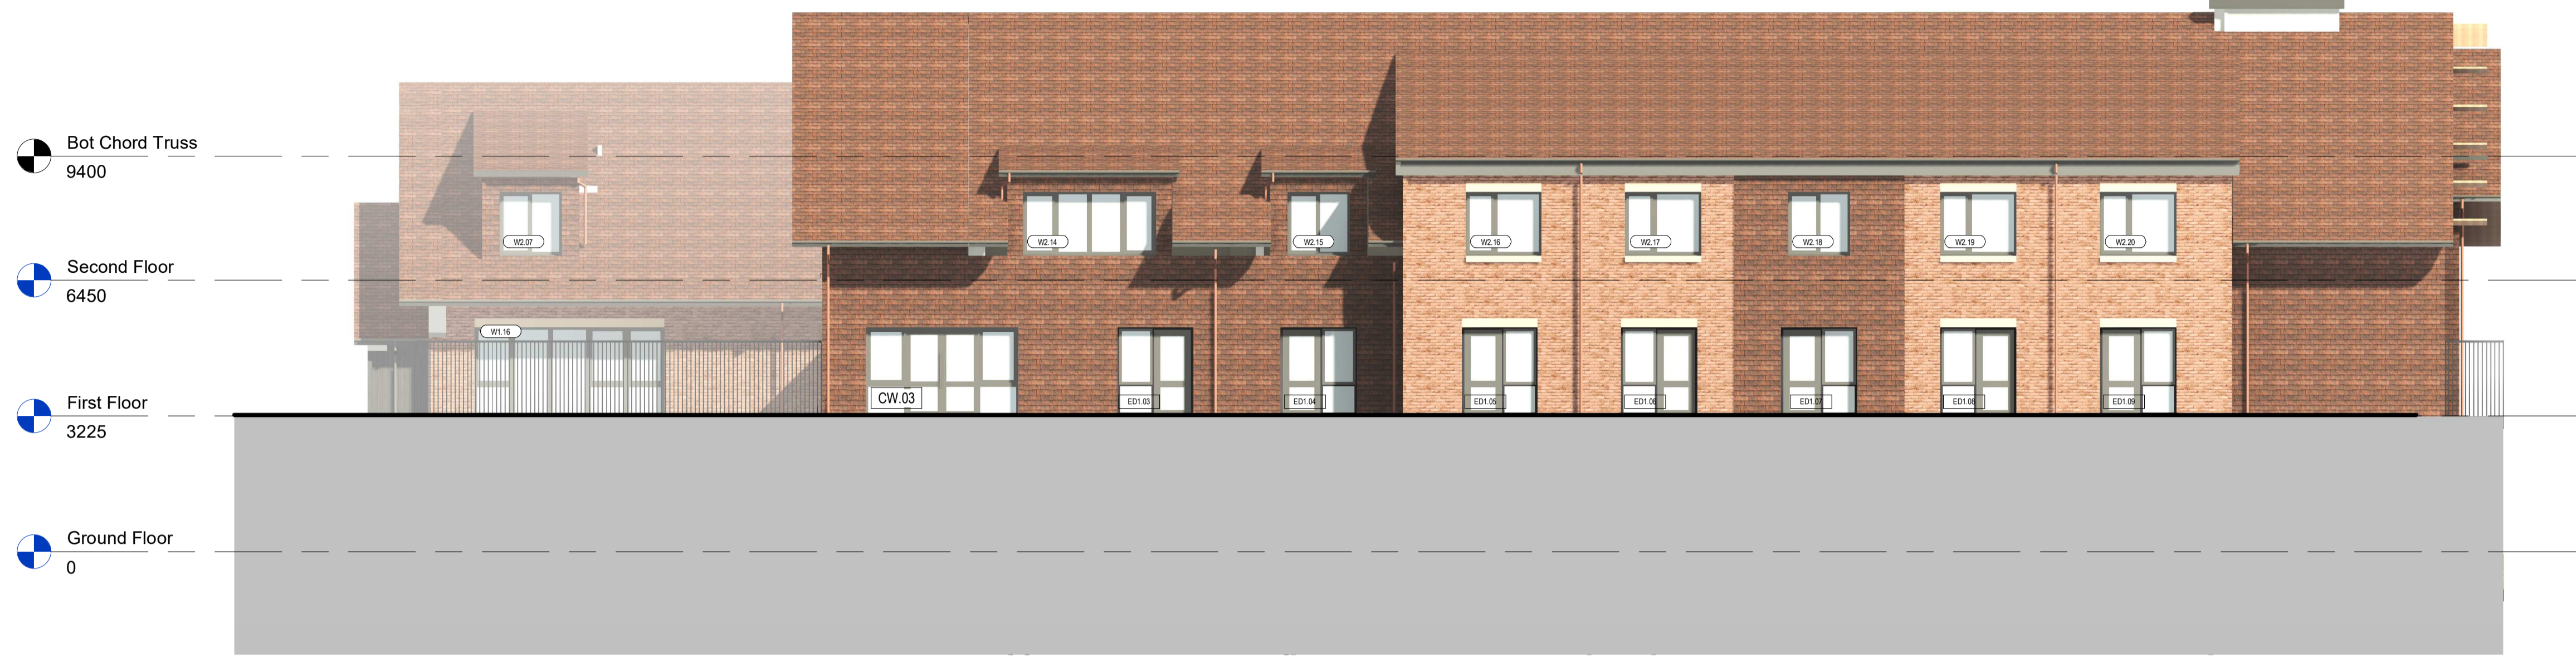
N North Elevation
 1 : 100

- Key:**
-   Red Clay Hanging tiles
 -   Red Multi-Brick
 -   Pale Brick work
 -   Black Timber style Cladding
 -   Grey Clay Hanging tiles

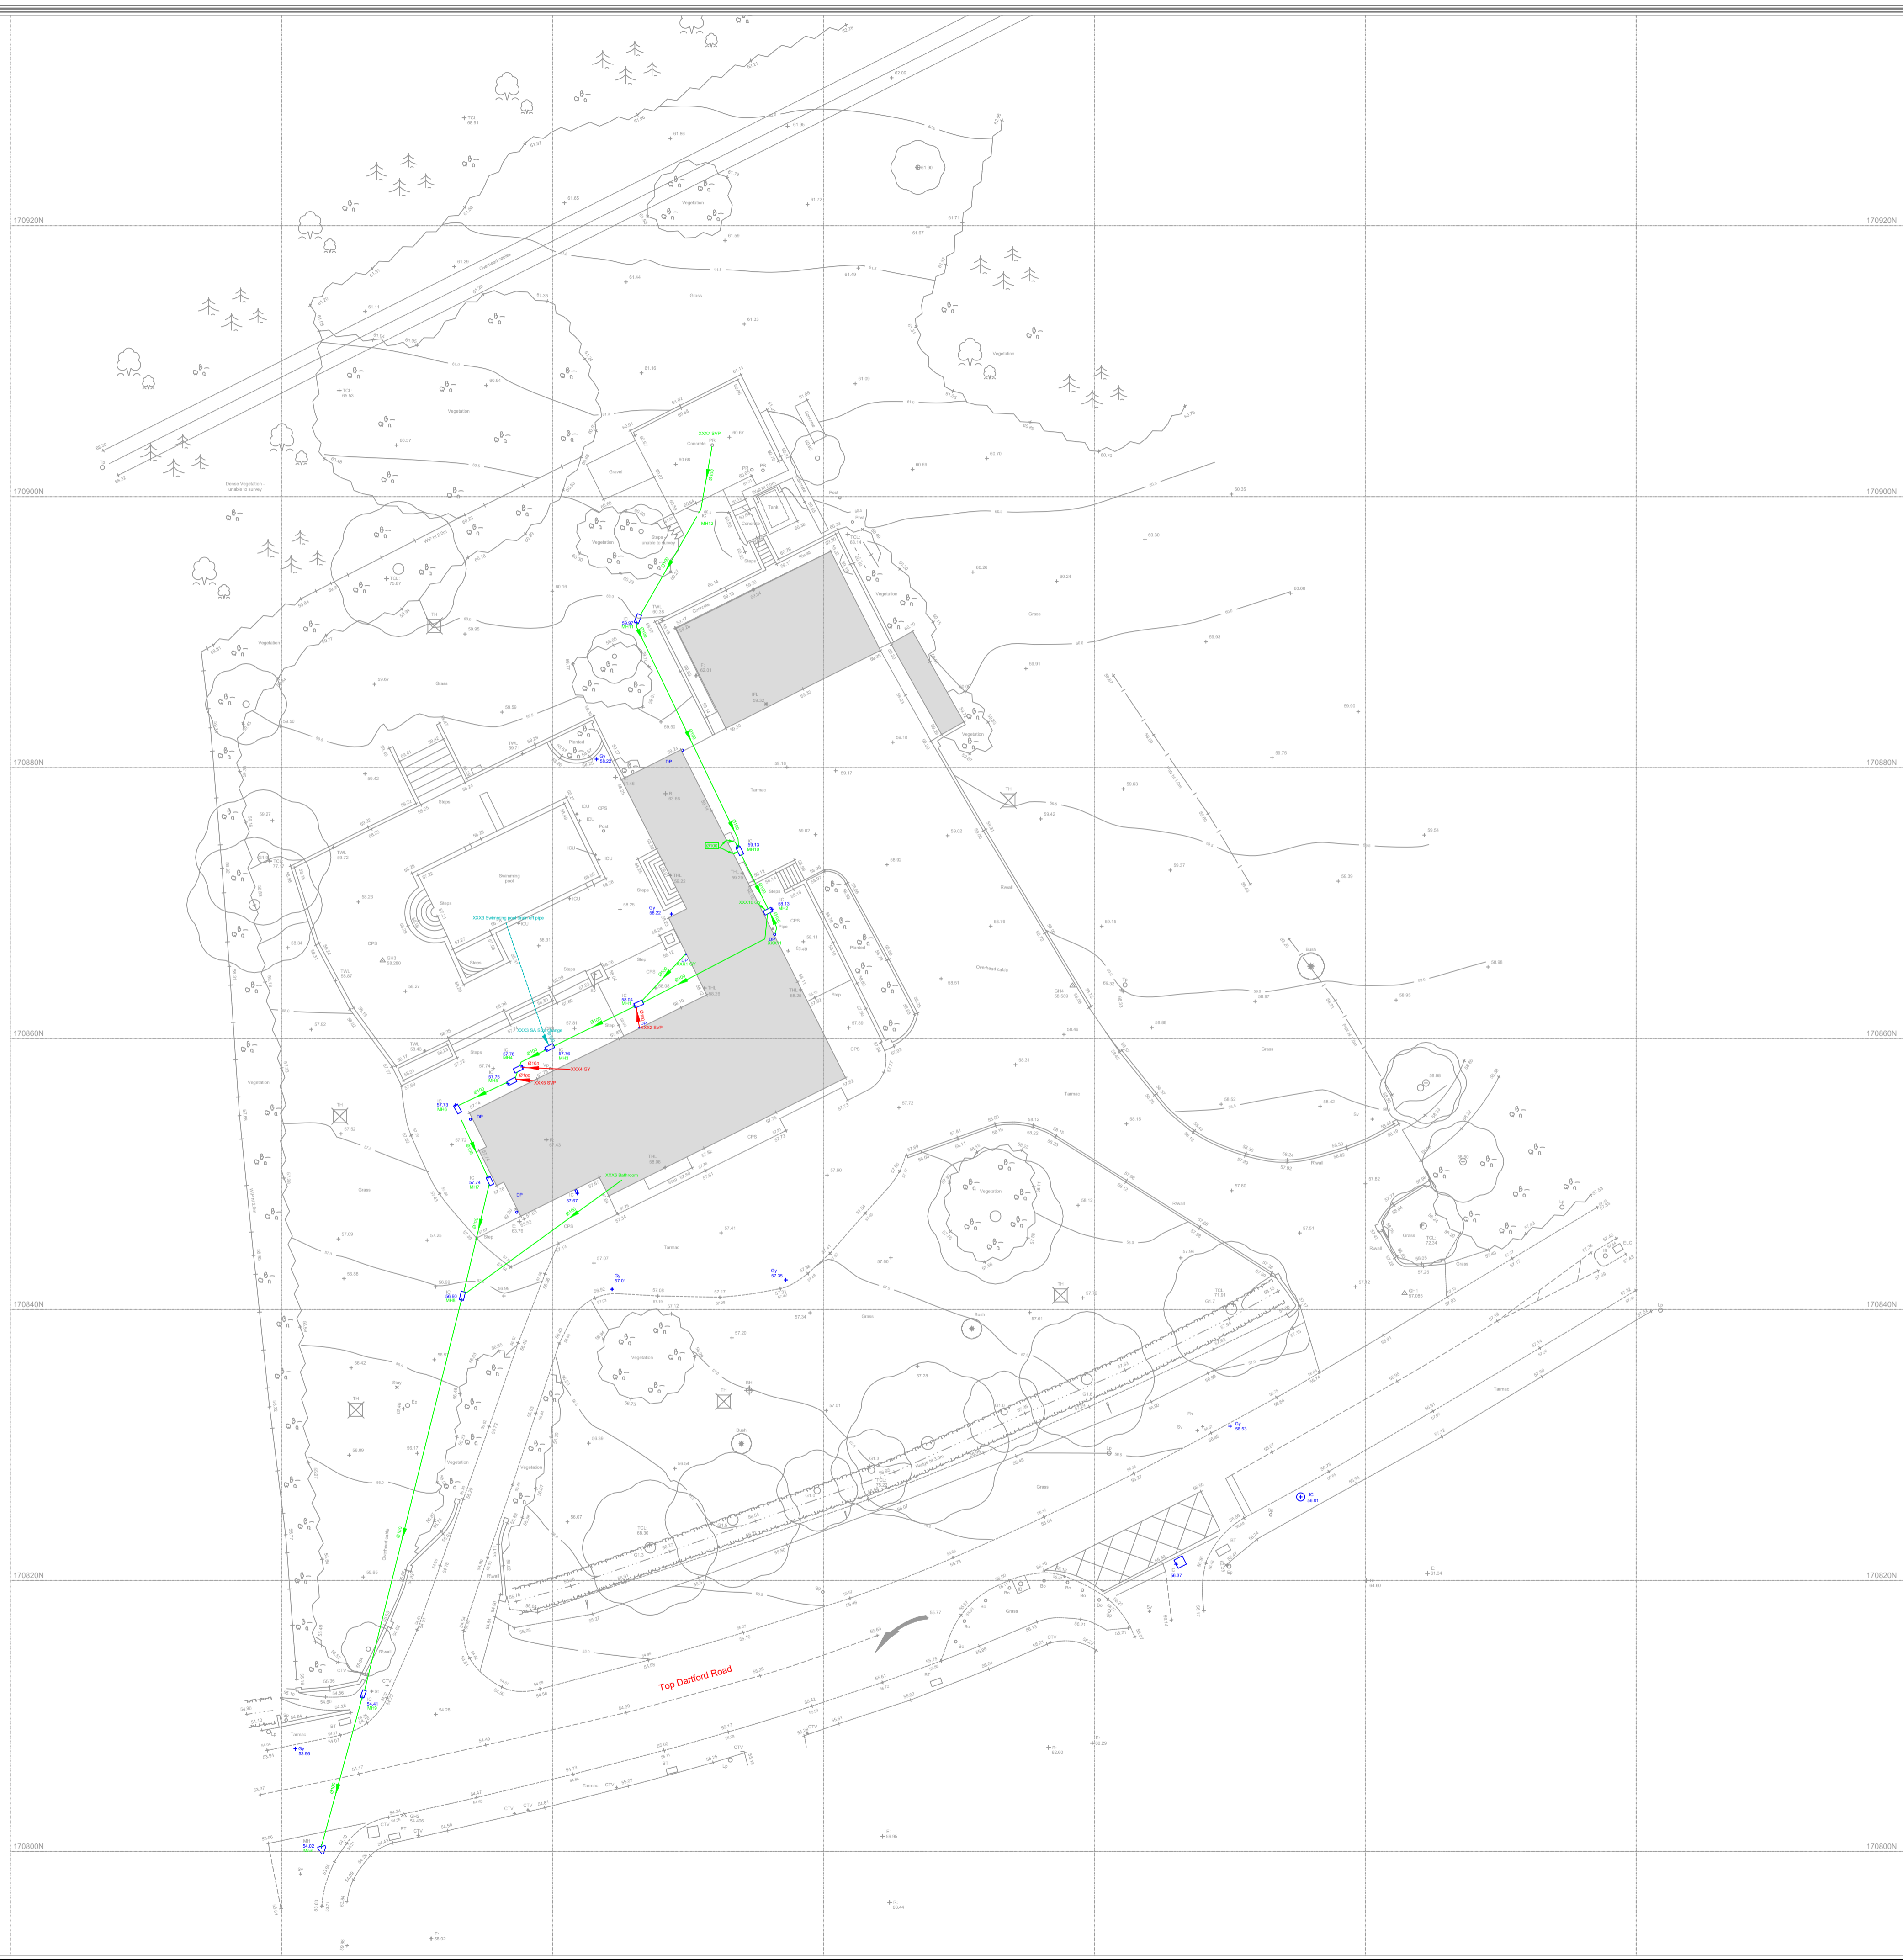
CCTV KEY

—	Surface Water
---	Assumed Surface Water
—	Foul Water
---	Assumed Foul Water
—	Combined Water
---	Assumed Combined Water
