The proposed works are for listed building repairs and replacements to the main house:

Project Ref: 24.41	Proposed Listed Building Repairs to Walls, Roof and Replacement of Internal Elements.
Drawing No: HR_01	Craddock Lodge, Craddock, Devon, EX15 3LL

Planning & Heritage Statement Introduction - March 2024
Copyright AA Ltd. All Rights Reserved. RIBA Chartered Practice & Accredited Conservation Architects

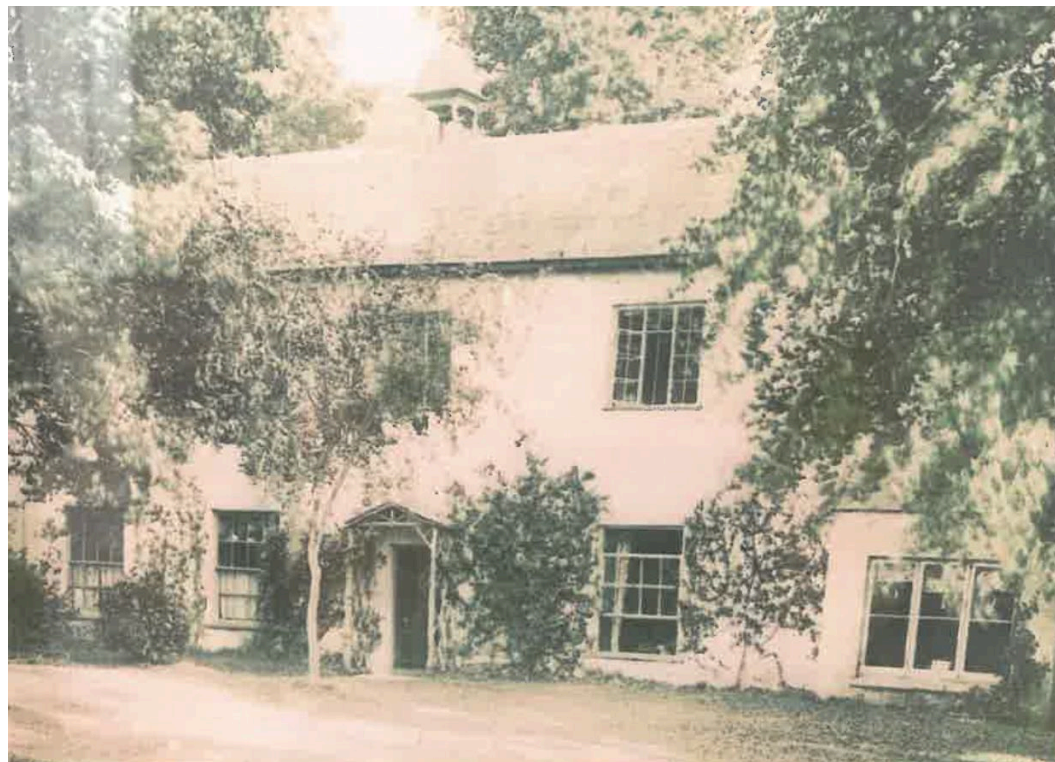
Photograph circa 1900. West facing facade. Showing the original entrance door location and sash window arrangement. Existing first floor windows are 20th C replacements now.

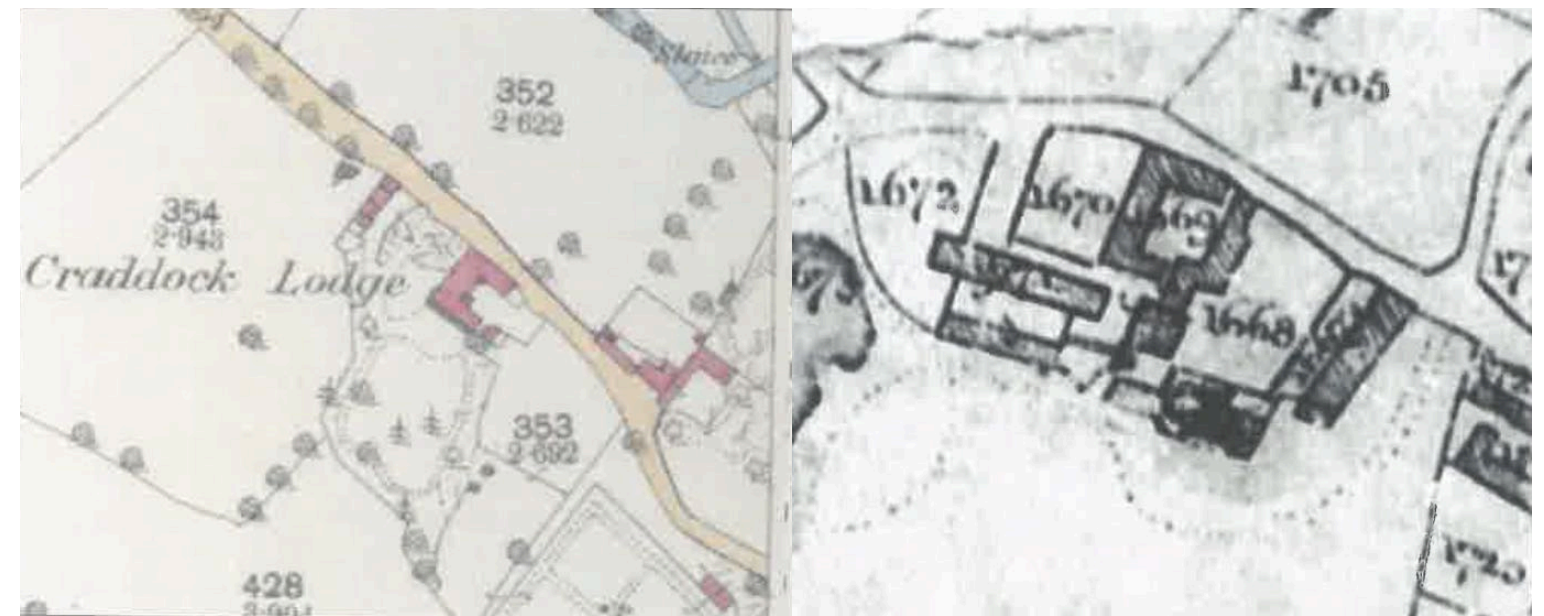
1840 Devon Tithe Map. The original 17th C block visible along with stables outbuildings east.

1888 Ordnance Survey. Larger south wing added 19th C and some outbuildings removed.

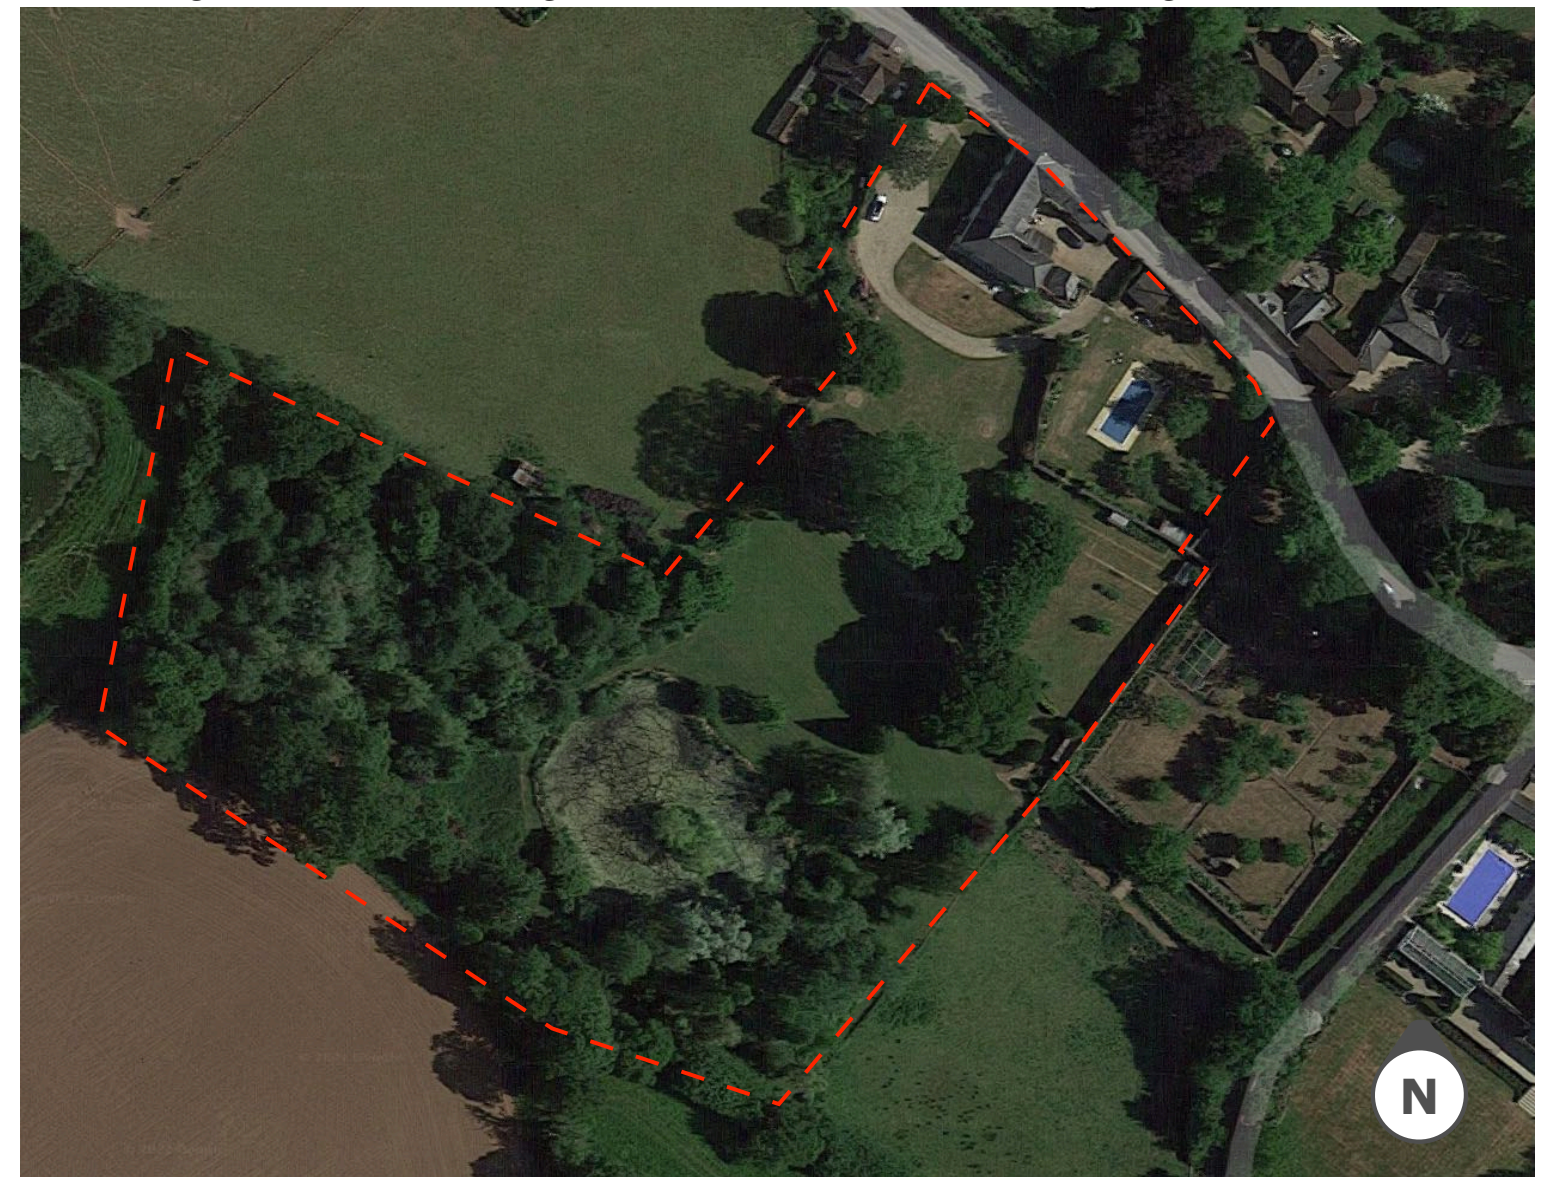
2022 Ariel Photograph. The original 17th C block and the main 19th C south wing now form the body of the house. The lane side stables outbuildings form part of the house annexe.

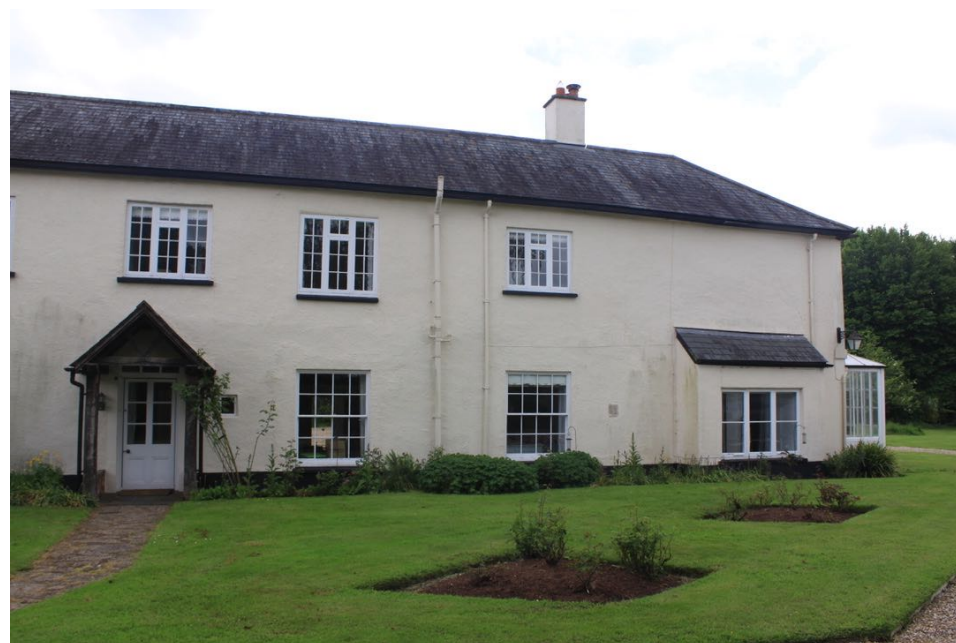
View of the west facing elevation. The first floor casement windows are relatively crude softwood painted type from the mid - late 20th Century.

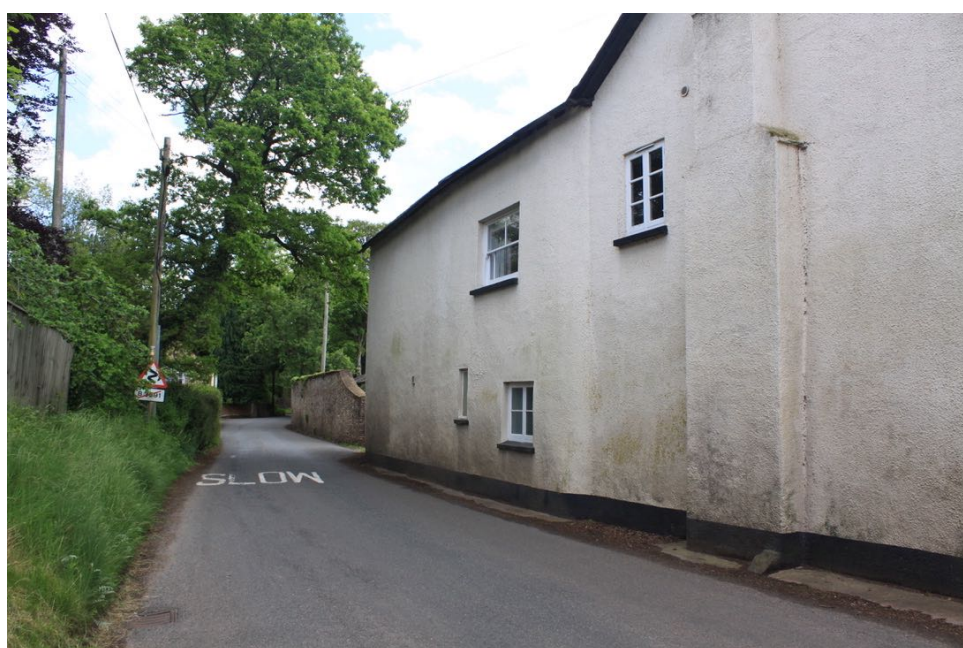
View from the public lane. The hard cement render will be replaced with a stone plinth at road level and lime render above at first floor.

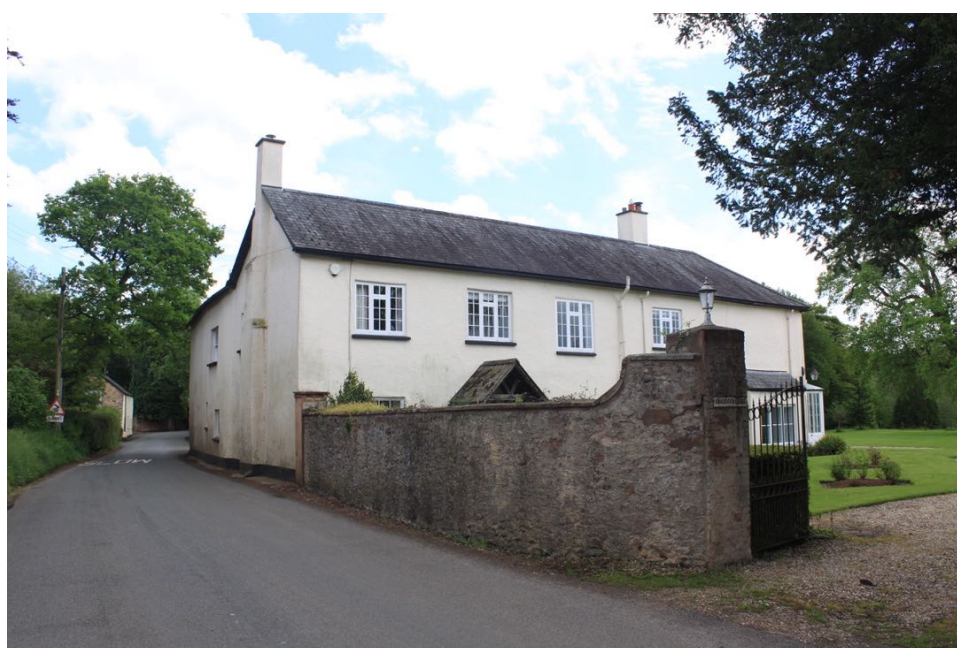
View from the public lane and the vehicular entrance on the north western side. The existing stone boundary wall will continue as a plinth at street level along the building.

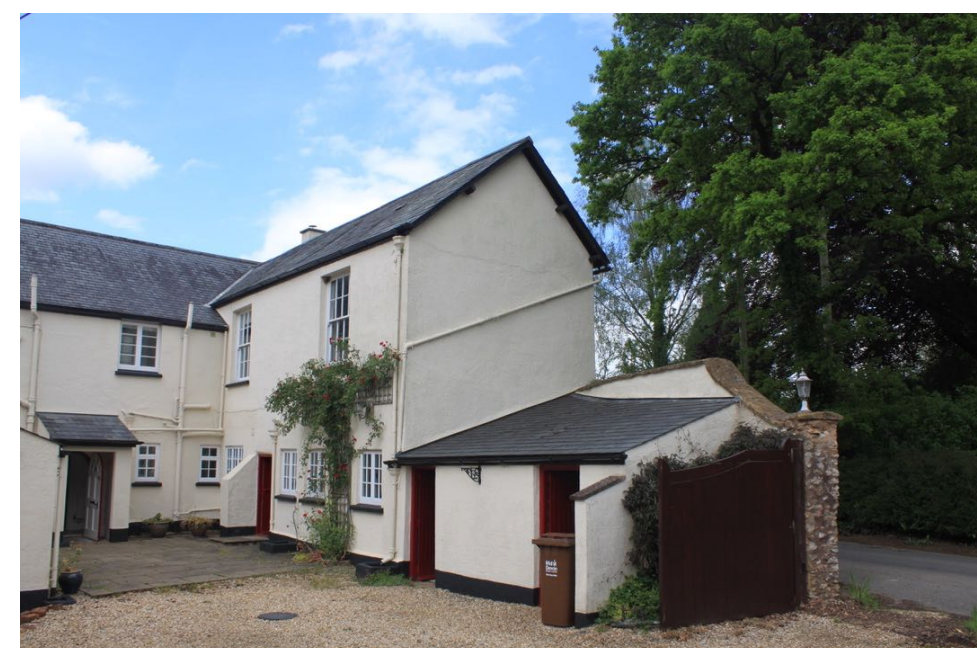
View of the courtyard, former small stable and lane access. The proposed window replacements are around this area as itemised.

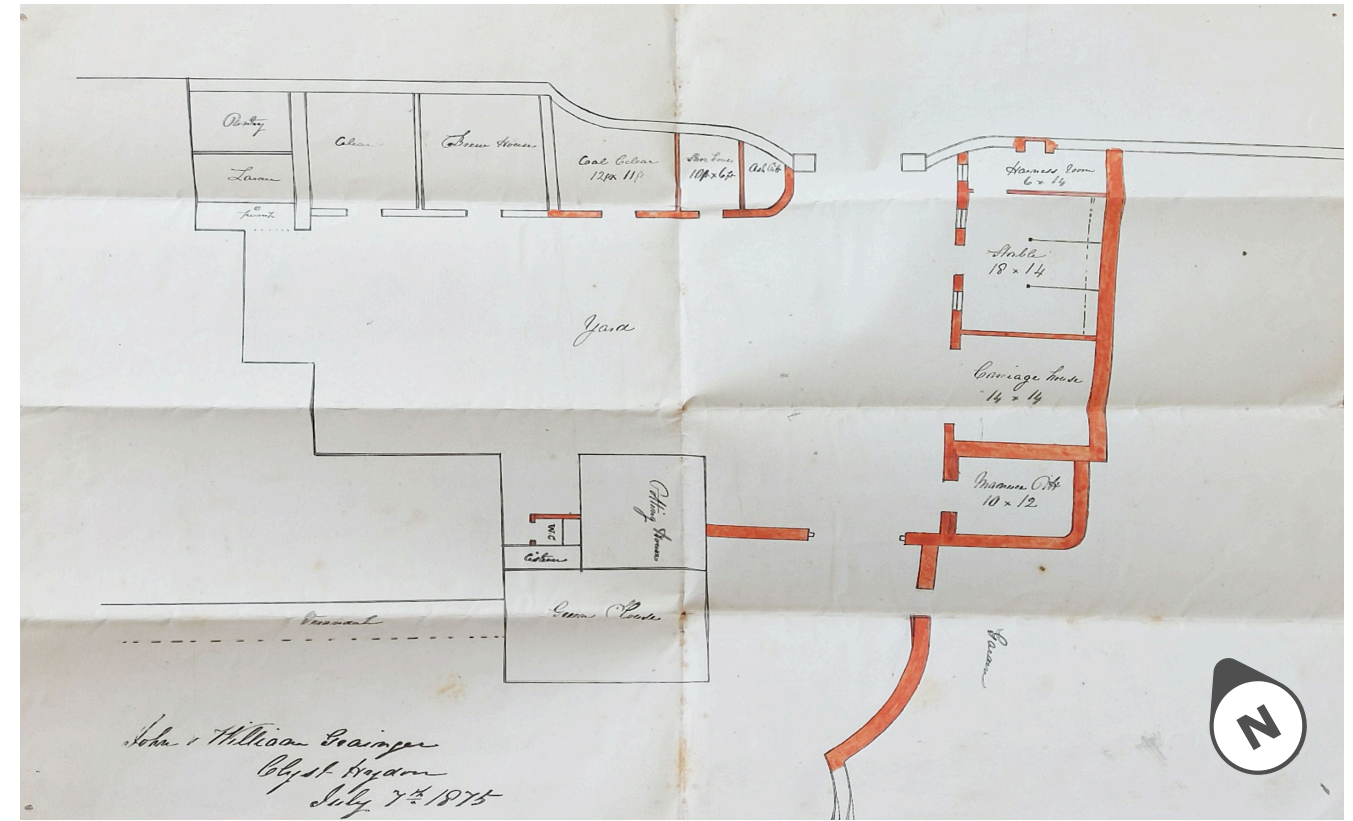
Drawing dated 1875 that illustrates in red the separate stables and carriage house wings. The wing on the right hand side has been demolished. The building affronting the lane remains intact - at ground floor used as storage.

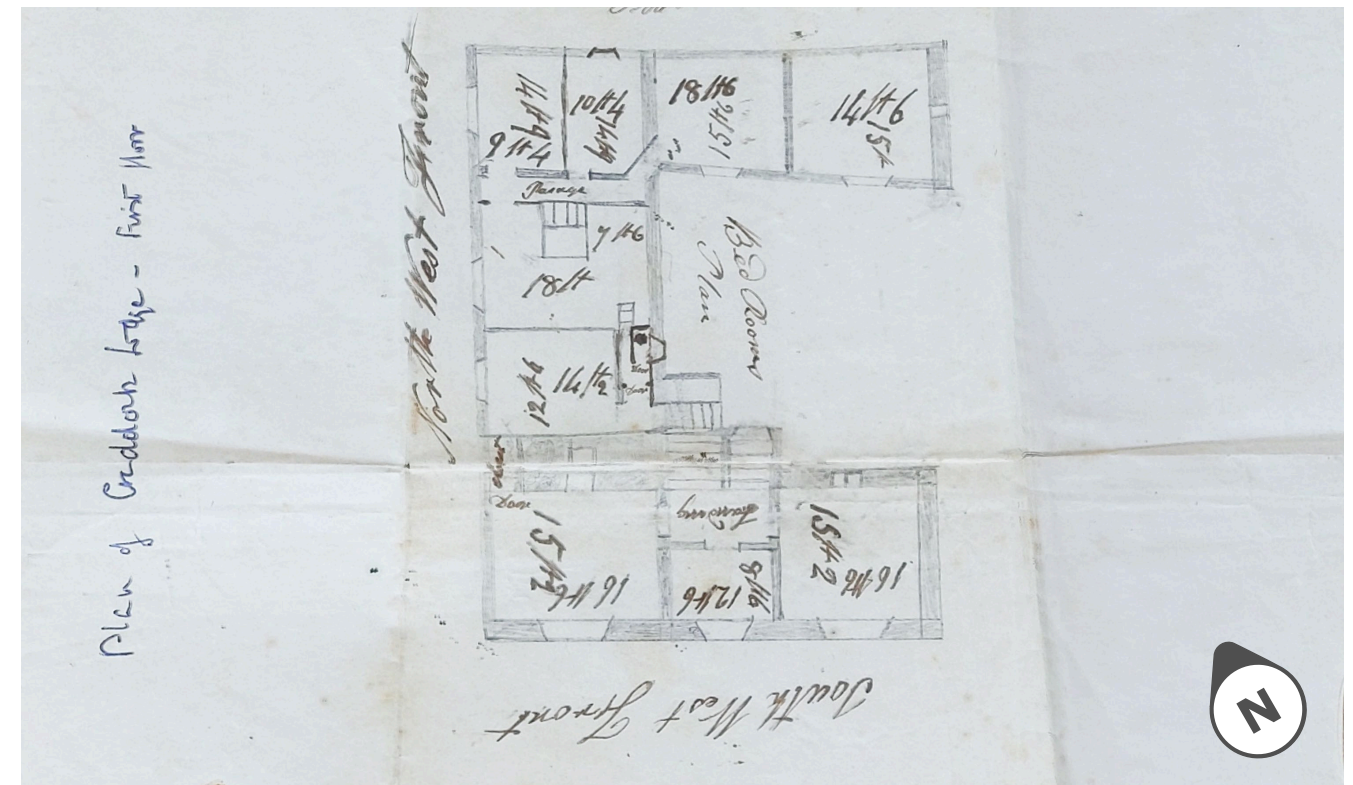
Drawing undated with room dimensions, but was before the courtyard corridor was added. Note also the heavy double wall lines between the original 17th longhouse and the main Georgian south wing. Estimated date 1850.

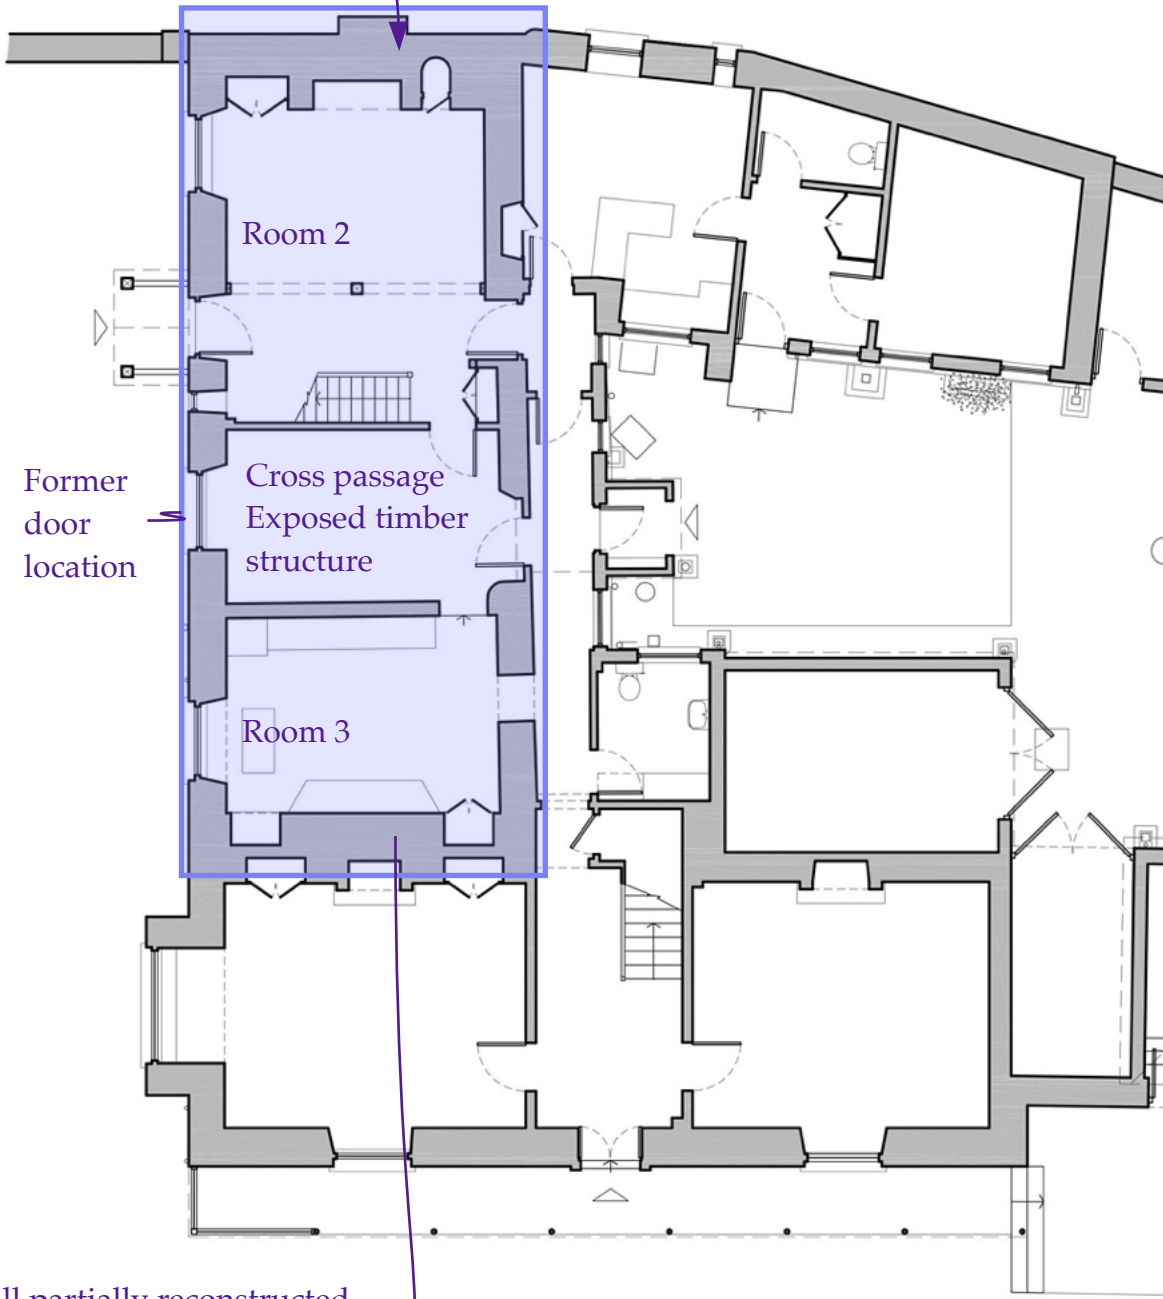
Ground Floor

Original 17th C fireplace, hearth and separate bread oven.

Former door location

Cross passage
Exposed timber structure

Wall partially reconstructed with chimney stacks and openings.

Mid 17th Century - Originated as a traditional three room, cross passage Devon Longhouse running north - south axis. The cross passage walls and ceiling structure remain largely intact and are partially visible in the room interior. The old black and white photo on sheet DR_01 shows the main entrance door in a previous, believed to be original position giving access directly into the cross passage.

To the north, facing the public road / lane the fireplace features traditional elements including a main hearth, side warming recesses and a separate bread oven.

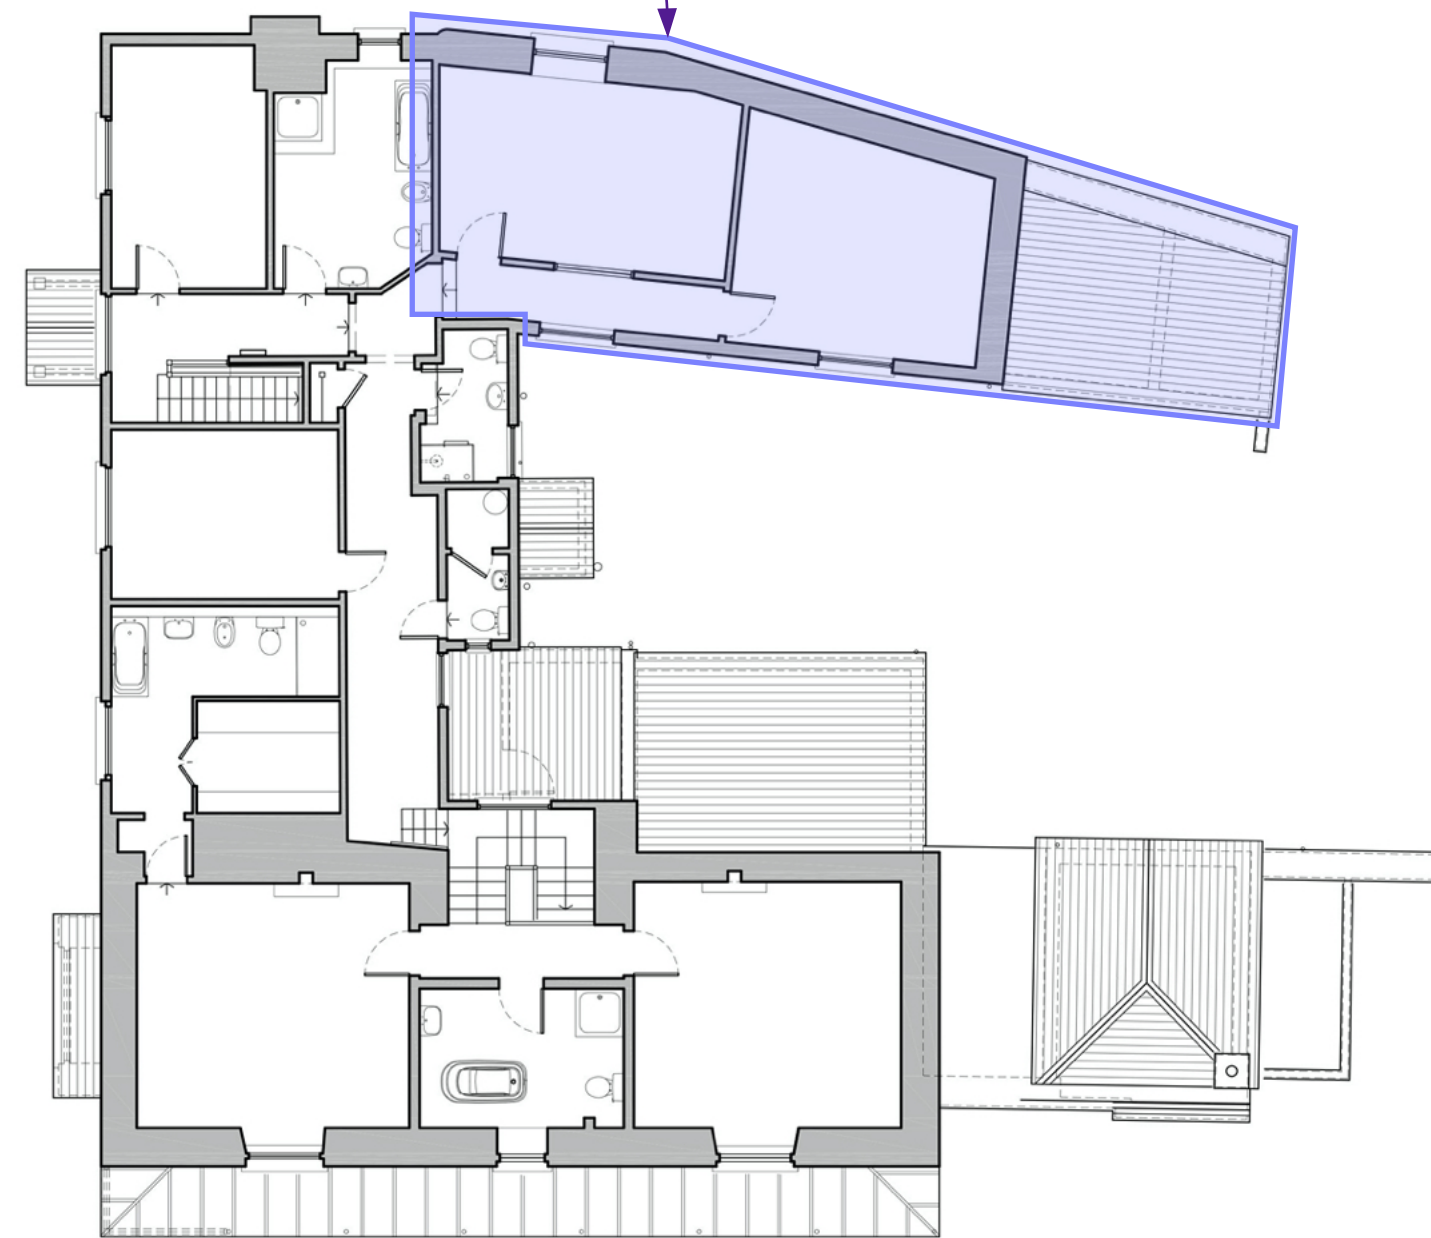
First Floor

Historic stone wall to the lane with evidence of single storey barn, stables outbuildings remaining in this location close to the road for direct cart access.

17th Century Original Devon Longhouse

Three room with cross passage.

Single storey or attic space above (not fully two floors due to very thin first floor wall depth).

The remaining wall thicknesses imply that the 17th century dwelling was either single storey or part roofspace because at ground floor they are 40-60cm thick solid masonry - but the first floor is much thinner and clearly a later addition.

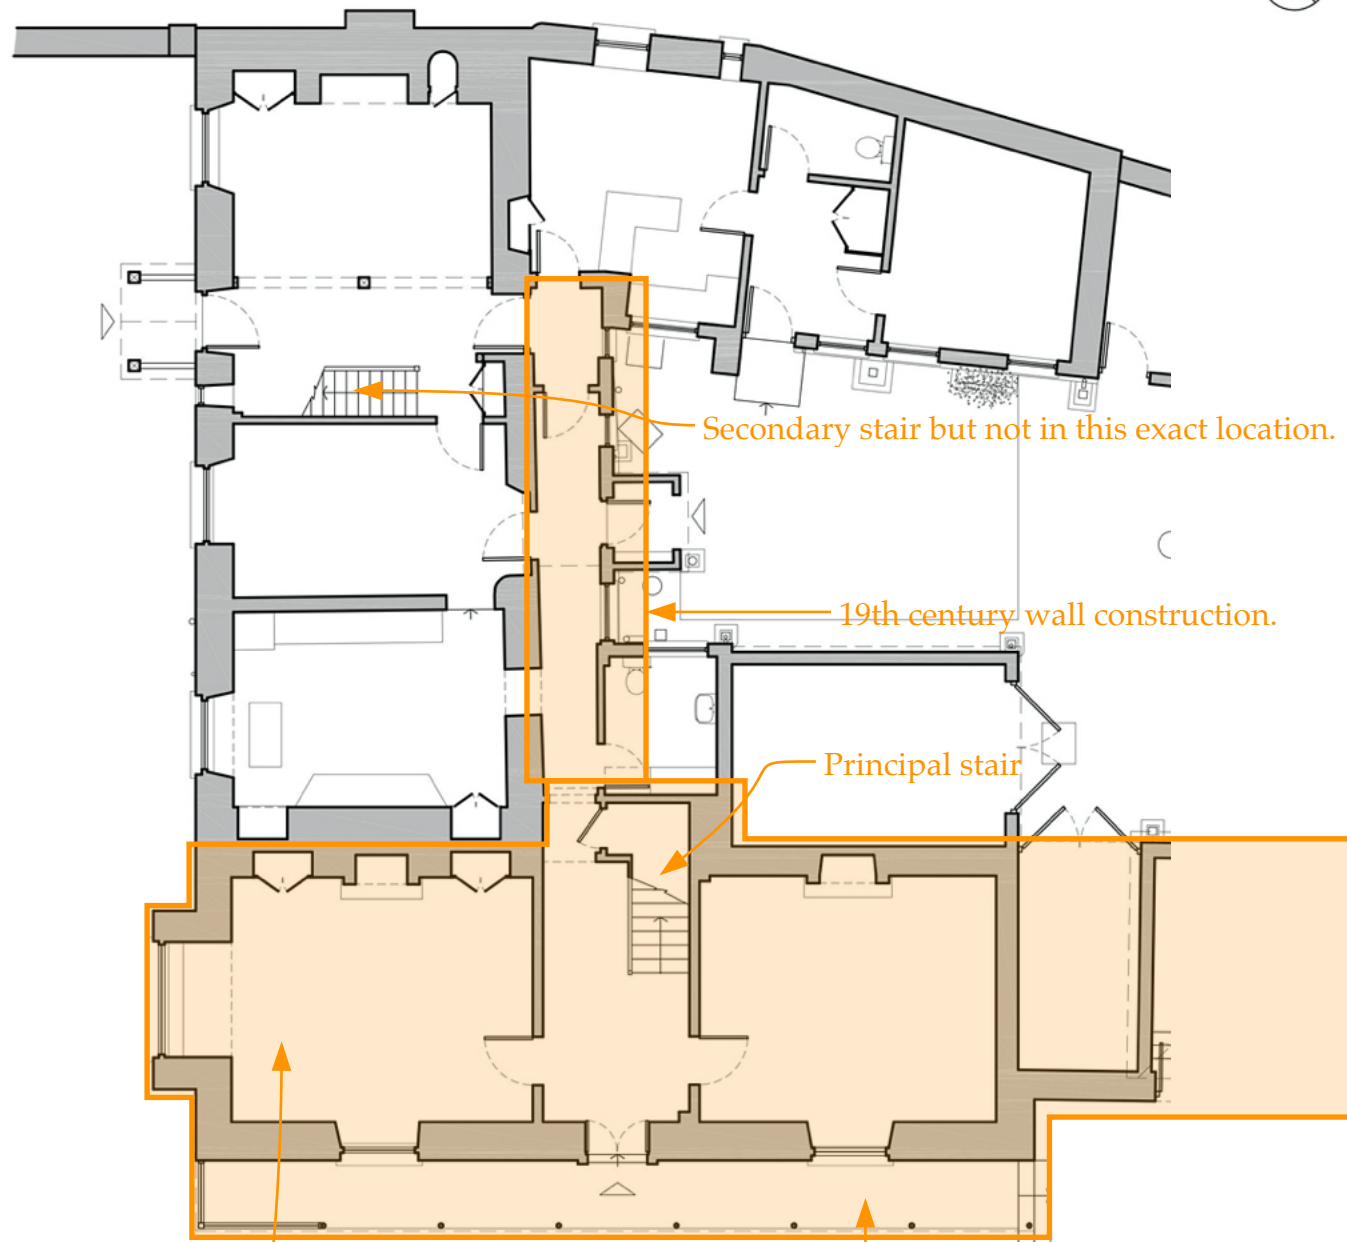
Ground Floor
Garden

Thin wall construction at first floor consistent with late 18th century residential enlargement of buildings.

South facing two storey wing with formal reception rooms split by the central staircase.

Glazed colonnade verandah

18th Century - Early 19th Century
Georgian Expansion, Main Wings to the South and West

Mid 18th Century - Early 19th Century - During the Georgian period, Craddock Lodge was extensively altered and enlarged with a first floor above the original longhouse and a major, two storey south wing. These new buildings are well ordered with generous room proportions and consistent sash window openings to produce a formal appearance as befits a 'gentrified' estate country villa. The verandah colonnade runs along the full southern facade with a glazed roof and cast iron columns.

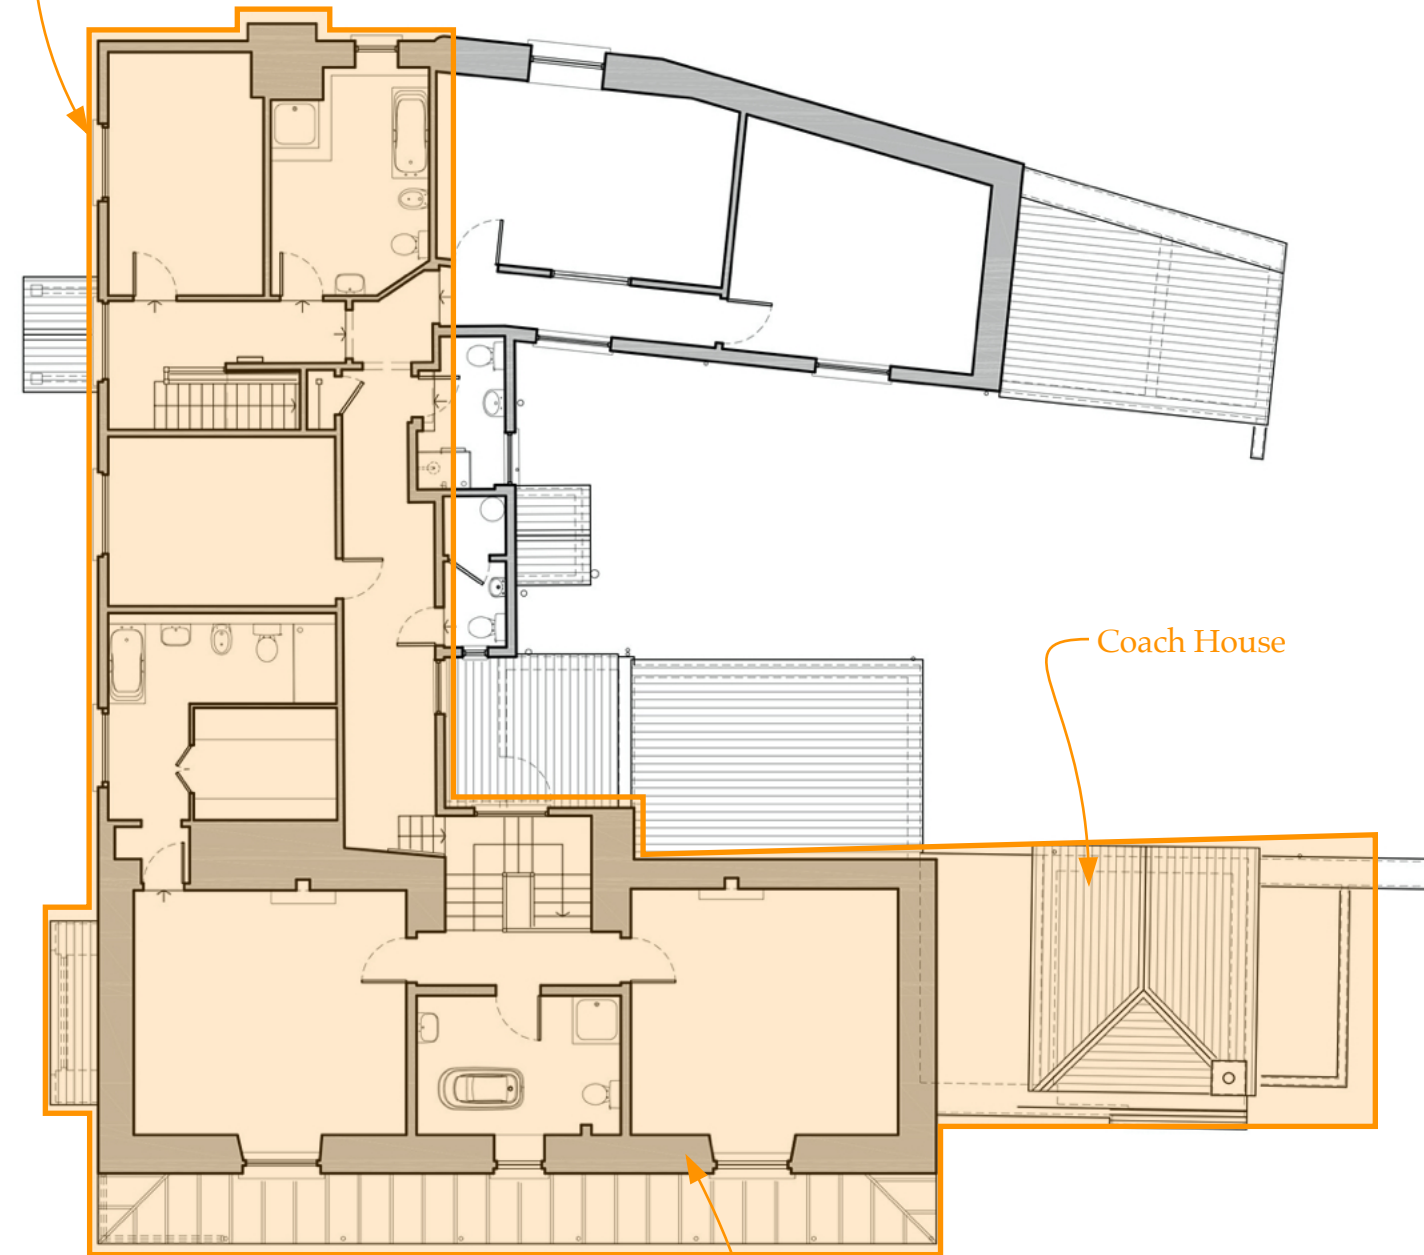
First Floor
Garden

Thick, solid load bearing masonry wall constructed from local shillet stone and lime mortar.
Full two storey building.

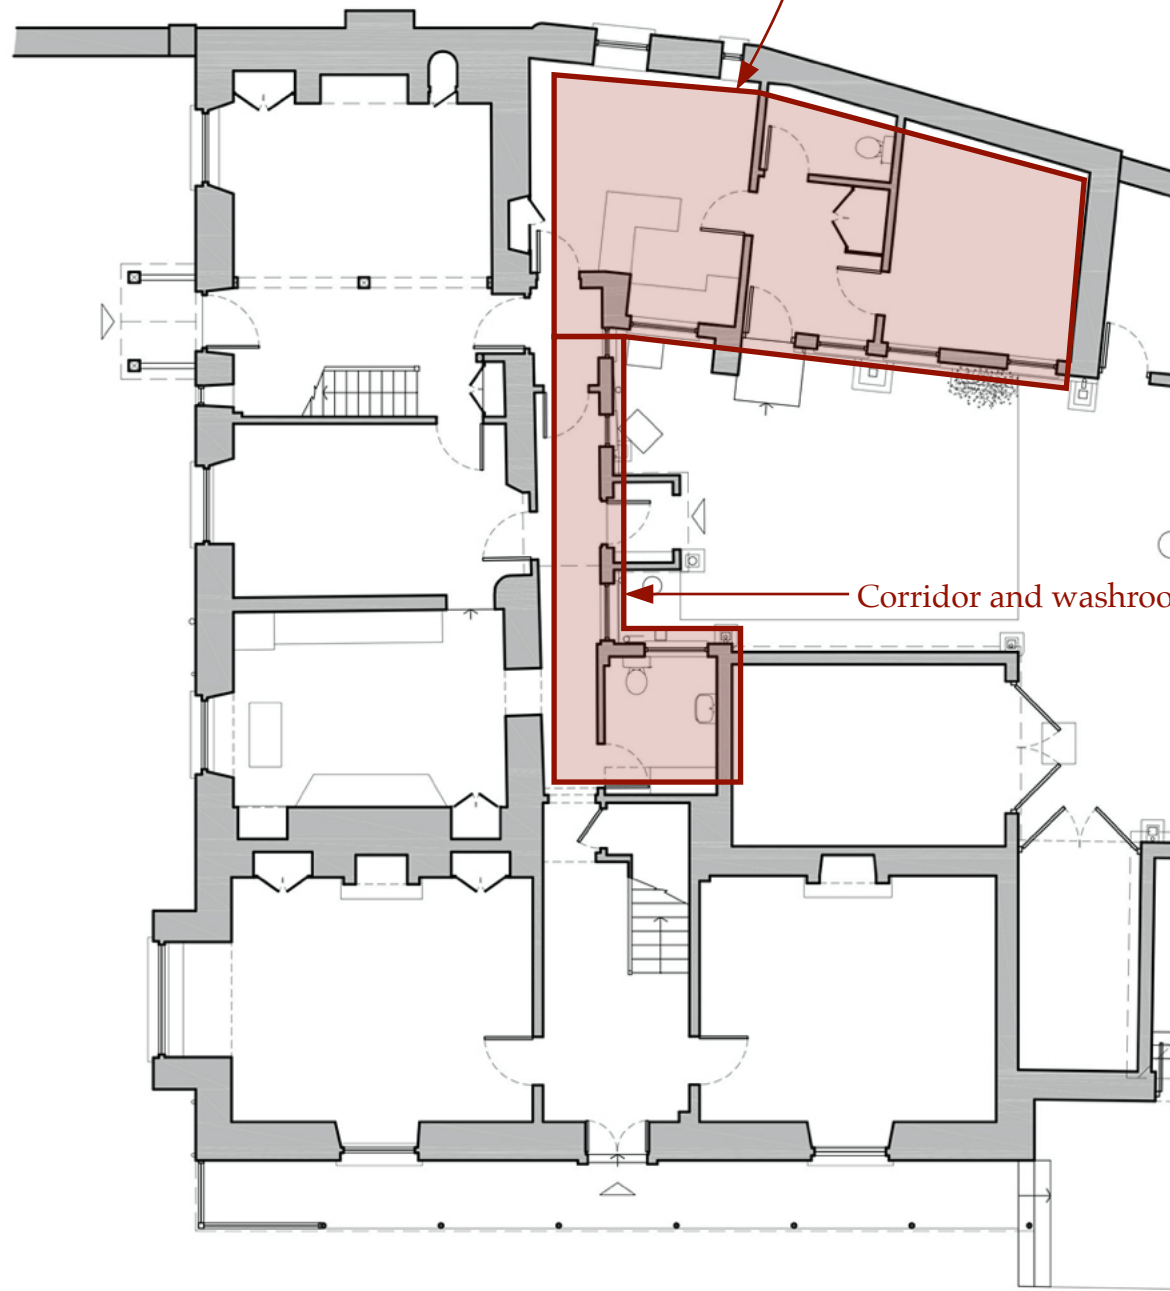
Ground Floor

Internal changes and most likely windows added to habitable rooms facing the public lane

Corridor and washroom added

19th Century - During this period, the courtyard and stables parts of the house were altered with the northern wing being largely integrated into the main house for extra bedroom and service spaces. The construction of the courtyard facing walls, particularly the corridor wall facing due east - is a combination of load bearing masonry and brick as only 30cm thick. All has been heavily over rendered with cement and aggregate.

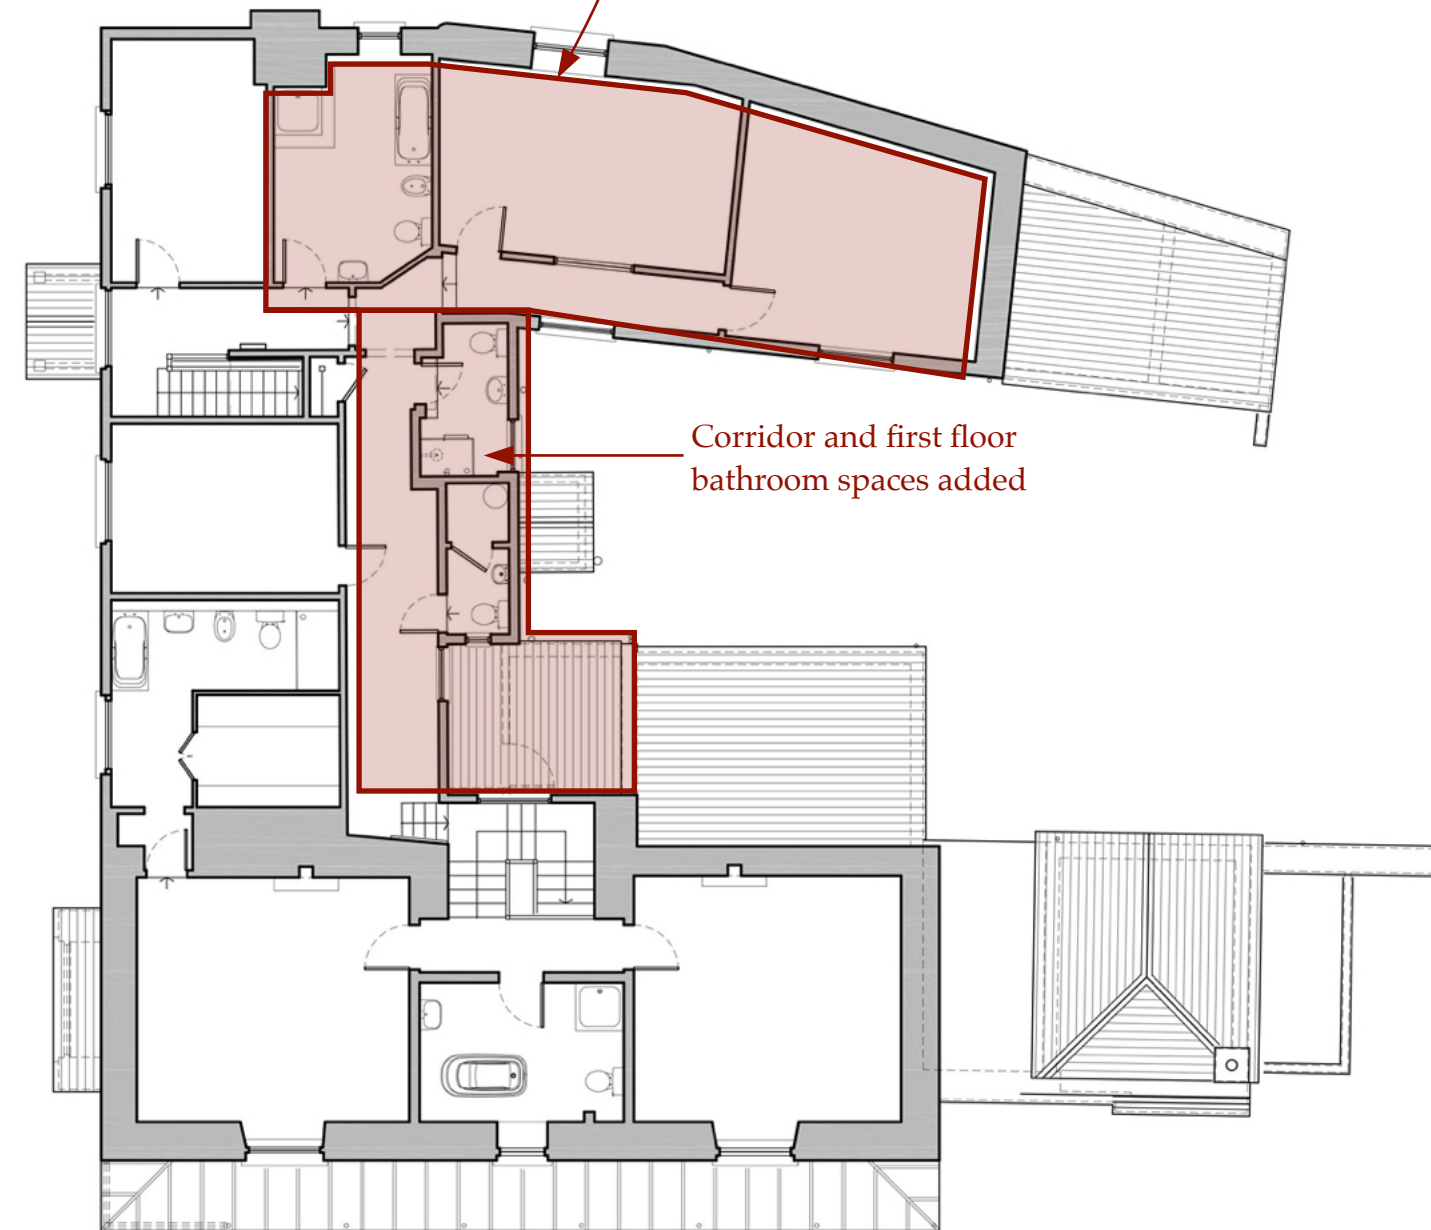
First Floor

Internal changes and most likely windows added to habitable rooms facing the public lane

Corridor and first floor bathroom spaces added

19th Century - Victorian Modifications & Extensions
Further changes to domesticate the interior
and provide additional habitable spaces
at first floor.

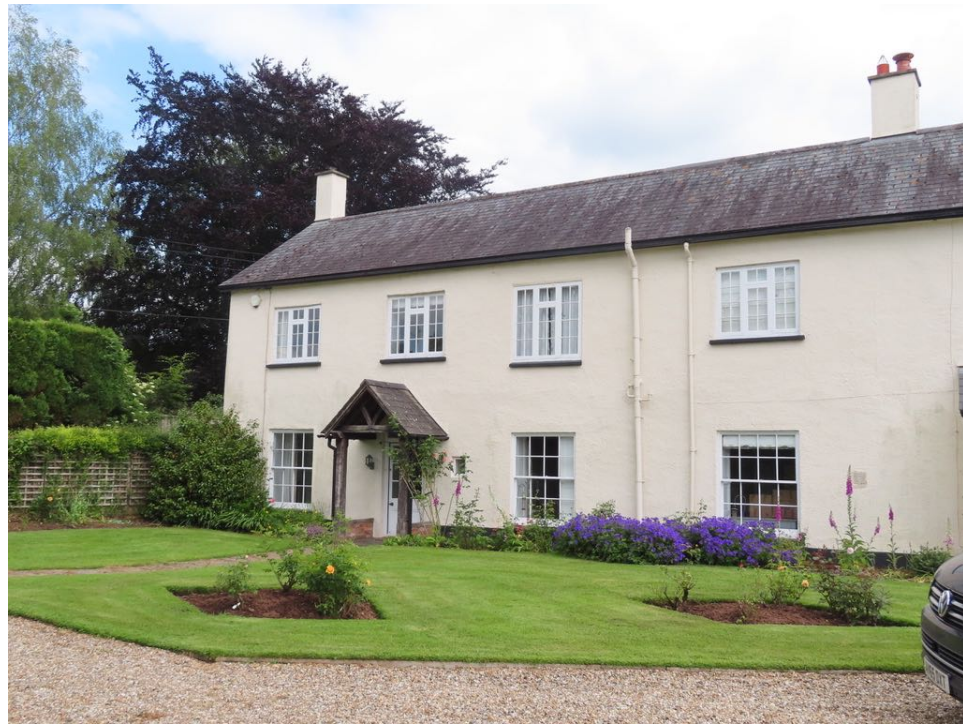
Photo of the western facing elevation with the principal entrance door in current location. The proposal is to replace the first floor casement windows with high quality traditional joinery flush casements.

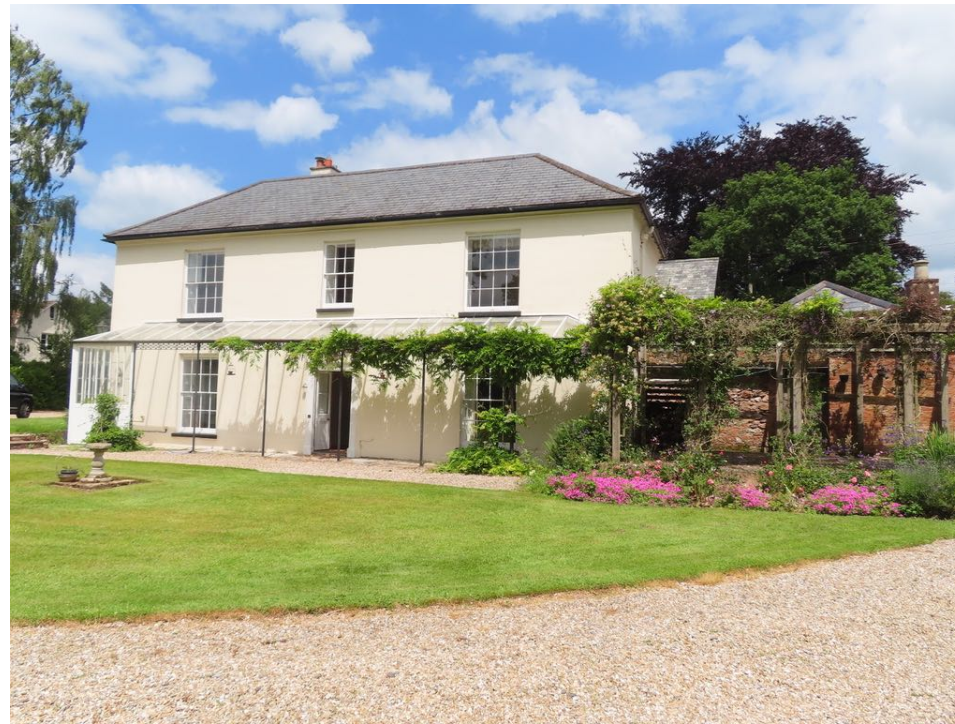
Photo of the southern facing garden facade. This is the late 18th - early 19th C Georgian style wing now containing principal rooms and a symmetrical central entrance. This will not be affected by any of the proposed design interventions.

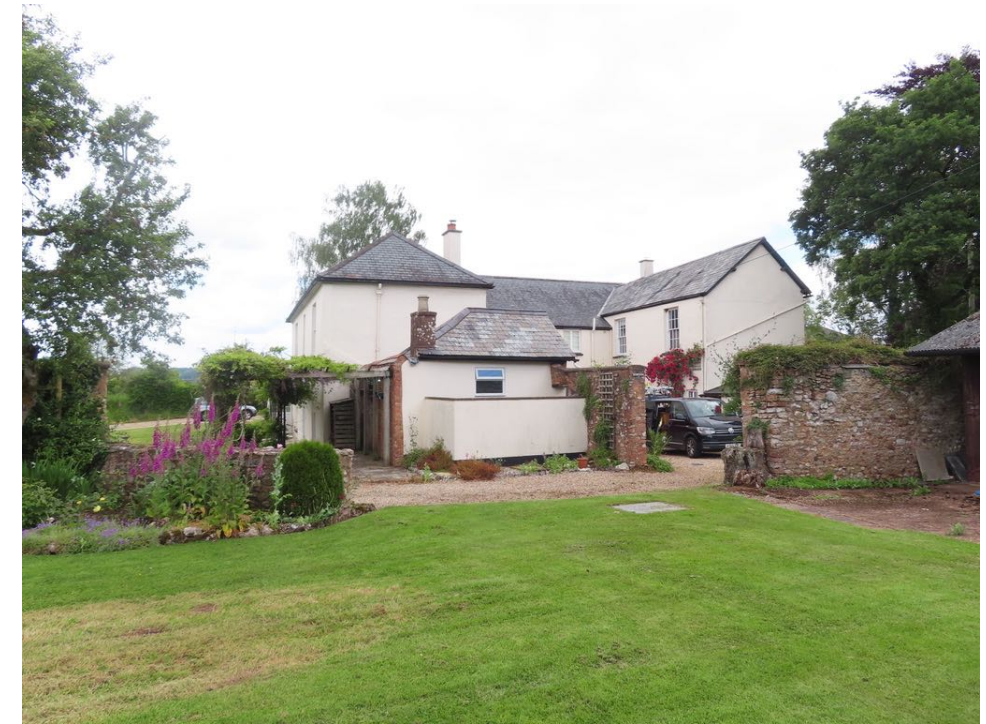
Photo of the eastern facade - the coach house, courtyard and outbuilding side. Secondary vehicle entrance, former stables and outbuildings with access to the gardens. The roof on the right hand side will be replaced with natural slate.

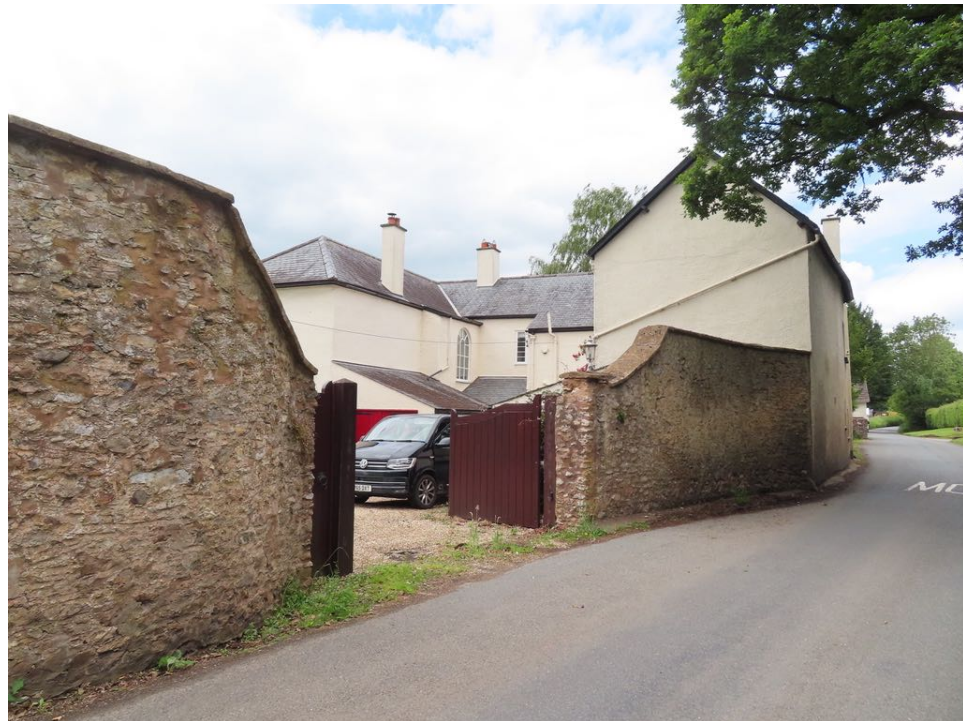
Photo of the northern facade addressing the public road. The original coach house and stables entrance. Gable end wall of the main house. The proposal being to continue the exposed stone as a plinth at street level with lime render above.
