The proposed works are for listed building repairs and replacements to the main house:

Project Ref: 24.41	Proposed Listed Building Repairs to Walls, Roof and Replacement of Internal Elements.
Drawing No: HR_01	Craddock Lodge, Craddock, Devon, EX15 3LL

Planning & Heritage Statement Introduction - March 2024
Copyright AA Ltd. All Rights Reserved. RIBA Chartered Practice & Accredited Conservation Architects

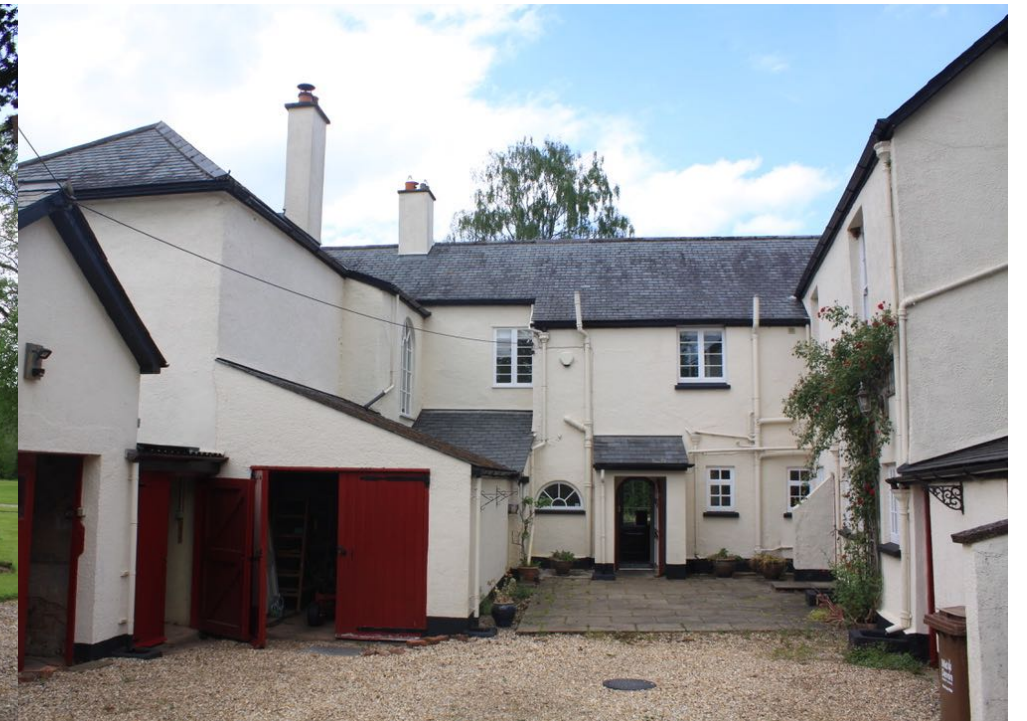
Photo of the courtyard showing the typically piecemeal evolution of this type of back of house area. The proposed window replacements are around this courtyard.

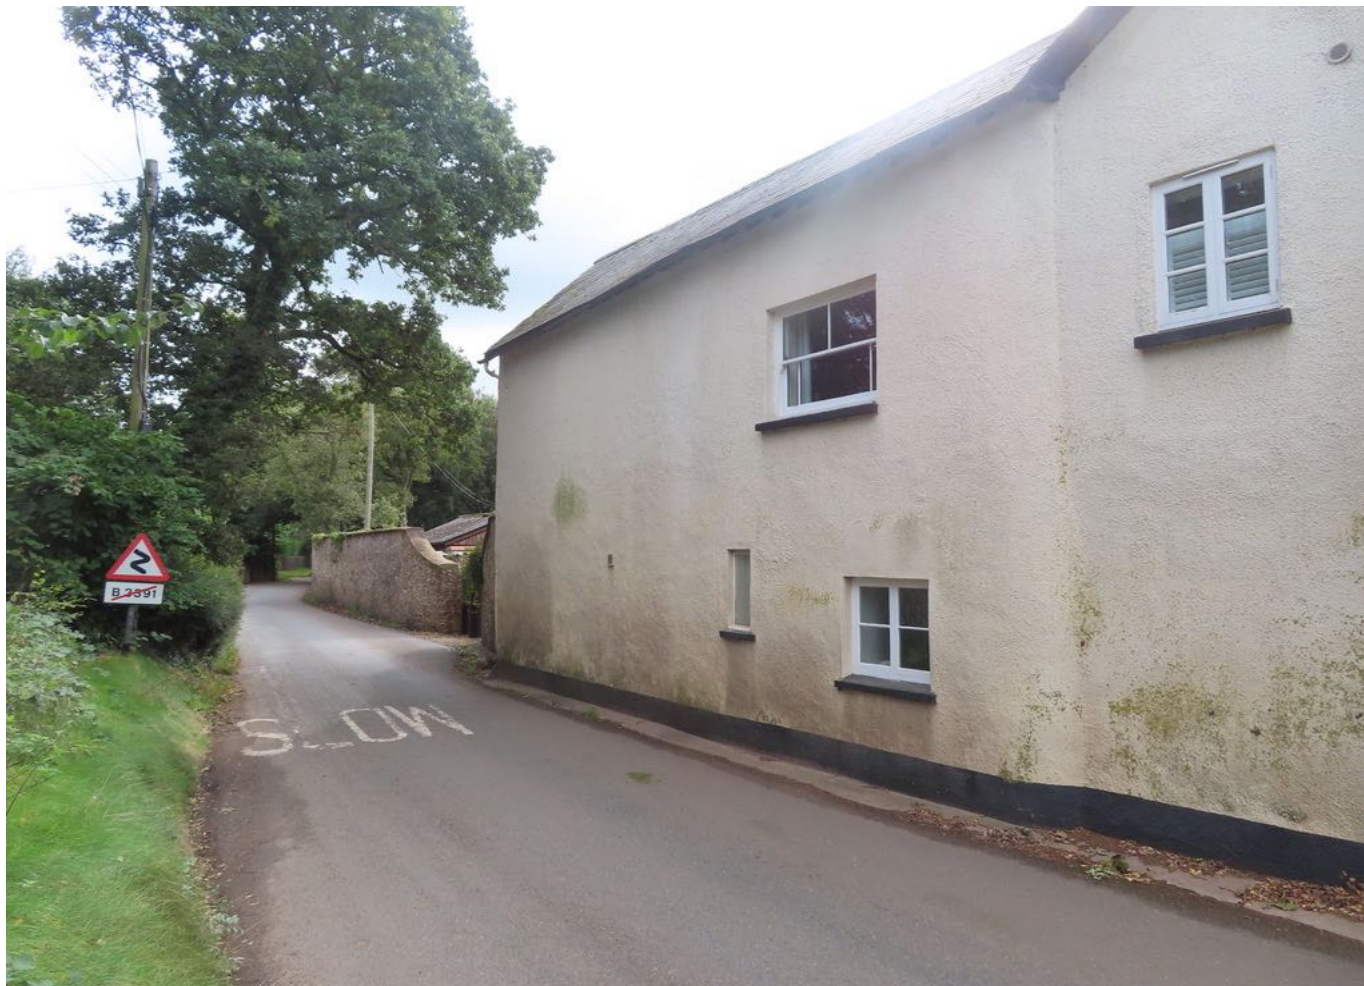
Northern facade addressing the public road. Significant internal damp caused by the hard cement render. This will be removed.

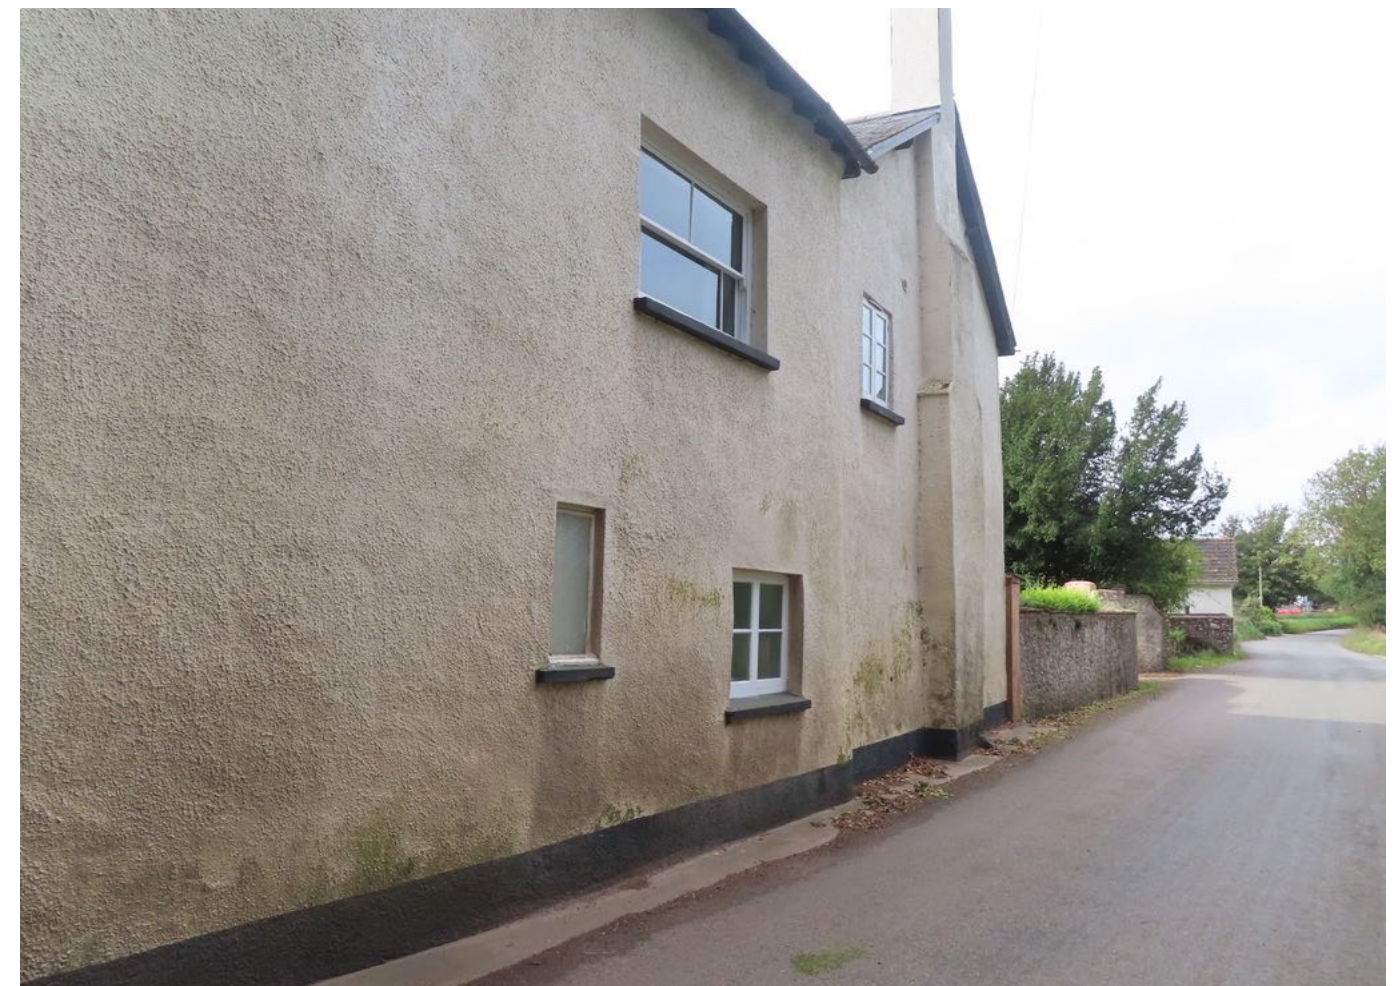
A new plinth of exposed stone will be formed as the existing stone wall to the house. Pointed with NHL 2.5 lime putty mortar and then fully lime rendered first floor above.

1. North Wall facing the public road - Remove hard cement render and form new facade with exposed natural stone at ground plinth closest the road and lime render above at first floor.
2. North wall internal lime plaster to form breathable layer and minimise existing damp problem.
3. Northern part of the roof - replacement of fibre cement tiles with natural slate.
4. Window replacement of non-historic 20th C casements with high quality, traditional joinery flush casements using conservation grade double glazing.
5. Modification to the second staircase which is a late 20th C softwood element in the NW corner. The new stair will have the flight direction changed to better suit the principal ground floor room and also improve first floor bedroom access. Minor changes to non-historic internal partitions.

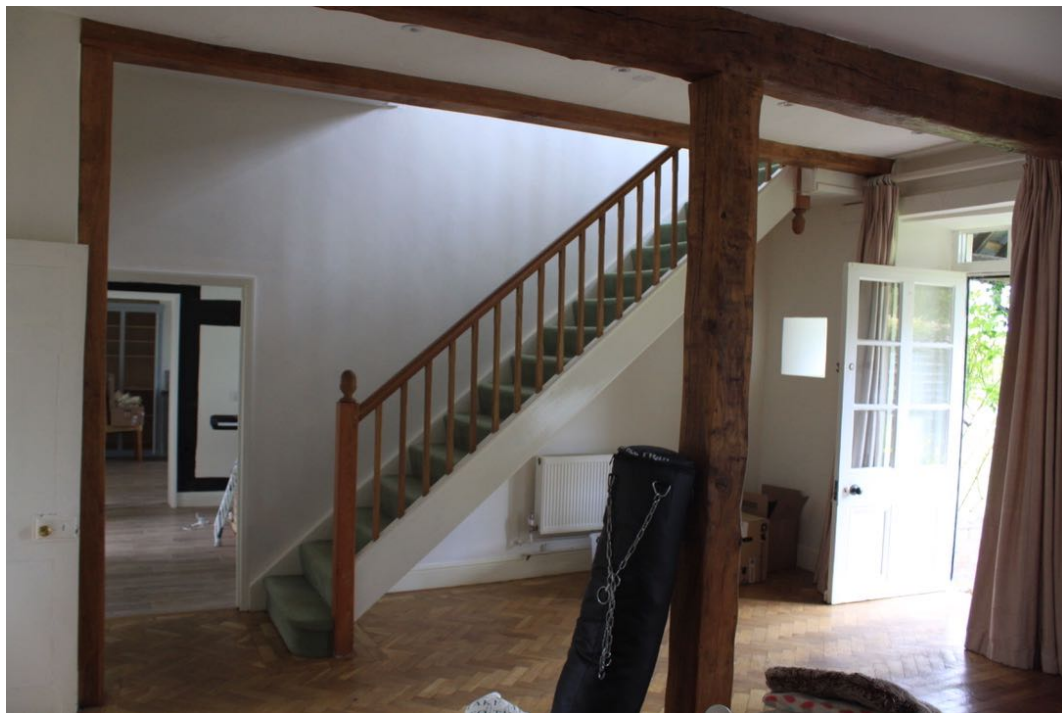
The secondary 20th C stair and opened up internal wall. The proposal is to swap the flight of this stair for more efficient circulation up at first floor and be less intrusive at ground floor.

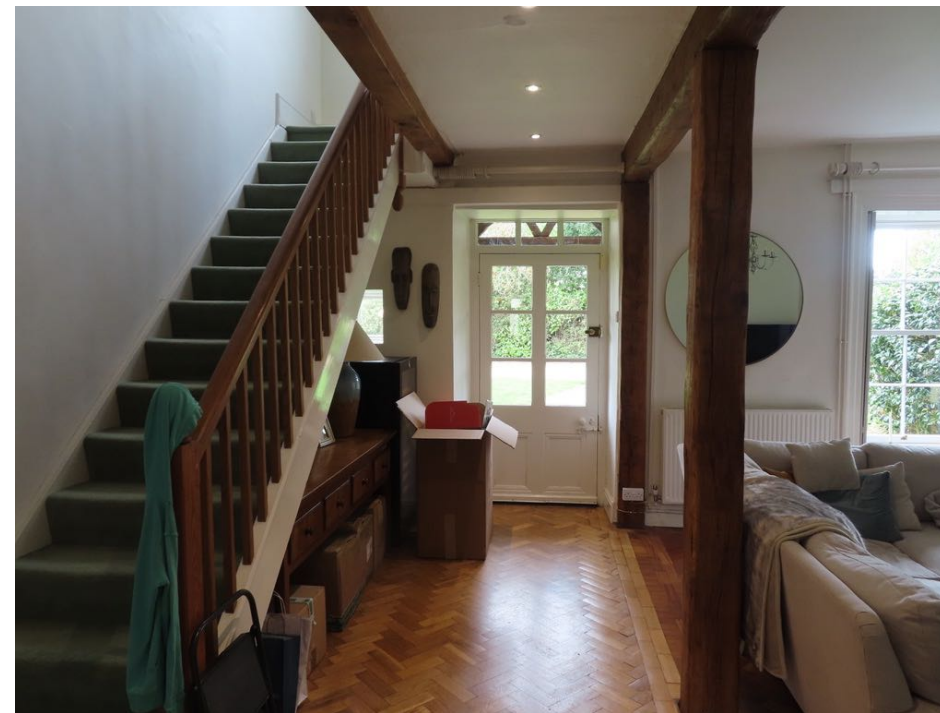
The secondary 20th C stair and opened up internal wall. The posts and beam are also 20th C infill and not wholly structural.

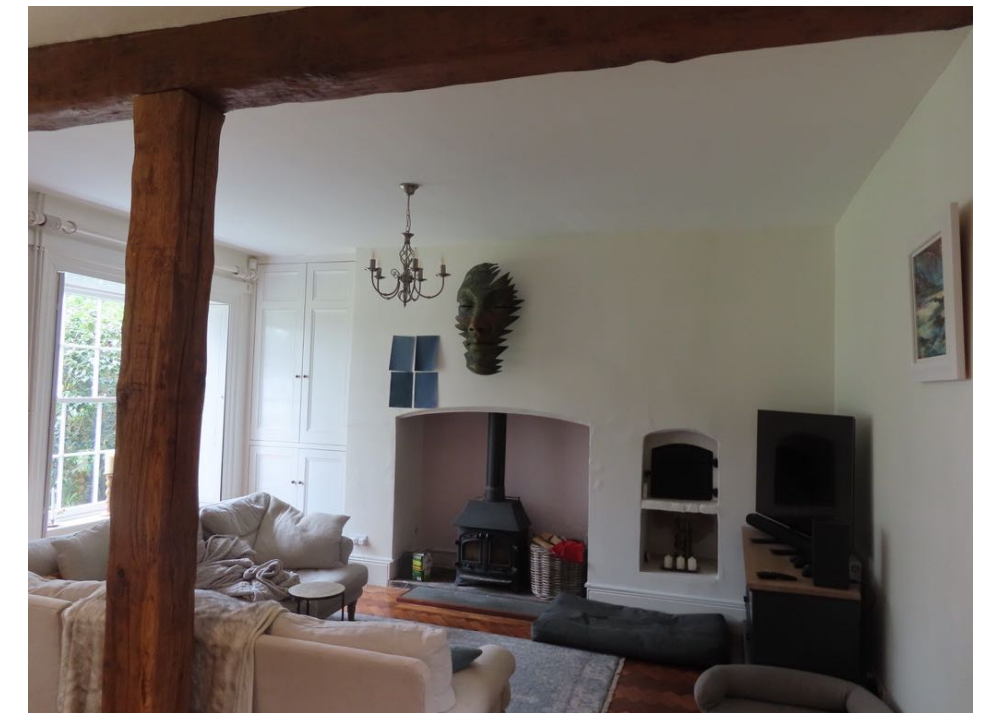
View of the north side wall with inset fireplace and bread oven part of the oldest area of the welling. This suffers from damp and will be remedied by hacking off the internal layers of modern plaster and using breathable lime plaster throughout.

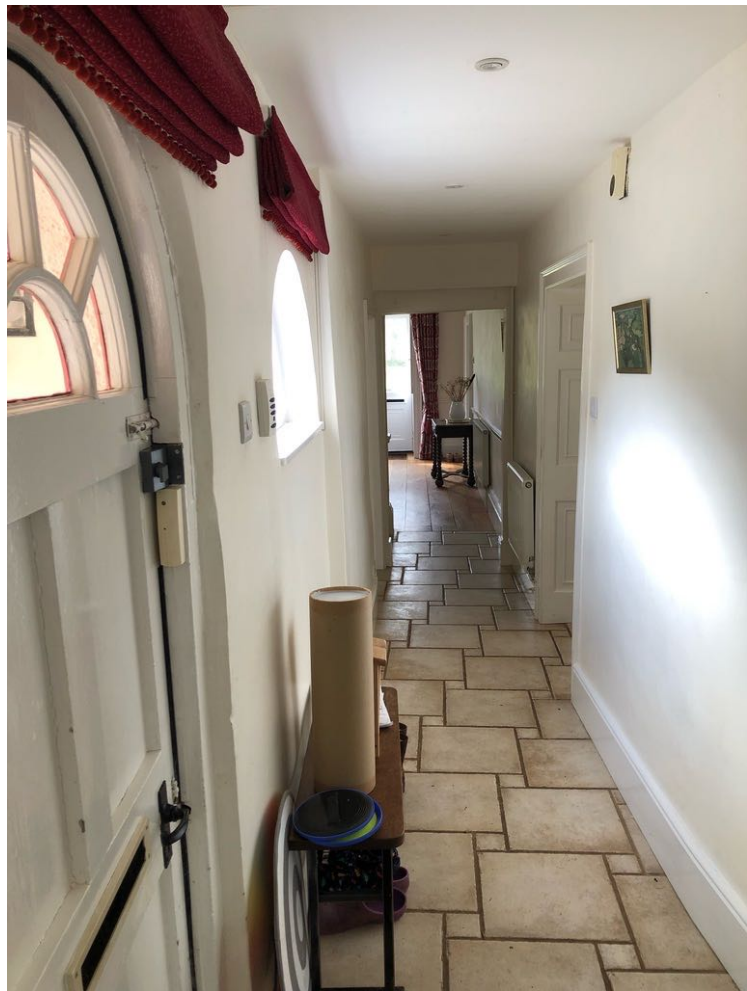
The 19th C corridor on the left, the original 17th C longhouse solid wall on the right. Selection of doors and windows. Modern floor on cement sub base.

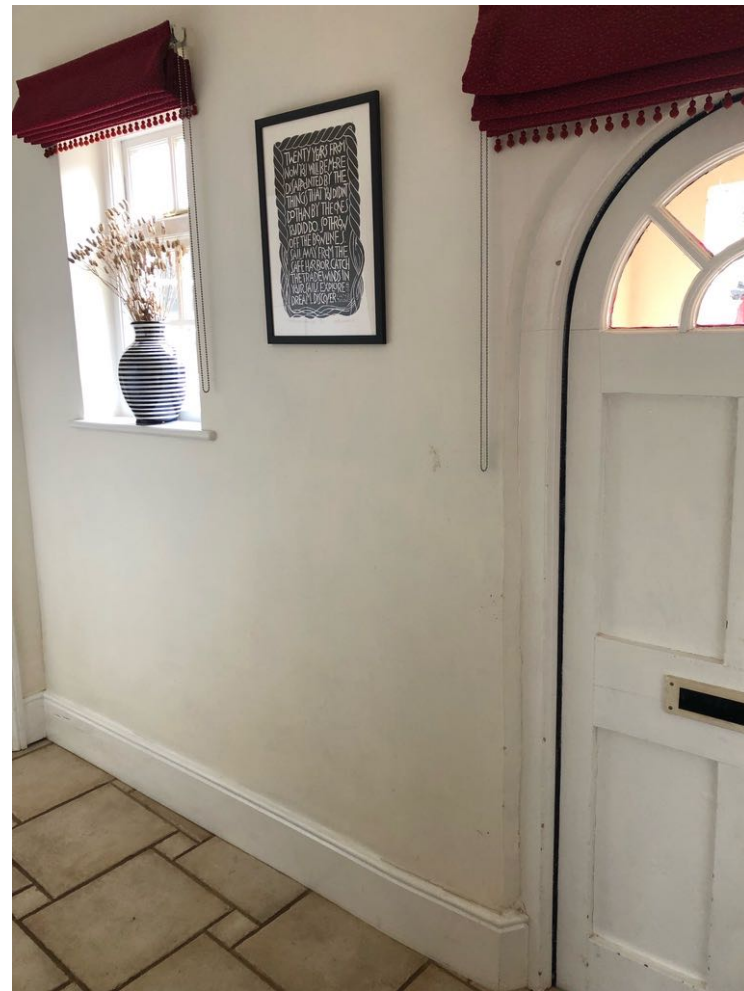
The 19th C corridor showing different window types, the early 20th C porch and modern door. These will be removed with the solid wall areas retained.

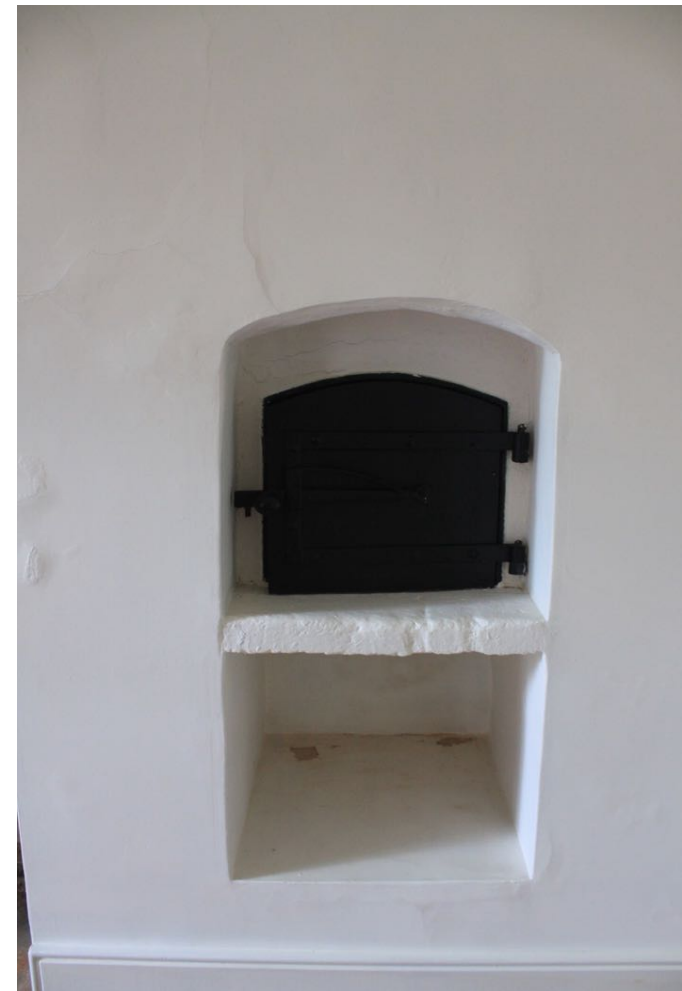
View of the bread oven located in the north western corner main room form the original Devon longhouse.

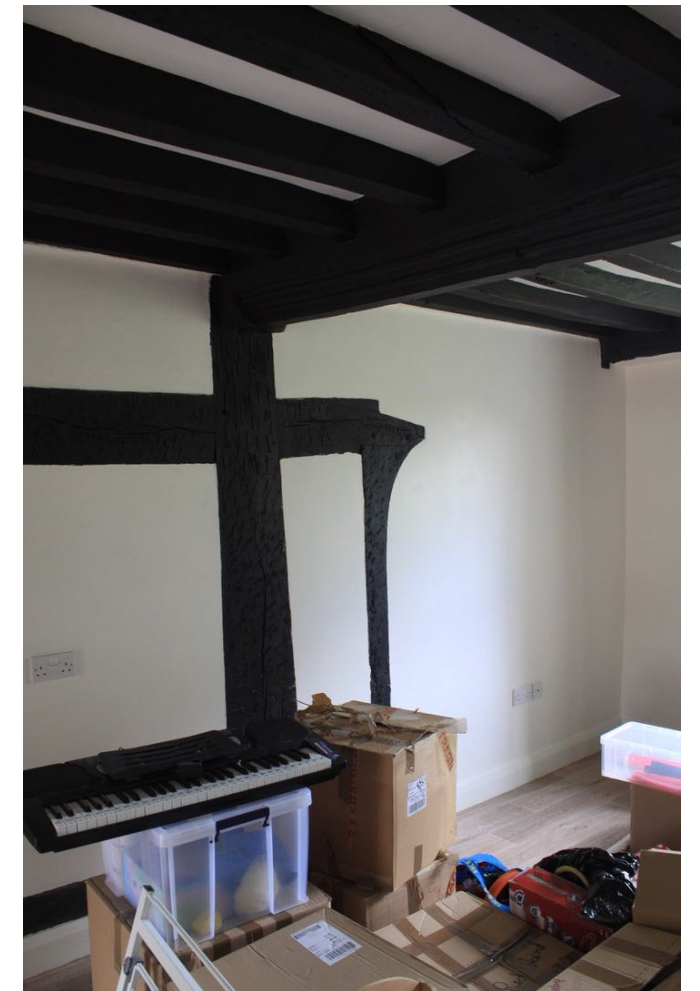
The original cross passage now has exposed timber structure.

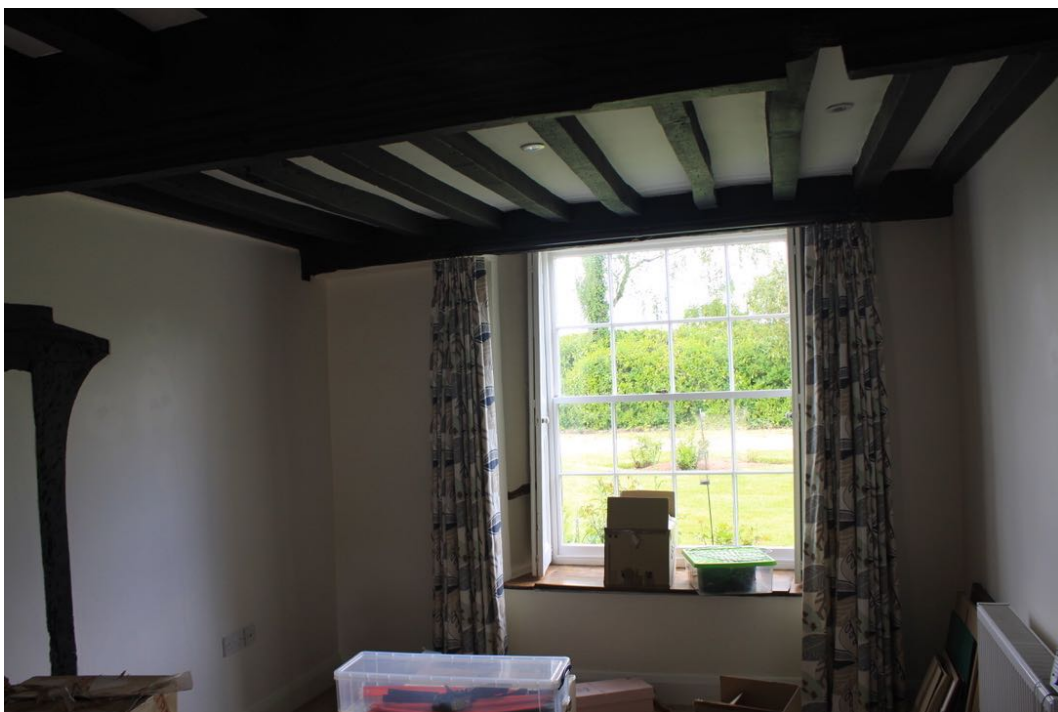
The original cross passage and remains of former arch opening.

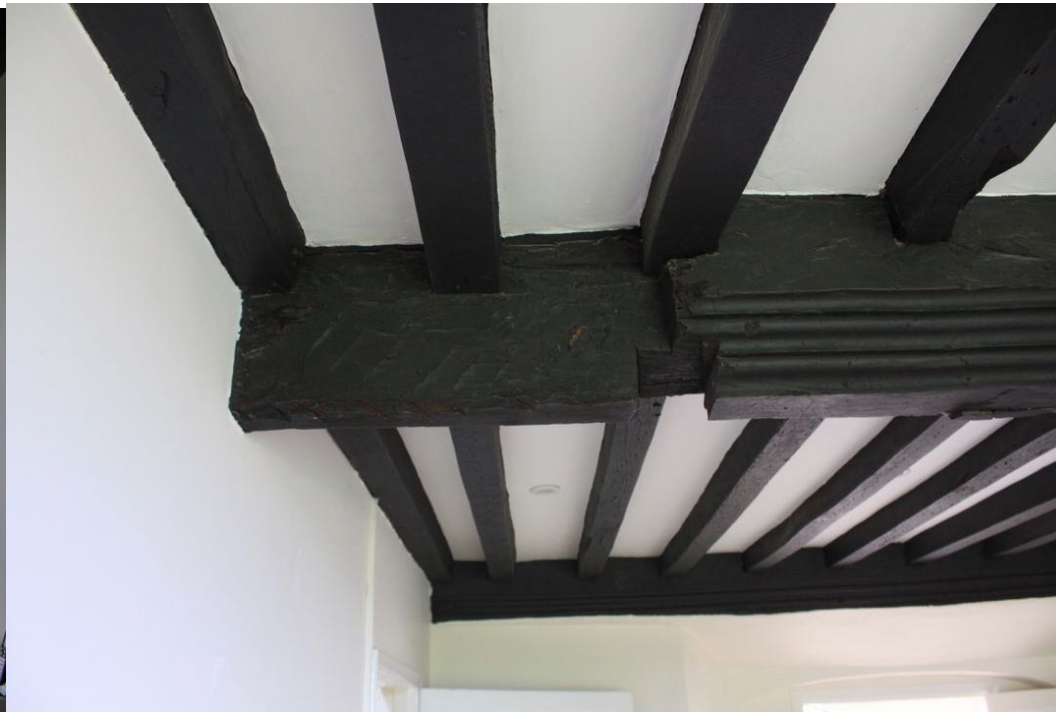
The beams as original elements remain largely intact, the ends have been modified. Ornate moulding on the main ceiling beams.
