Kendall VEH - 9-10 Upper Berkeley Place Roof Replacement Works

Purpose/Status 14/03/2024 PLANNING Drawn Checked Paper Size 1:50 CH SP ISO A1

Proposed Roof Plan

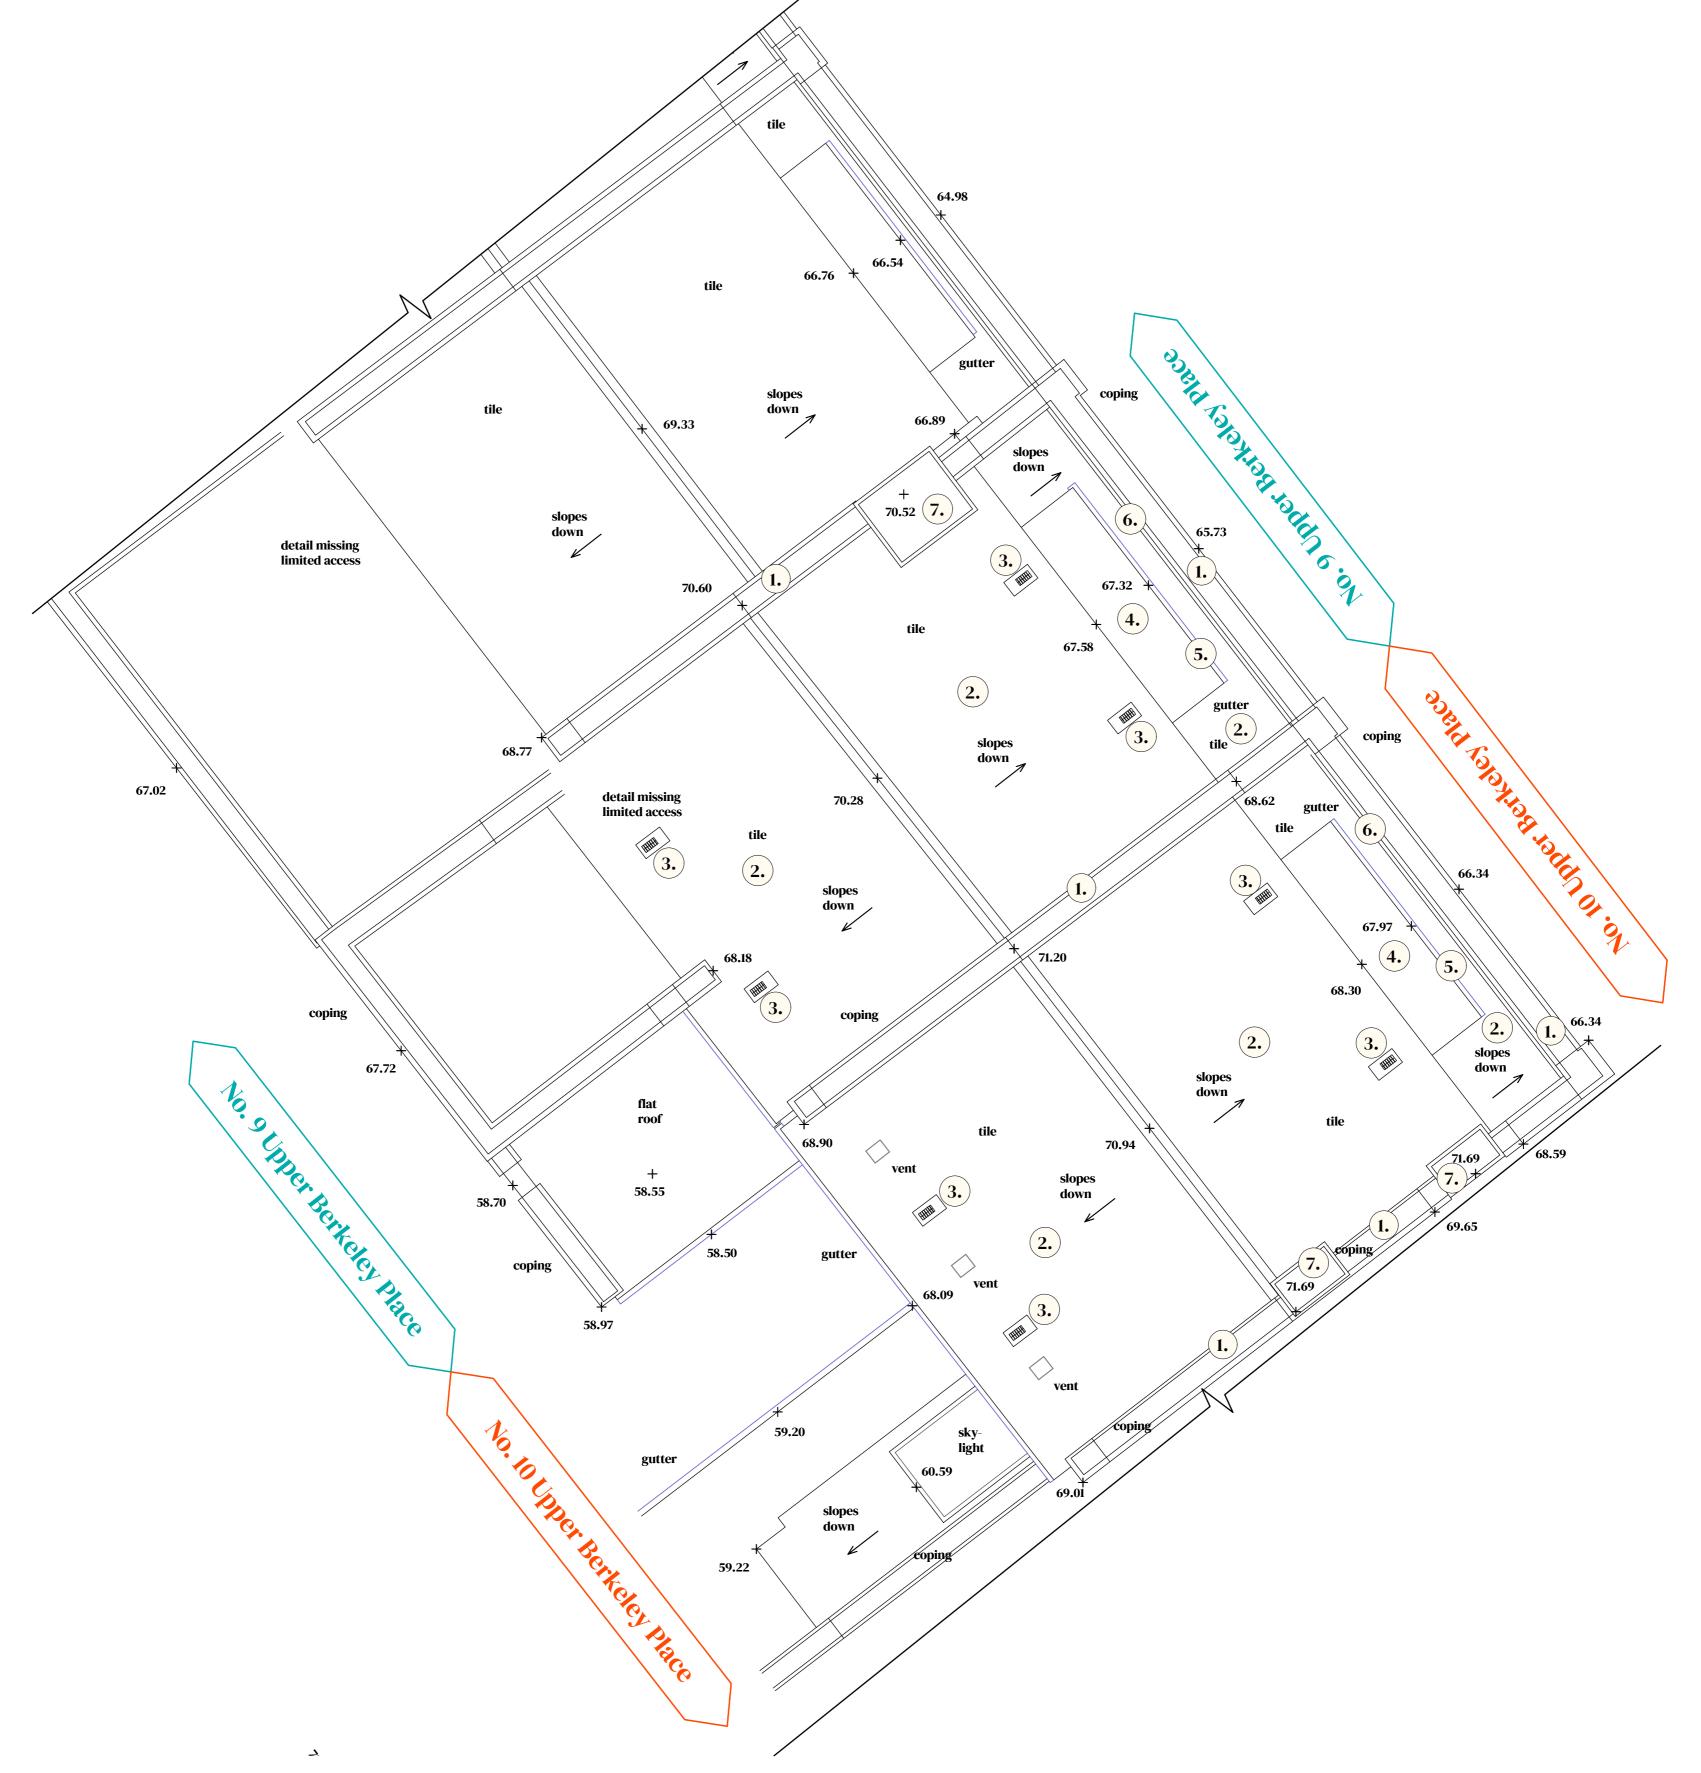
1. Secure loose coping.

Strip existing clay pantiles including timber battens, fixings & 2. bitumen felt underlay. Replace with clay pantiles with profile to match existing fixed to timber battens with a breathable underlay.

**3.** Ventilation tiles.

Replace all associated leadwork including cheeks & roof to dormer.

Replace rainwater goods with powder coated

aluminium heritage rainwater goods. Remove defective Portland cement-based render and apply lime render to rear side of parapet wall.

7. Repointing of chimney stacks and flaunching repairs, if required.
