RAAC ASSESSMENT

**RAAC VISUAL ASSESSMENT
BRAMHALL HIGH SCHOOL**

STOCKPORT COUNCIL

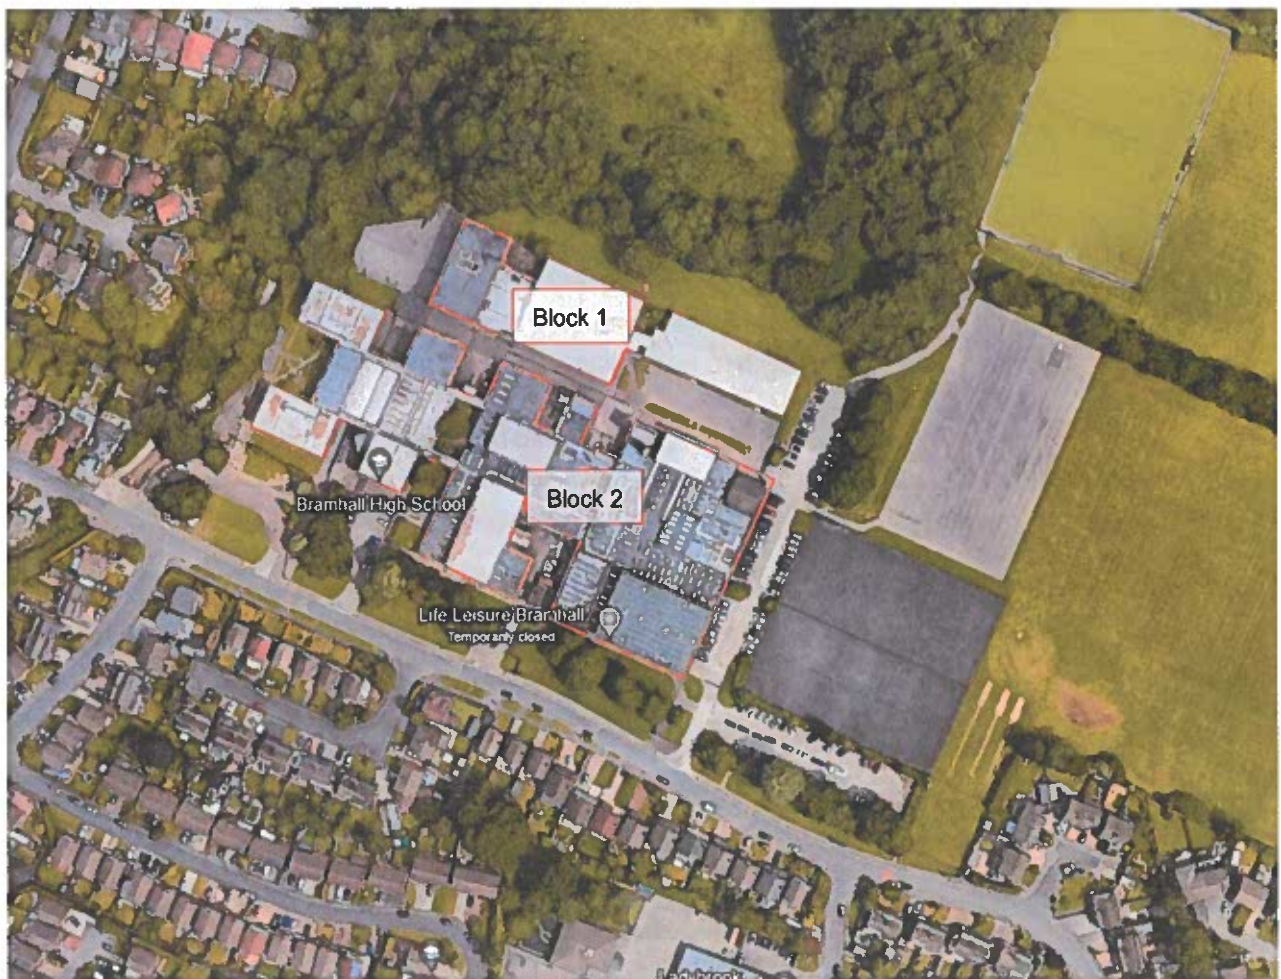
For the purposes of this report, we have split the site into the blocks shown below, as per layout plans provided by the school.

Cracking was particularly pronounced in the central section of block one (refer to Section 2.0 of the report), where the original RAAC flat roof has been overlaid with a pitched profiled metal system.

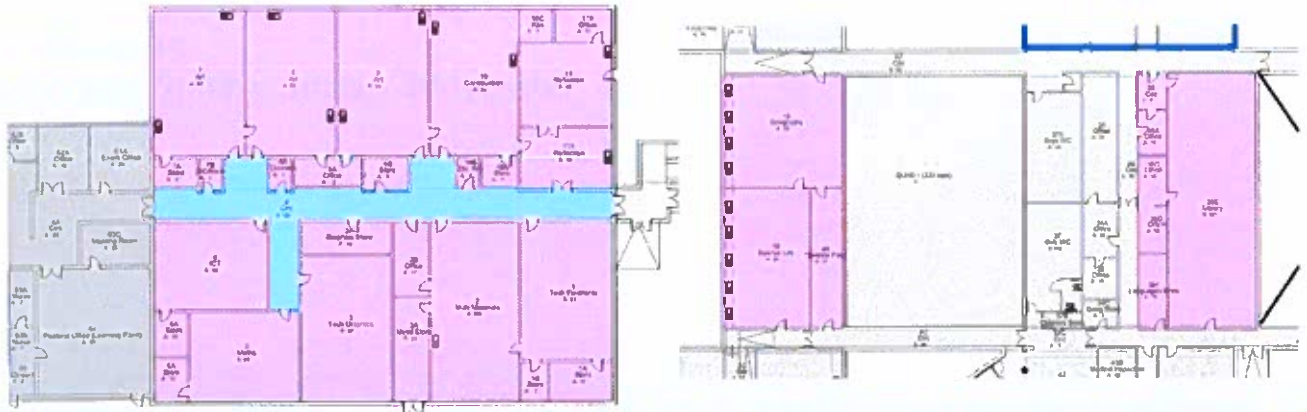
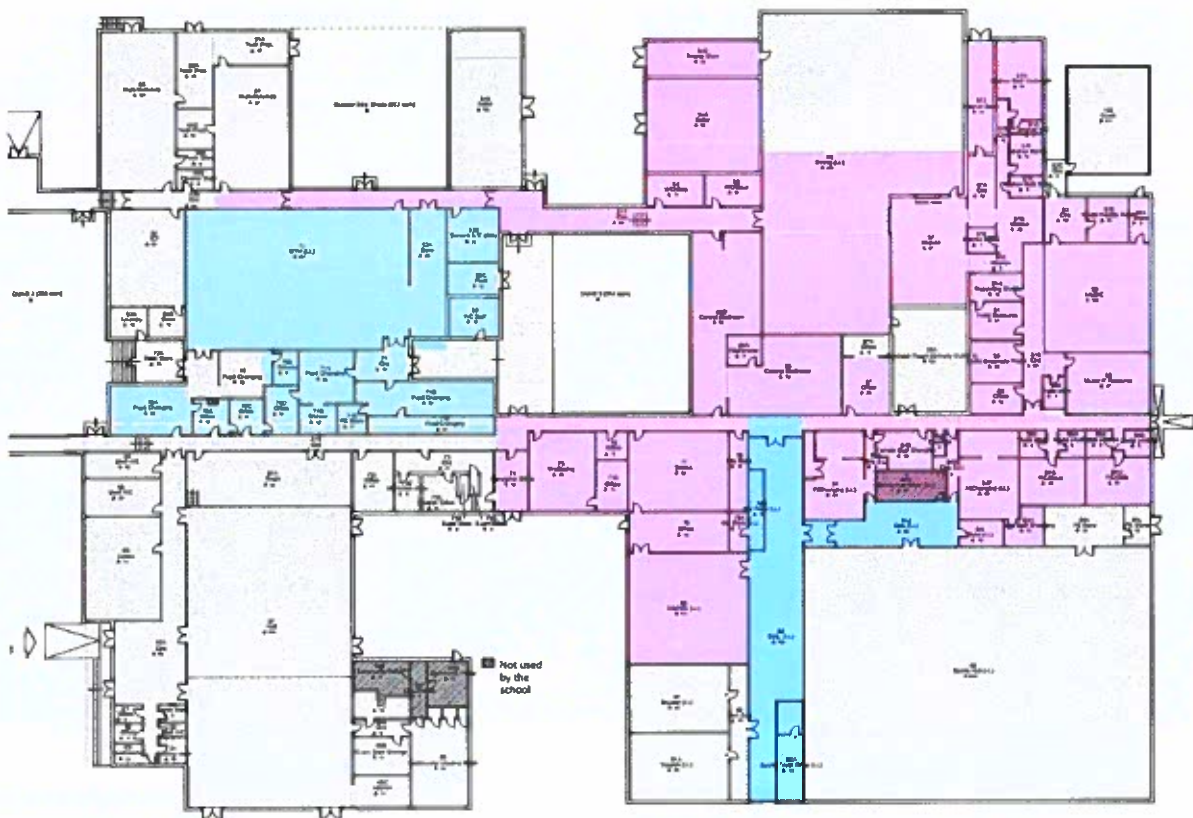
**APPENDIX B:
INDICATIVE CEILING REMOVALS PLAN**

No ceiling removals required

Marked up floorplans of inspection areas can be found in Appendices B and C of this document. Photographs taken on site can be found in Appendix D.

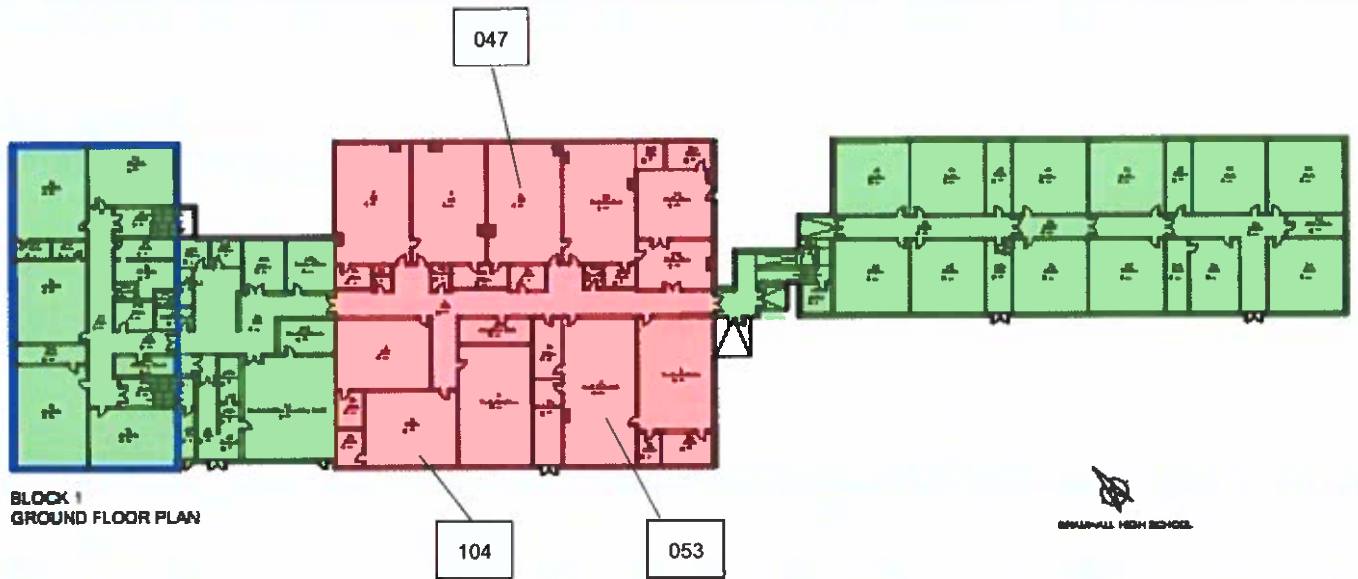
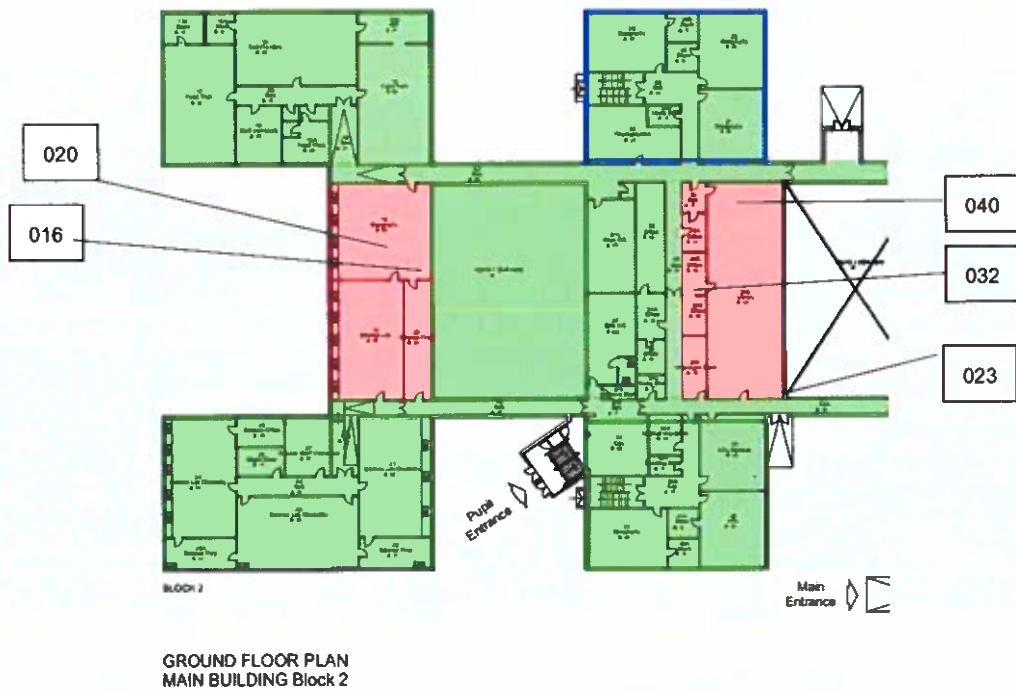
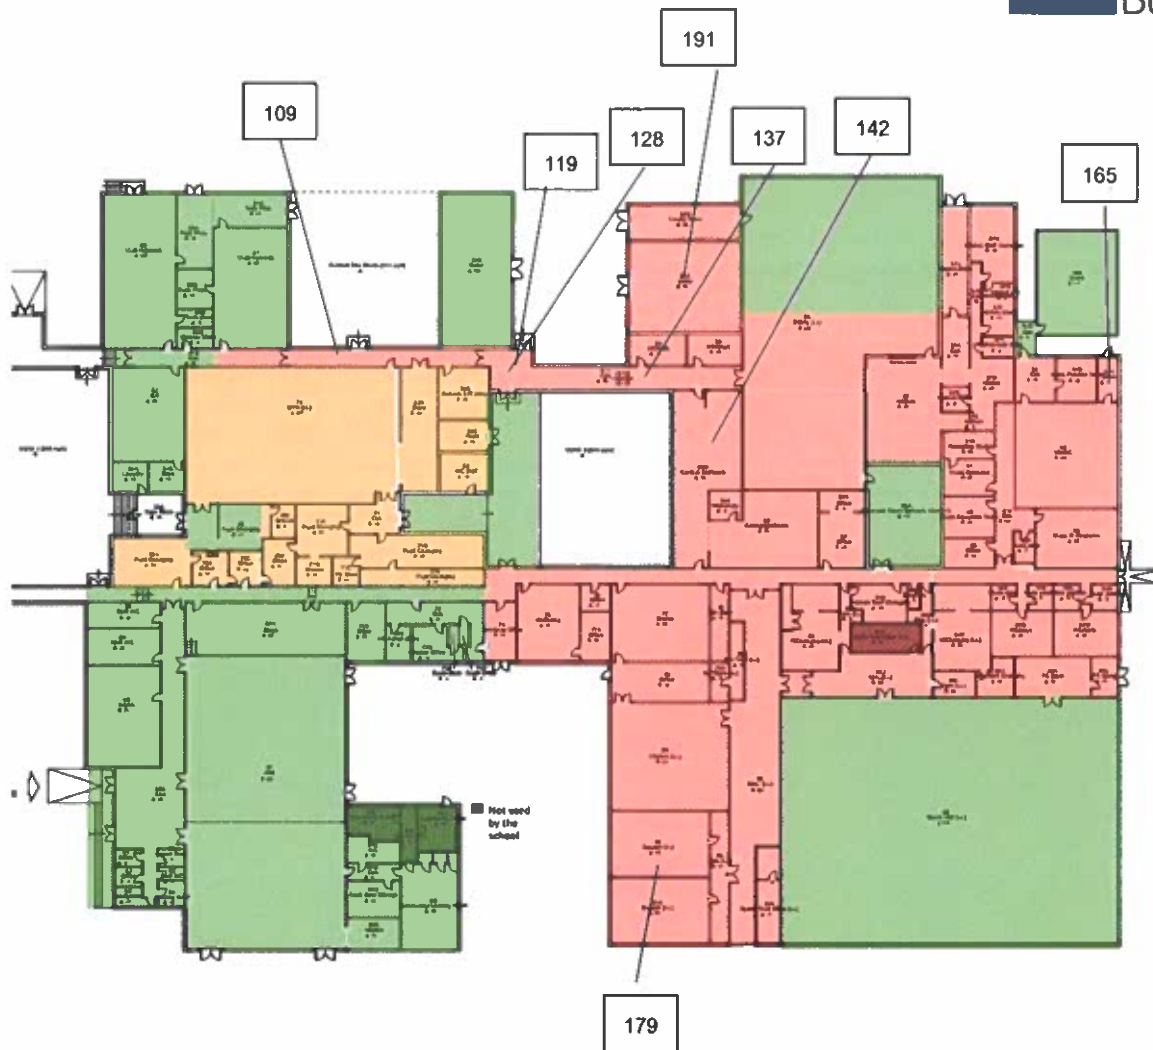
**APPENDIX C:
LOCATION OF PHOTOGRAPHS**

RAAC present

Limited access – see report
