**PROPOSED ALTERATIONS TO  
FAIRSTEAD FARMHOUSE  
EYE ROAD  
HOXNE IP21 5BA**

**DESIGN & ACCESS and HERITAGE STATEMENT  
and SCHEDULE OF WORKS**

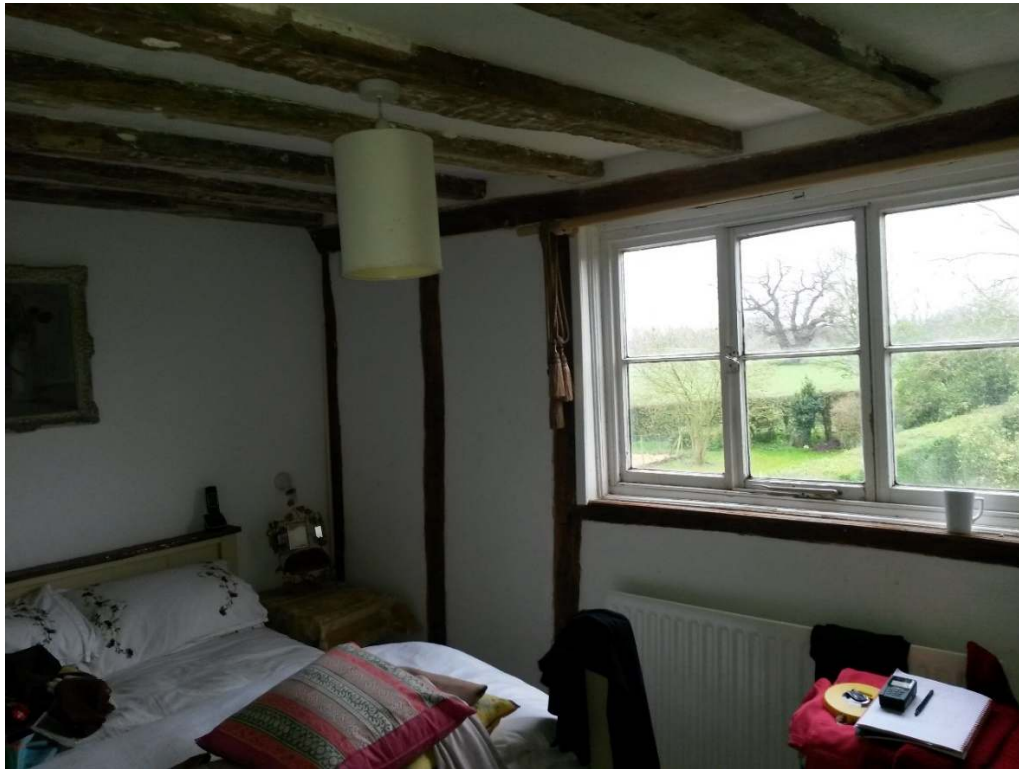
*The first-floor window that will need replacement to achieve means of escape requirements following discussion with Building Control*

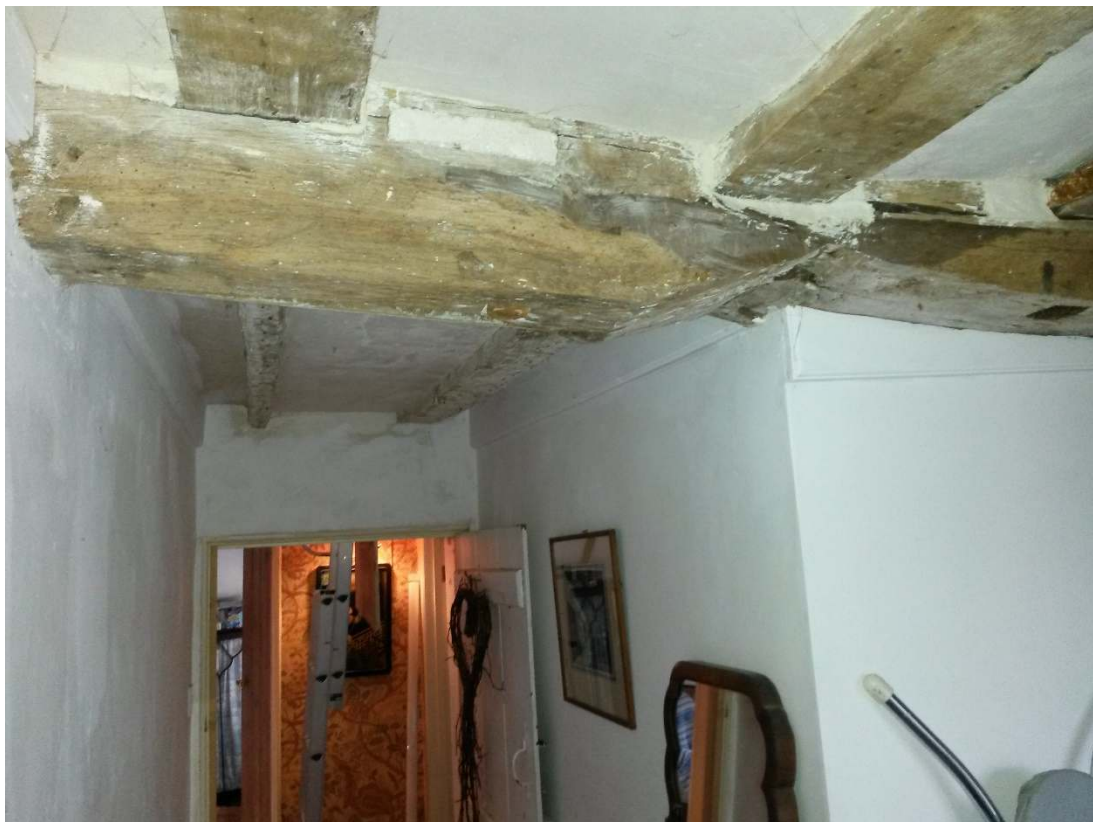
*First floor showing existing door at landing level that will be upgraded to be fire resistant.  
ARCHITECTS TWO LTD FEBRUARY 2024*

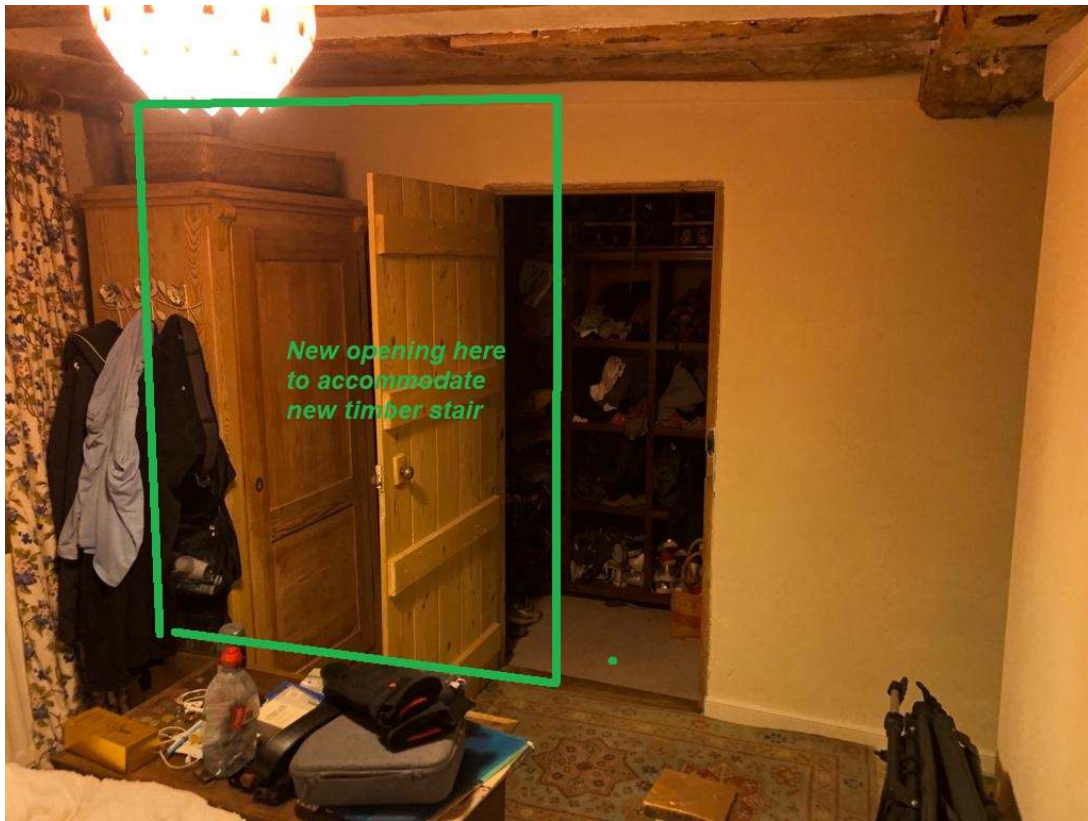
*Existing cupboard at first floor altered to accommodate new staircase to second floor.*

Form new opening in existing cupboard and in the second-floor structure for new staircase.

New purpose made sw staircase. Storage space retained under new stair with cupboard door repositioned.

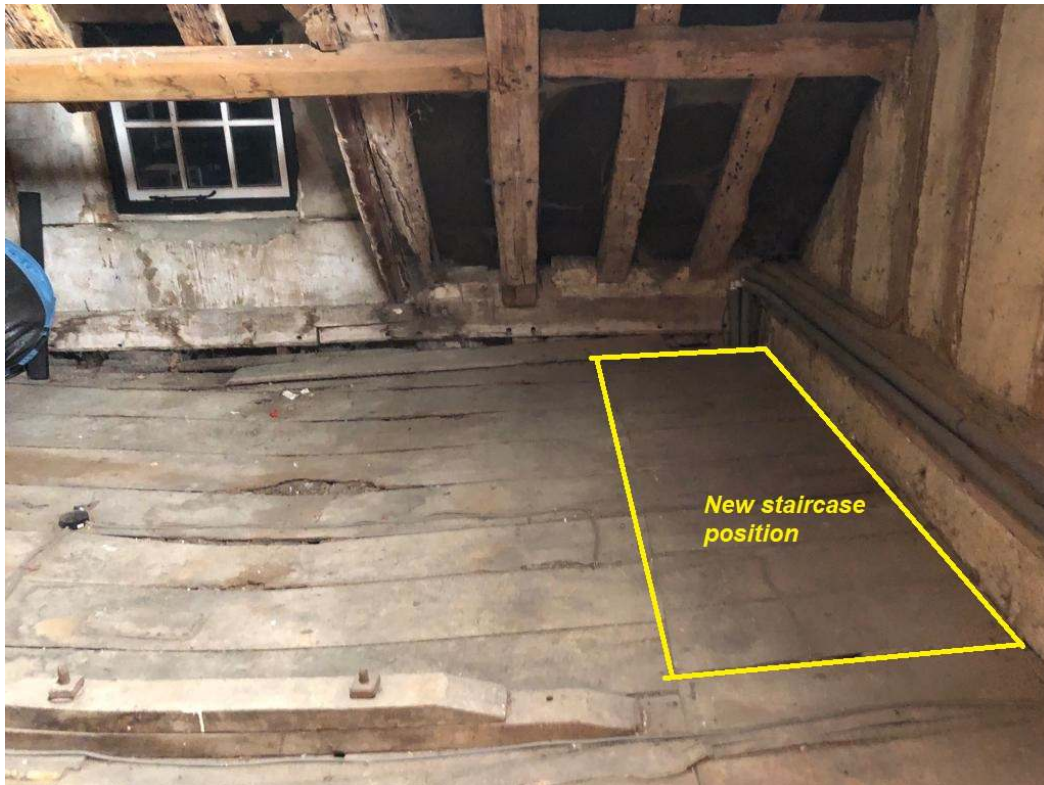
*Proposed new opening in second floor for new staircase.*

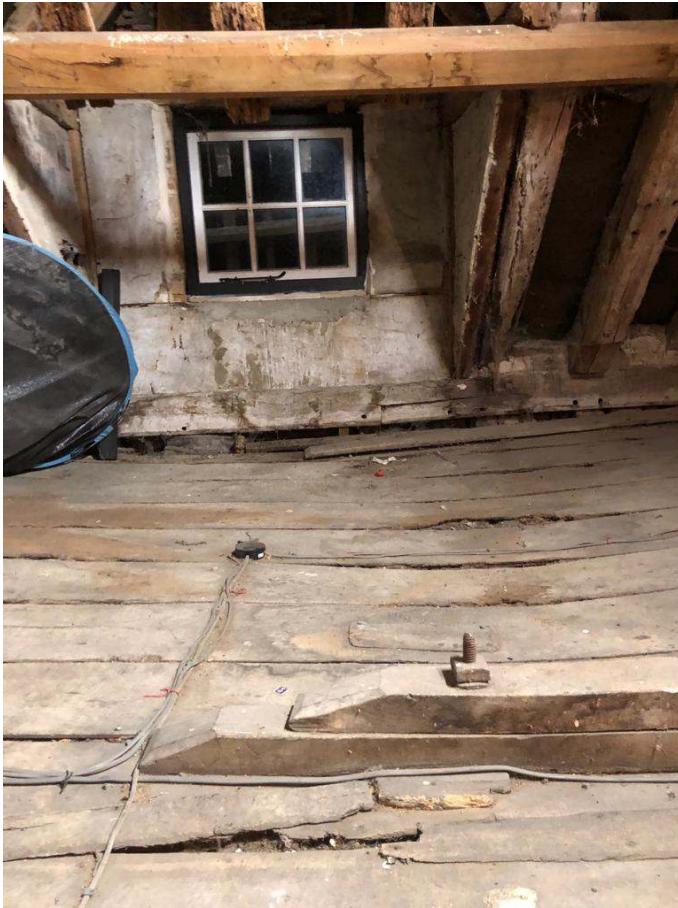
*Earlier repair to weakened spine beam to be replaced with suitable steel fitch plates to engineer's design.*

Remove part of existing internal first floor partition and carefully investigate structural integrity of the spine beam above the partition line. There is a substantial timber packing piece with a central bolt at second floor that is a previous repair to this element. Structural engineer to advise regarding a suitable steel fitch plate solution. The partition removal should have minimal impact on this beam. See photo below and also view from attic above:

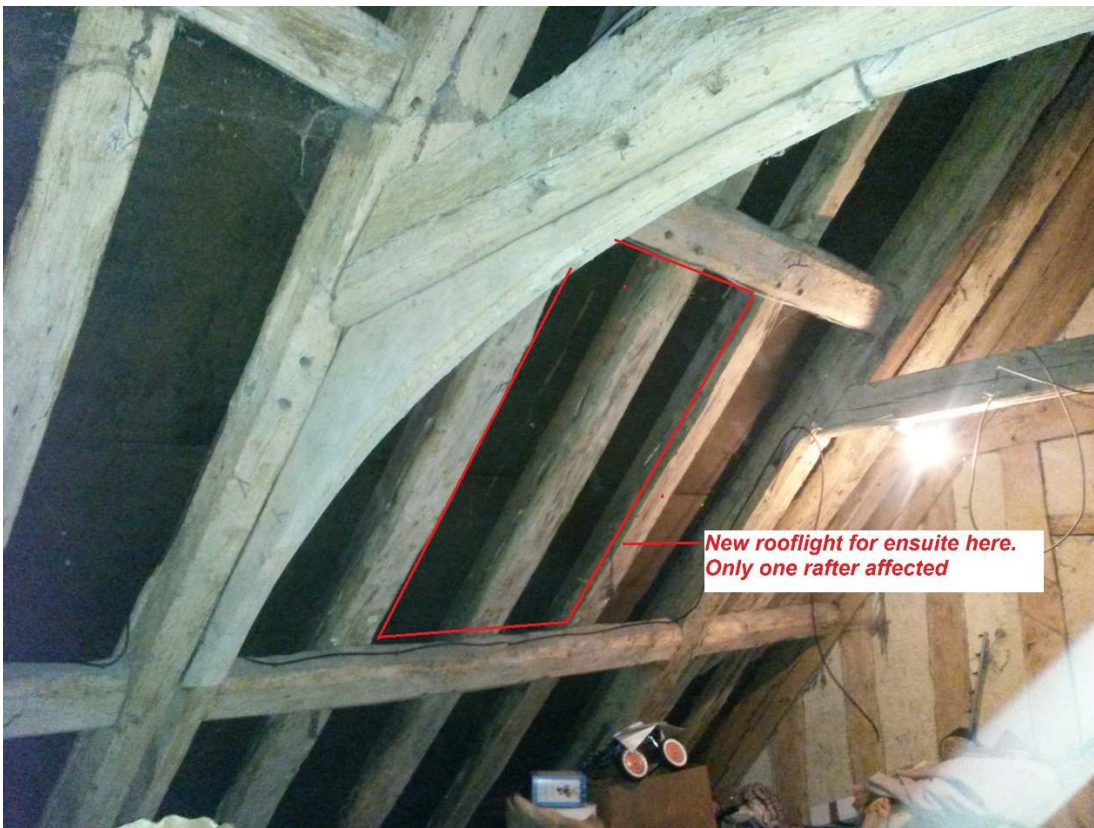
*Existing roof with new rooflight for ensuite.  
2 other new rooflights serving new attic bedroom positioned similarly to affect only one rafter each.*

The proposal is limited to internal alterations only with the addition of 3 new rooflights on the north elevation.

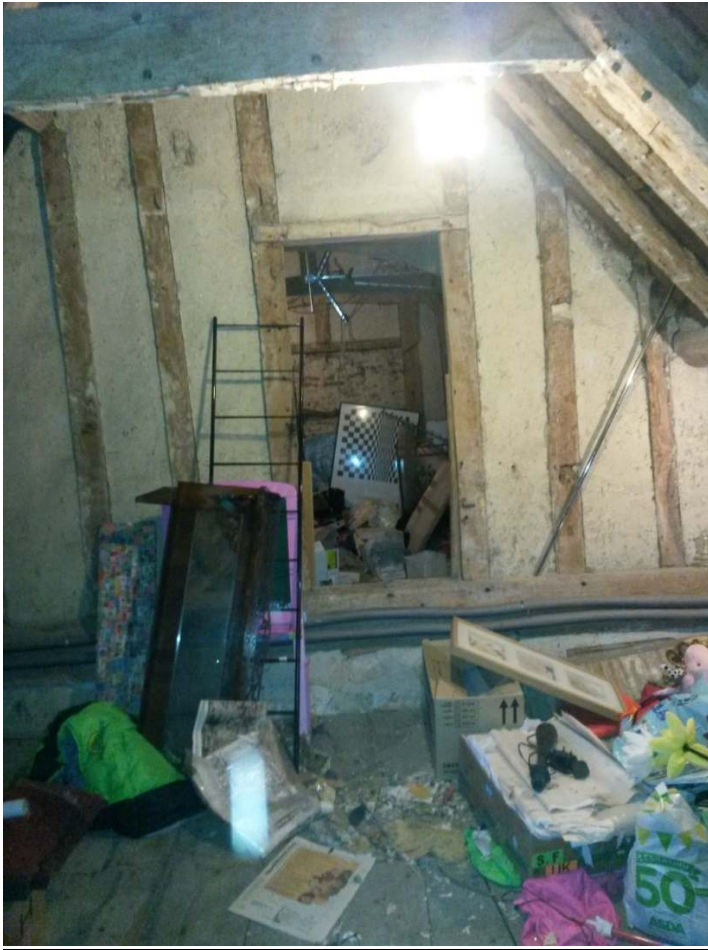
*Existing doorway in attic partition will provide access to new ensuite bathroom.*
