## HERITAGE STATEMENT

**Manor Farm Barns, Holywell, Rowington,  
Warwickshire**

**Morton Titterton**

**January 2024**

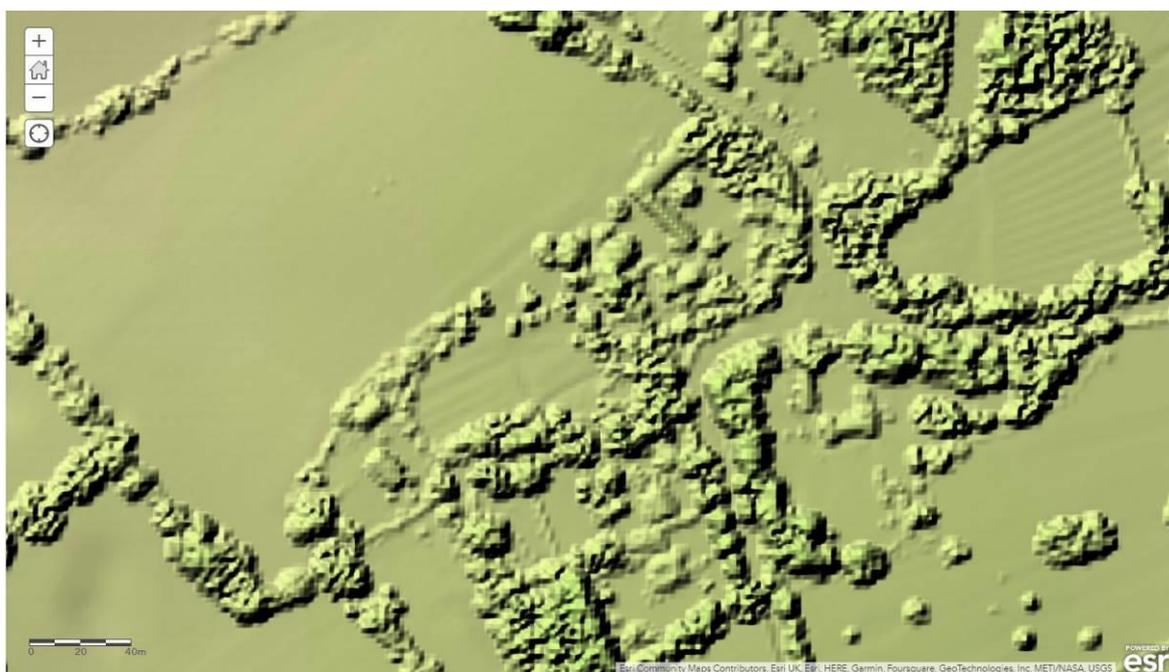
*Fig.1: LiDAR mapping*

- 2.6 The historic map evidence and the topography of the site suggest that it may have been moated in the medieval period. Indeed, this is recorded as a possibility (it has not been archaeologically investigated) on the Warwickshire Historic Environment Record (HER) under ref. MWA13504. In addition, visible earthworks in a pasture field (formerly an orchard) west of the farm site may potentially comprise evidence of a deserted medieval settlement (as recorded under HER ref: MWA 13507). Surviving ridge and furrow earthworks in fields nearby also attest to medieval settlement of the area. **Fig.1** shows LiDAR data covering the site and its environs, in which it appears ridge and furrow is present in this field, if not other forms of earthwork.

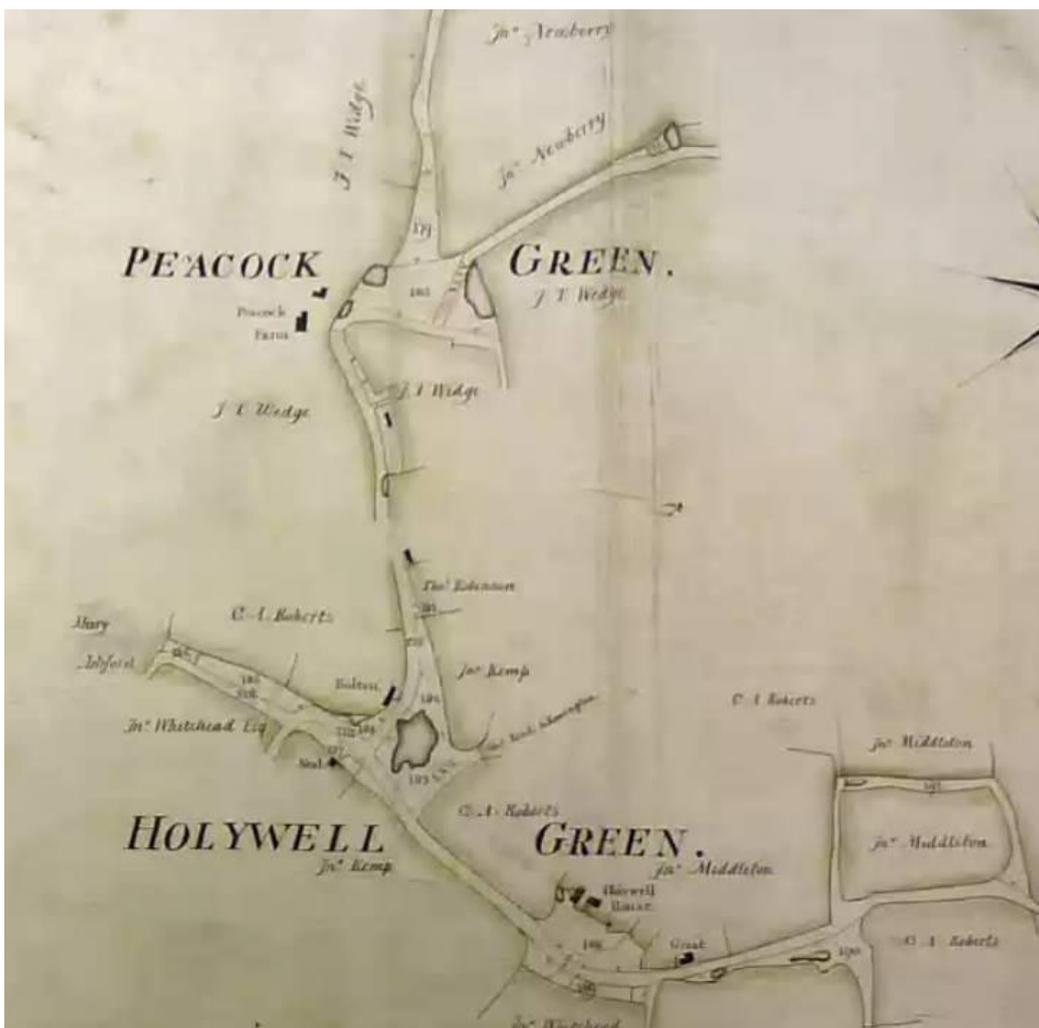
Fig.2: Rowington enclosure map, 1824

- 2.7 The 1824 enclosure map for Rowington (**Fig.2**) shows no detail of the site other than depicting a single building of long rectangular plan form to the east against the road around the green, which does not accurately relate to any building currently on the

site or shown on the 1847 tithe map. This is labelled with the name Bolton, but other than showing each end of the western boundary of the site, the map does not show any internal detail or other buildings within the plot. The green itself is shown to have contained a very large pond and it is not clear whether any part of this corresponded with the pond shown within the Manor Farm plot in 1847 (albeit the road layout on both maps seems generally to correspond).

2.8 The map also shows a building in the rough location of Holywell Farmhouse, and shows Holywell House further to the east.

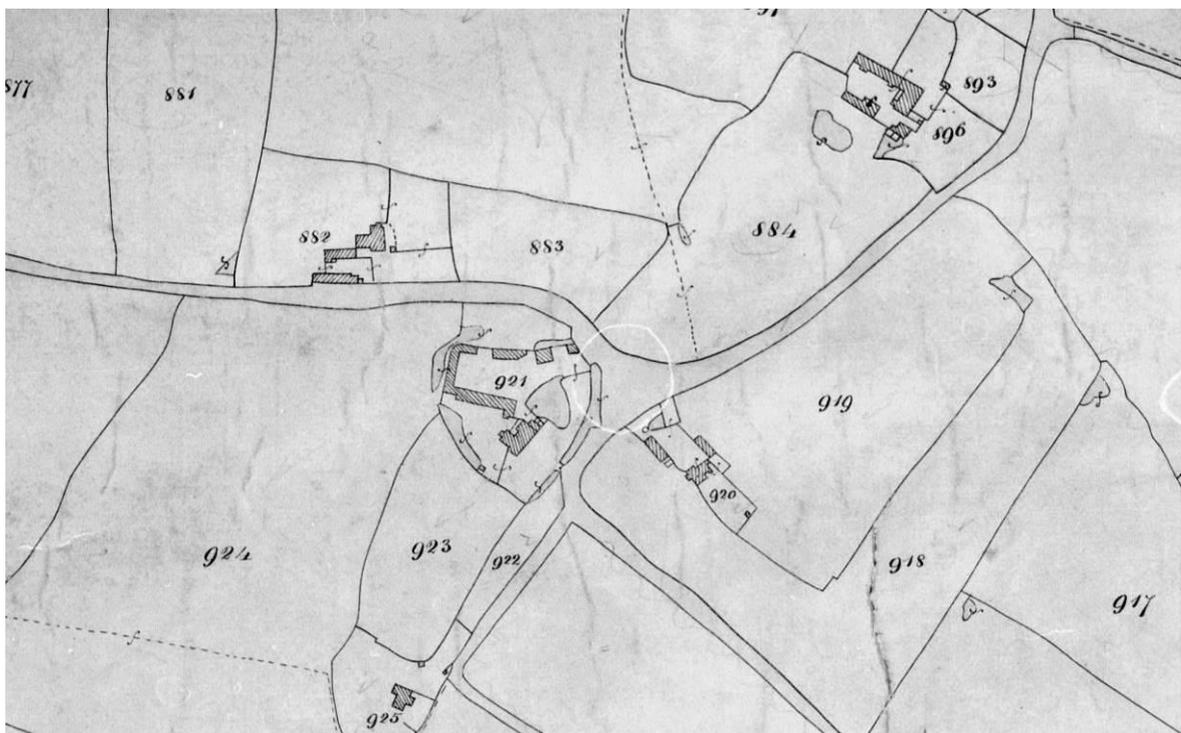
*Fig.3: Rowington tithe map, 1847*

2.9 The 1847 tithe map presents a much clearer picture of the site (**Fig.3**), showing the farmhouse largely as it appears in footprint today, the barn and a number of outbuildings no longer extant. The barn is depicted as a long 'L' shape in plan, with its

'foot' at the south-eastern end. It did not extend as far north-west as it does now, being attached to a 'C'-shaped farm range at this end, which provided enclosure to the northern side of the farmyard. Along the north-eastern side of the yard were three other farm buildings of varying proportion, the small square building at the eastern end possibly a granary. A small garden building stood west of the farmhouse. There was an entrance from the road into the eastern end of the farmyard, at the southern end of which was a large pond.

2.10 The map shows other bodies of water around all sides of the farm site, including two long sections along its western boundary against the fields, and curving around the north side; a long section along its south-eastern boundary, breached by a pedestrian entrance from the road to the garden at the front of the farmhouse; and a shorter section along the north-eastern boundary. While these did not all connect to each other, it seems almost certain that they once formed a continuous moat around a farmstead. It is not evident that the moat was fed by any watercourse, although it is possible that it was fed by a natural spring.

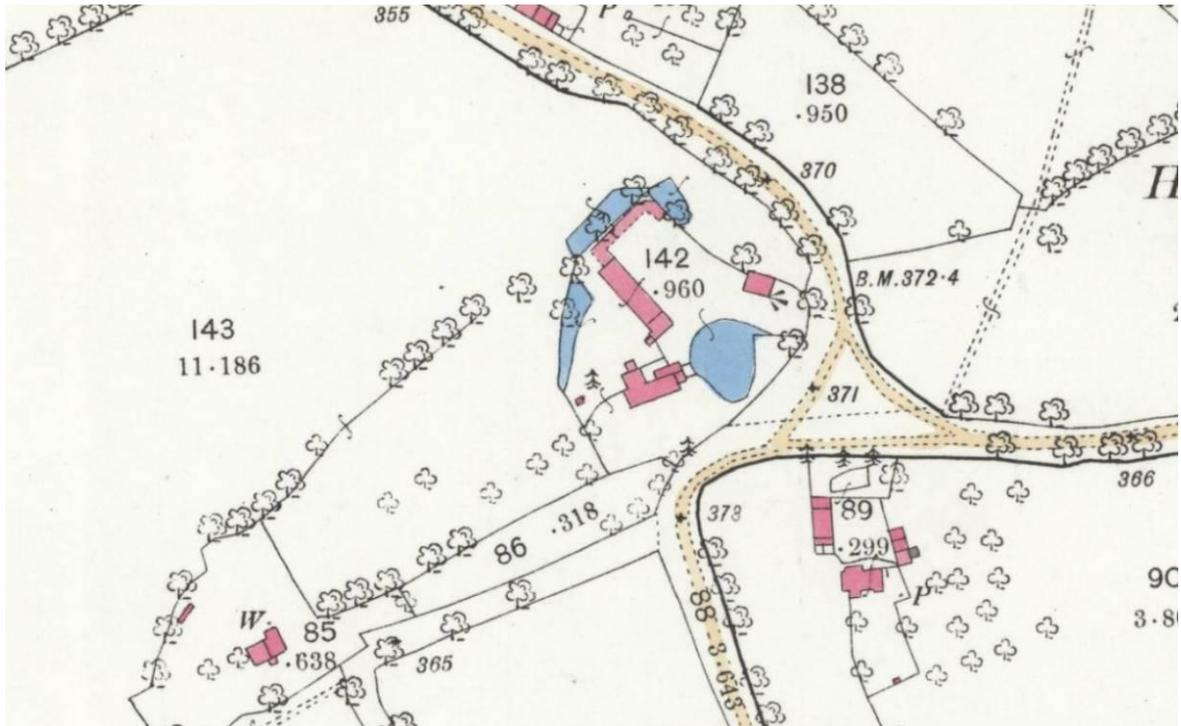
Fig.4: OS map, 1887 (surveyed 1885)

- 2.13 The 25-inch Ordnance Survey (OS) map surveyed in 1885 and published in 1887 (**Fig.4**) shows the further deterioration of the former moat; the south-eastern section is not shown at all (albeit it reappears on the 1905 map) and the short north-eastern section is no longer shown either. Two of the farm buildings along the north-eastern side of the yard had gone. The 'C'-shaped building at the north-western end is shown to have an open front to the yard and an open front to the south-west. The field enclosure to the south-west (in which earthworks have been noted) is depicted as still containing some orchard trees.

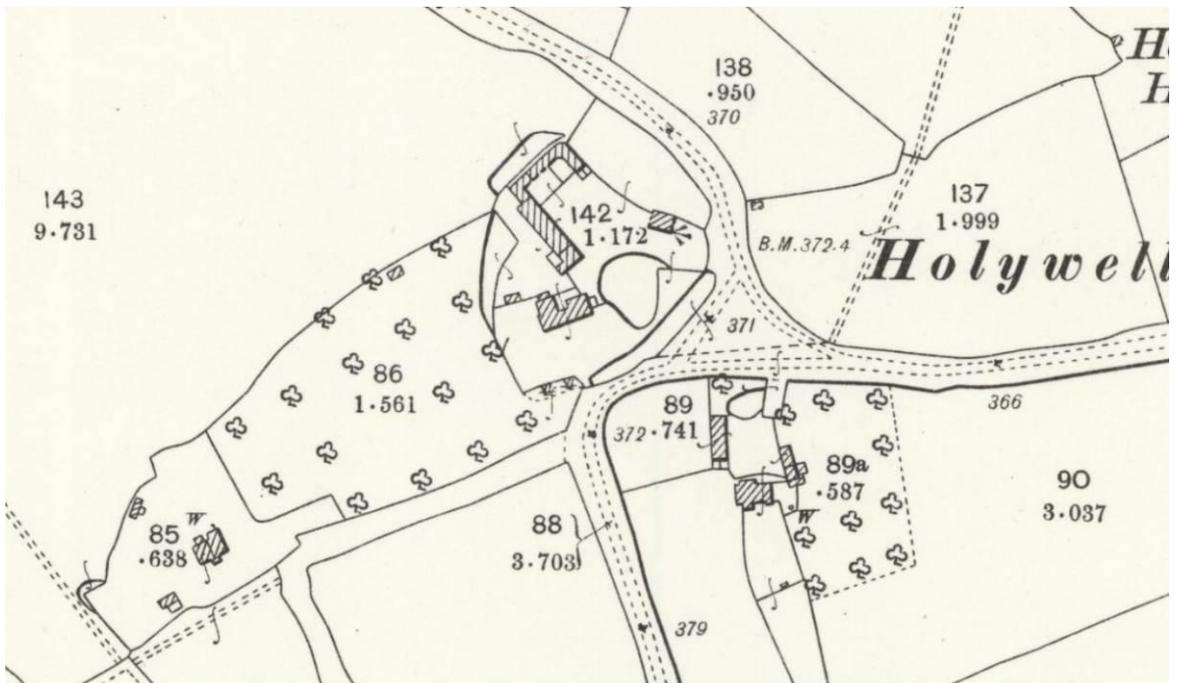
Fig.5: OS map, 1905 (surveyed 1903-4)

- 2.14 The 1905 OS map (**Fig.5**) once again depicts the south-eastern arm of the former moat – perhaps it had silted up by 1887 and was subsequently reinstated. The orchard, too, appears to have been replanted by this date as many more trees are shown. The small garden building west of the farmhouse had gone and a new slightly larger garden building had been erected nearby. The projecting 'foot' of the 'L' of the large barn had been extended and new yards had been created in front of the 'C'-shaped farm range. The surviving farm building against the north side of the yard is shown with an open front to the west. This period between 1887 and 1905 would appear to represent a phase of improvements to the property as a whole.

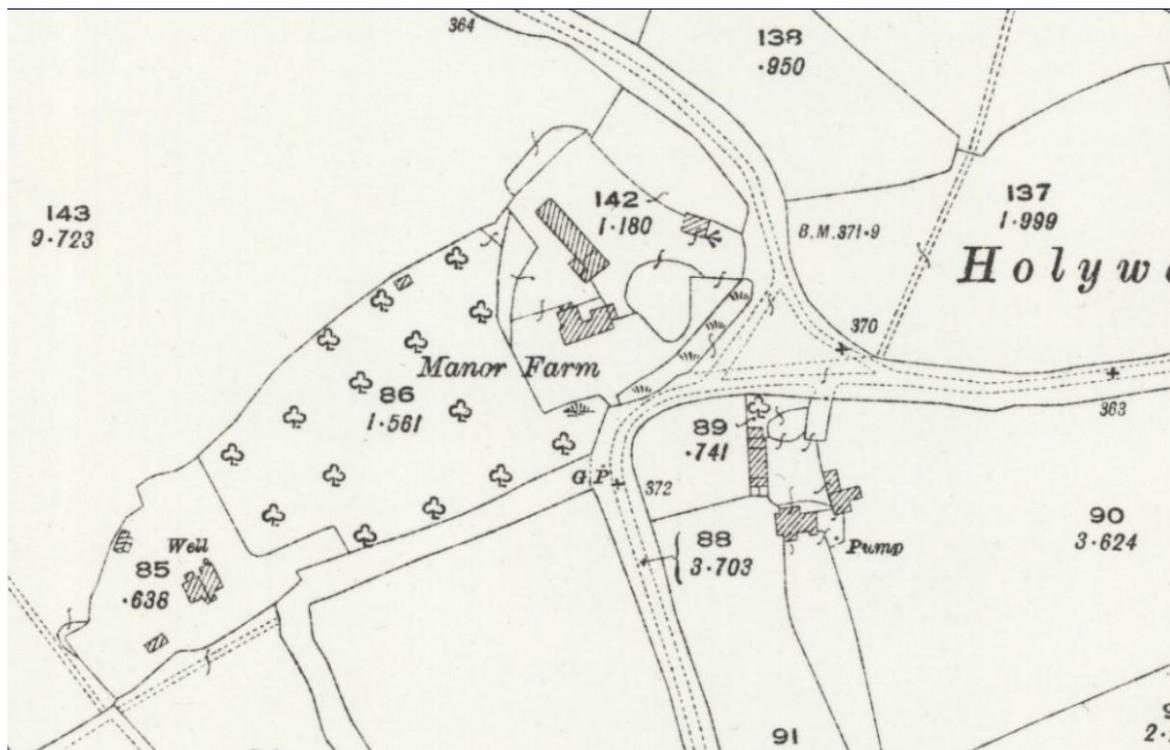
Fig.6: OS map, 1925 (revised 1923)

2.15 The 1925 OS map (**Fig.6**) is the first to label the site 'Manor Farm.' By this date, the 'C'-shaped farm range had been taken down and the south-eastern arm of the former moat is shown as being filled with reeds. These changes perhaps indicate that the farm range had fallen into disrepair.

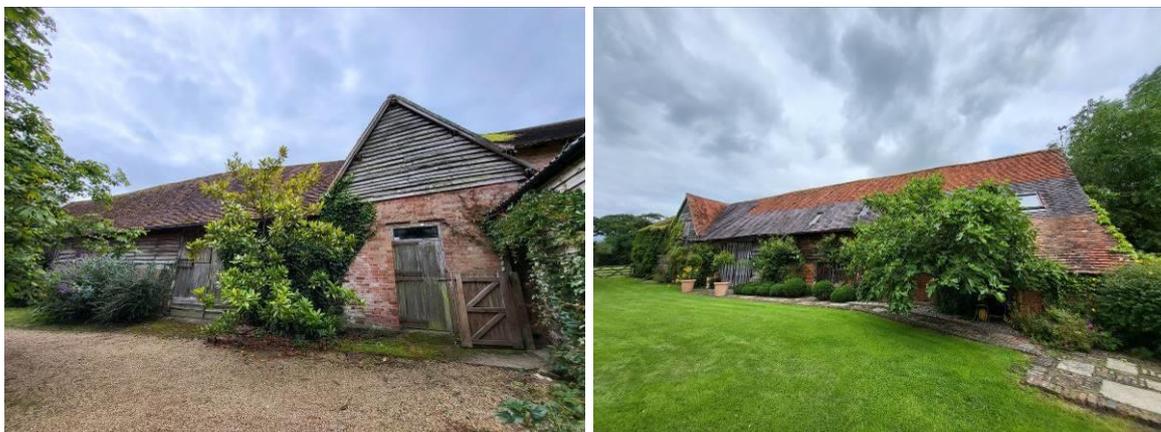
- 3.1.1 The list description describes the barn (a former threshing barn) as being probably of mid-17<sup>th</sup>-century date, but with what it calls a 're-sited spine beam bearing a date of 1719.' Generally, it comprises a box-framed timber structure on a brick plinth, with brick infill of varying date to the lower framed panels and weatherboard cladding over the upper panels. The roof is pitched and covered with plain clay tiles. At the north-western end is a cross-gabled bay and at the south-eastern end a projecting lean-to structure (**Plate 1**).

*Plate 1: Barn: NE elevation (left) and SW elevation (right)*

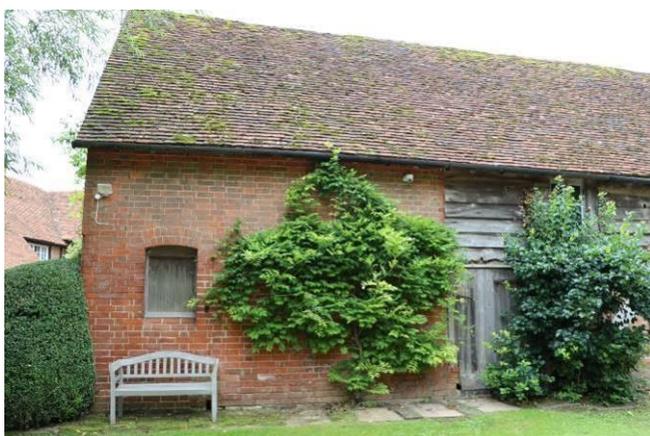
- 3.1.3 Beginning with Bay 1 (containing G1 & F1), the left-hand end of the north-eastern elevation, originally facing onto the farmyard, this (and the south-eastern gable end), has been rebuilt in red brick laid in Flemish Garden Wall Bond, probably an early 19<sup>th</sup>-century intervention (**Plate 2**). The elevation incorporates a window opening finished with closer bricks beneath a segmental brick arch. A timber window frame is retained but the opening is currently infilled with vertical boarding.

*Plate 2: NE elevation, Bay 1*

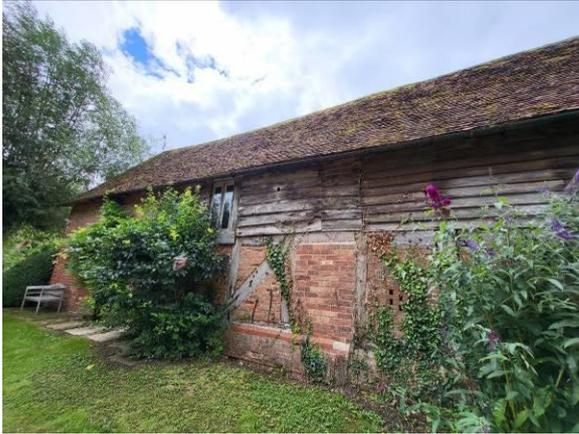
- 3.1.4 Bay 2 (containing G2) (**Plates 3-5**) is timber-framed on a brick plinth, with later-added chamfered tiled capping, with brick infill to the lower row of panels and weatherboard cladding covering the upper framing above the mid-rail. In the first panel is a door opening with ledged and braced boarded door. In the second panel there is historic, perhaps original, brick infill with lime mortar, with a window opening at the upper level with 20<sup>th</sup>-century two-light timber casement. The third panel contains historic, perhaps original, brick infill, with lime mortar, either side of an angled timber brace (the bracing at the upper level is concealed externally by the weatherboard cladding). The fourth panel contains 20<sup>th</sup>-century Fletton brick infill with a cementitious mortar.

*Plate 3: NE elevation, Bay 2*

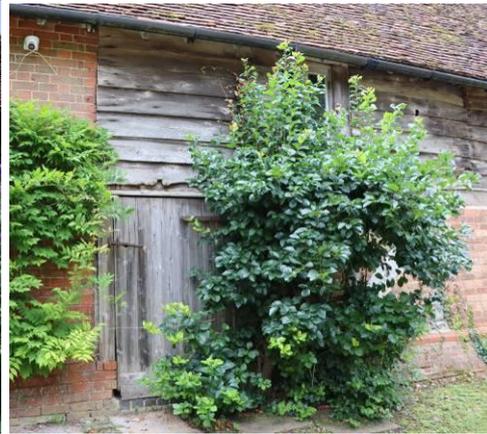
*Plate 4: Bay 2, panel 1 with entrance*

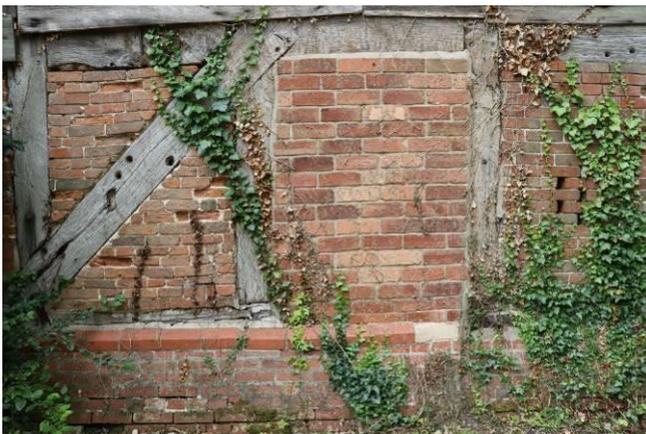
*Plate 5: Detail of brickwork infill, Bay 2, panels 3 & 4*

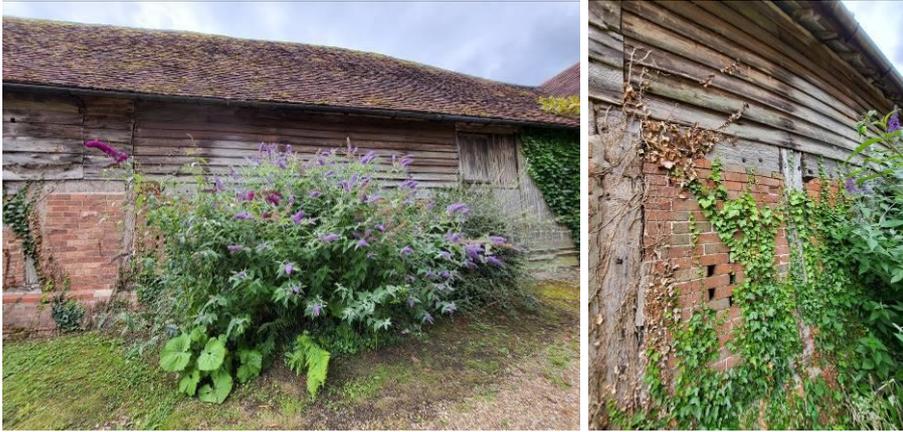
3.1.5 Bay 3 (containing G3 & F2) (**Plates 6 & 7**) is timber-framed on a brick plinth (with cement capping). The first panel has historic but non-original (probably 19<sup>th</sup>-century) brick infill and a pattern of vent holes in the centre. The second panel, largely concealed by vegetation, appears to have similar brick infill. The third appears similar, but has an inserted window opening (of 20<sup>th</sup>-century date) the full width of the panel. The infill to the fourth and fifth panels appears to be historic, possibly original, brickwork. There is weatherboard cladding to the upper level.

*Plate 6: NE elevation, Bay 3, concealed by vegetation, with detail of panel 1 (right)*

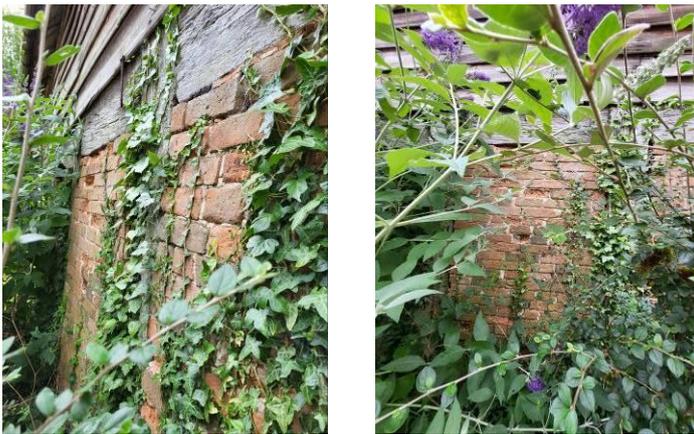
*Plate 7: Bay 3, detail of panels 4 & 5 (left) and panel 4 (right)*

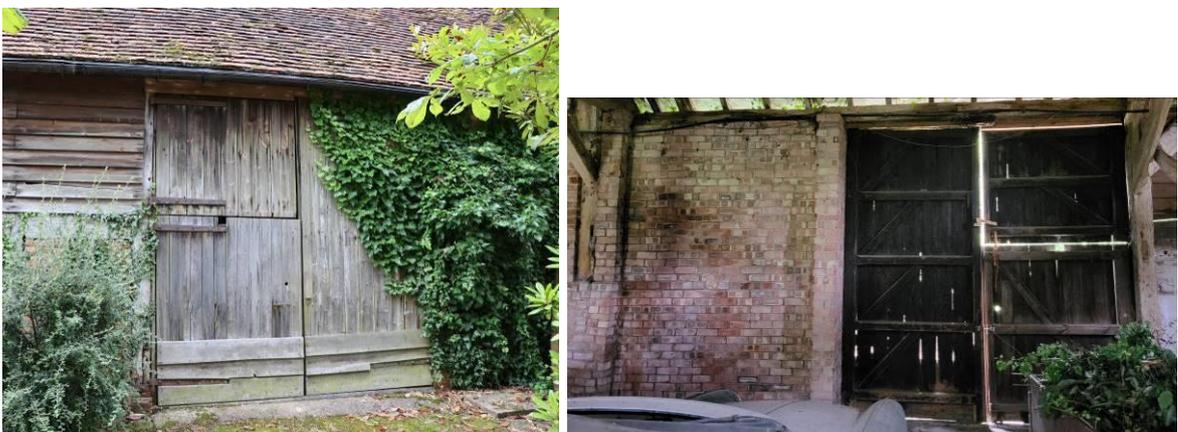
3.1.6 Bay 4 is the former threshing bay (G4), incorporating full-height double doors, of probable early 20<sup>th</sup>-century date. To right of this opening the rest of the elevation of this bay has been rebuilt in 20<sup>th</sup>-century stretcher-bond Fletton brickwork (**Plate 8**).

*Plate 8: NE elevation, Bay 4, detail of external and internal elevations*

- 3.2.12 As already noted, the external walls adjoining the two sets of threshing doors have been rebuilt in 20<sup>th</sup>-century Fletton brickwork, with four full-height brick piers, one adjoining the north-west side of each opening and another on each wall on the alignment of Truss 1 (**Plates 8, 35 & 36**): on the north-east wall, the original principal post (which supports Truss 1 and also the gable end of Bay 5 (G5) has been truncated, with only its upper half surviving, embedded in the later brickwork. The brick pier directly adjoining it provides support for an additional tie beam, presumably nailed to the existing, which extends across to rest on the opposing brick pier on the south-west side, where the original principal post has remained fully intact.

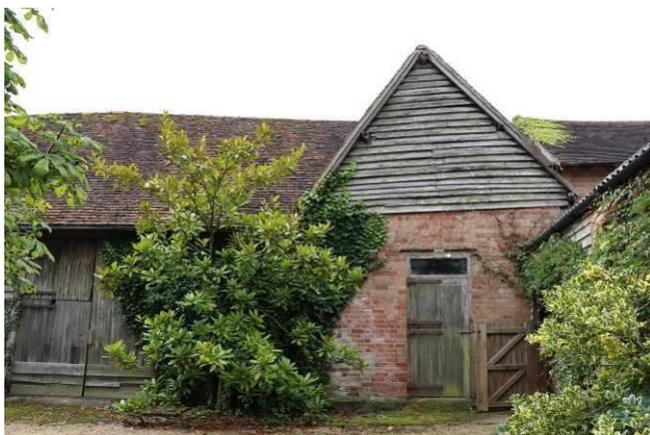
- 3.1.7 Bay 5 (containing G5) (**Plate 9**) is gabled on both this and the other side of the building. Its elevation on this side has been rebuilt in 20<sup>th</sup>-century Fletton brickwork laid in Flemish Garden Wall bond, with a central entrance with 20<sup>th</sup>-century stable-type door. The original corner post is still present (visible from within the 20<sup>th</sup>-century steel-framed barn). The gable end retains its original timber framing, which has been over-clad with weatherboarding.

*Plate 9: NE elevation, Bay 5 (with gable)*

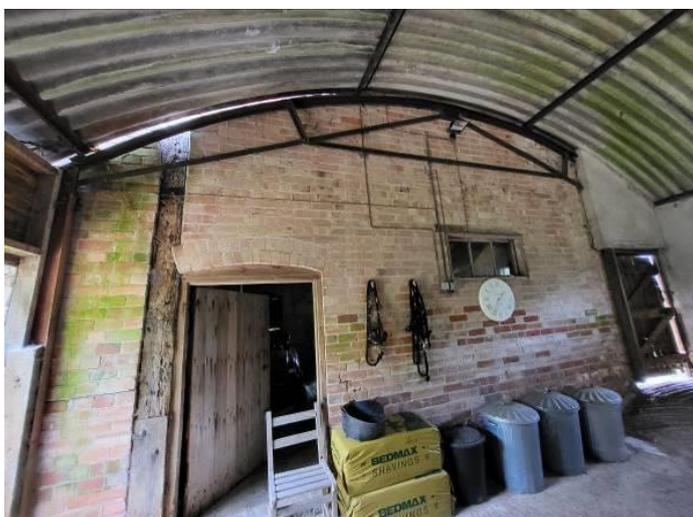
- 3.1.8 Bay 6 (containing G6 & F3) (constructed after 1925) is visible from within the 20<sup>th</sup>-century barn addition and comprises Fletton brickwork laid in Flemish Garden Wall Bond (**Plate 10**). This element was built with a first floor partly contained within the roof space; at ground-floor level it incorporates an entrance beneath a segmental brick arch and a high-level window opening.

*Plate 10: NE elevation, Bay 6*

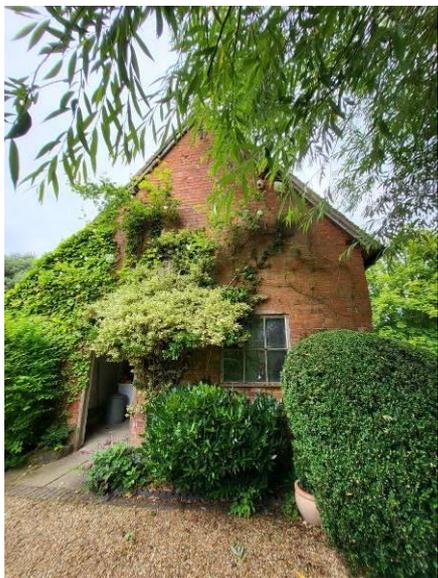
- 3.1.9 This (**Plate 11**) is constructed of probably 19<sup>th</sup>-century red brick laid in Flemish Garden Wall Bond. It incorporates an entrance and a window opening with segmental arch to both ground and first floors (the first floor being partly contained within the roof space), albeit the low-set upper window has been blocked with boarding.

*Plate 11: SE gable-end elevation*

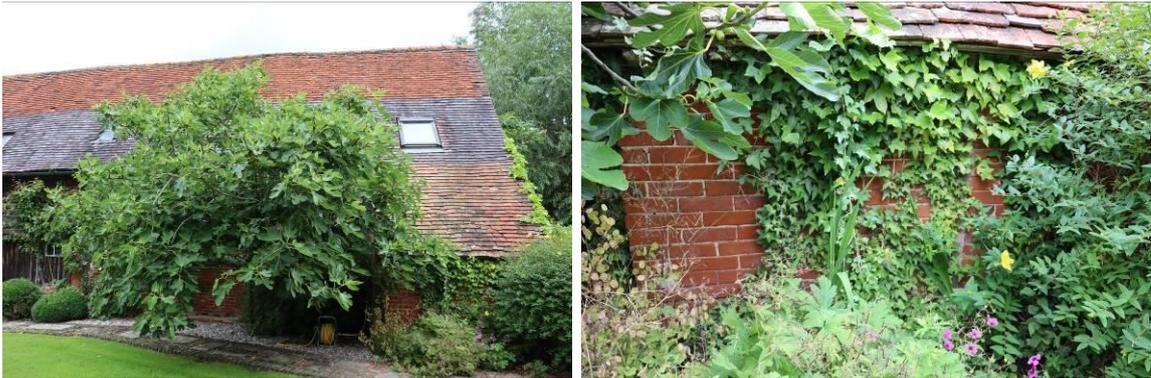
- 3.1.10 Beginning at the right-hand end in order to reflect the order in which the opposing elevation was described, the elevation to Bay 1 (containing G1 & F1) (**Plates 12 & 13**) is partly concealed by a single-storey addition of stretcher-bond red brick construction under a catslide roof. The 1847 tithe map depicts a projecting structure here, albeit one of different form. The current form emerged from that between 1887 and 1905 but was extended to the left; this extension has since been removed. The original wall behind the extension is timber framed with painted brick infill, with much evidence of rebuilding (possibly for reasons of reinforcement) below the mid-rail.

*Plate 12: SW elevation, Bay 1, with detail of brickwork to catslide addition*

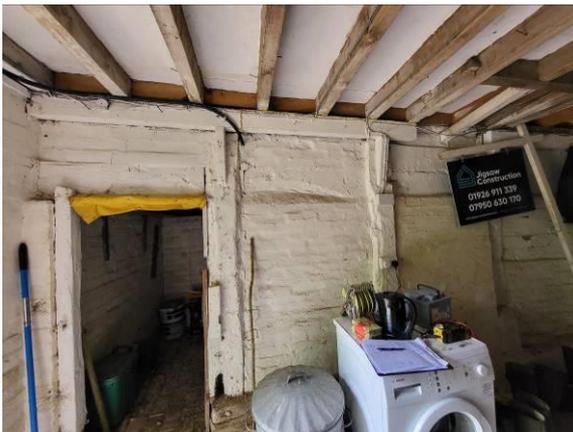
*Plate 13: Internal side of SW elevation, Bay 1, with catslide addition beyond*

- 3.2.2 The timber framing and brick infill and reinforcement to the south-west elevation against G1d and e is described above at paragraph 3.1.10 and can be seen at **Plate 13**. G1d comprises a brick-paved storage area and G1e a WC divided by a late 20<sup>th</sup>-century partition, the branch-like appearance of the purlin indicating the rather crude construction of this lean-to.

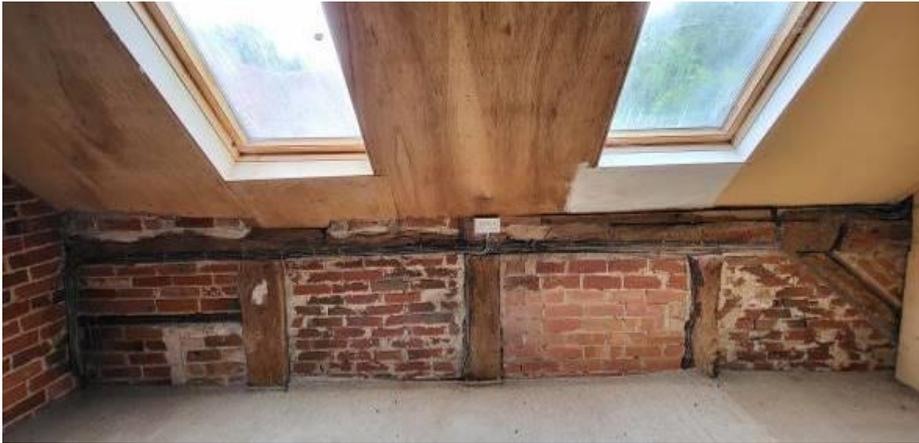
3.1.11 To the left, the timber framing comprises smaller square panels than those present to the adjoining bays and opposite side, such that there are three panels from plinth to eaves (as on the gabled Bay 5) rather than two. The brickwork infill is difficult to see externally because of vegetation growth, but the top row of four panels can be seen from within F1 on the first floor, indicating that panels 1 and 3 contain early brickwork, panel 2 comprises 20<sup>th</sup>-century Flettons, and panel 4 a mix of probably 19<sup>th</sup>- and 20<sup>th</sup>-century bricks (**Plate 14**).

*Plate 14: Internal side of SW elevation from first-floor room, F1, with panels 1-4 (right to left)*

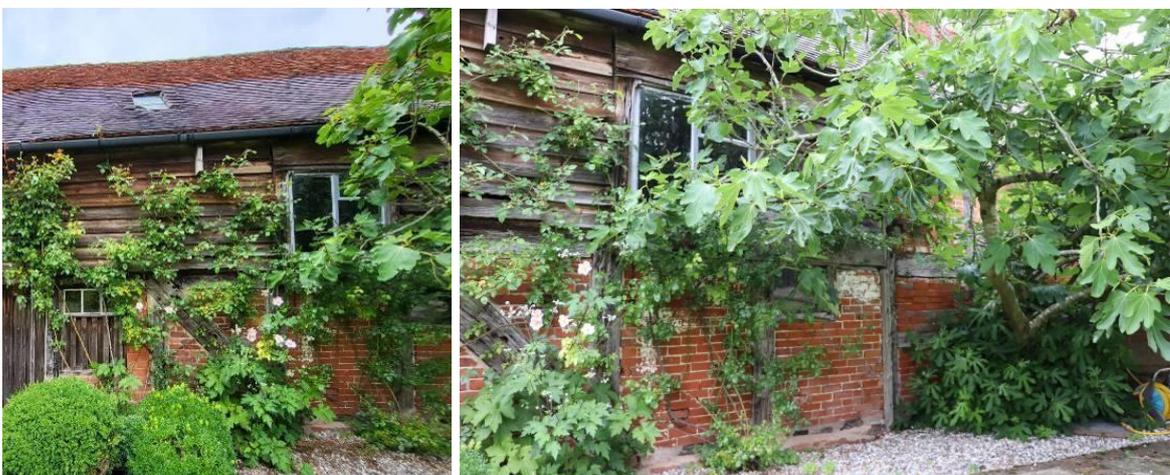
3.1.13 Bay 2 (containing G2) (**Plates 15 & 16**) is constructed of the larger box framing (of two panels high) found on the opposite elevation, the upper panels clad with weatherboarding and the lower infilled with brick.

3.1.14 From the left, panel 1 contains a window opening, the lower two-thirds filled with alternating vertical planks serving as a vent, with three-light glazing above, and 20<sup>th</sup>-century brickwork to right and above. Panel 2, with angled brace, is infilled with historic, possibly original, brick. Panel 3 is infilled with non-original (perhaps 19<sup>th</sup>-century) brick and above it the weatherboarding has been cut into to insert a 20<sup>th</sup>-century casement window. Panel 4 is infilled with the same type of brick and incorporates a small half-width window which was originally full-width (as is evident internally). In the roof-slope above this bay is an 'agricultural' rooflight.

*Plate 15: SW elevation, Bay 2*

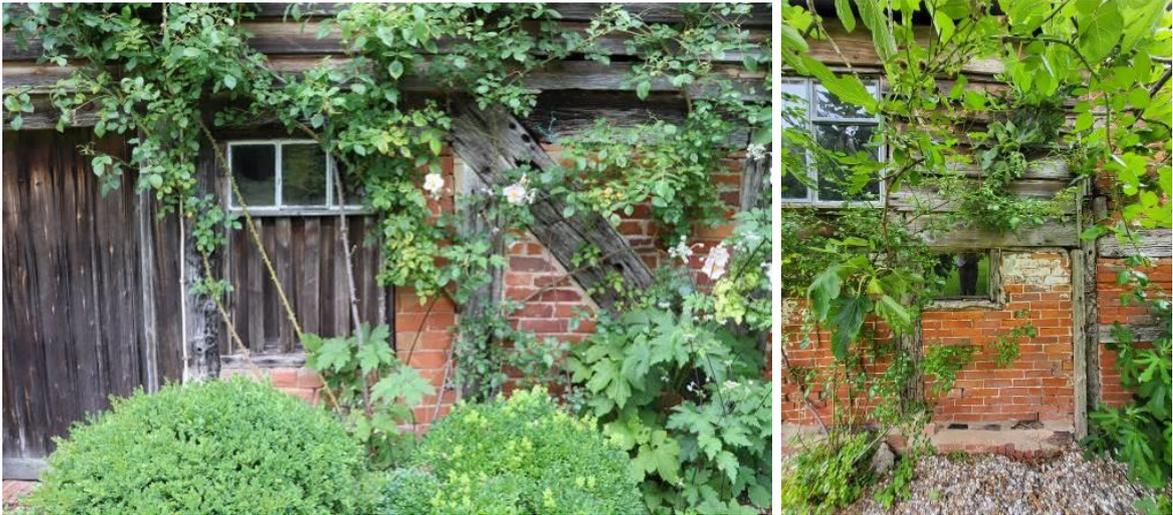
*Plate 16: Bay 2, detail of panels 1 & 2 (left) and 3 & 4 (right)*

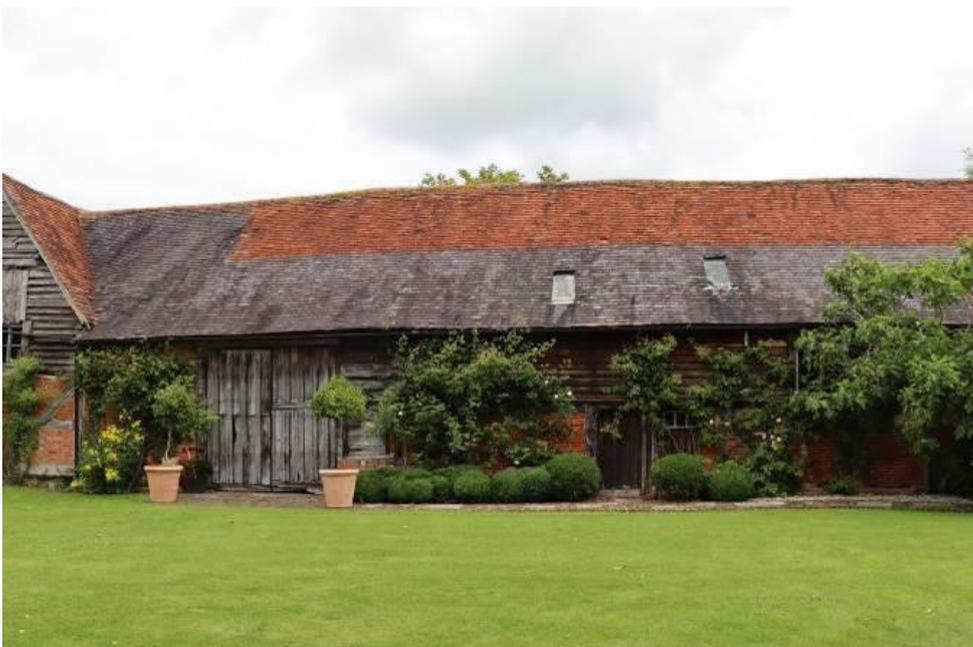
3.1.15 On Bay 3 (containing G3 & F2), panels 2, 3 and 4 are infilled with the same non-original brickwork with high plinth, and weatherboard cladding to the upper framing (**Plates 17 & 18**). Panel 1 is infilled with later 20<sup>th</sup>-century brickwork and contains a shuttered opening. Panels 3 and 4 contain a pattern of vent holes, and panel 5 an entrance with boarded and battened door, probably of 19<sup>th</sup>-century date. In the roof-slope above this bay is an 'agricultural' rooflight.

*Plate 17: SW elevation, Bay 3 (with pedestrian door); threshing Bay 4 to left*

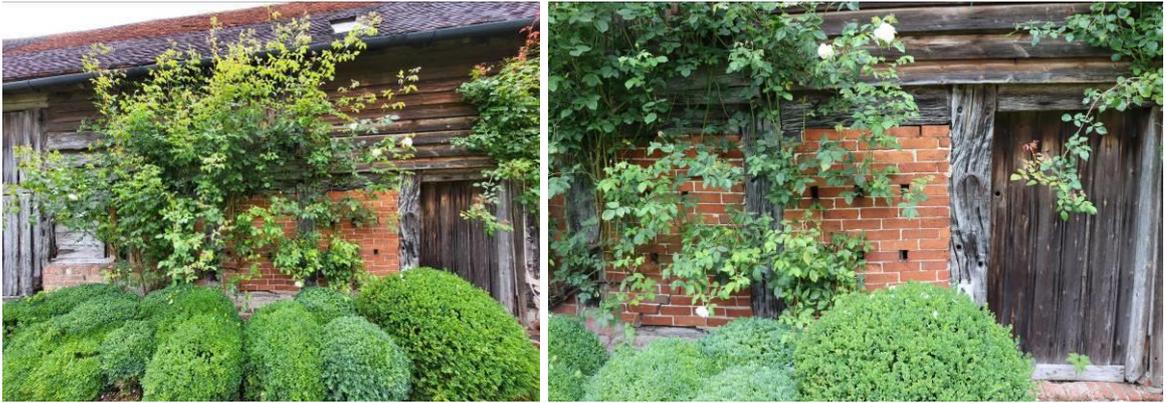
*Plate 18: Details of Bay 3*

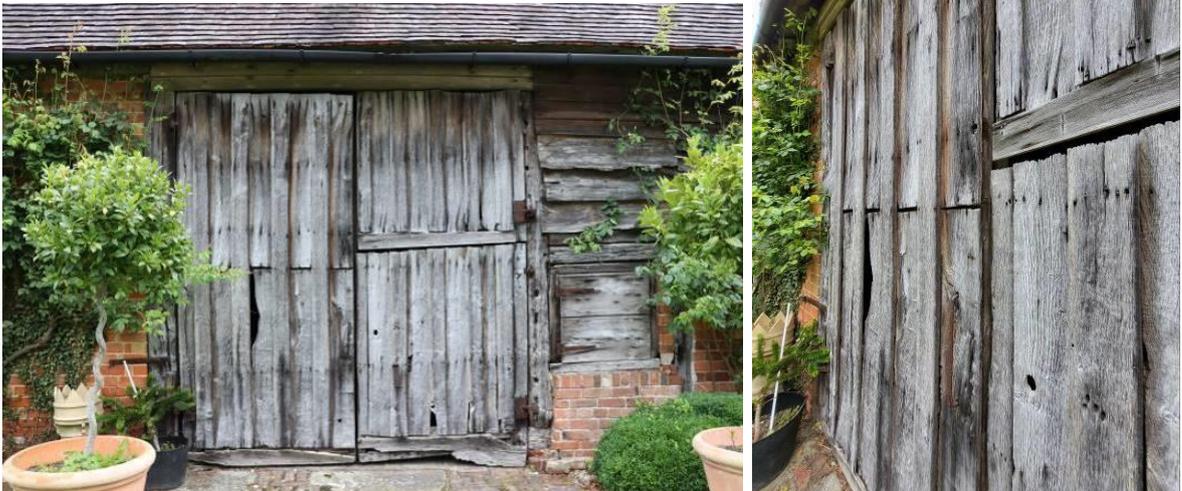
3.1.16 Bay 4 (containing G4, the threshing bay) has a pair of full-height plank doors of probably 18<sup>th</sup>-century date (**Plates 19 & 20**). The right-hand door incorporates a pedestrian entrance. The doors are made up of wide planks nailed to a mid-rail, top-rail and base plate, reinforced by battens and braces. There are wide gaps between each plank which are covered externally by narrower planks set further forward (possibly enabling some ventilation of the threshing bay), which are continuous (to the left-hand door) from top to bottom. To left of the doors is 20<sup>th</sup>-century Fletton brick infill.

*Plate 19: SW elevation, Bay 4, detail of threshing doors*

- 5.2.14 In actual fact, the 'double plank' nature of the doors' construction is equally fully appreciable from either side of the doors (see **Plates 19 & 20**), such that fixing them back to the elevation in an open position would not at all remove the ability to appreciate this aspect. Nevertheless, it is now proposed to insert the glazed screens but to retain the threshing doors such that they can be held open or closed as currently, rather than fixing them back to the external walls.

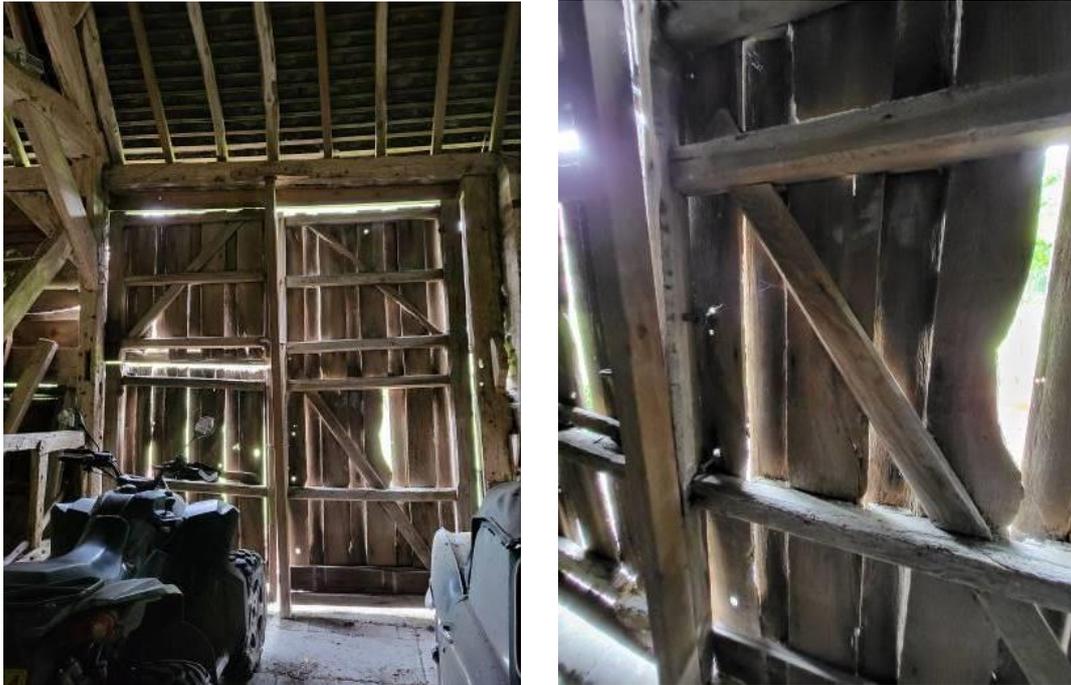
*Plate 20: Threshing doors in SW elevation, seen from inside G5*

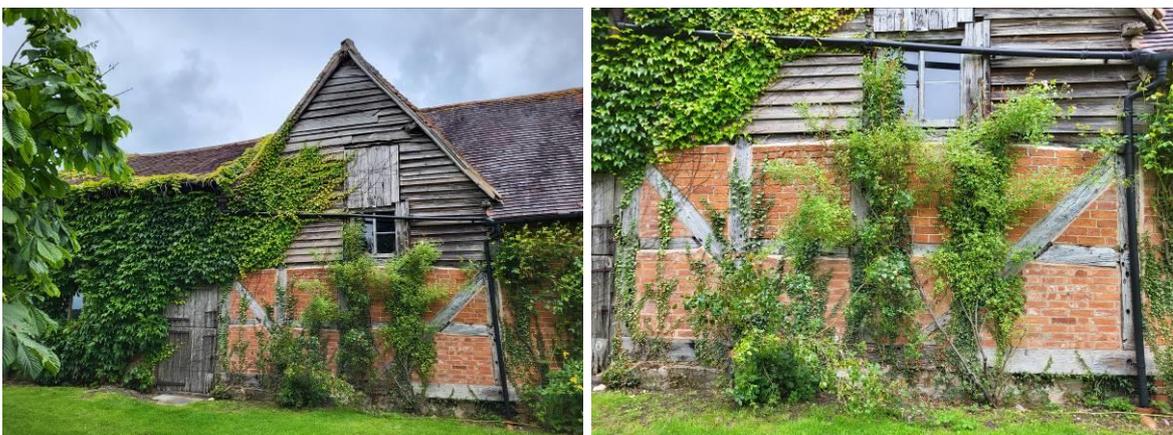
3.1.17 Bay 5 (containing G5) is gabled and of box-framed construction, with smaller square panelling extending throughout: with three rows of panels up to eaves height, another above in the gable end, and inclined struts into the apex (**Plate 21**). Externally, the two lower rows of framing are exposed, with brick infill, with the upper panels clad with weatherboarding. Two angled braces rise from the base plate to the end posts. The brickwork infill is from different periods, with 20<sup>th</sup>-century Flettons to the lower panels and a mix of possibly 18<sup>th</sup>- or early 19<sup>th</sup>-century and 20<sup>th</sup>-century bricks to the second row. In the gable end, above panel 3, is a 20<sup>th</sup>-century casement window and, above this, a timber-shuttered opening.

*Plate 21: SW elevation, Bay 5*

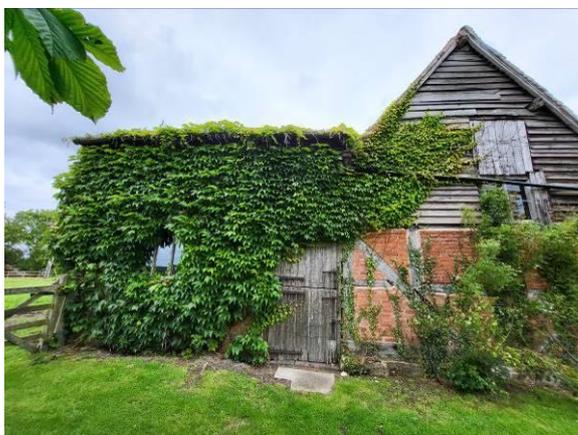
3.1.18 At the north-western end is Bay 6 (containing G6 & F3), the 20<sup>th</sup>-century brick extension, with stable door and two-light window to ground floor and small two-light window beneath the eaves (largely concealed by vegetation) (**Plate 22**).

*Plate 22: SW elevation, Bay 6*

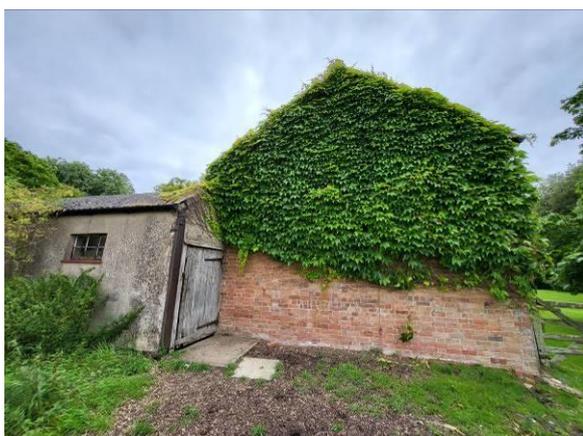
3.1.19 This gable end of the 20<sup>th</sup>-century extension to the barn range has a three-light window in the gable apex (currently concealed by vegetation) (**Plate 23**).

*Plate 23: NW elevation, with steel-framed barn to left*

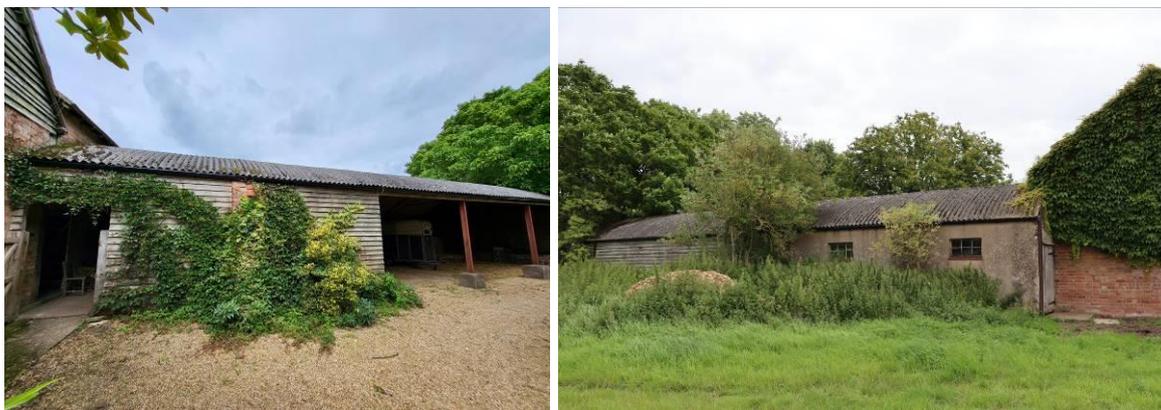
3.1.20 Standing forward of the north-western end of the historic barn is the 20<sup>th</sup>-century steel-framed barn addition. The long north-western elevation has been infilled - the left-hand half is weatherboarded over a timber-framed infill (as is the north-eastern end) while the right-hand half has been infilled with rendered concrete. The left-hand

half of the long south-eastern elevation is similarly weatherboarded over timber-framed infill, with the remaining three bays left open (**Plate 24**).

*Plate 24: 20<sup>th</sup>-century steel-framed barn: SE elevation (left) and NW elevation (right)*

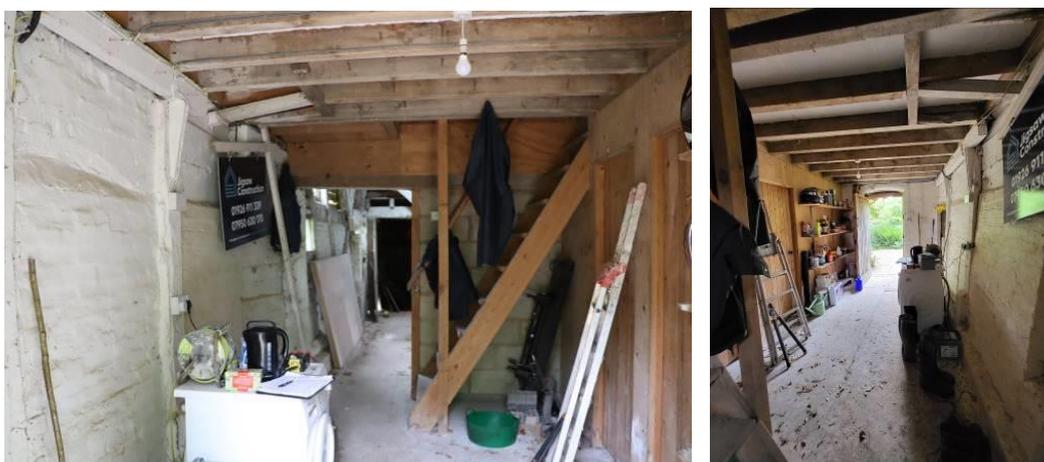
3.2.1 This bay (**Plates 25-27**) has had a first floor inserted across it at some point during the 20<sup>th</sup> century, albeit there is a historic longitudinal beam running across G1 (behind the plywood partitions) and emerging through the timber framing of the partition with G2, which may suggest the presence of an earlier floor or mezzanine in this bay (which may also relate to the blocked opening in the gable end). The ground floor has been divided up into three spaces (a passageway and two storage areas) with modern plywood partitioning and there is a ladder-type stair to provide access to the first-floor room, F1. There is a concrete screed floor.

*Plate 25: G1a, looking NW (left) and SE (right)*

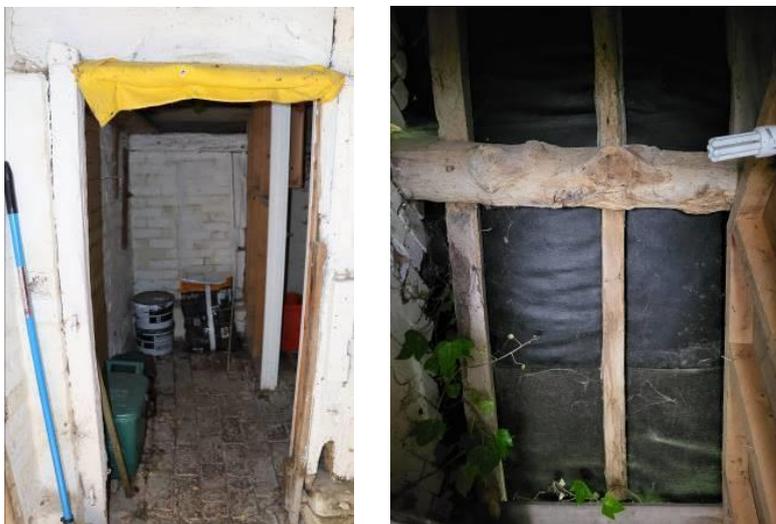
*Plate 26: G1d & e, with detail of purlin*

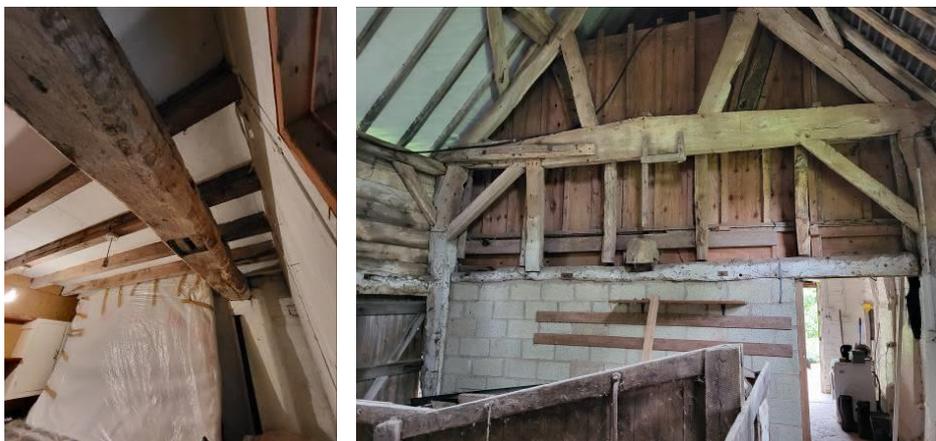
- 3.2.3 The bay partition against G2 (beneath Truss 4) is of concrete block construction at ground-floor level, clearly replacing a former timber-framed partition, the upper part of which remains intact and can be seen from within G2. Above the concrete blockwork, and set behind the timber framing exposed in G2, is a plywood partition enclosing F1.

*Plate 27: Historic beam running across G1 (left) and part-concrete/part-timber frame partition between G1 and G2 beneath Truss 4 (right; note end of beam emerging through centre of timber frame)*

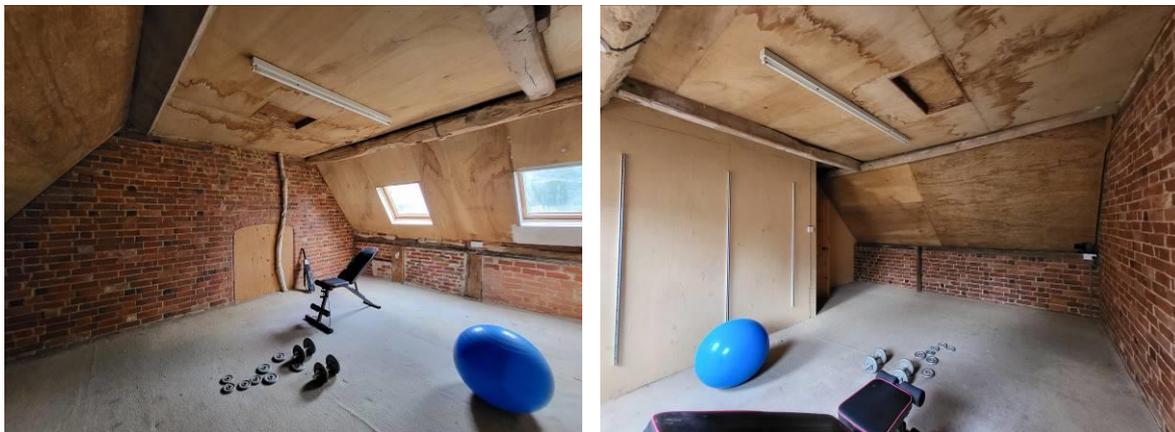
- 3.2.4 In F1, the roof has also been lined with plywood beneath the rafters, leaving the purlins exposed. The brickwork walls are also exposed. In the gable end is a blocked opening beneath segmental arch (**Plate 28**).

*Plate 28: F1, looking towards gable end and SW elevation (left) and NE elevation (right), with plywood stair enclosure*

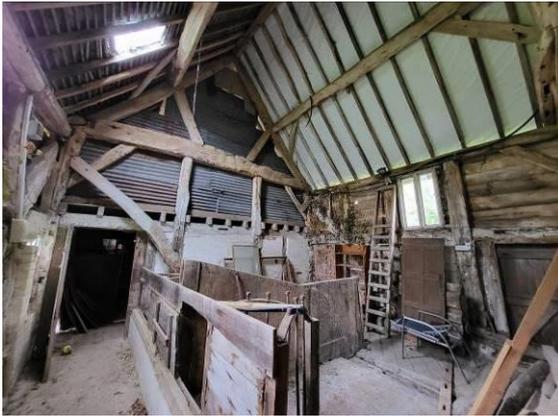
- 3.2.5 G2 is fully open to the exposed original roof structure (**Plate 29**). This (in general) comprises a butt-purlin roof with trusses comprising substantial principal rafters and tie beam which carry a ridge purlin and side purlins with the aid of inclined struts. Although the list description refers to this as a 'queen strut' roof, this is not strictly true as queen struts are normally vertical and do not directly carry side purlins. The tie beam is additionally supported by angled braces rising from the principal posts. The struts comprising the timber-framed internal walls are tenoned into the soffit of the tie beam. Truss 4 and the partly rebuilt partition between G2 and G1 are illustrated at **Plate 27**, while Truss 3 between G2 and G3 is shown below at **Plate 29**. Truss 4 between G1 and G3 appears to bear the carpenter's mark 'IIII', albeit this is unclear.

*Plate 29: G2, looking NW towards Truss 3 dividing G2 from G3*
