## HERITAGE STATEMENT

**Manor Farm Barns, Holywell, Rowington,  
Warwickshire**

**Morton Titterton**

**January 2024**

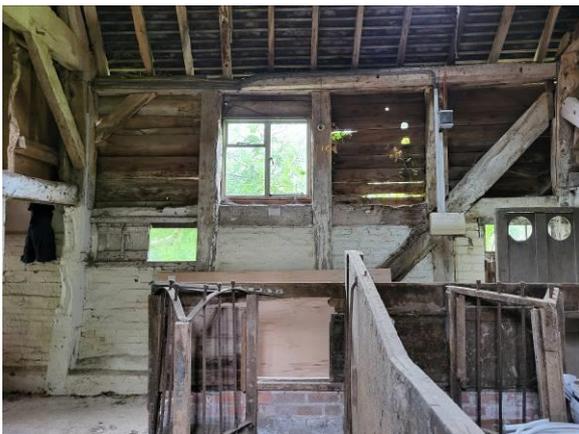
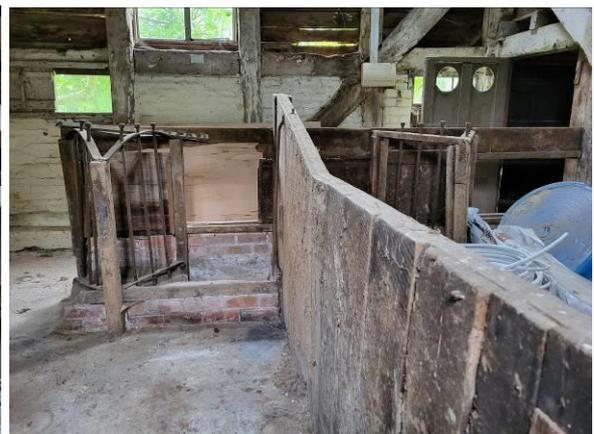
- 3.2.6 G2 has latterly been used as an animal shelter, evidenced by the remains of brick and timber stall partitions forming two stalls with mangers, and a concrete floor with a drainage channel (**Plate 30**). The brickwork plinth to the stalls is formed of Fletton bricks, indicating the stalls are most likely of mid-20<sup>th</sup>-century date. The door into G3 has two large circular holes cut into it, presumably for ventilation purposes.

*Plate 30: G2, Looking towards SW elevation, with detail of livestock stalls*

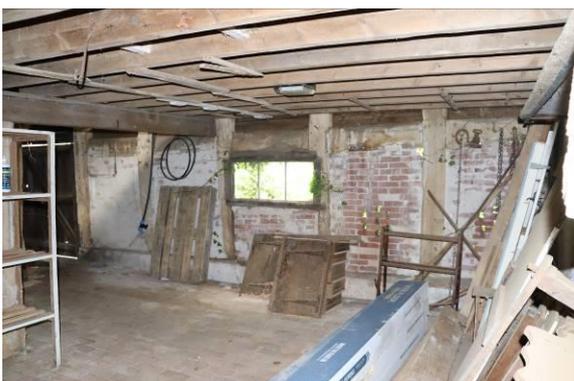
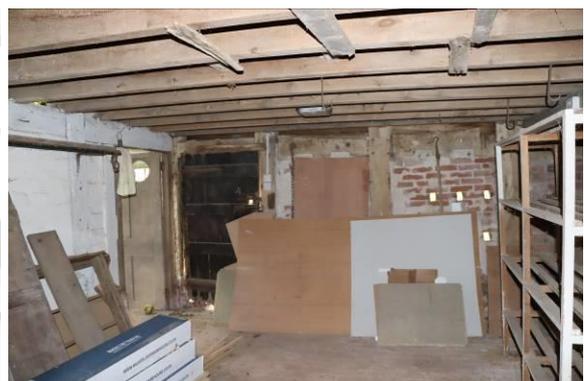
3.2.7 This bay (**Plates 31 & 32**) has a brick-paved floor and a timber mezzanine floor extending across the south-eastern two-thirds of the bay, providing a partial first-floor space above (F2). Access to the mezzanine floor is provided by a rudimentary unenclosed timber staircase.

*Plate 31: G3, Looking towards NE elevation (left) and towards SW elevation (right)*

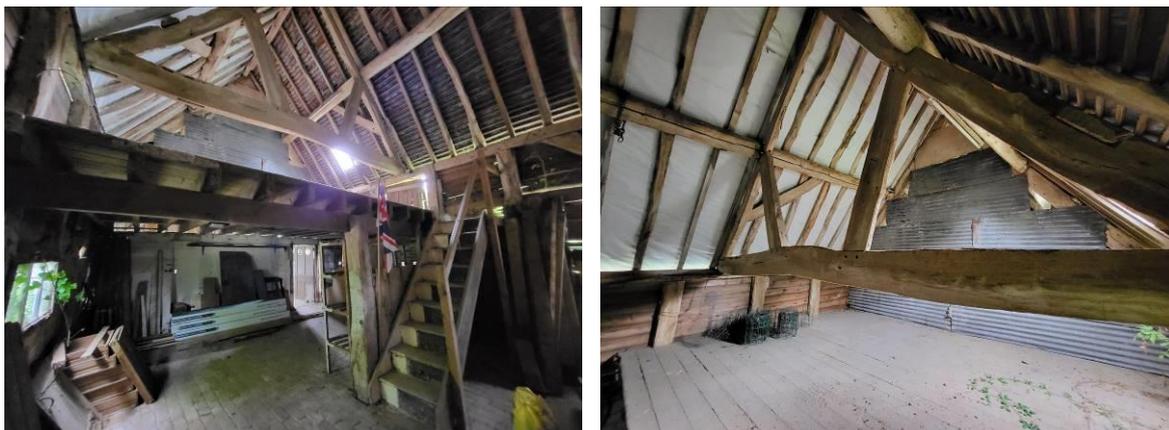
*Plate 32: G3, looking SE, with mezzanine (left) and detail of interim' Truss 2.5, seen from F2 (right)*

- 3.2.8 F2 has a boarded floor. Truss 2.5 is suspended above it (**Plate 32**). I have referred to this as an 'interim' truss as it is not, like the other principal trusses, supported by principal posts, but simply rests on the wall plate.
- 3.2.9 Truss 3 and the timber framing below it have been clad with corrugated sheeting to provide separation between the mezzanine floor and G2 (see **Plates 29 & 32**).
- 3.2.10 The bay is divided from Bay 4 (G4) by the remnants of a c.1m high horizontally boarded partition beneath Truss 2 (**Plate 33**). This is fixed to two substantial and long raking struts which are jointed to the principal posts supporting the truss, just below the top, and at the bottom to a base plate. This may have been installed to provide separation of G3 from the adjoining threshing floor in G4.

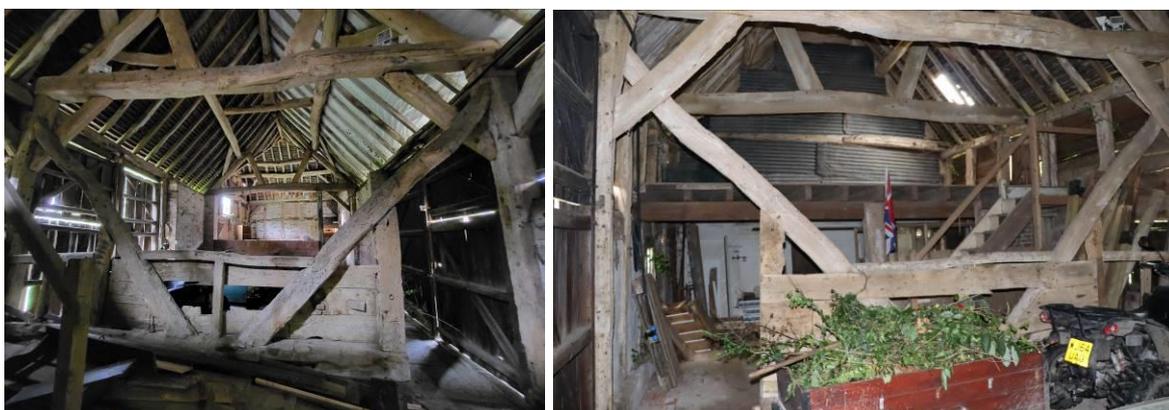
*Plate 33: Framing and divider beneath Truss 2 between G3 and G4, looking from G3 side (left) and G4 side (right)*

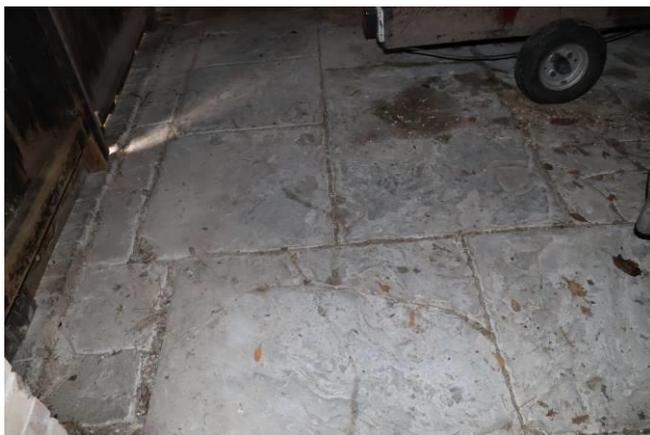
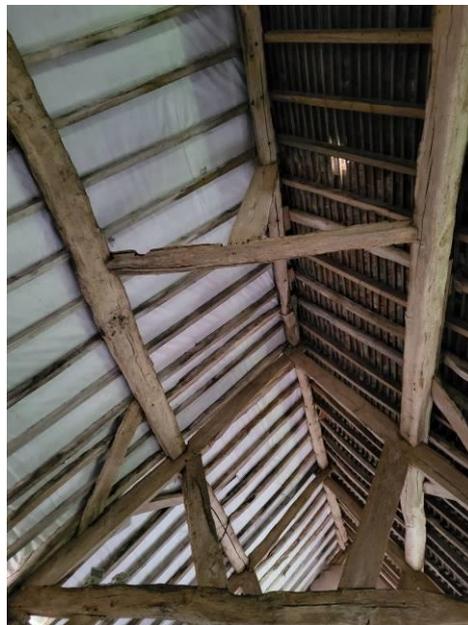
- 3.2.11 This is the original threshing bay and retains a stone-flagged threshing floor. Above the bay is Truss 1.5; this is not a full truss but a collar between purlins with kingpost up to the ridge (**Plate 34**).

*Plate 34: G4, details of stone flagged threshing floor (left) and kingpost 'truss; (Truss 1.5) (right)*

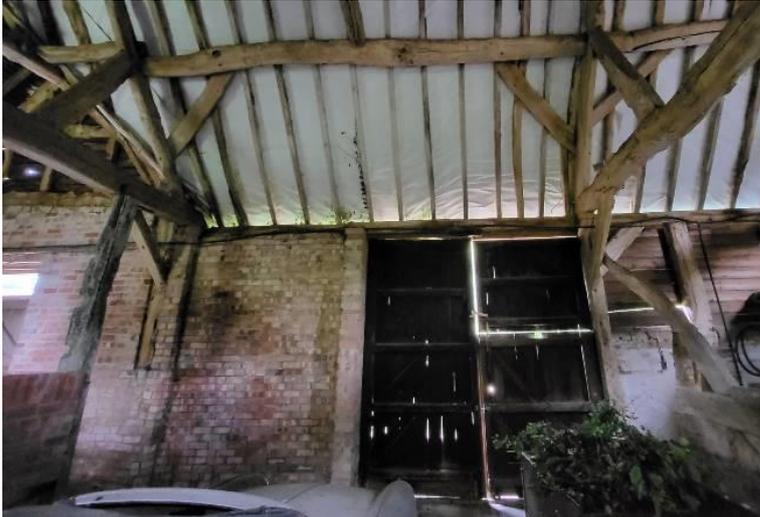
- 3.2.12 As already noted, the external walls adjoining the two sets of threshing doors have been rebuilt in 20<sup>th</sup>-century Fletton brickwork, with four full-height brick piers, one adjoining the north-west side of each opening and another on each wall on the alignment of Truss 1 (**Plates 8, 35 & 36**): on the north-east wall, the original principal post (which supports Truss 1 and also the gable end of Bay 5 (G5) has been truncated, with only its upper half surviving, embedded in the later brickwork. The brick pier directly adjoining it provides support for an additional tie beam, presumably nailed to the existing, which extends across to rest on the opposing brick pier on the south-west side, where the original principal post has remained fully intact.

*Plate 35: G4, looking NE. To left, note truncated principal post supporting Truss 1 and adjoining brick pier carrying additional tie beam. Truss 2 to right*

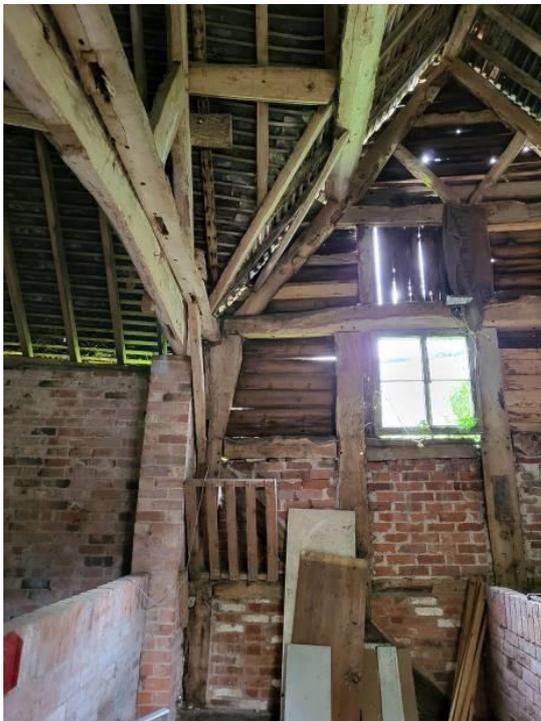
- 3.2.13 Empty mortices in the soffit of the original tie beam indicate there was previously a timber-framed partition here, dividing G4 from G5 in the cross-gabled element. The framing has been removed and replaced at the lower level by a Fletton brick wall dividing off livestock stalls in G5.

*Plate 36: Looking SW across G5, with Truss 1 and G4 beyond it to left; note brick pier supporting additional tie beam, empty mortices in soffit of truss tie and retained principal post in corner of G5, supporting Truss 1 and gable structure*

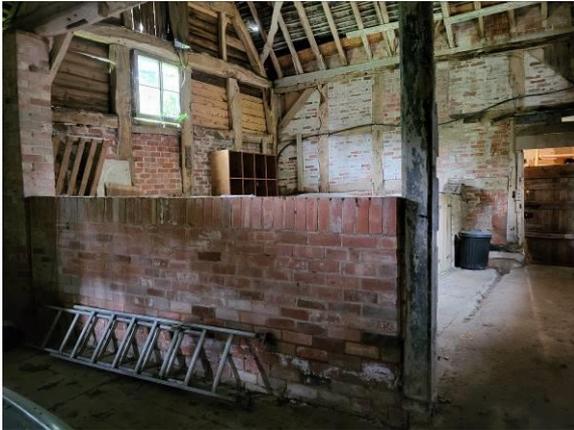
3.2.14 The livestock stalls in this space are of mid-late 20<sup>th</sup>-century date and constructed of Fletton bricks and concrete blockwork (**Plates 37-40**). The north-west wall of G5 is the original box-framed wall, with three rows of panels, infilled with limewashed brickwork, of uncertain date, some panels earlier than others. The floor is of concrete

*Plate 37: Looking NW from G4 to G5*

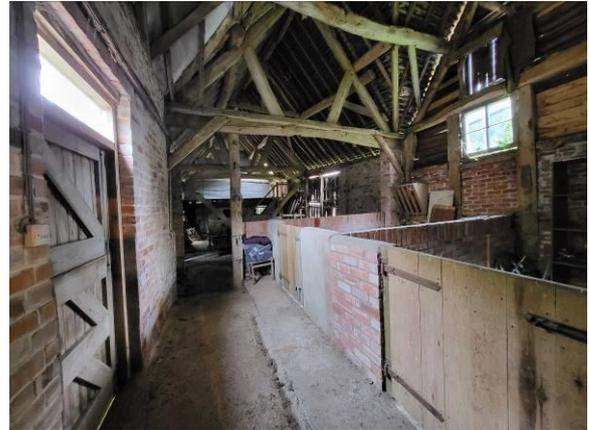
*Plate 38: G5, looking SE*

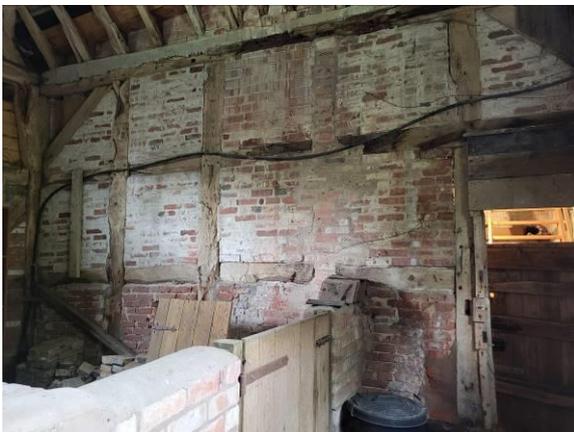
*Plate 39: G7, NW wall*

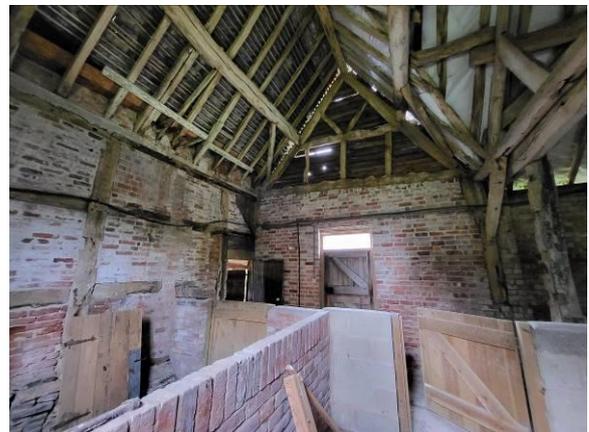
*Plate 40: G5, looking NE*

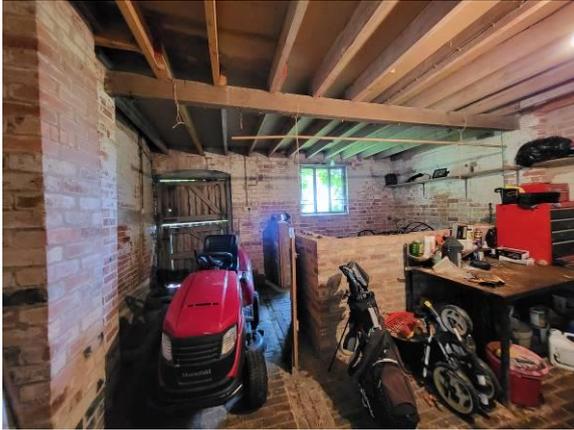
3.2.15 This has a brick-paved floor and contains a livestock pen formed by brick walls (**Plates 41-45**). Carpenter's marks are visible on the exposed timber framing of the end wall of the original barn. The space has a first floor accessed by a simple ladder-type staircase. F3 has been separated from the staircase by chipboard panels.

*Plate 41: G6, looking SW*

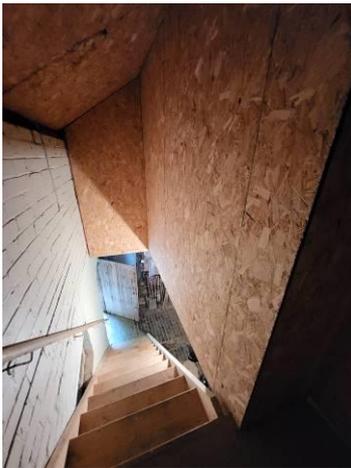
*Plate 43: Stairs from F3 down to G6*

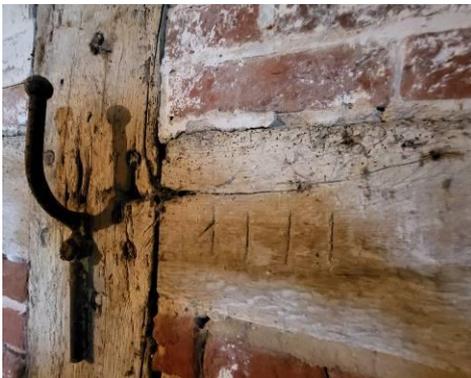
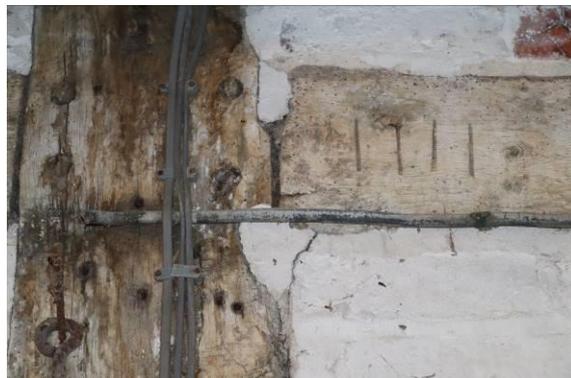
*Plate 45: Carpenter's marks on framing of SE wall of G6 (NW external wall of original barn)*

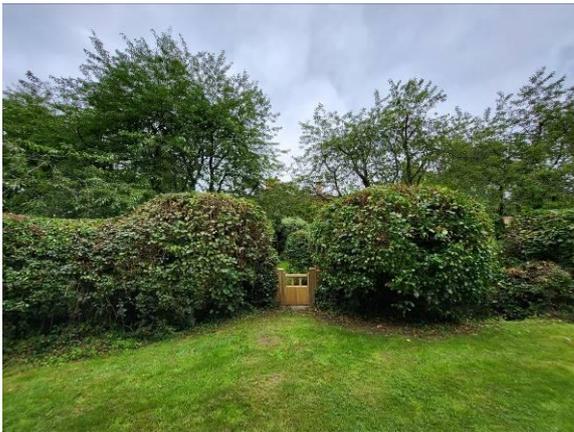
3.3.4 The front garden area (the main garden area historically) is accessed from the lane, across a grass verge and through a pedestrian gate and path between hedges that bridges the putative moat, aligned on the façade of the farmhouse. The site boundary against the lane is reinforced by the presence of the ditch/putative moat (**Plates 49 & 50**).

*Plate 50: Gated pedestrian entrance which bridges ditch/putative moat*

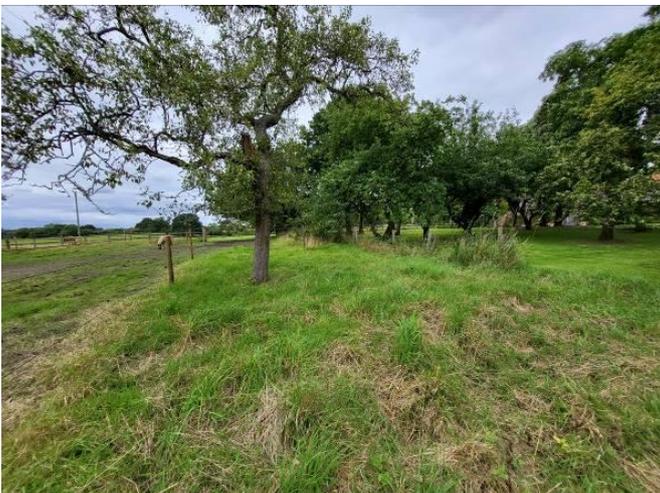
*Plate 56: Looking NW along boundary of field and western lawn*

- 3.3.6 The area west of the barn (which formerly contained a section of the probable moat, now infilled) was historically divided from the front garden area by a boundary, probably a fence, which had shifted northwards slightly by 1905. This boundary marked the division between the domestic dwelling and the secondary farmyard west of the barn. A tall hedge stands along part of this alignment but the area is now largely contiguous with the front garden area, forming a single large garden space (**Plates 53 & 54**). This part of the garden contains a wide expanse of lawn and various trees and shrubs, and is separated from the fields beyond by a wooden post-and-rail fence (**Plates 55 & 56**).
