**Client:** Enerveo Limited  
 Unit 8  
 Spring Copse Business Park  
 Slinfold  
 West Sussex  
 RH13 0SZ

**Area:** Chichester Racquets & Fitness Club

**Job Ref:** 70826

### **Report on Testing of Street Lighting Units**

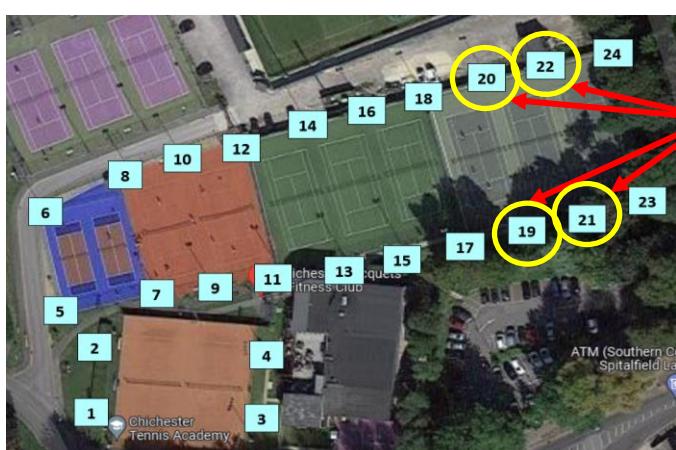
- 1- These calculations are structural assessment of the base and shaft of the lighting columns based on in-situ testing data and specification of proposed attachment(s) provided by client.
- 2- The calculations are in accordance with BS EN 40-3-1 and BS EN 40-3-3.
- 3- The material of lighting columns is assumed as of mild steel S275.
- 4- If the size and weight of any existing traffic sign(s) mounted to the testing lighting column(s) are not available, each sign will be assumed to have a size of 0.5m x 0.5m and be mounted at 2.5m above GL, with a weight of 5kg.
- 5- If the size and weight of the existing light(s) are not provided, each light will be assumed to have a size of 0.6m x 0.25m and a weight of 20kg.
- 6- The specification of proposed attachment: **LEDs**

Assumed BV518HGB will be used & fitted at max 15° therefore wind area & weight will be of 0.22m<sup>2</sup> & 28kg as marked up on the table above - Please confirm this angle before installing new LEDs.

Type	kg HGB	kg BV	m <sup>2</sup> 90° HGB
BVP528	31	25	0,47
<b>BVP518</b>	<b>27</b>	<b>21</b>	<b>0,33</b>
BVP528 L	32,8	26,8	0,47
BVP518 L	28,2	22,2	0,33

Configuration	0°	15°	30°	40°	50°	65°	90°
<b>BVP518 HGB</b>	0,18	<b>0,22</b>	0,25	0,27	0,27	0,29	0,33
BVP518 HGB+ EXTERNAL LOUVER	0,23	0,25	0,27	0,26	0,25	0,25	0,32
<b>BVP518 BV</b>	0,10	<b>0,17</b>	0,21	0,24	0,26	0,30	0,34
BVP518 BV+ EXTERNAL LOUVER	0,13	0,18	0,22	0,25	0,25	0,26	0,32

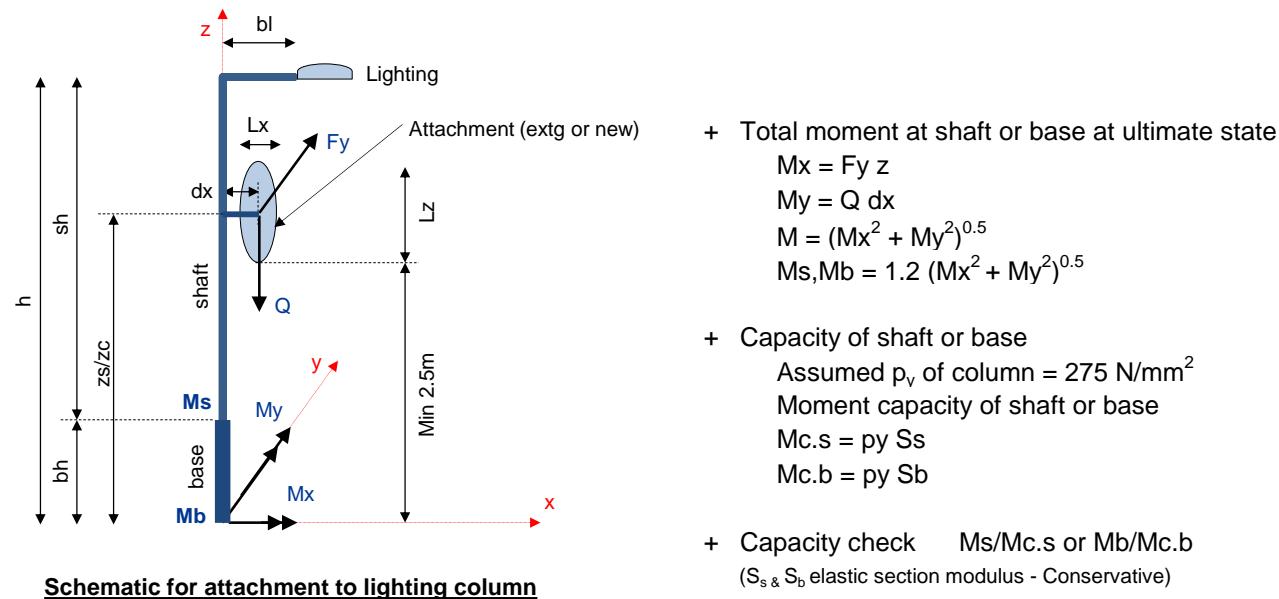
Table 4 - Wind Load Calculations to Lighting Column

Sketch below shows the concept of checking each column

Name	Type	Lx (m)	Lz (m)	dx (m)	zc (m)	Q (N)	C_shape
Sign	S	0.50	0.50		2.50	50	1.8
Philips BVP518 @8m ht	B1	0.69	0.32	0.50	8.16	280	1.5
Philips BVP518 @10m ht	B2	0.69	0.32	0.50	10.16	280	1.5
Philips driver box @8m ht	B3	0.50	0.10	0.50	8.05	53	1.5
Philips driver box @10m ht	B4	0.50	0.10	0.50	10.05	53	1.5
Street light	L	0.60	0.40			200	1.2

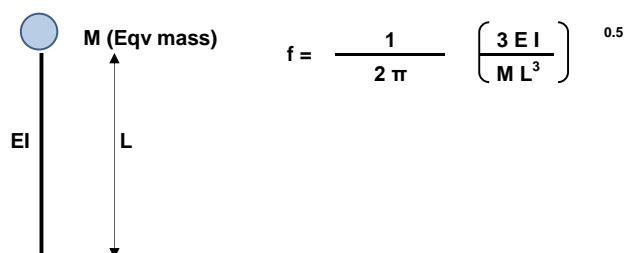
Each lighting column is considered as a single DOF to identify basic period of column

$C_s$  octagonal column = 1.3
