## CONTENTS

| 5.0 | Description of the proposals | |

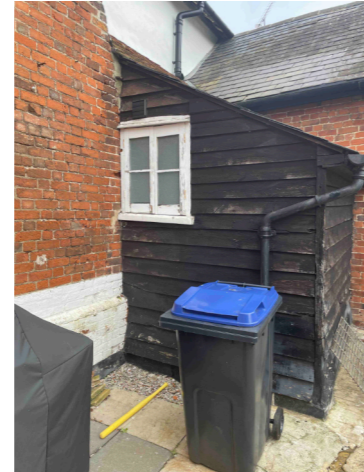
In addition to the information as noted above, below is a description of the 19<sup>th</sup> century single storey structure to the rear of the original house, currently accommodating a bathroom.

19<sup>th</sup> century addition with mono-pitched slate running on from clay plain tiled roof. Structure is timber frame with a timber suspended floor. There is evidence of rot throughout the structure, especially within the floor joists/sole plate and lower section of wall studs. Concrete is present externally around the base of the structure. There is 1 no. timber framed casement window with obscure glazing.

Existing ground floor bathroom

The ground floor bathroom will be retained as its current use but, as noted in the description, there are several defects within the existing structure, primarily down to the ingress of water and lack of ventilation.

It is proposed to remove the external concrete surrounding the structure to be able to assess the structure beneath ground level. It is difficult to provide a full scope of remedial works required at this point. However, the applicant wishes to replace, like-for-like any rotten floor/wall timbers and repair timbers where deemed appropriate. New breathable insulation will be installed between and on the external face of the wall studs (such as wood fibre boards) followed by the re-installation of black horizontal weather-boarding (either re-used if in suitable condition or new to match). Breathable insulation will also be installed between the floor joists prior to the installation of a vapour permeable membrane and floorboards over. Vents within the lower level of the wall will ensure continuous ventilation beneath floor level to mitigate any further damp issues.

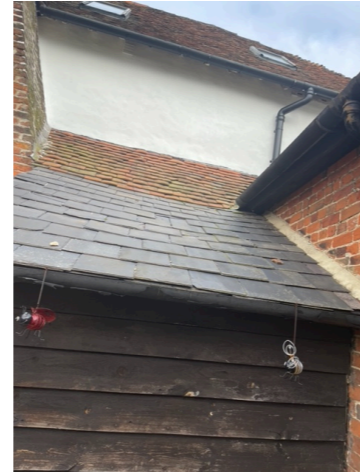
Existing roof over bathroom

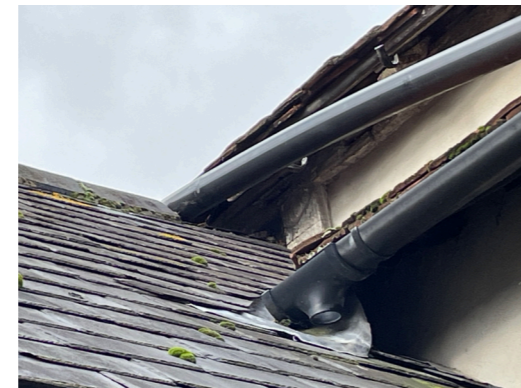
Another particular area of relevance is the abutment of the rear range roof against the main dwelling. The end ridge tile is not present as there is not enough space between it and the existing eaves detail. The gutter line is also broken here for the same reason.

Roof abutment viewed from east

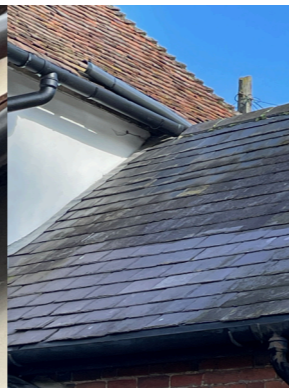
Roof abutment viewed from west
