**Frampton Garage
6 The Causeway
Coalpit Heath
South Gloucestershire
BS36 2PD**

NOISE IMPACT ASSESSMENT

Acoustics Report 2007/R01
17th June 2020

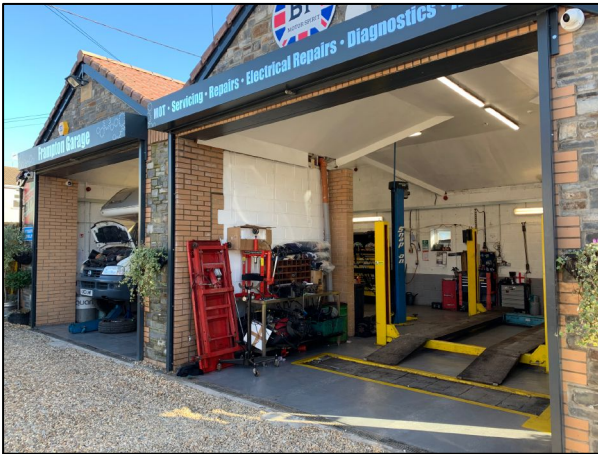
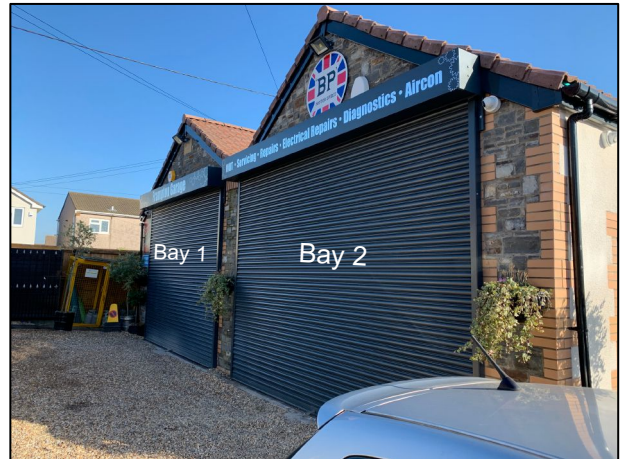
Views of workshop west façade, with bay roller shutter doors open and closed

The workshop, which contains two bays, is constructed of masonry walls, concrete floor and pitched concrete tiled roof with plasterboard ceiling; there are no acoustically absorbing materials within the space. The building only has one single small double-glazed window, which is located on the east façade. Access to the building is via metal doors on the south facade or via metal roller shutter doors on each bay on the west façade.

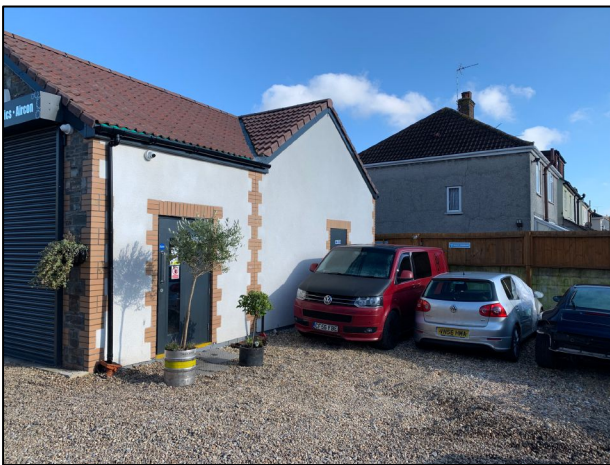
View of workshop south façade with Dwelling C in the background

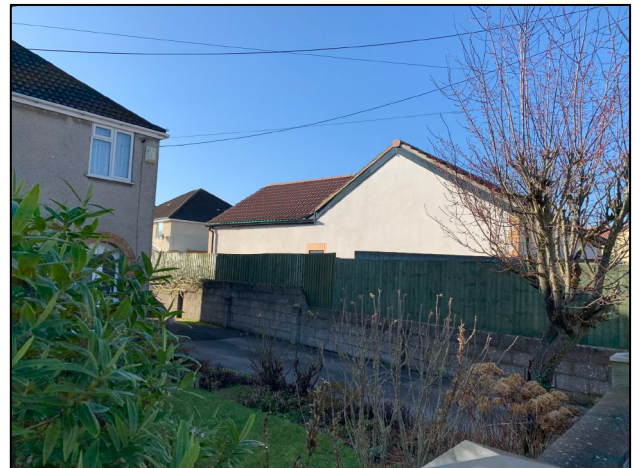
View of workshop east façade from The Causeway

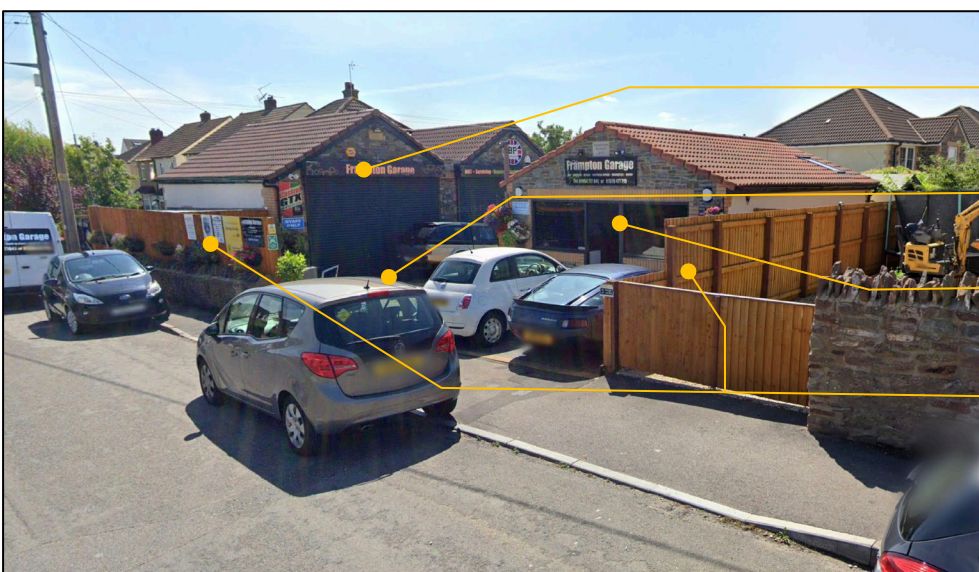
Figure 2. Site photos

- Workshop
- Car park entrance
- Garage office
- Boundary close-boarded fences

View of the workshop from The Causeway

This acoustic report documents a noise impact assessment of activity noise emissions from Frampton Garage's new additional workshop at 6 The Causeway, Coalpit Heath, South Gloucestershire; Figure 1 and 2.

Frampton Garage's new additional workshop is a single storey building, located at the north-east corner of Frampton Garage's car park at 6 The Causeway, Coalpit Heath, South Gloucestershire; Figure 1 and 2.

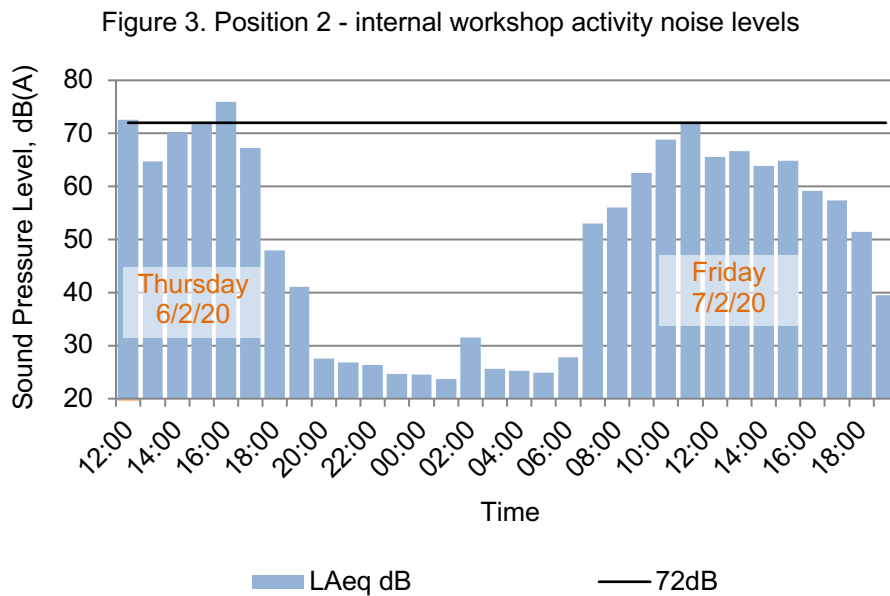
Frampton Garage’s new workshop was only operational during Thursday and Friday of the survey. Figure 3 provides the recorded 1hr ambient noise levels made within the workshop during this period (Position 2). Elevated noise levels can clearly be identified during the workshop hours, with ambient noise levels ranging between $L_{Aeq,1hr}$ 52 – 76dB.

Reviewing the survey data an internal workshop activity noise level of $L_{Aeq,1hr}$ 72dB is considered a suitable representative value for the purpose of the assessment; for the majority of the time the internal workshop activity noise levels are below this level.

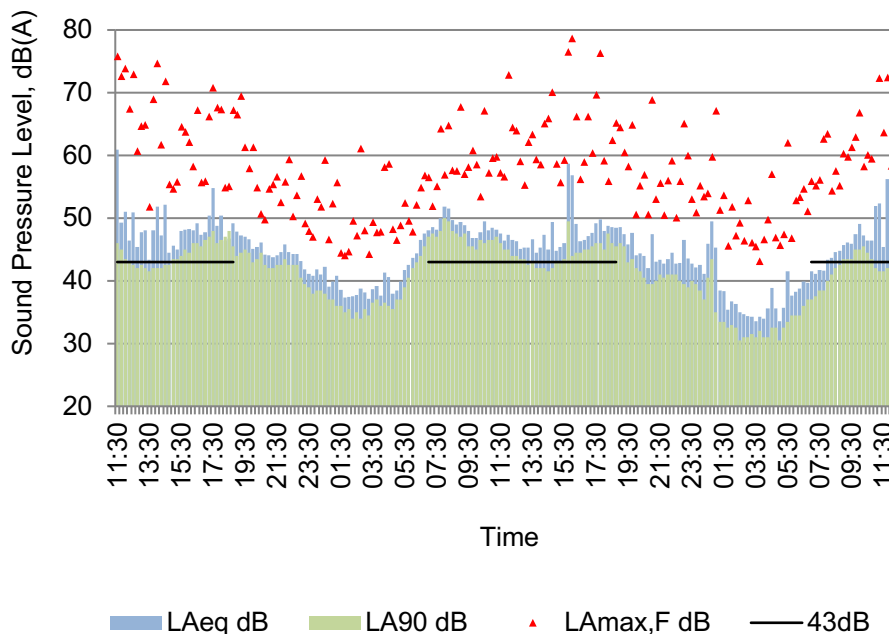
Figure 4. Position 1 - environmental noise levels (free-field)

Figure 4 shows the variation in the measured maximum (L_{Amax}), ambient (L_{Aeq}) and background (L_{A90}) noise levels over the survey period at Position 1. As can be seen there is the expected variation in the noise levels in relation to road traffic noise, with identifiable peaks during the morning and evening rush hours and a significant drop in noise levels during the night period.

There is no correlation in the noise levels recorded within the workshop and those made at Position 1. This indicates that with the roller shutter doors closed (which we understand was the case throughout the survey period) the influence of the workshop activity noise at Position 1 was negligible.

From the survey data a typical background noise level during the opening hours of the workshop has been established as L_{A90} 43dB. This value is considered representative to the typical background noise levels at the nearest noise sensitive receptors.

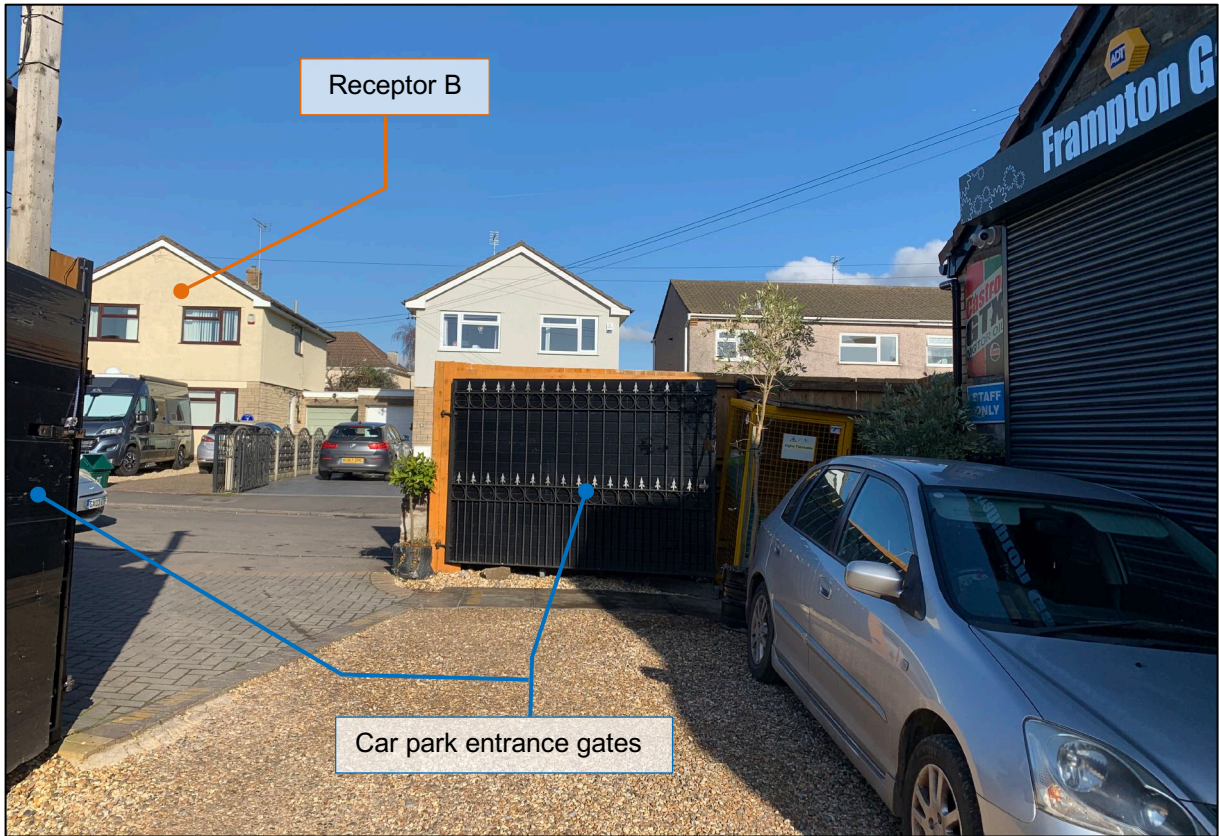
Figure 5. Photo with car park entrance gates identified

- **Car park entrance gate:** The car park has entrance gates (which were observed during the site visit to be left open during the opening hours of the workshop) consisting of two metal gates clad with a lightweight material; see Figure 5. Useful shielding attenuation of noise emissions from workshop bays (when roller shutter doors are open) for Receptor B can be achieved by closing the gates. To maximise the shielding attenuation the sound insulation of the gates should be upgraded and height increased to 1.8m (i.e. the height of the adjacent timber fence); a suitable sound insulation upgrade would be the replacement of the lightweight cladding with 18mm marine ply. Any gaps around the perimeters of the gates, for example the gap between the car park floor and the gates, should be as small as practical. With this upgrade a shielding attenuation of noise emissions of between 5 – 10dB is expected for Receptor B.
