REV	BRIEF DETAILS	DATE	26/03/21	PROPOSED ELEVATIONS	NO.	2331 / PD / 251	REV	CHECKED
				for	SCALE	1 : 100 @ A2	DATE	SEPT '23
				JOLLYBOYS BAKERS LANE FELSTED DUNMOW CM6 3LP	DRAWN	OZ		
					<b>KAY PILSBURY THOMAS ARCHITECTS</b> TEL 01799 599208 FAX: 01799 599965 www.kpt.co.uk info@kpt.co.uk HONEYLANDS, RADWINNER, SAFFRON WALDEN, ESSEX, CB10 2TJ

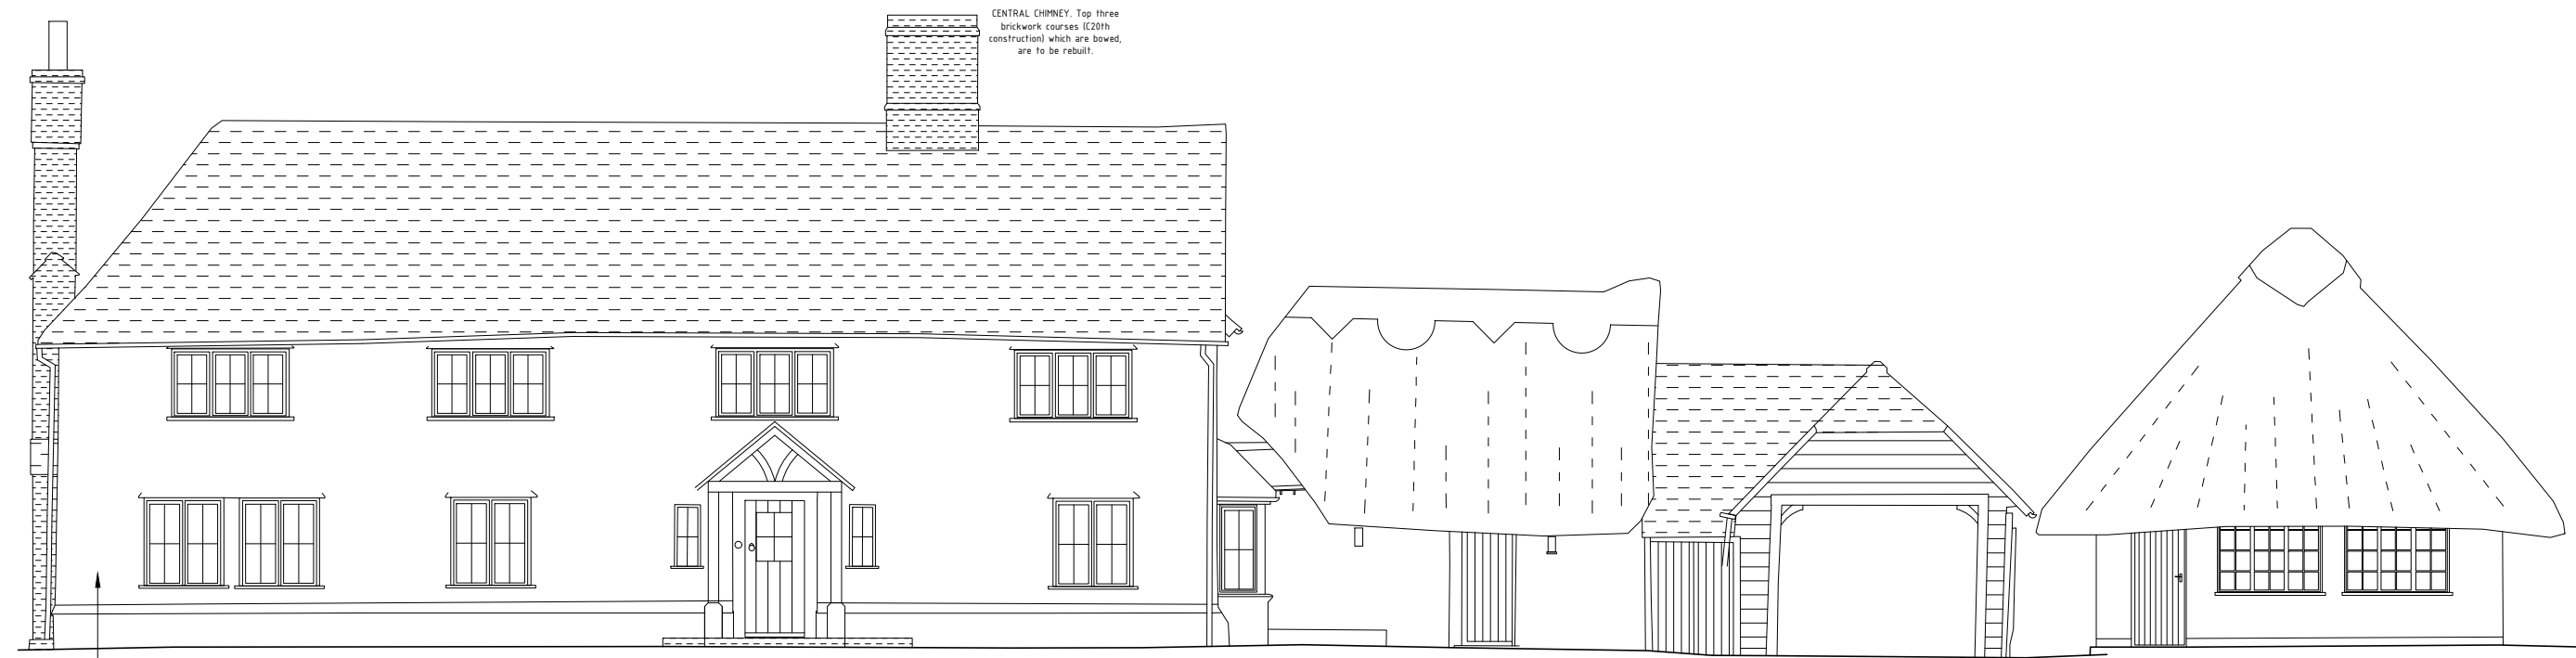
**ELEVATION SOUTHWEST**

Replace circa 1970s cement render and mesh. Carefully remove mesh, repair frame if required using conservation splice techniques. Insulate with breathable insulation, savolit and lime hair plaster

Replace circa 1970s heavy cantilevering physically damaging porch and door with a lightweight open oak structure on oak posts with peg tile roof and painted timber door style more in-keeping.

FRONT ELEVATION WINDOWS NOTE: C20th windows on main house have a fine extant LBC permission UTT/13/0293/AB (as part of built out rear extension) to be single glazed timber flush casements with cross integral glazing bars. There were no window conditions that needed discharging.

CENTRAL CHIMNEY: Top three brickwork courses (C20th construction) which are bowed, are to be rebuilt.

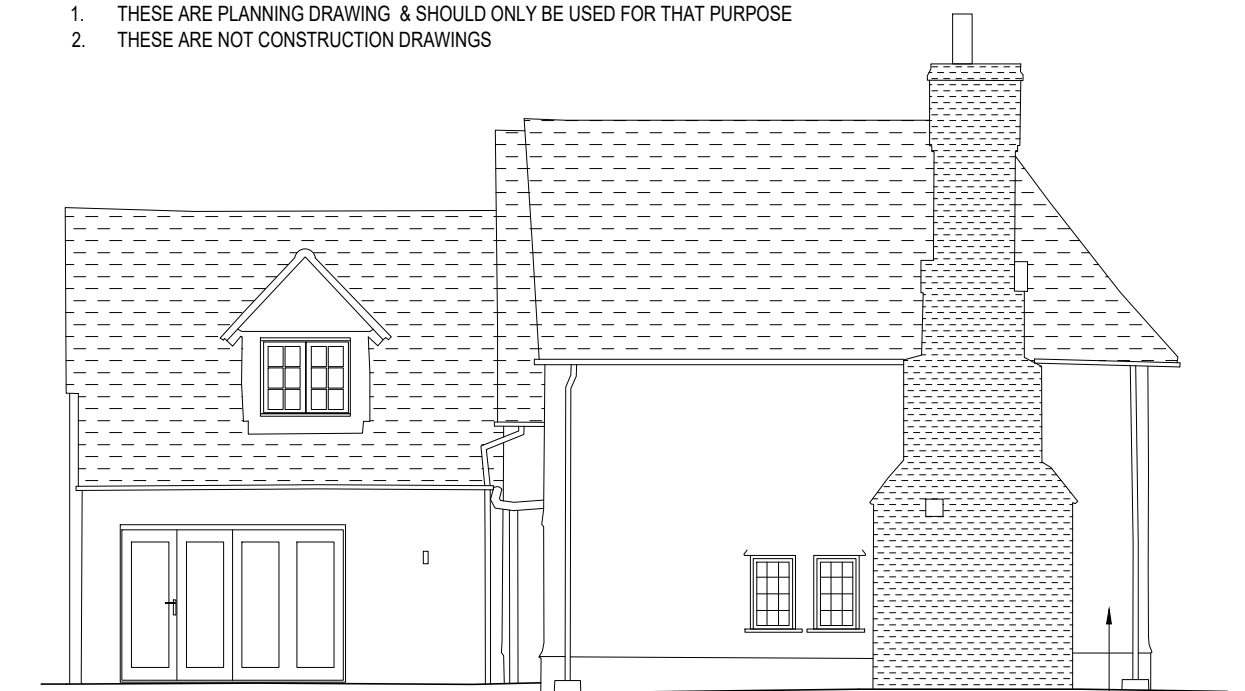
**ELEVATION NORTH-WEST**

SIDE ELEVATION WINDOWS NOTE: C20th windows have a fine extant LBC permission UTT/13/0293/AB (as part of built out rear extension) to be single glazed timber flush casements on the old (pre 1948) house with cross integral glazing bars. There were no window conditions that needed discharging.

Replace circa 1970s cement render and mesh. Carefully remove mesh, repair frame if required using conservation splice techniques. Insulate with breathable insulation, savolit and lime hair plaster

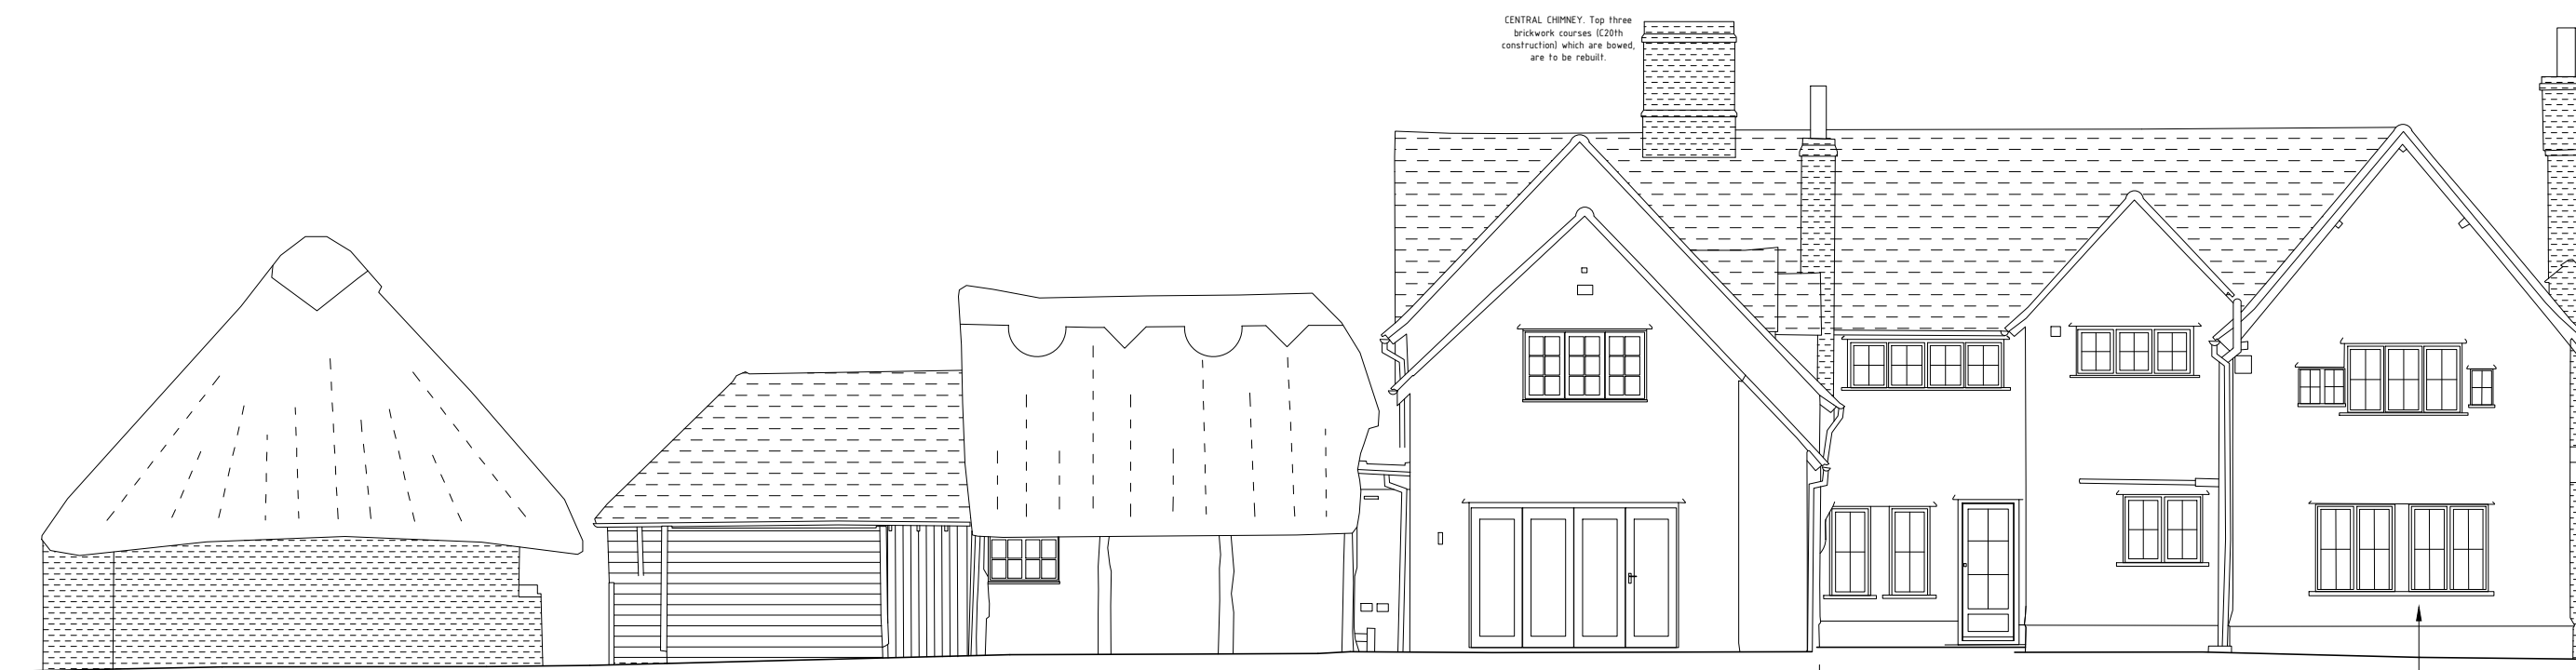
**ELEVATION NORTH-EAST**

CENTRAL CHIMNEY: Top three brickwork courses (C20th construction) which are bowed, are to be rebuilt.

REAR ELEVATION WINDOWS NOTE: It is proposed to replace the C20th windows with six line double glazed timber flush casements only on the rear of the old (pre 1948) house with cross integral glazing bars. Refer to detailed primary drawing ref: 2319/0256 Window details.

Replace circa 1970s cement render and mesh. Carefully remove mesh, repair frame if required using conservation splice techniques. Insulate with breathable insulation, savolit and lime hair plaster

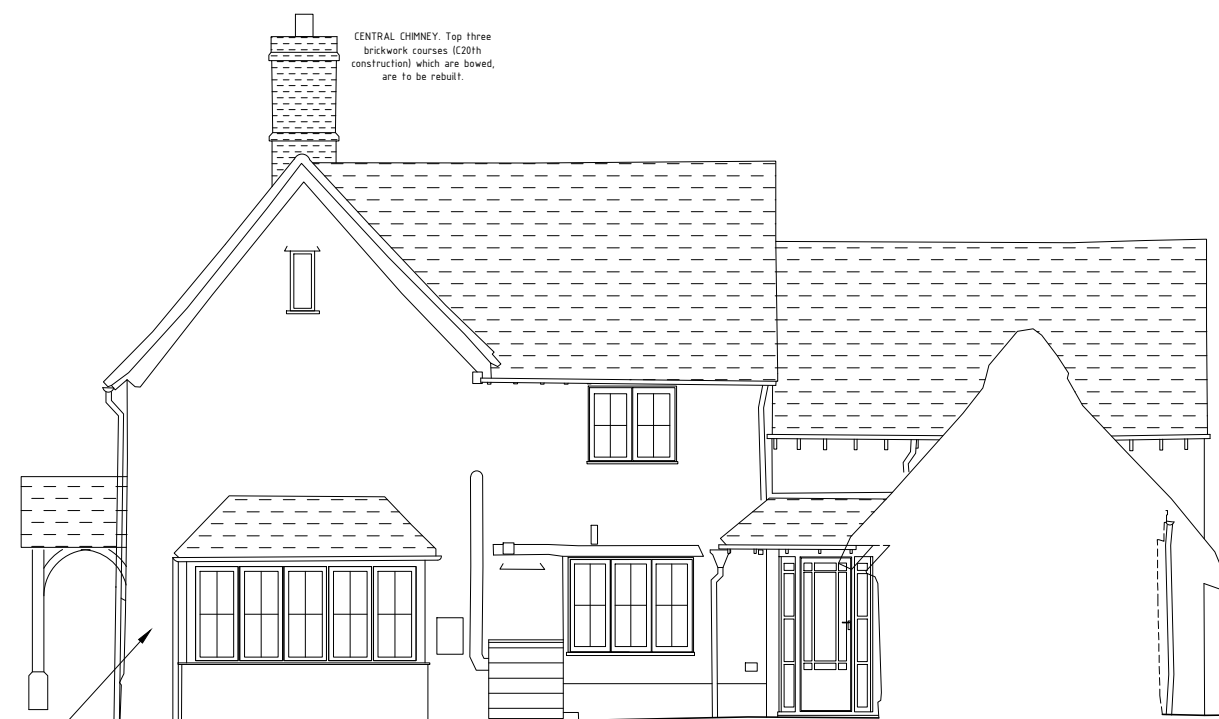
**ELEVATION SOUTH-EAST**

Replace circa 1970s cement render and mesh. Carefully remove mesh, repair frame if required using conservation splice techniques. Insulate with breathable insulation, savolit and lime hair plaster

SIDE ELEVATION WINDOW NOTE: C20th windows have a fine extant LBC permission UTT/13/0293/AB (as part of built out rear extension) to be single glazed timber flush casements on the old (pre 1948) house with cross integral glazing bars. There were no window conditions that needed discharging.

CENTRAL CHIMNEY: Top three brickwork courses (C20th construction) which are bowed, are to be rebuilt.
