DOBSONS MILL, HIGH STREET, BURGH LE MARSH, LINCOLNSHIRE PE24 5JT: REINSTATEMENT WORK  
DESIGN, ACCESS AND HERITAGE STATEMENT

This statement has been prepared in support of a Planning and Listed Building Consent application to Lincolnshire County Council for consent to remake and reinstate the cap, sails and fan, with associated walling repairs and external wall redecoration.

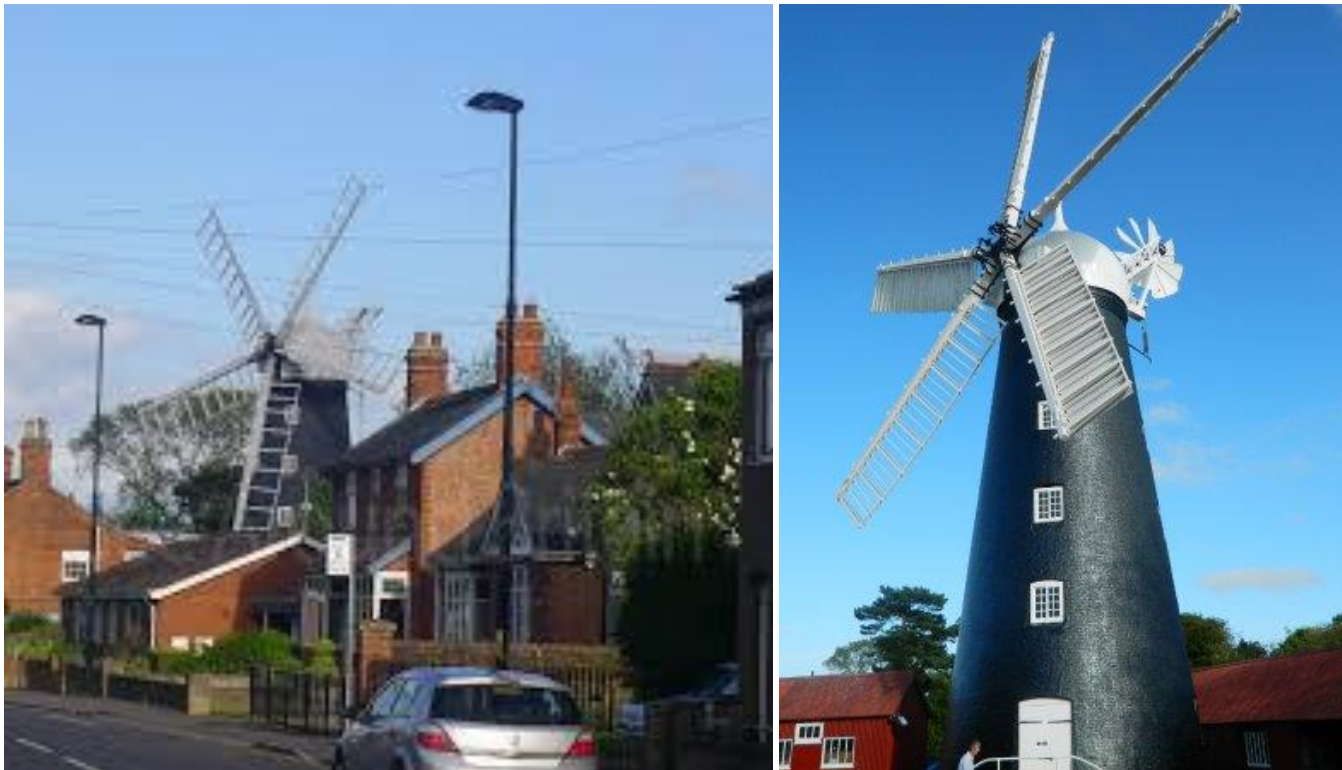
Mill images before gale, taken from web

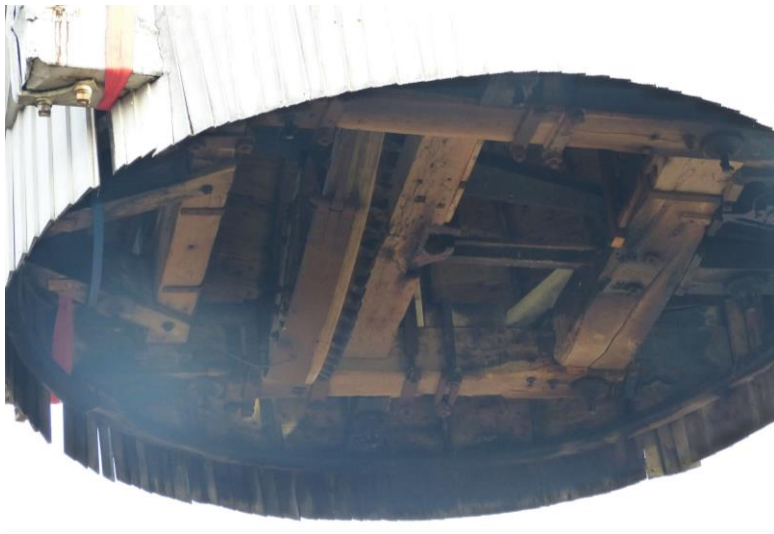
Cap underside during lifting for 2013 repairs / renewals

**3.3** The brick tower and the floors appear all to be of the plausible 1844 date. External finishes have been “refreshed” at intervals. Internal finishes are generally modern relatively impermeable paints. The smashed cap and sail parts incorporated some work from the 1844 improvements but large amounts of timber will have been renewed during regular repairs, especially in 1947 and 2013.

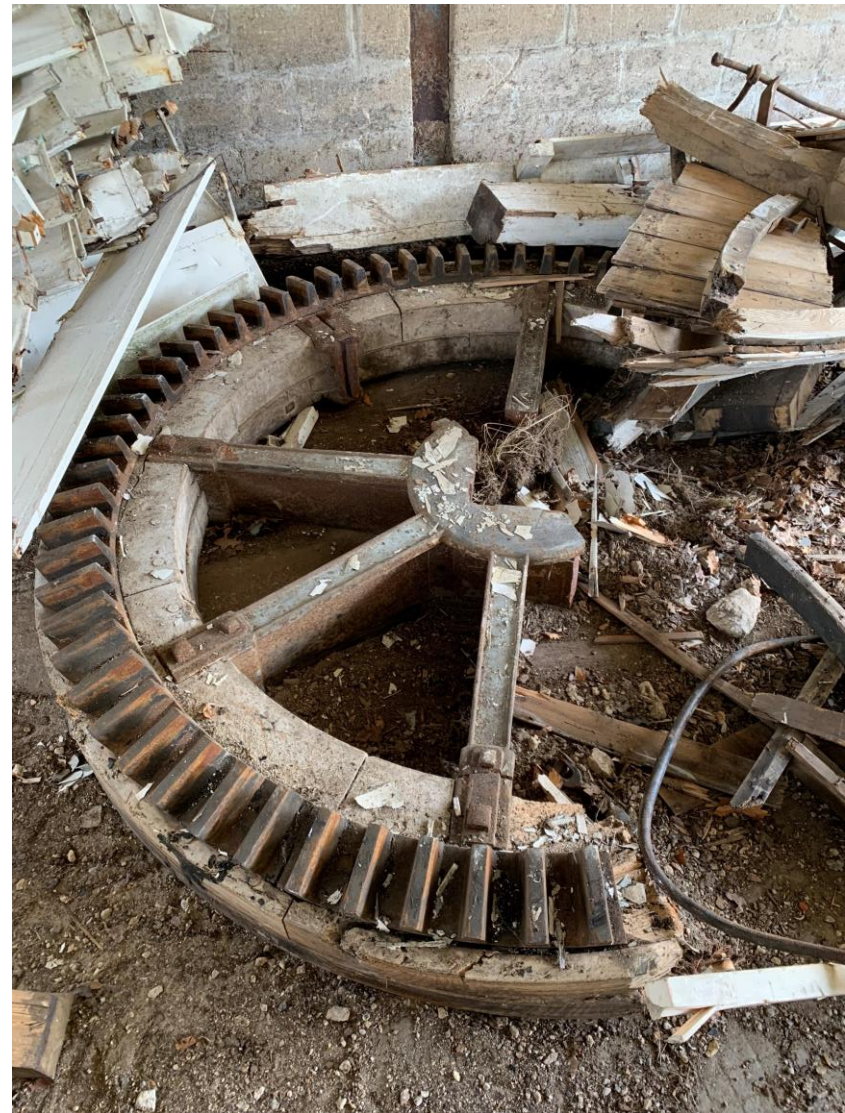
Brake wheel in current broken state following 2020 gale

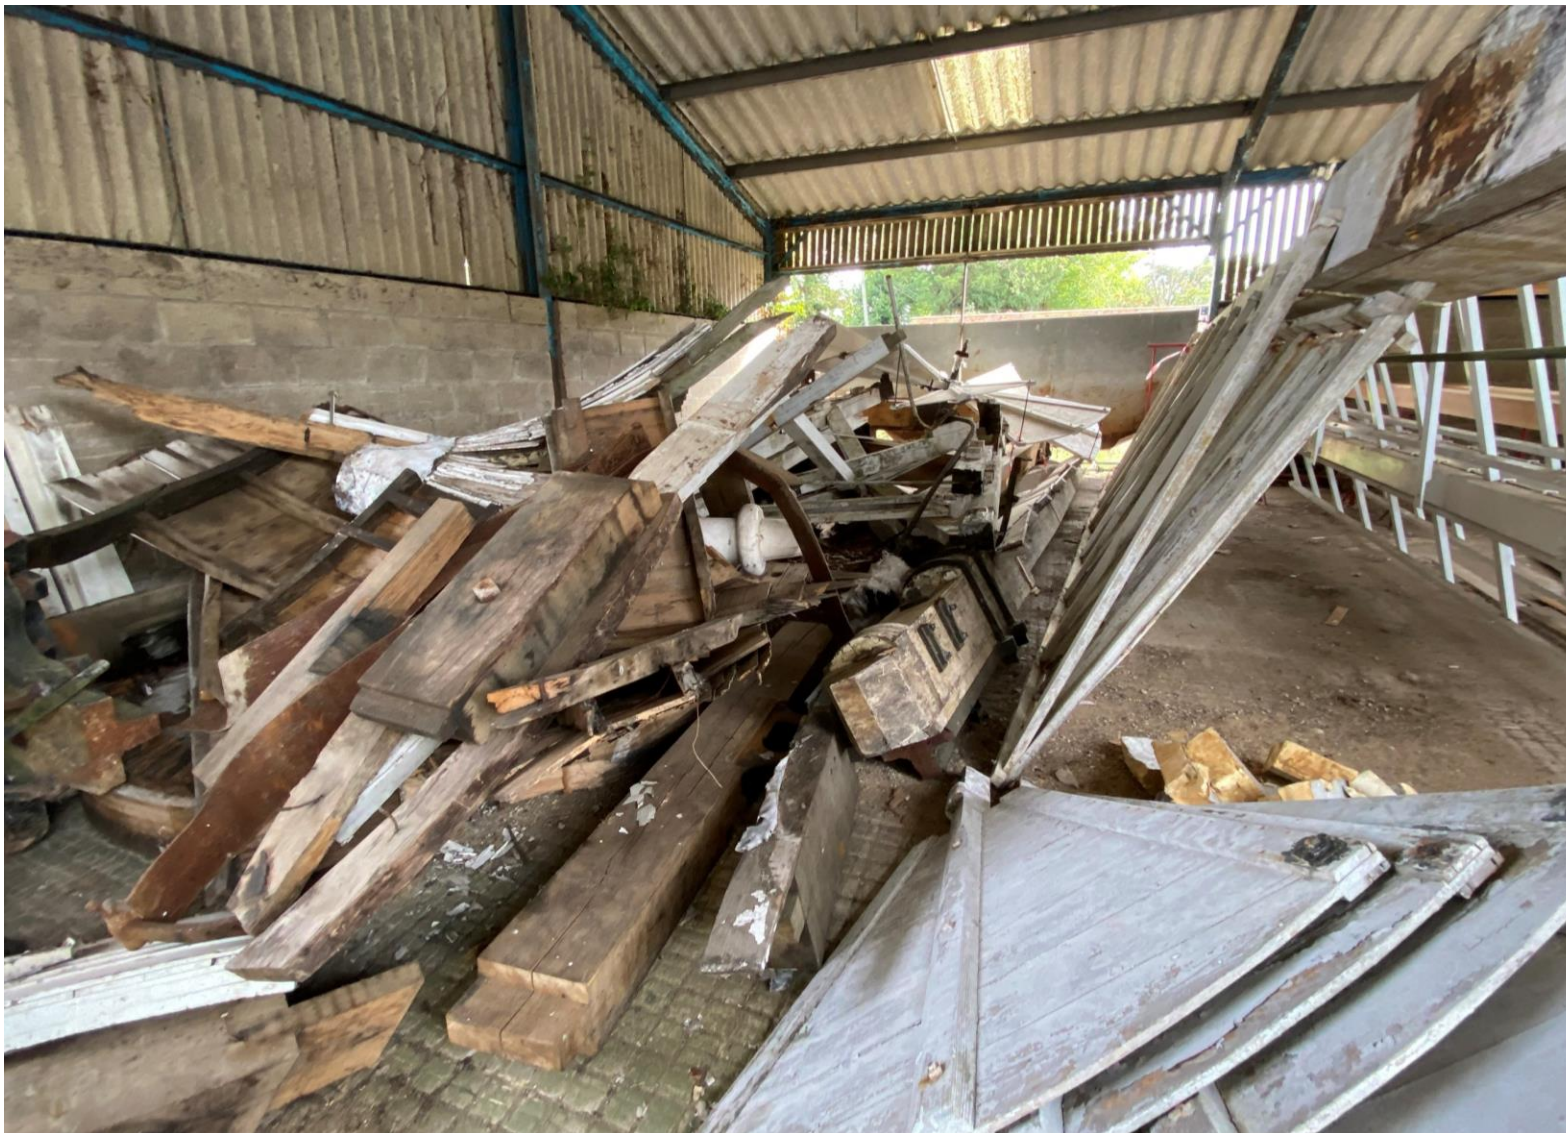
Fallen and broken parts in storage

The cap, sails and fan were blown off the mill in a gale in 2020 and a temporary roof is in place. The damaged parts, both salvageable and beyond reuse were removed to safe storage and it is now planned to reinstate the missing and damaged parts so that the mill functions and turns to wind once more. The mill will be better preserved in the long term by being complete and usable.
