ST ANDREW'S CHURCH, BISHOPSTONE, EAST SUSSEX: PLANNING APPLICATION FOR EXTENSION TO NORTH AISLE

HERITAGE STATEMENT

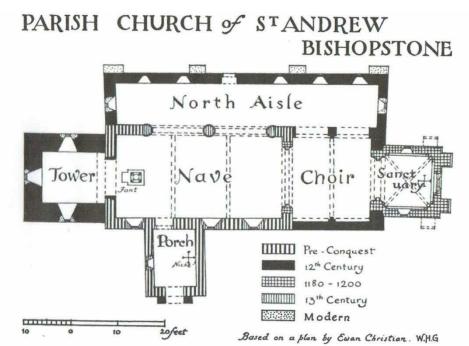
- 2.2 The early church consisted of the present nave, with a porticus on the south side, subsequently converted into a porch. It is assumed that there would have been a similar porticus on the north side, but this would have been destroyed when the north aisle was constructed. A porticus was a side chapel, with entry only from the body of the church, and an altar against the east wall. In the early church the entrance would have been in the west wall of the nave, and it is assumed that the later construction of the tower, which has no external entrance, was coeval with the conversion of the south porticus into a porch with a new central external south doorway.

- 2.4 The date of the early church has left scholars divided, some preferring an early date in the 8th or 9th C, while others prefer the 10th to 11th C, but agreement exists that it is pre-conquest, supported by the rare survival of the porticus. Other survivals of the early church, as the plan above indicates, are the nave south and west walls and parts of the north and east walls although most of the latter were destroyed by later alterations.

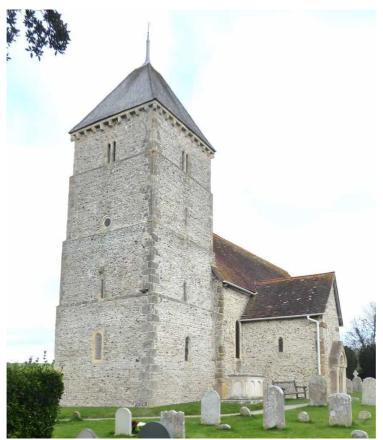
Tower, and porticus to right

- 2.6 The tower is of four reducing stages, finishing with a corbel table where the roof rises, and of flint which apparently was once plastered, again with mostly Caen stone dressings. The ground floor round-headed windows are modern. Windows in the second and third stage are narrow and tall. At the top stage, belfry level are similar double openings. The tower was built without disturbing the older west wall of the nave, although the wide and low arch through that wall must be of the same date. A large arch was thrown across behind the nave wall to carry the upper part of the east wall of the tower this arch was not visible from the nave, and neither were the small high-level windows in the east wall of the tower.

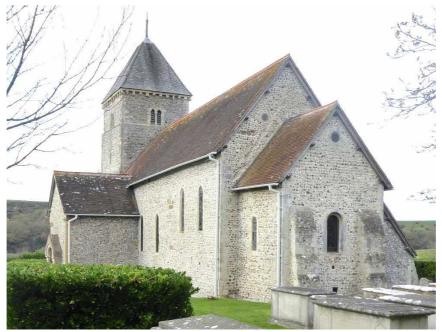
- 2.9 The small square sanctuary, lower and narrower than the choir, was the last of the Norman building, It has water leaf capitals inside, round arched windows, much renewed, massive buttresses to the east and a single circular window in the gable. It is thought to date to around 1175.

Church from the east, showing sanctuary, and choir as extension of the nave

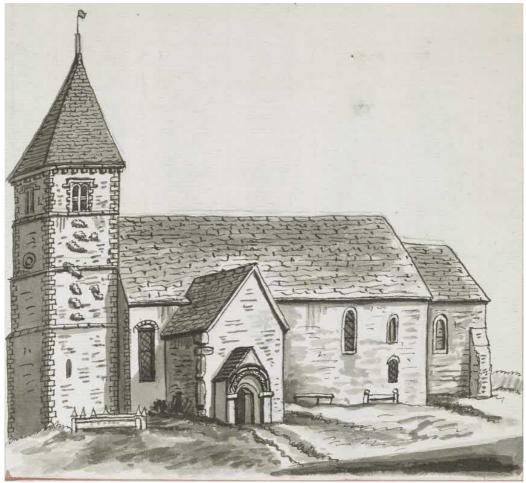
The Burrell view of the Church of 1777

- 2.11 There seems to have been little change in the church after the 13th C. Two blocked 16th C windows were found in the chancel in 2007, and preserved. Post-reformation changes included a south nave window perhaps of 18th C date and shown in the sketch of the church which accompanied the notes made by Sir William Burrell when he visited in 1777. Internally flat plaster ceilings are shown in a drawing of 1820; the massive north aisle buttresses may well date from the same year.

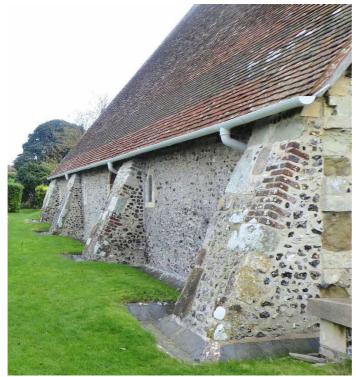
The 12th C north aisle with later buttresses

- 2.8 The construction of the tower was followed by the construction of the choir or chancel, and perhaps the north aisle, with its small round headed windows of early 12th C date (except for the 19th C west and east windows), at the same time the arcade to the nave appears to have been built or rebuilt at the end of the 12th C, and the precise sequence of construction here is not clear. Unusually the choir was built as wide and as high as the nave, with arcades to the north and south, that to the south being blank.

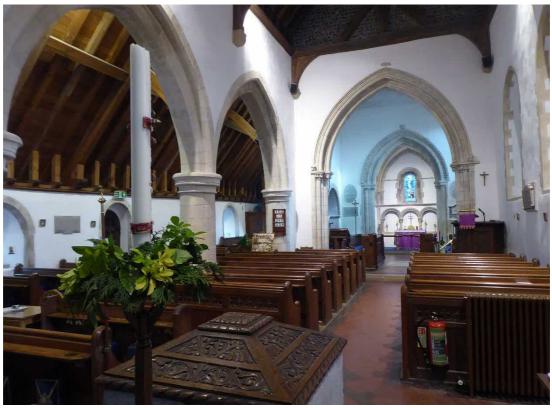
Internal view looking east from the nave into the choir and sanctuary, with the north aisle to the left.

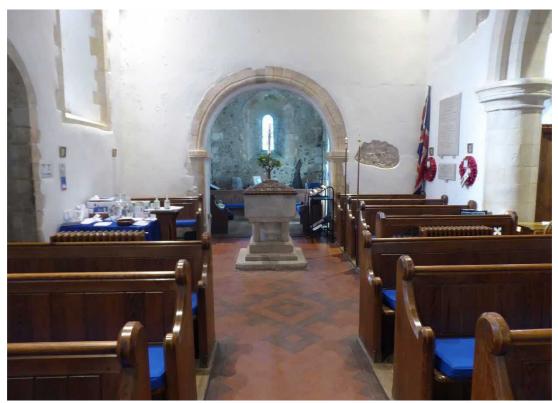
Internal view looking west from nave into the base of the tower

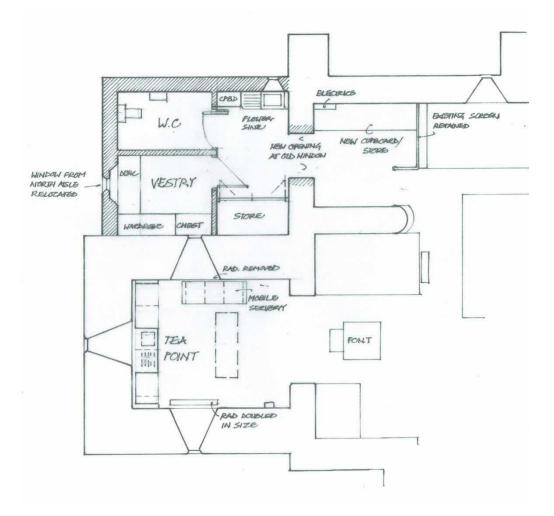
4.3 The extension is on the site of the present underground boiler room, and would require a doorway to be constructed through the west wall of the north aisle, roughly in the location of the existing west window. The proposal is that the extension will touch the north aisle and tower north walls, with the aisle north wall and aisle roof continuing westwards along the tower north wall. Drainage for the wc etc would be via gravity drainage across the narrow north area of the churchyard into the adjacent village green where there is mains drainage.

Plan of west end of church showing tea point and wc extension

- 4.2 The tea point is not part of this application, but, as an essential part of the scheme, brief comment will be made on the proposal. The tea point would consist of low-level fixed units, spaced slightly away from the tower west wall to allow ventilation. There will be in addition a mobile servery which at rest would be positioned next to the north wall of the tower, on casters so that it could be moved out to serve behind when in use. It is proposed that the units and mobile servery be constructed in oak to match other furniture in the church.
