PROPOSED REAR ELEVATION B-B

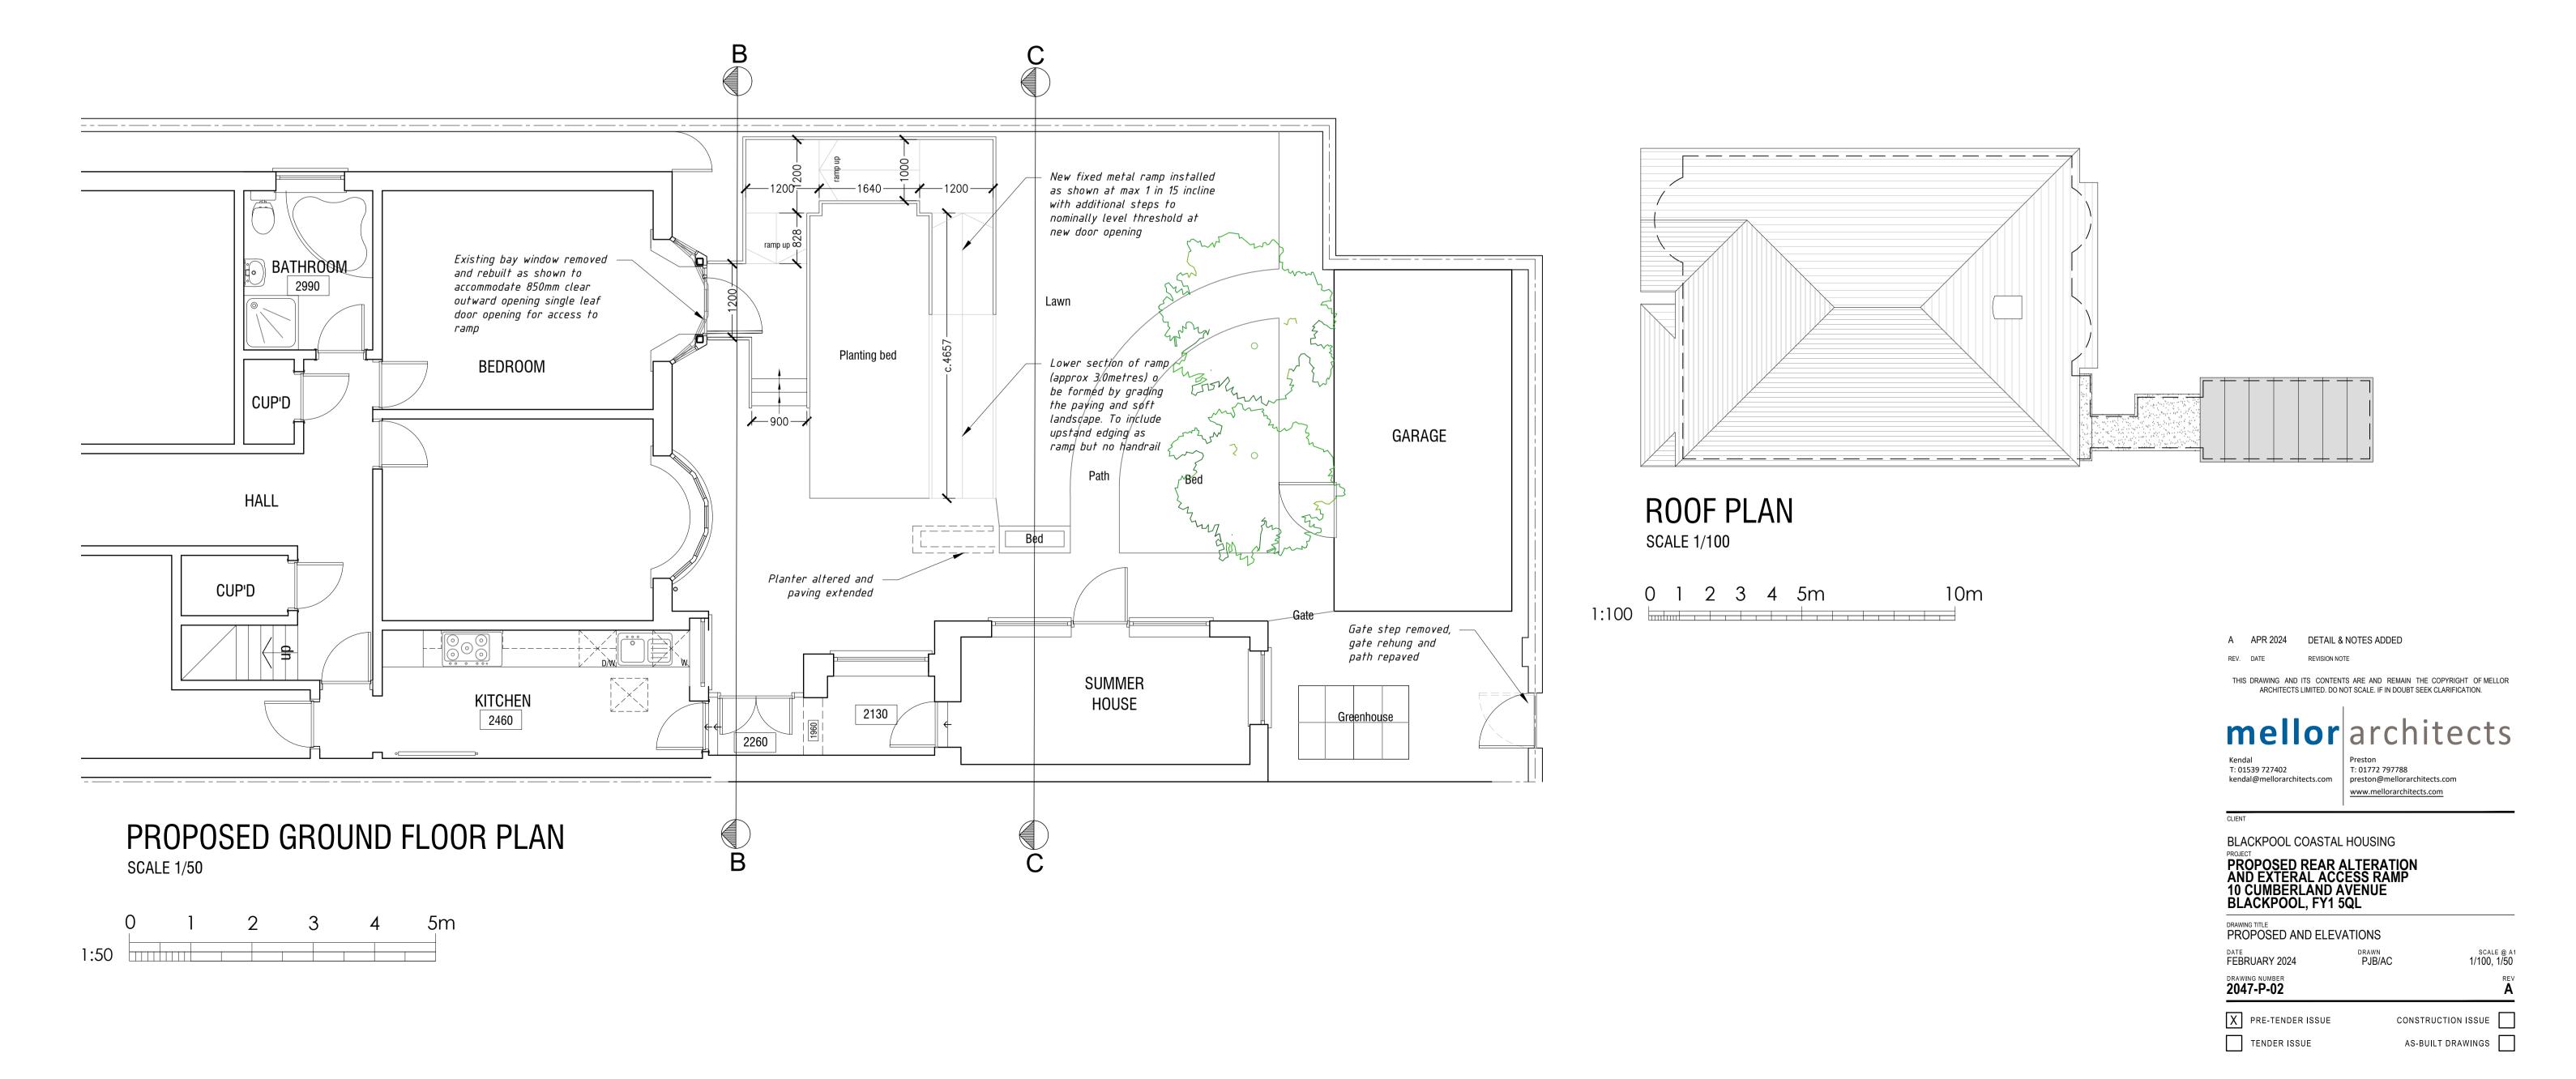
Main roof and overhang to bays to

Existing bay window to be removed

and rebuilt as shown with straight

face to accommodate a 850mm clear

outward opening single leaf door

opening for access to ramp

be unchanged

Second bay to

remain unchanged

FFL -0.325
