Heritage Statement **REV A**

Site: Soames Farm, Nine Ashes Road, Stondon Massey, Brentwood, CM15 0EL.

Proposal: Replacement windows, removal of cement render and installation of woodfibre boards and lime render, and insertion of insulation.

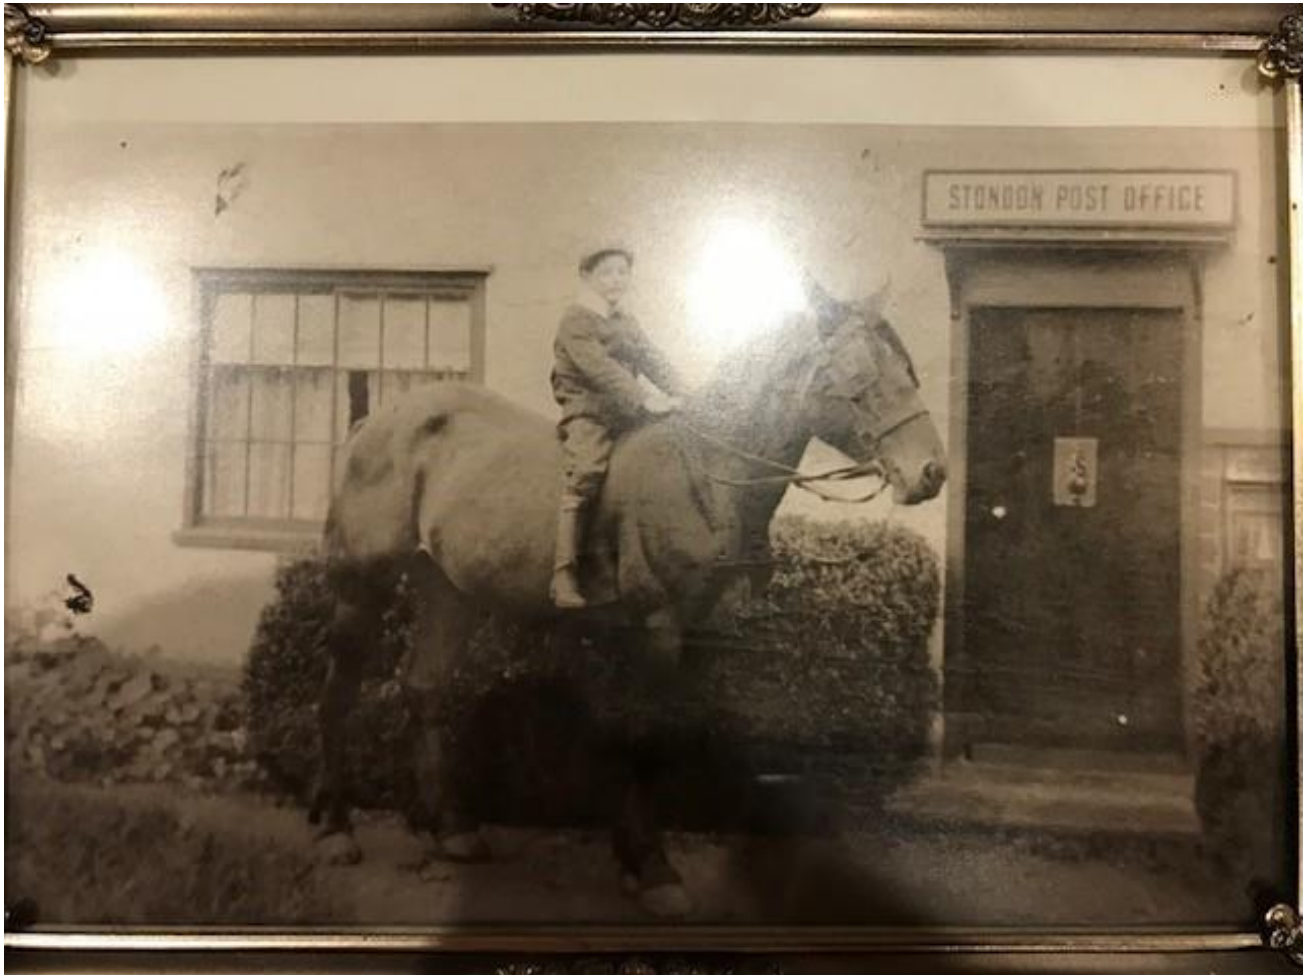
- 2.7 Below is a historic photograph of the front elevation. There is no date on the photograph, but what it does show is that the windows historically were once horizontal sliding timber windows. Furthermore, the window opening sizes appeared to have been altered since the time of this photograph. The only remaining feature from the photograph is the door surround, which is still present. It would appear the photograph dates from somewhere between 1920-1940.

Fig 1. Historic Photograph of when the building served as the village post office (un-dated)

- 3.1 The existing windows to the front (east) elevation are mid-20th century metal casements with lead lights. The historic photograph supports the evidence that the windows had been changed from sliding timber units.
- 3.2 The remainder of windows are a mixture of timber windows most likely dating from the early 20th century, with exception for the metal casement window to the ground and first floor stairwell, metal casement windows to the side (north) elevation ground and first floor, and a Victorian metal window to the North elevation bedroom.
- 3.3 The condition of the windows to the front (east) elevation are poor. The cills are completely rotten and the paint has peeled from most of the frame. The lead comes are in a good condition, however the windows are not of any historical value. (refer to window types 01 to 05 and photographs below)

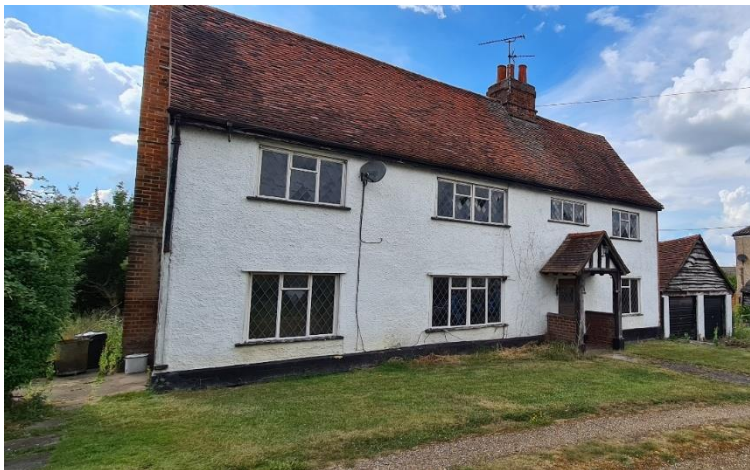
Fig 2. Photograph of the front elevation

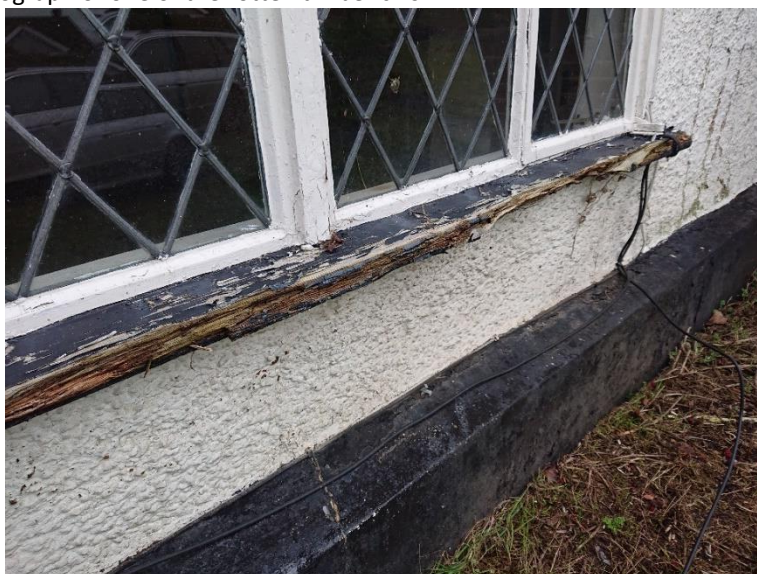
Fig 3. Photograph of one of the rotten timber cills

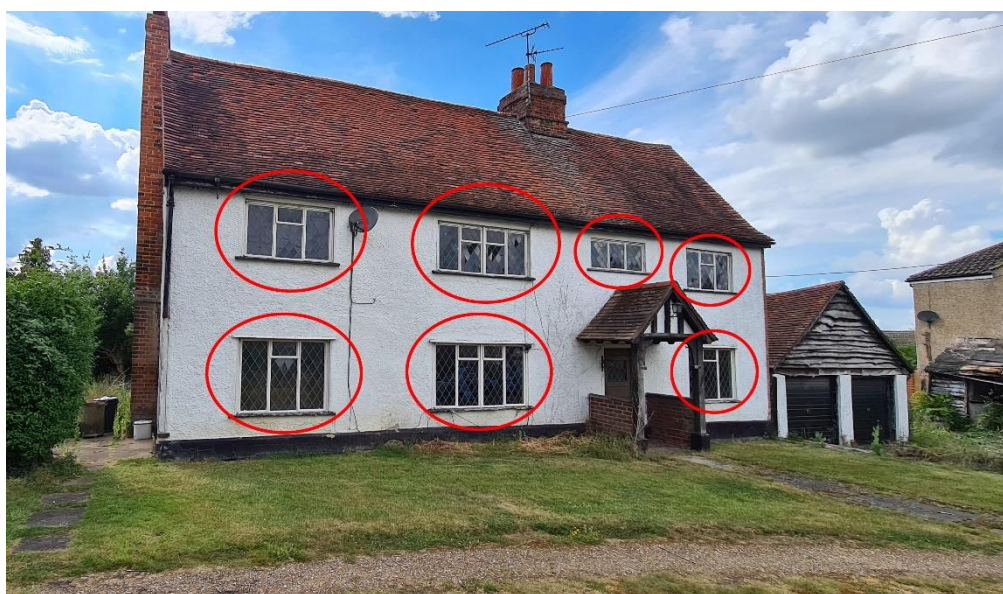
Fig 4. Front elevation – Metal frame 20th century windows

- 4.2 The windows to the front elevation are in poor condition and of no historical merit and therefore need to be replaced to ensure continued deterioration does not occur, which may lead to water egress and damage to the frame of the building. (Windows W1 – W5).

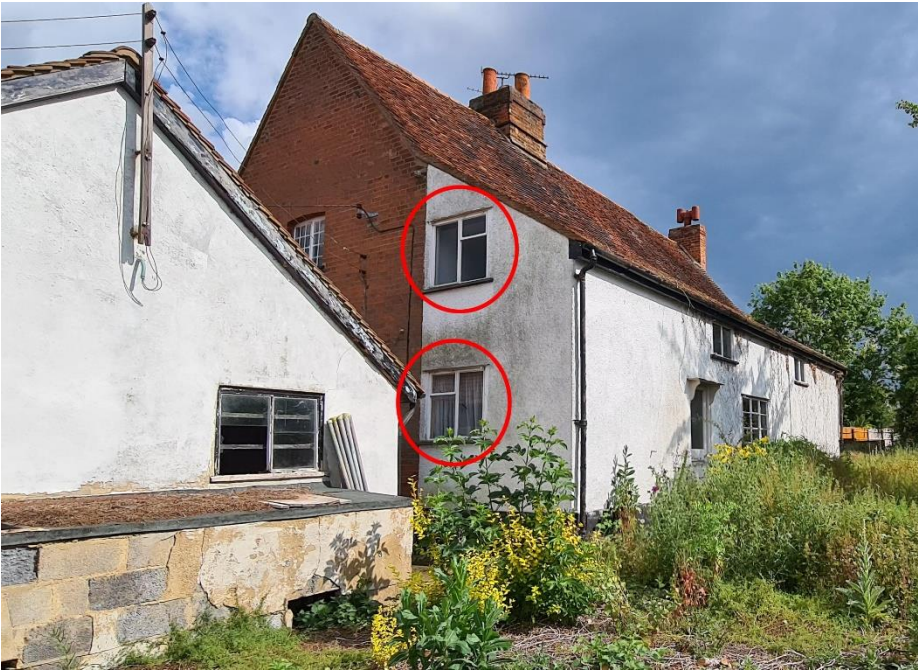
Fig 5. Side elevation (north) mid-20th century metal framed windows to be replaced.

- 4.3 The two windows indicated on the side elevation (north) are mid 20th century metal frame casement windows and are completely out of character with the appearance of the building. The metal frame window types from this period reflect a more modern style of architecture associated with post war architecture, not listed timber frame farmhouses. It is therefore proposed to replace both of these windows (window W06).

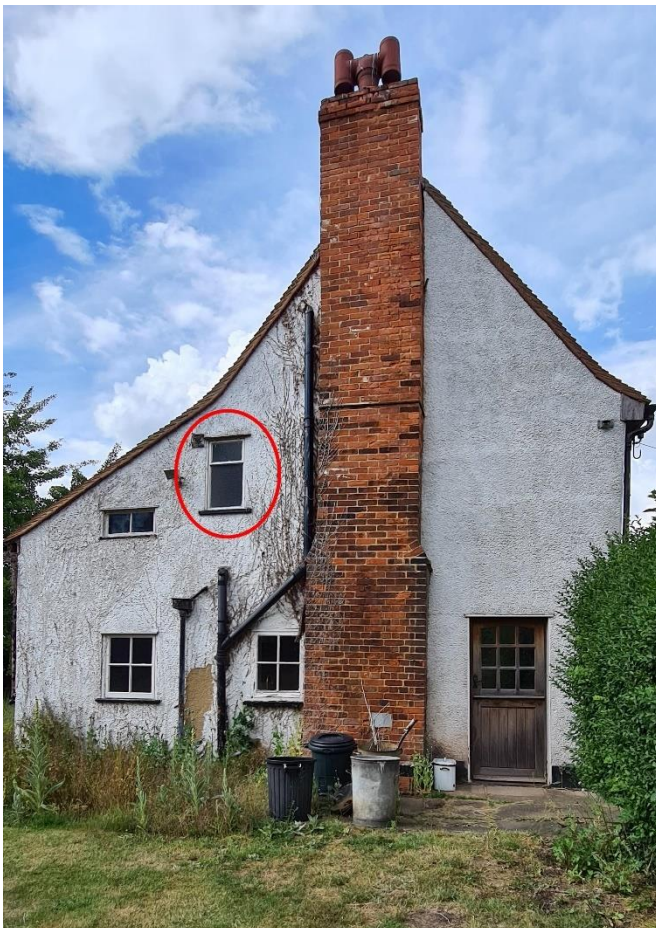
Fig 6. Side elevation (south) mid-20th century metal framed windows to be replaced.

- 4.4 The windows to the side elevation (south) are a mixture of timber windows and a metal casement window to the bathroom. In order to reform some continuity, the proposal is to replace the metal casement window in the bathroom to result in all the windows to this elevation being timber.
