SURFACE WATER:

THE PROPOSED LAYOUT IN THIS DRAWING SHOWS THE PROPOSED LAYOUT OF THE SURFACE WATER INFILTRATION SYSTEM AT THE SITE.

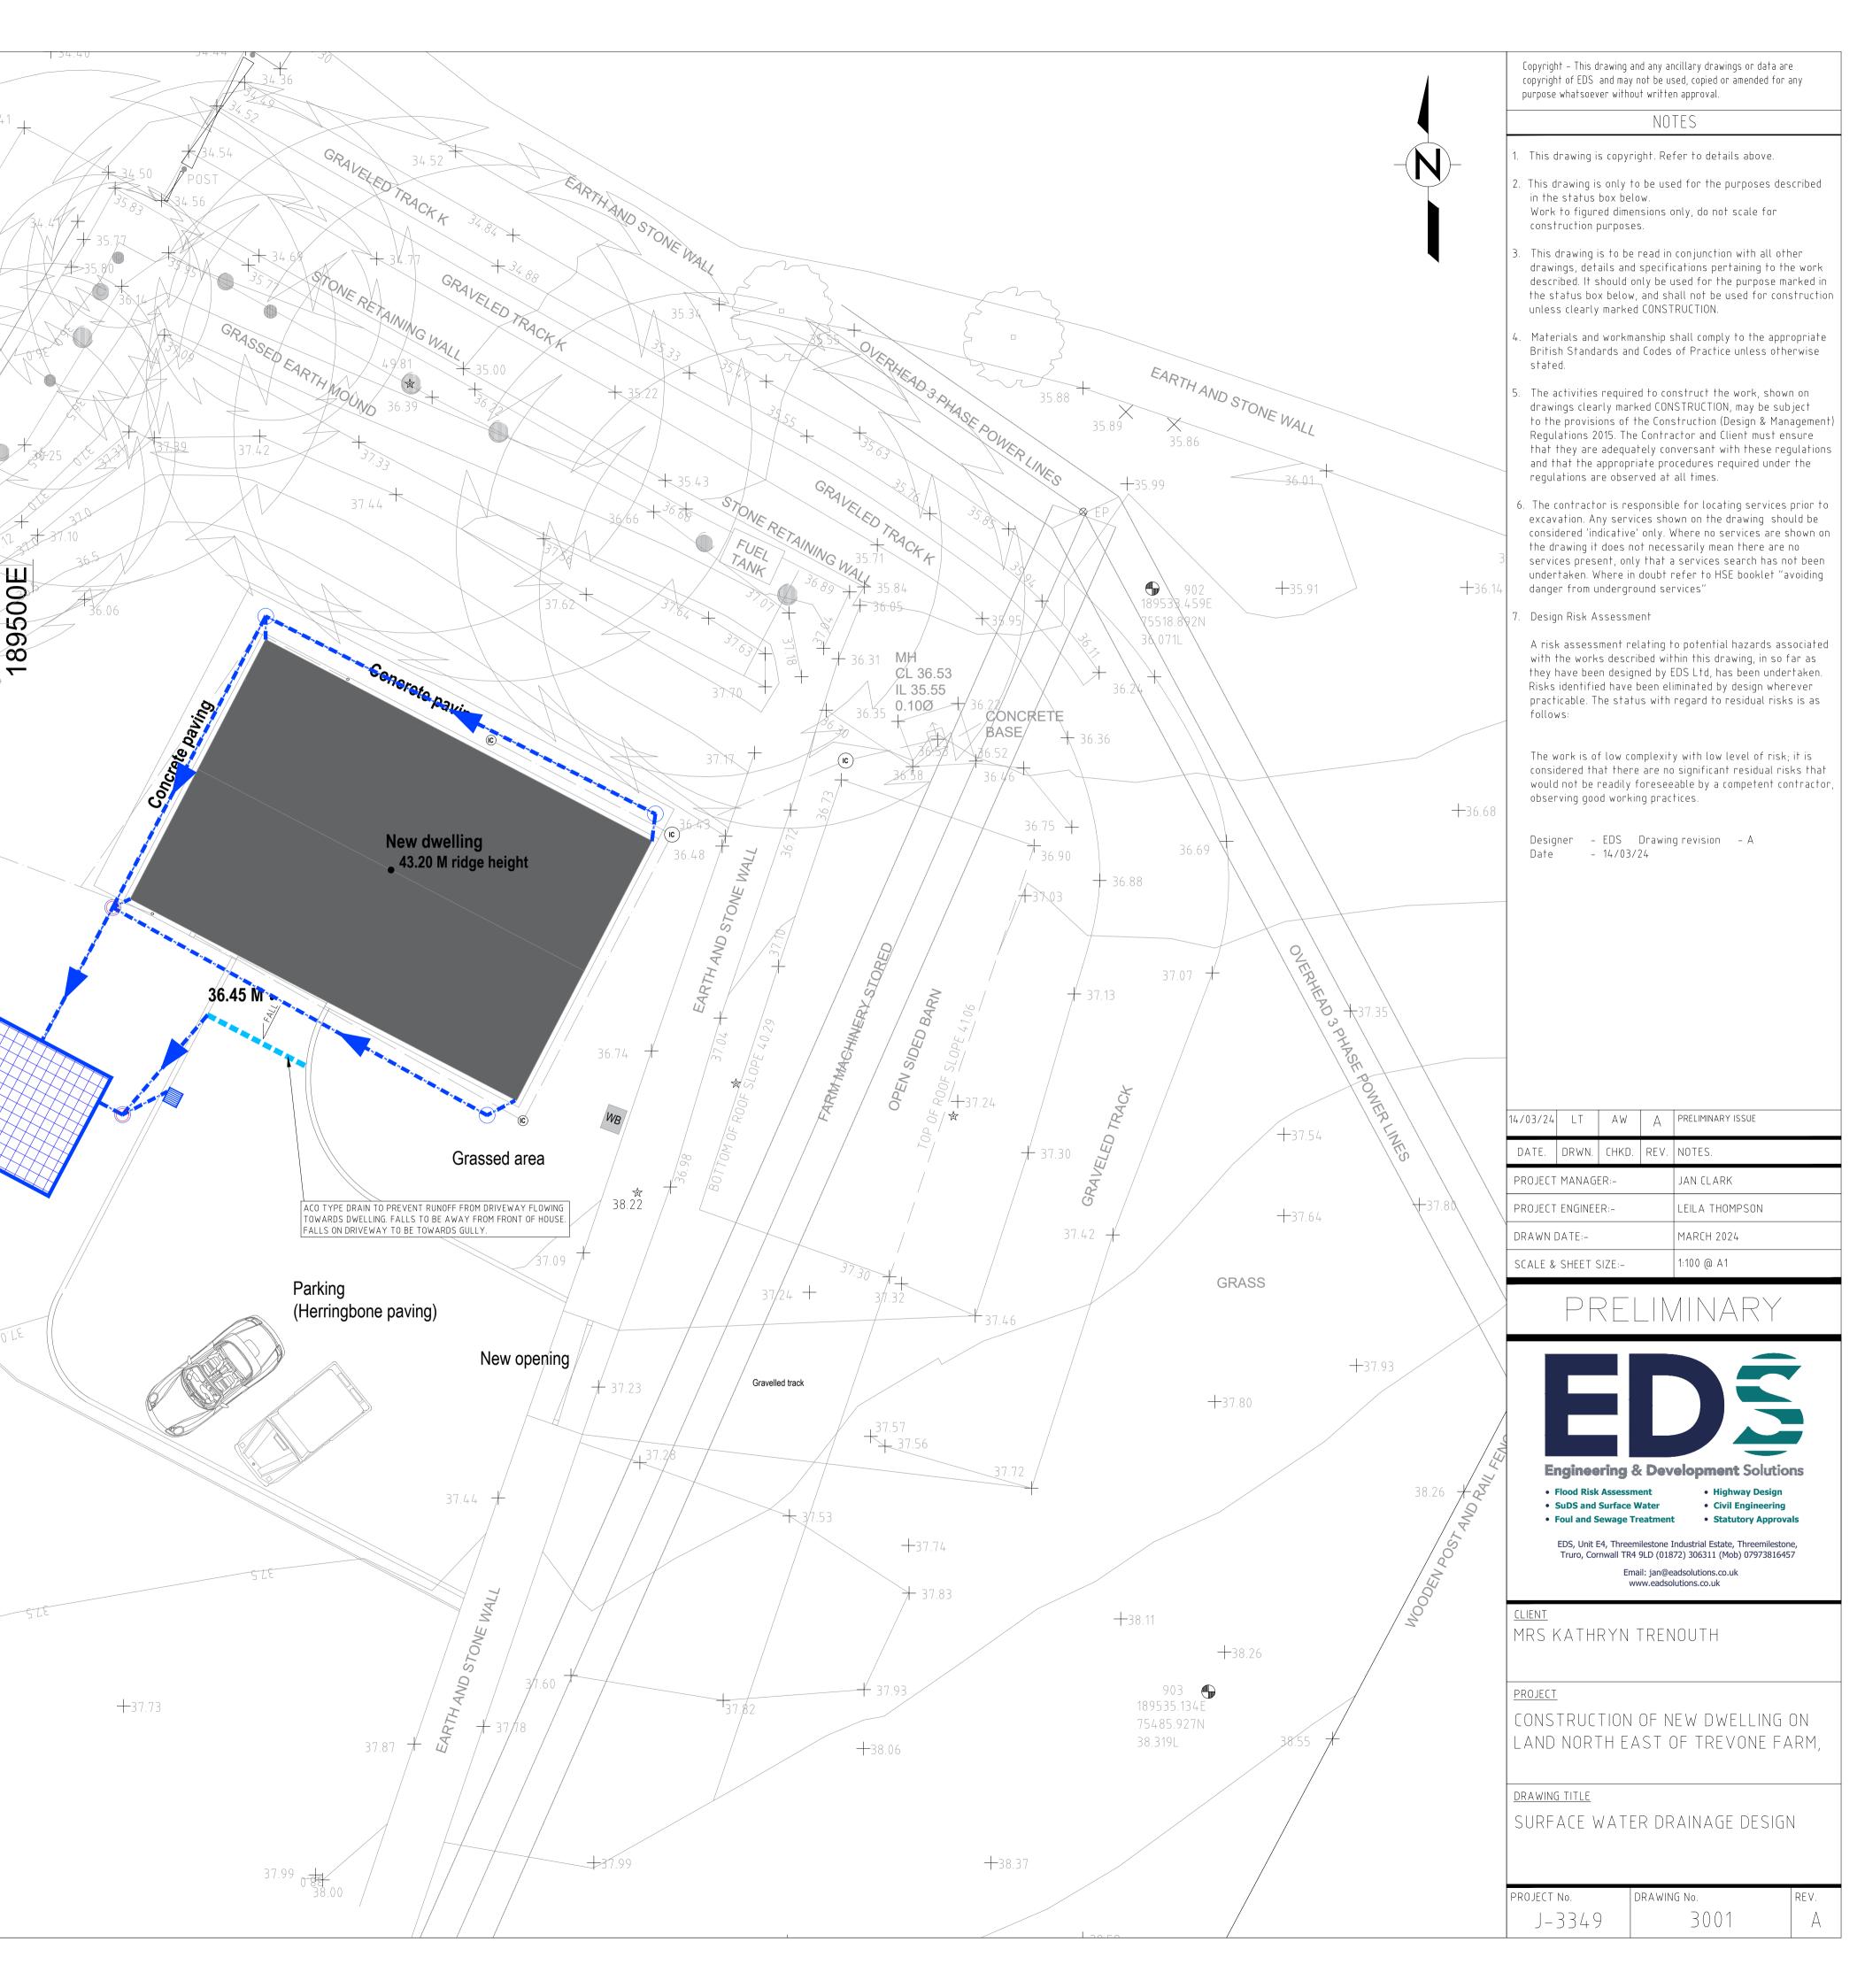
-		
	136.66		
	Bore hole		
	+36.64		/
	50.04		
		PROPOSED SOAKAWAY COMPRIS UNITS WITH 95% VOID RATIO 4m	
		CL 36.50 (APPROX)	
		TOP OF SOAKAWAY 35 20

TOP OF SOAKAWAY 35.20 BASE OF SOAKAWAY 34.00

Grassed area

THE SITE IS LOCATED IN THE VILLAGE OF TREVONE, NEAR TO PADSTOW. PERCOLATION TESTS WERE UNDERTAKEN ON SITE TO BRE 365 TO DETERMINE WHETHER THE IMPERMEABLE AREAS CREATED BY THE PROPOSED DEVELOPMENT COULD BE DRAINED BY INFILTRATION. TESTS CONFIRMED THAT AN INFILTRATION DRAINAGE SYSTEM COULD BE USED TO DISCHARGE SURFACE WATER FROM THE PROPOSED DEVELOPMENT. THE FOLLOWING RATE HAS BEEN USED FOR THE CALCULATIONS TO DETERMINE THE DIMENSIONS OF THE SOAKAWAYS REQUIRED.

PIT 1: 0.203m/hr

MICRO-DRAINAGE SOFTWARE HAS BEEN USED TO SIZE THE STORAGE REQUIRED TO DRAIN THE IMPERMEABLE AREAS FROM THE PROPOSED DEVELOPMENT. THIS CALCULATION IS BASED ON MODULAR INFILTRATION UNITS TO ACCOMMODATE THE WORST CASE DESIGN STORM (100-YEAR) WITH RAINFALL INTENSITIES INCREASED BY 50% TO ALLOW FOR THE EFFECTS OF CLIMATE CHANGE. FEH RAINFALL DATA HAS BEEN USED. AS REQUIRED BY THE LOCAL DRAINAGE GUIDANCE FOR THIS AREA.

ROUTINE INSPECTION OF THE SOAKAWAYS SHOULD OCCUR TO ENSURE THAT THEY REMAIN EFFICIENT, SILT REMOVAL MAY BE NEEDED FROM TIME TO TIME
