6. DESIGN PROPOSALS

6.1 PRESERVING THE HISTORIC INTERIORS

6.2 EXTERNAL REPAIR OF HISTORIC FABRIC

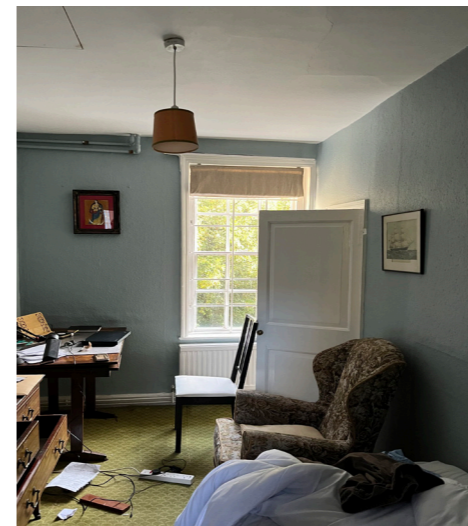
Image 25: West wing bedroom

To other minor floor areas where heating pipe work, hot and cold-water supply will be replaced the floor boards will be carefully lifted and repositioned. Whilst, areas affected by the insertion of new shower rooms at second floor of the east wing and first and second floor of the west wing, the timber floor boards will be removed and replaced with plywood, water proofed and finished with hard flooring. The salvaged timber boards will be reused at the first floor of the west wing where a bedroom is reinstated in place of the communal shower room.

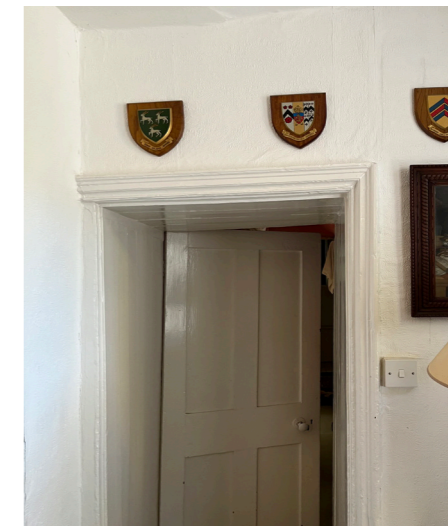
Image 26: West wing 18th C. doorway adjacent to the central chimney breast

The proposals will retain all historic decorative features including joinery and plasterwork. All existing doors affected by minor alterations to the west wings will be carefully overhauled and reused within the proposals. Where historic lime render has been affected beyond repair, careful patch repair will be undertaken using natural lime matching the depth and chemical composition of the existing.

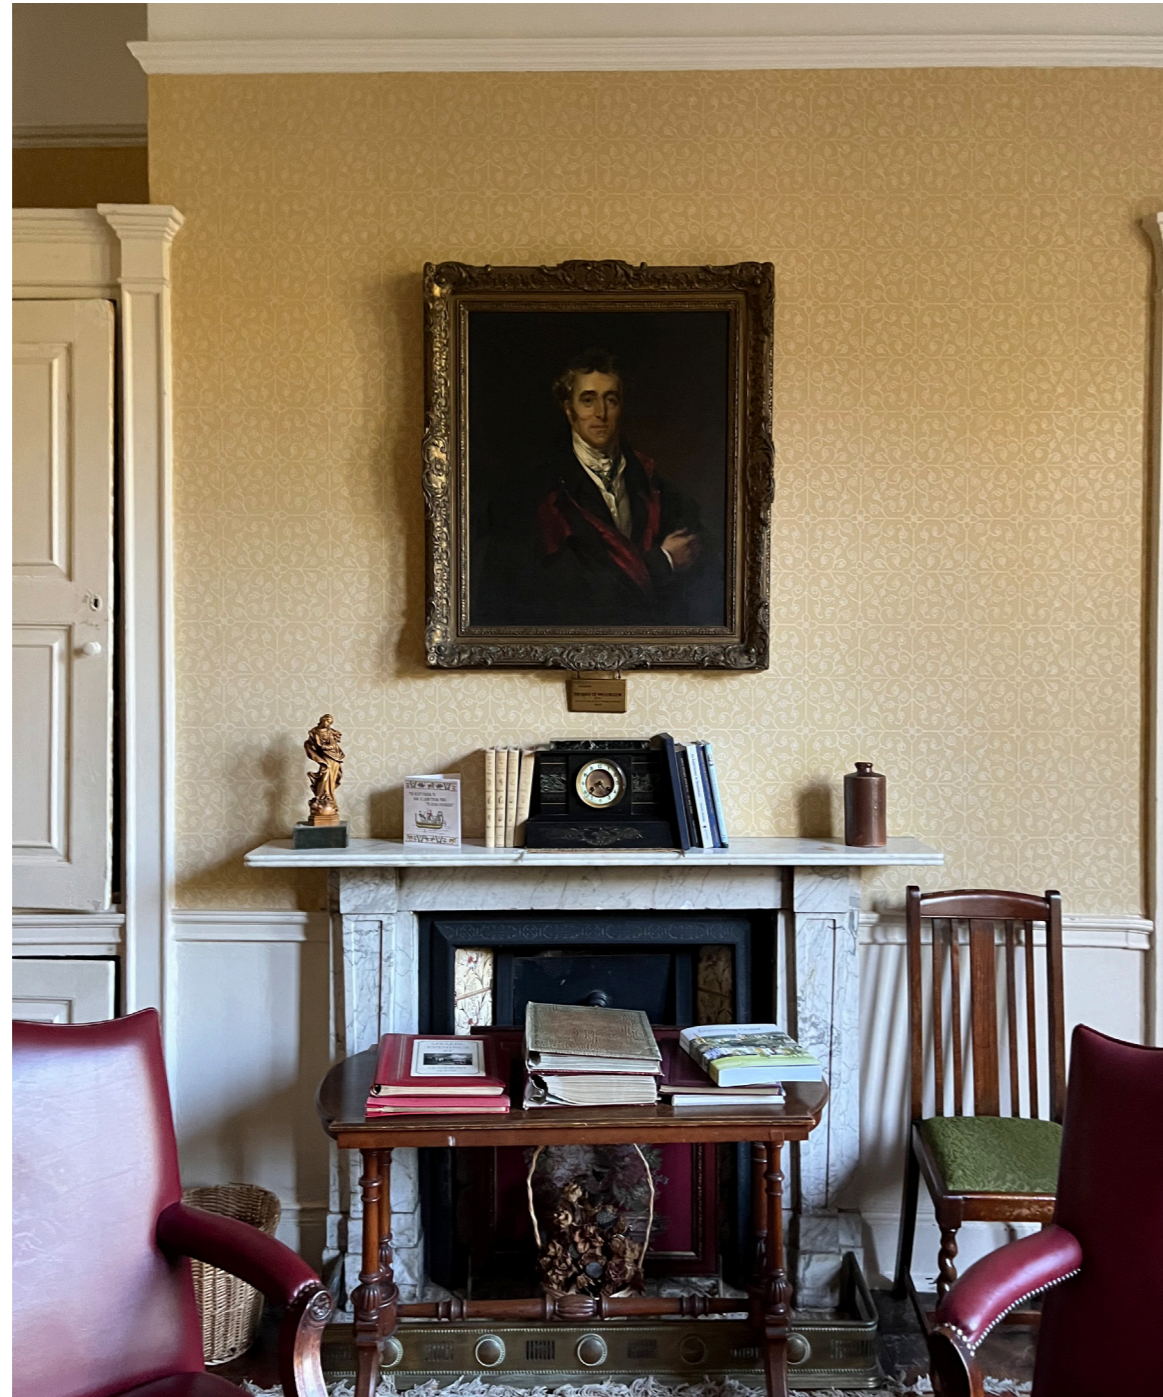
Image 27: East wing ground floor north principal room fireplace and surrounds

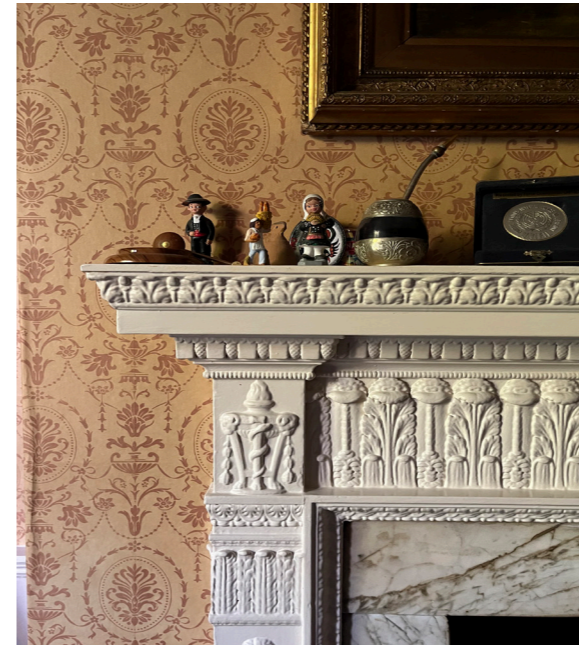
Image 26. East wing ground floor south principal room fireplace and surrounds detail

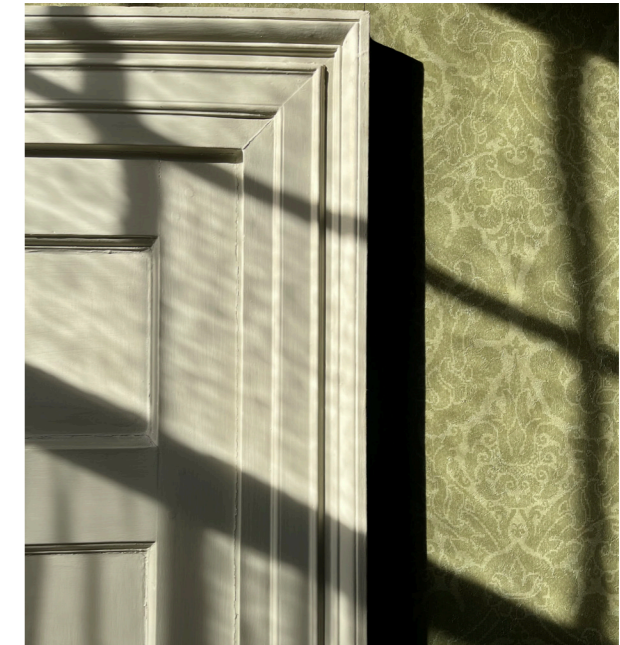
Image 27. East wing first floor south principal room door detail

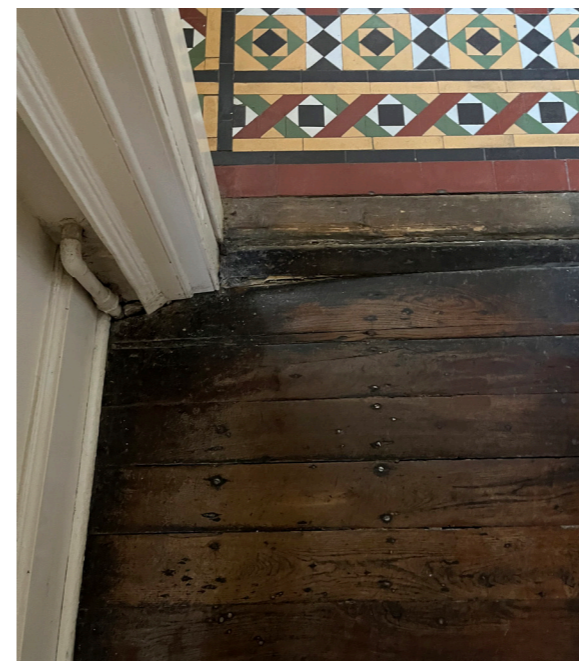
Image 28: East wing ground floor north principal room timber floor detail

The existing timber floor boards will be retained and sensitively refurbished where necessary. At ground floor, a careful removal of the timber boards will be required with repositioning to their original configuration. Their temporary removal is required to allow inspecting the timber structure, reassuring ventilation within the voids and installing breathable insulation between the floor joist.

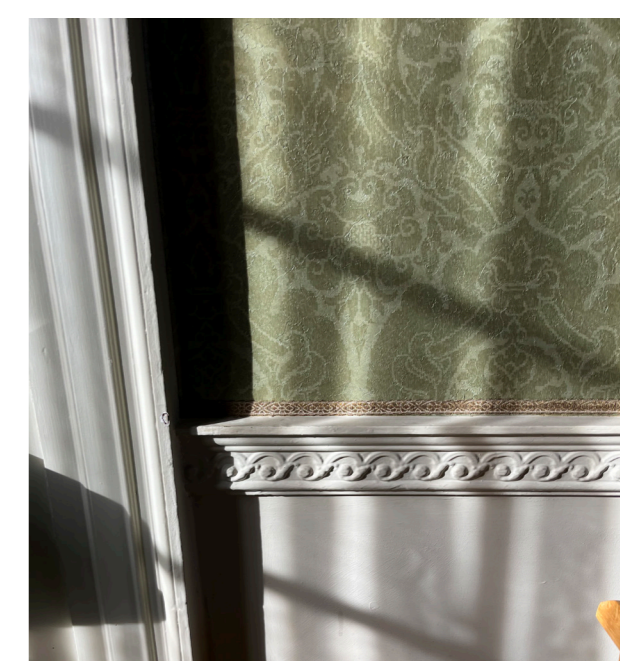
Image 29: East wing first floor south principal room dado detail

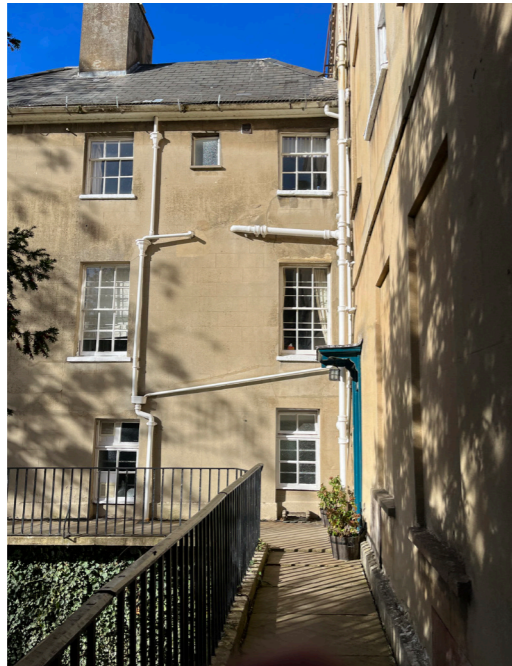
Image 30: West wing south elevation

- Careful removal of all later addition cement render to the west wing. Mortar joints repaired with lime putty and facades covered in three coats lime render finished with 4-8 coats lime wash.

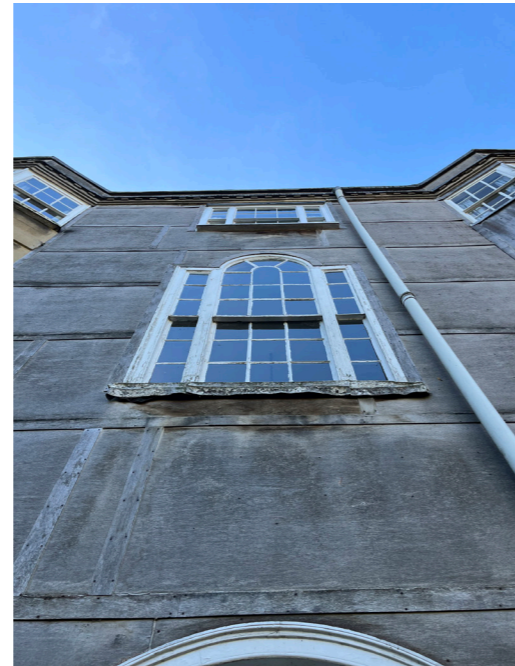
Image 31: West wing east elevation plywood paneling

- Refurbishment of the external windows and doors.
- Restoration of lost/crudely replaced window timber sills to the east facade.
- Removal of all plywood and render to the timber stud facades of the east wing (mostly defective and with large amounts of cementitious patchwork repairs). All exposed timber structure to be surveyed and repaired where necessary before reinstating oak laths and three coats lime render finished with 4-8 coats lime wash.

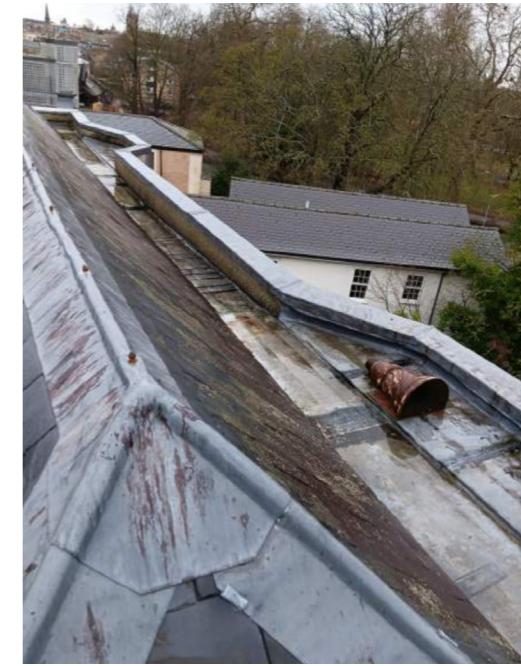
Image 33: West wing main roof showing slates and lead coverings

- Replacement of non-sympathetic hopper to west facade of east wing with a cast iron Georgian hopper.
- Removal of all non-sympathetic Spanish slates to the west and east wing roofs and replacement with grey Welsh slates.

- Replacement of all degraded leadwork to the principal building roofs, including guttering, flashings, and parapet aprons.
- Reopening of blocked windows to the north elevation of west wing.

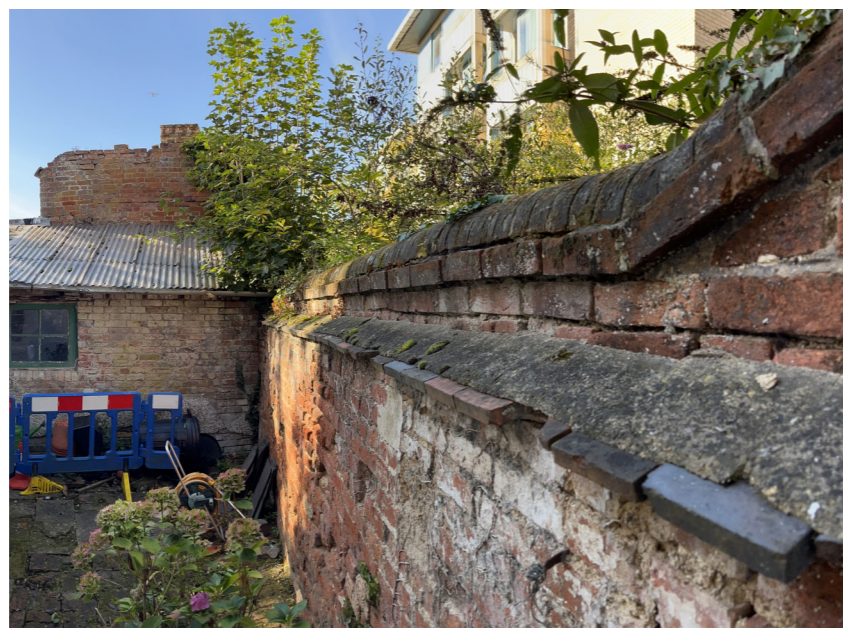
Image 34: View of north river boundary wall to service yard

- Rebuilding of the north river boundary wall to the former north service yard reusing salvage brickwork – due to large areas of the mortar bedding having significantly deteriorated and compromising the long-term stability of the wall.

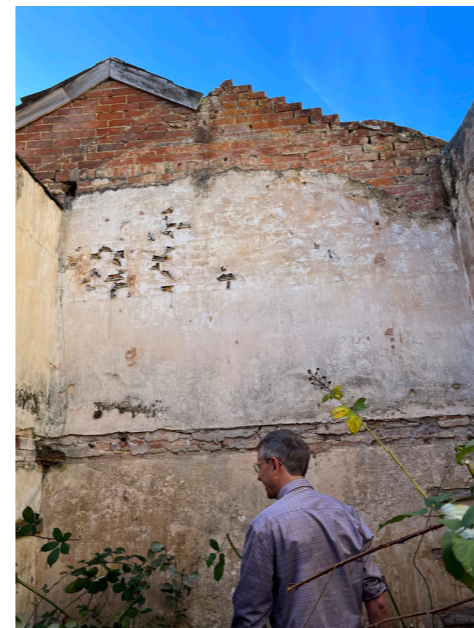
Image 35: View of ruined servants' cottage interior

- Localized patch re-pointing to stables and coach house outbuilding with lime putty render.
- Rebuilding of the precarious servant's cottage north river wall reusing salvage brickwork.

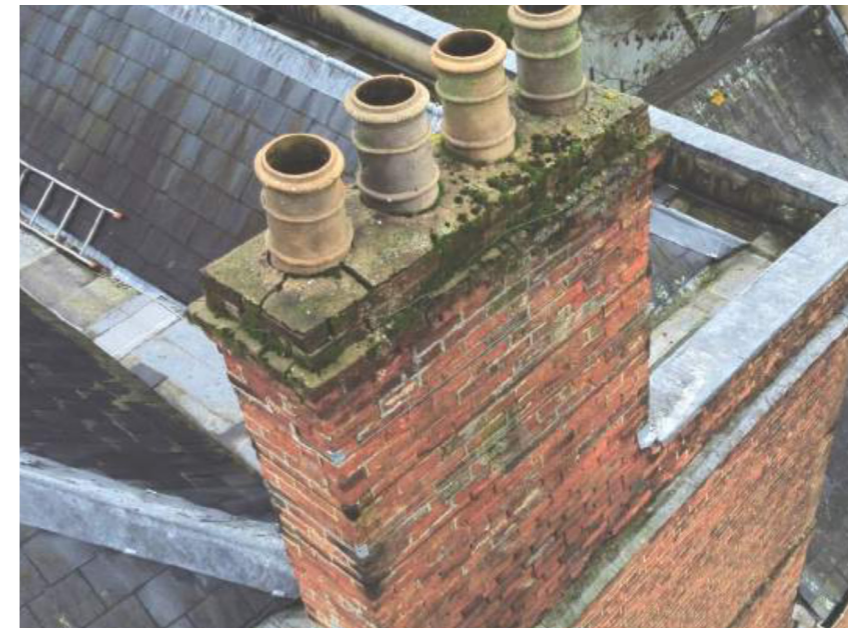
Image 36: East wing north chimney stack

- Careful rebuilding of leaning east wing north chimney stack.
- Replacement of non-sympathetic bitumen roof felt to former butler room with traditional batten roll lead roof.

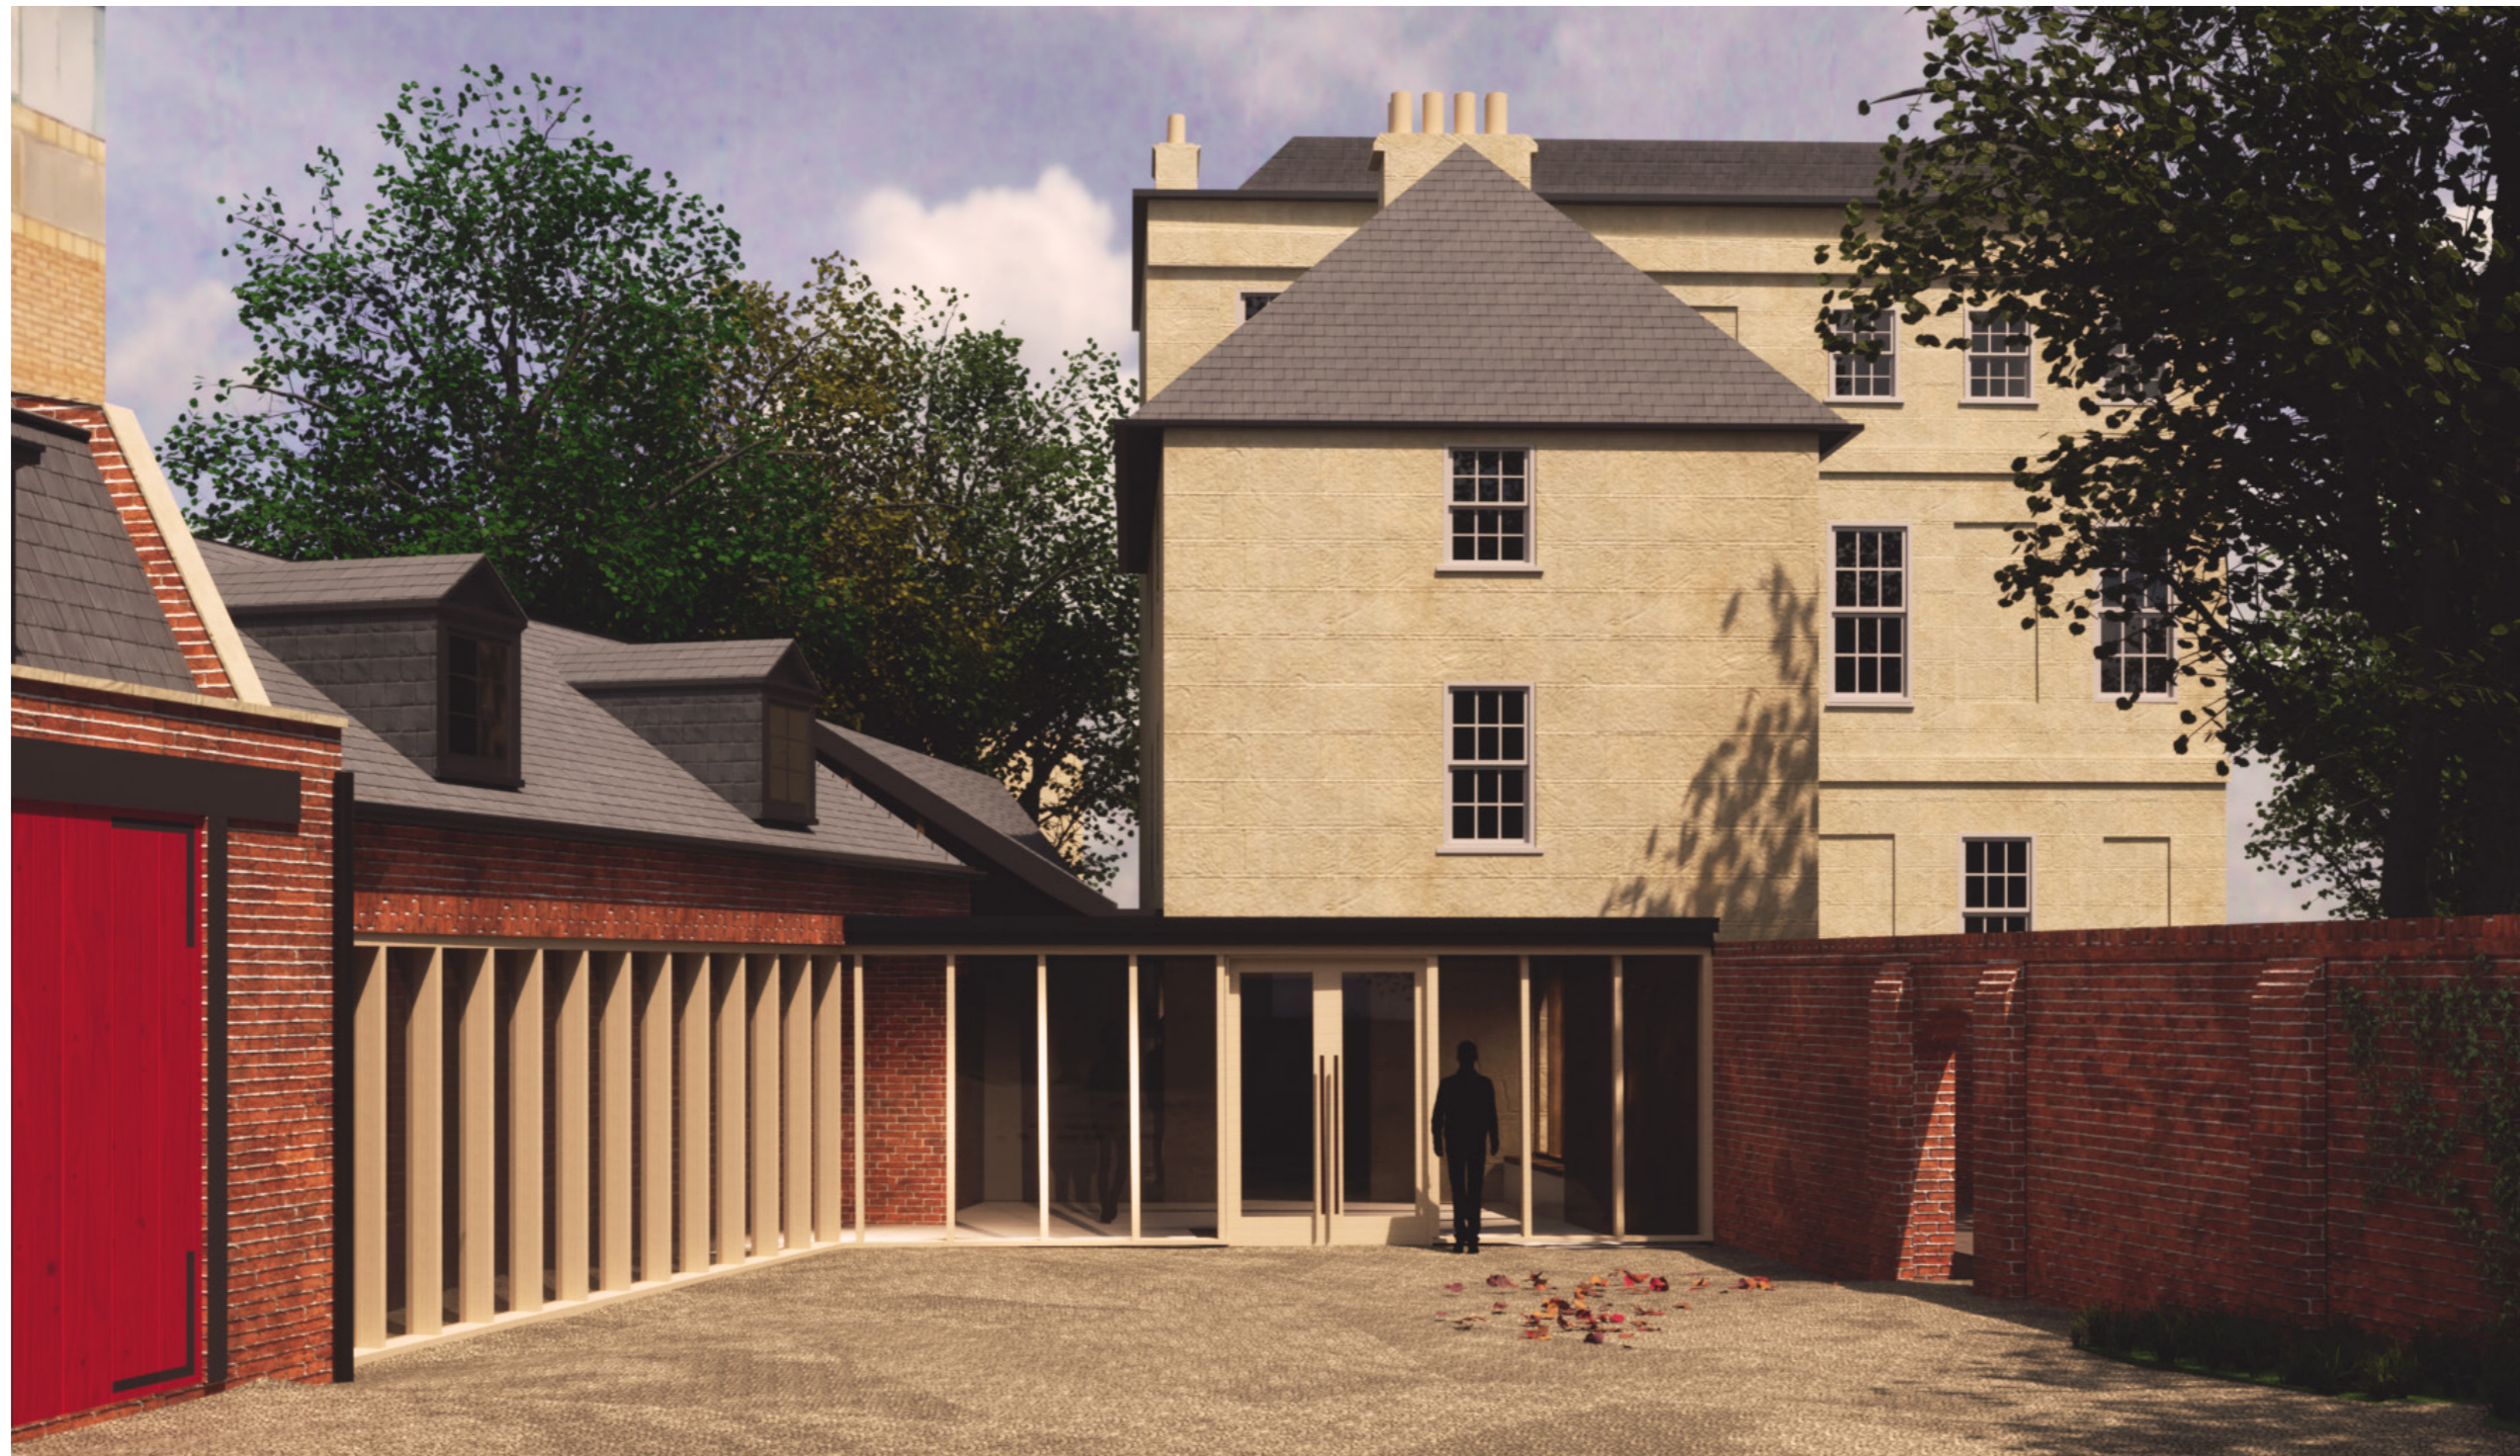
Image 37: Proposed visualization of the new entrance and link extension

The aforementioned repairs will form part of larger and coherent development of the site to satisfy key client brief requirements through the re-adaptation of the disused outbuildings and the creation of a new entrance building, which will consolidate the use of the property and secure the future of Grandpont House and the Charity's mission.
