Proposed North Elevation - E01
1:100 @A1

Planning Application	28/03/24	-
issue:	date:	revision:

Project
Grandpont House
Drawing
Proposed North Elevation - E01
Drawing No.
GH(20)A18

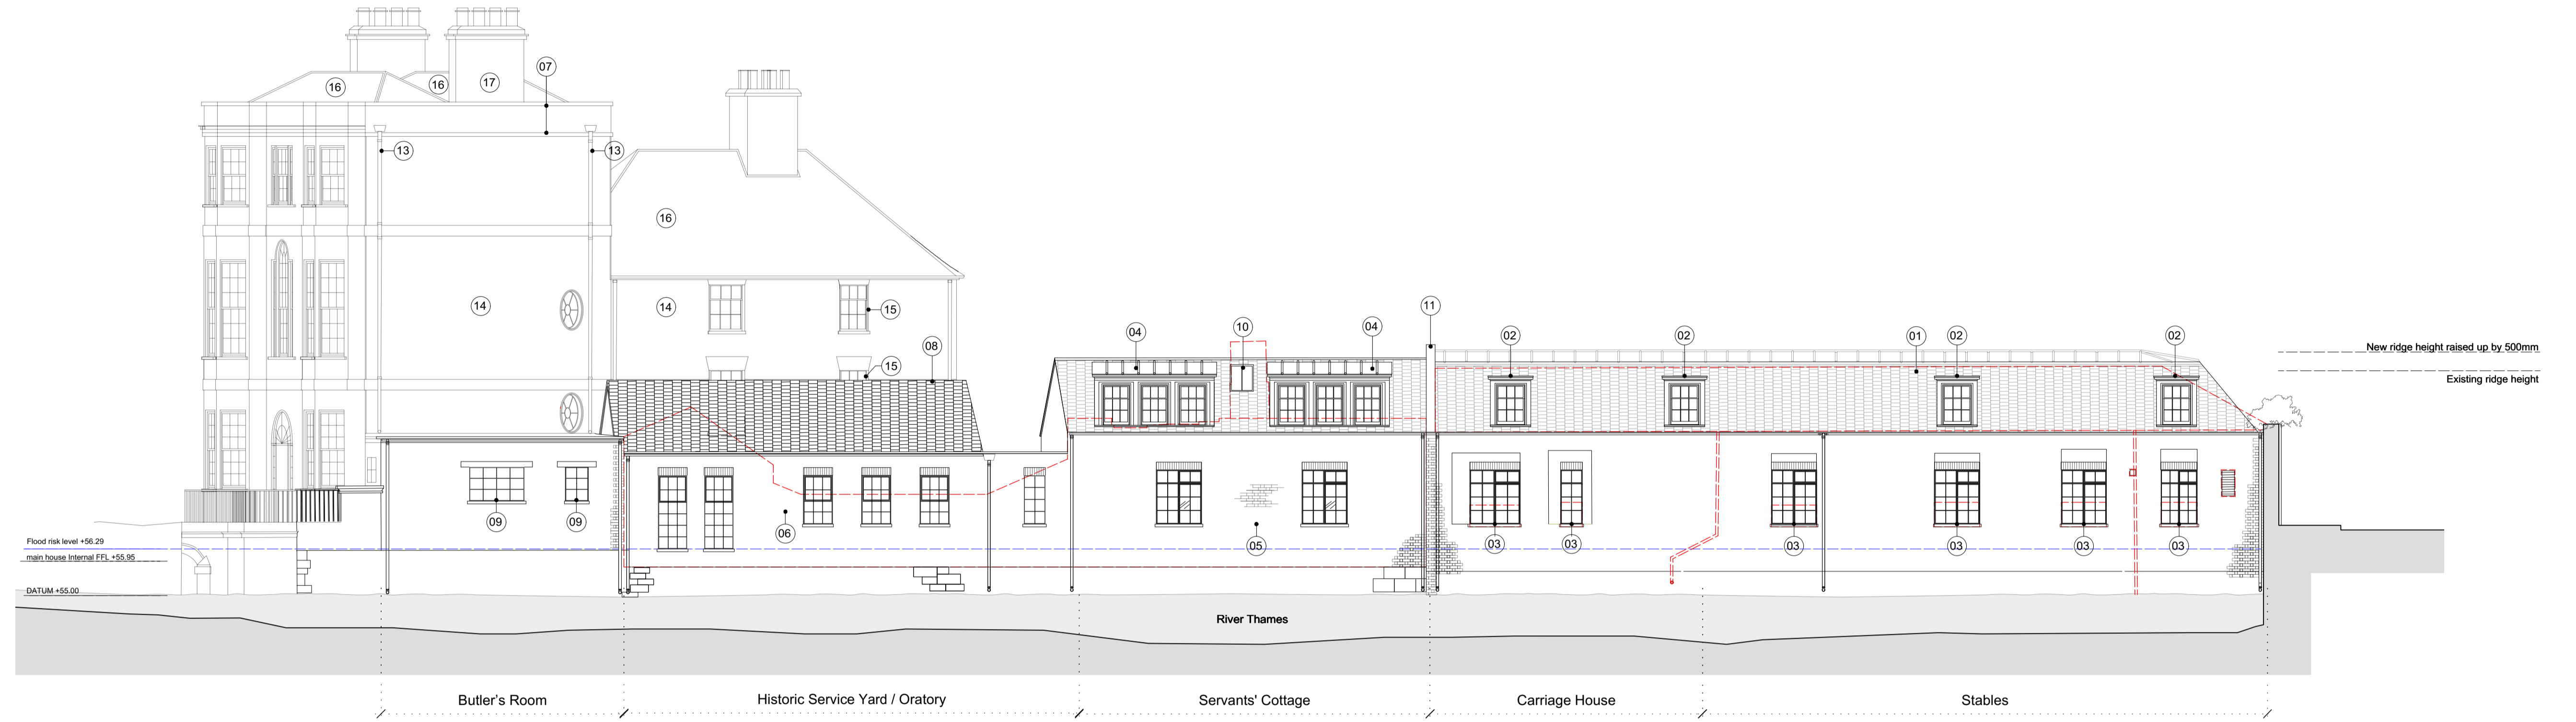
- 01 Historic Stables and Carriage House masonry wall to be retained and later addition slate roof to be replaced. New roof ridge level to be 500mm above existing and roof to be insulated and covered with natural grey Welsh slates to match existing, to allow forming Student accommodation at the mezzanine level

- 02 New batten roll lead dormer. New dormer to be fitted with a double glazed 3 over 6 pane timber sash window, timber surrounds and slate cladding to cheeks of dormer

- 03 Existing window opening to the stables and the carriage house to be lowered, whilst maintaining the reading of the historic openings. Infill using a varying brickwork, brick header and slightly set back from the facade. Later addition non-sympathetic PVC casement window to be replaced with a new thermally broken triple-glazed, steel crittal style, black-coloured window

- 04 New batten roll lead roof dormer. New dormer to be fitted with double glazed 3 over 6 pane timber sash windows, timber surrounds and slate cladding to cheeks of dormer

- 05 Existing precarious masonry river wall of the servants' cottage to be rebuilt with salvaged brickwork. Wall rebuilt with matching brick bonding and lime mortar joints. New window openings with brick headers fitted with new steel frame black-coloured, thermally broken, double-glazed Crittal style windows

- 06 Existing precarious masonry river boundary wall to historic service yard to be rebuilt using salvaged brickwork. Wall rebuilt with matching brick bonding and lime mortar joints. New window openings with brick headers fitted with new steel frame black-coloured, thermally broken, double-glazed Crittal style windows

- 07 Degraded lead flashing on cornice ledge and upon parapet to be replaced
- 08 New lightweight self supporting roof structure. Roof to be covered in welsch grey slates with west facing clerestory windows

- 09 Existing non-historical metal casement window to be replaced with a new thermally broken double-glazed, crittal style, black-coloured steel windows

- 10 New openable dark grey conservation rooflights to provide natural light and ventilation
- 11 New brick parapet to match existing brickwork and bond with stone coping to gable end of stable block

- 13 New rainwater outlets with salvaged Georgian hoppers and cast iron down pipes to improve rain water drainage from the principal roof as recommended by Hutton and Rostron

- 14 Mortar joints repaired and exposed brick work finished with lime paint
- 15 Historic blocked window to be reopened and fitted with a new timber sash to match existing design and detailing

- 16 All unsympathetic later addition roof slates to be replaced with grey welsch slates and all defective lead work to be replaced
- 17 Rebuilt precarious north chimney external stack to be rebuilt with salvaged brickwork with bonding and lime mortar joints to match existing
