## SOW OPT-7829 Agreement to install a root barrier for Crawfords

**OUR REFERENCE:** OPT-7829

Specifications of Barrier					
Barrier Type	length	Max Root Depth from SI	Minimum depth to be achieved with barrier	Distance between tree / Vegetation and barrier	shortest distance between barrier and foundation
Copper	70m	3.0m*	3.5m	Varies	Approx. 2.0m

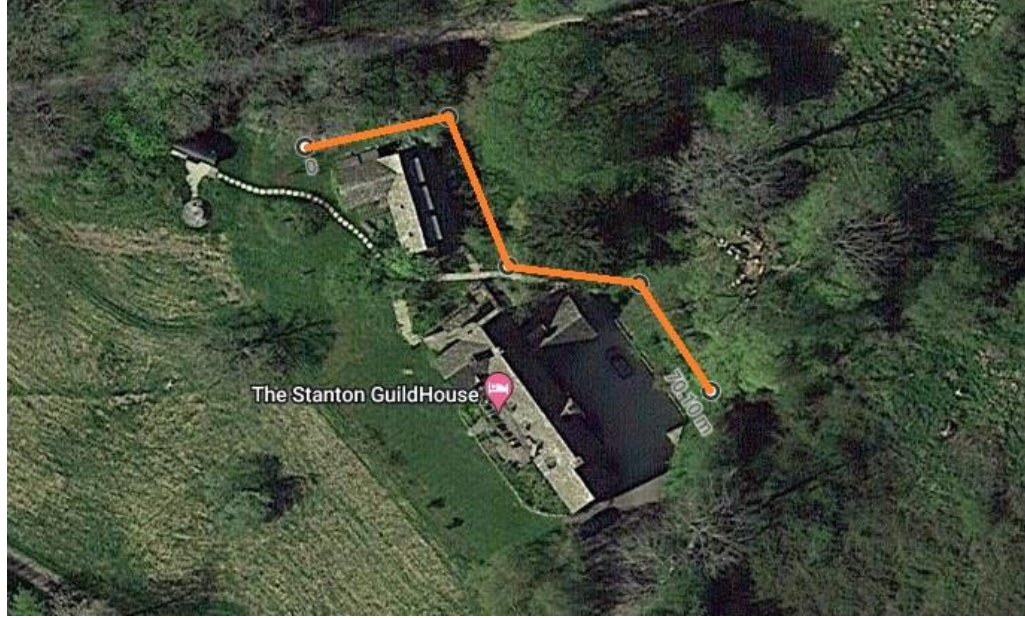
Aerial plan indicating proposed alignment of barrier

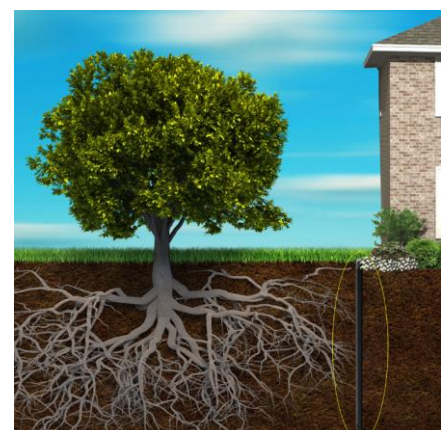
Trees are known to cause clay soils to shrink by drawing water through their roots, predominantly during the Spring and Summer months. The shrinkage results in both vertical and horizontal ground movement that, when transmitted to a building's foundations, cause damage to the building's structure. The amount of shrinkage depends on the type of clay soil, the type and size of vegetation, and on weather patterns.

The moisture content of a clay soil tends to vary with depth. Closer to the surface there can be relatively large changes in soil moisture content between summer and winter as a result of evaporation from the ground surface, the drying effect of the Sun and general vegetation, including grasses. Such variations are normally confined to the upper 1m of the ground. However, where trees are growing within influencing distance of a building, then the soil moisture profiles will fluctuate much more widely through the seasons and to a much greater depth; in response, soil volume changes are amplified, and consequential building movements will be far greater.

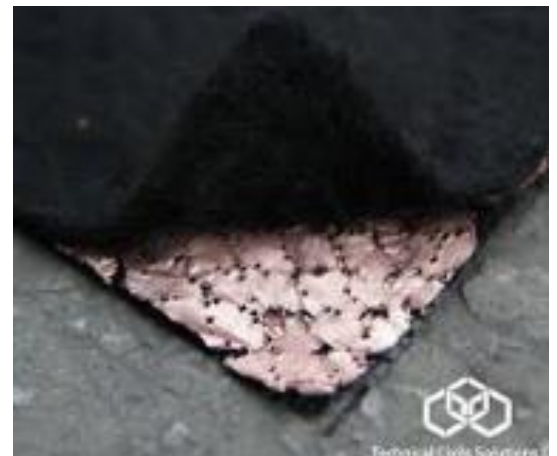
The bio-root barrier is strong and flexible, with very high tear resistance, as well as being water-permeable, thus allowing the natural movement of water through the ground without impediment. The Copper contained within the core of the membrane also acts as a chemical repellent to the roots without constituting a hazard to plants or animals. The Copper foil securely bonded within the porous geotextile membrane, releases Copper ions into the adjacent soil by forming Copper Carbonate (verdigris); these signal adverse conditions to any roots growing towards the barrier, preventing a proliferation of roots close to the barrier. The levels of Copper generated do not constitute a burden on the eco-system or impact groundwater quality.

Outdated, impervious barriers divert rather than stop roots and may prevent the movement of groundwater causing unintended consequences. The use of Optera's permeable barrier stops roots both by forming a physical impenetrable obstacle and by acting as a chemical inhibitor to the reestablishment of roots.

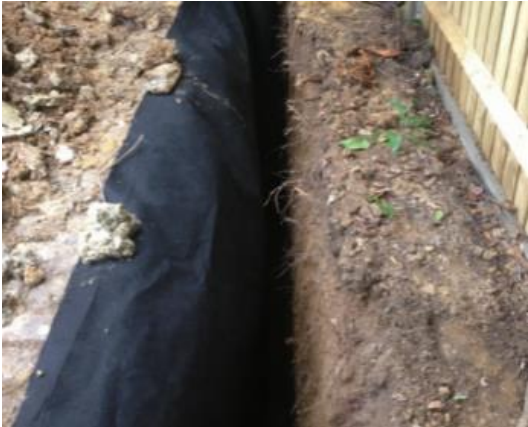
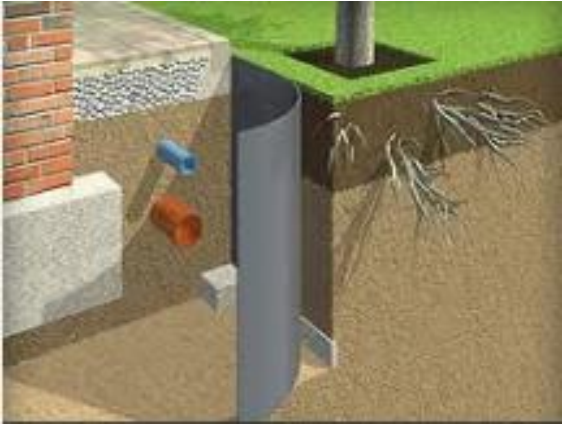
Following installation of the root barrier, the trench may be backfilled with 20mm single sized stone, alternatively, and dependent upon site conditions, backfilling could be done with as-dug material, which would be placed and compacted with a plate-compactor mounted on the excavator arm. In specific circumstances, we may also use no-fines concrete on the structure side of the shield.
