Hawes Associates

Geotechnical and hydrological report for pond construction at Viola Hill, Steep.

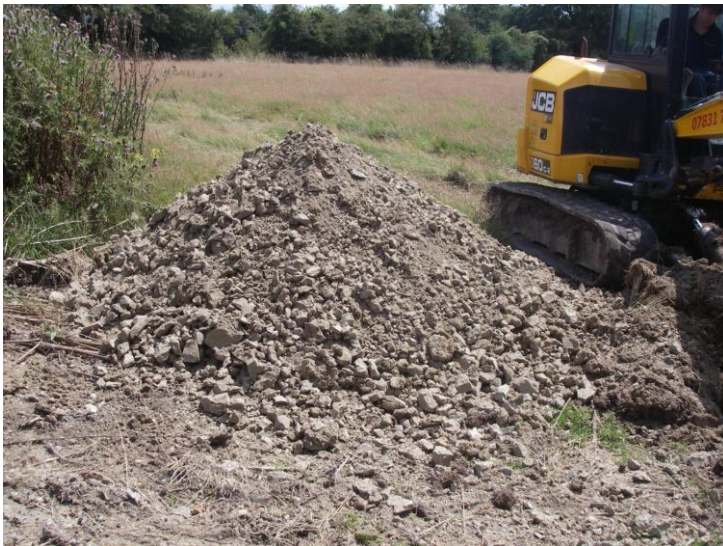
The hill wash deposits consisted of a 2m thickness of pale grey clayey silt. This material would be suitable to engineer into a low permeability internal blanket to retain the 1.5m water depth proposed.

The British Geological Survey details Head deposits (hill wash) overlying chalk. A site investigation was completed to identify the actual ground conditions beneath the pond site.

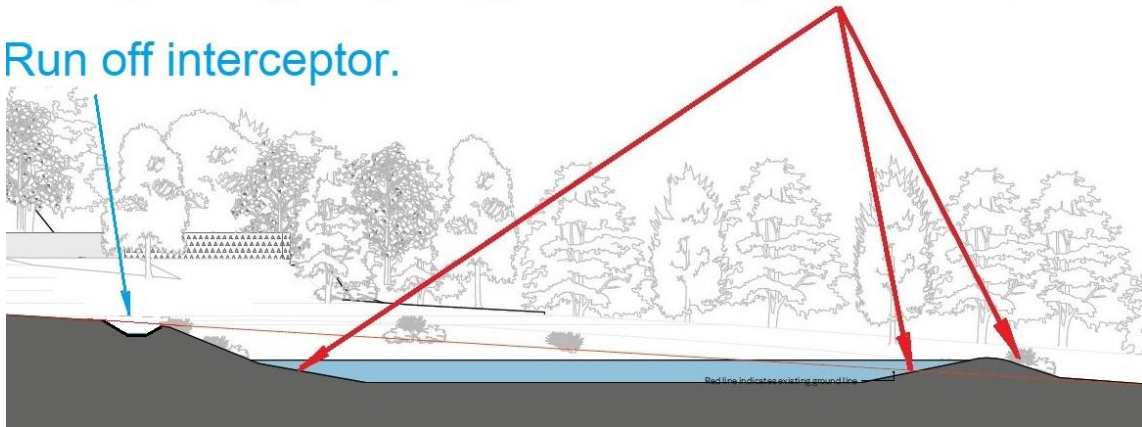
1:5 (11 degrees) engineered clay embankments.

Run off interceptor.

No slopes will be steeper than 11 degrees (1:5) and no embankment higher than 1.5m. Constructed in compacted layers with a 2m wide crest will create a 17m wide embankment at the base of the highest section. The slack embankment slopes are to soften the landscape impact and facilitate marginal planting, material of this type would be stable at an 17 degree angle (1:3).

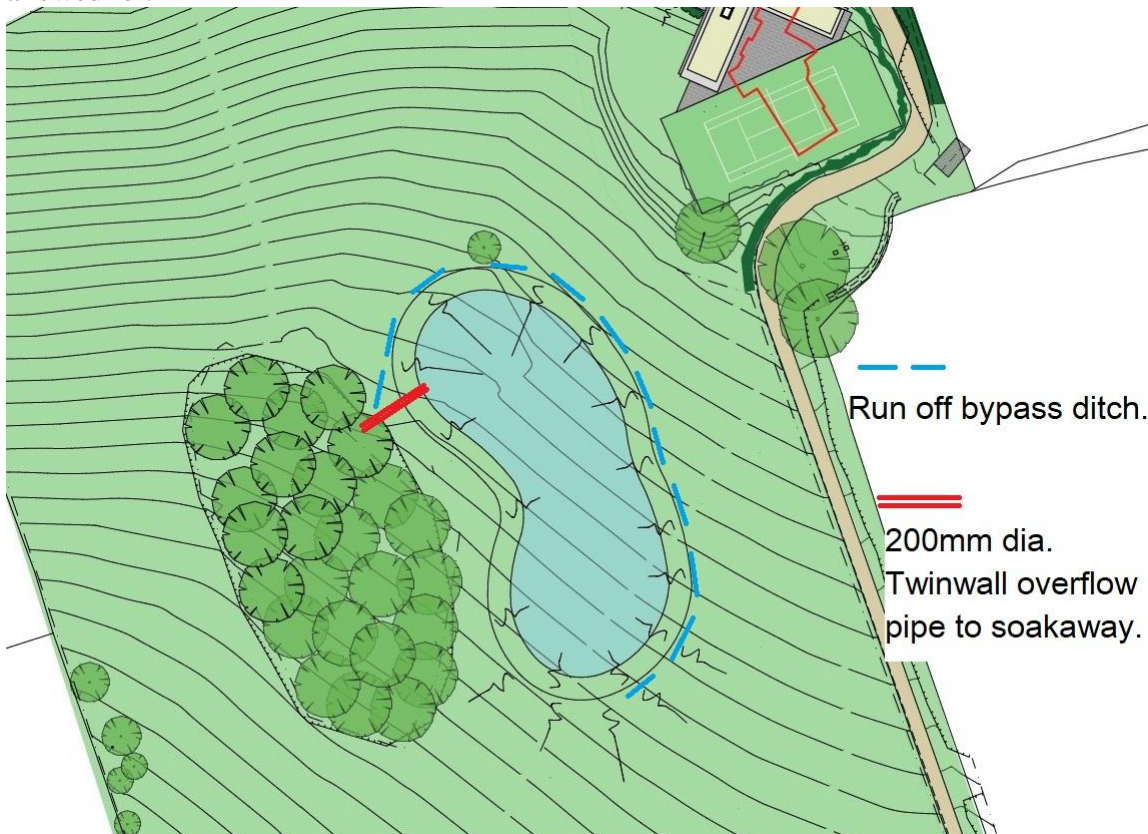
Design top water level safe guards, Ref. Plan Schematic below.

The design has been amended to remove the ability of the pond to fill accidentally in a storm event, this has been achieved by introducing a run off interceptor ditch around the up gradient boundary.

A further safeguard to prevent accidental overfilling of the pond is the introduction of a 200mm dia. overflow pipe preventing a water level above a 0.5m freeboard (freeboard is the vertical height between the overflow level and the embankment crest). The overflow has been sized to remove the chance of debris obstructing the low flow discharges the design has allowed for.
