INFORMATION IN SUPPORT OF AN APPLICATION FOR HOUSEHOLDER PLANNING PERMISSION AND LISTED BUILDING CONSENT FOR: CONVERSION OF THE EXISTING LOFT SPACE INCLUDING INSTALLATION OF A SMALL CONSERVATION ROOF LIGHT TO THE REAR ELEVATION PITCHED ROOF SLOPE AND ASSOCIATED INTERIOR ALTERATIONS TO FORM A NEW LOFT STAIRCASE; OTHER REPAIR AND MAINTENANCE AND ASSOCIATED MINOR INTERIOR ALTERATIONS TO THE GROUND AND FIRST FLOOR ROOMS; AND CAREFUL REPAIR AND MAINTENANCE TO THE EXISTING HOUSE TIMBER WINDOWS AND EXTERNAL DOORS INCLUDING REPLACING PANES WITH NEW SLIMLINE DOUBLE GLAZED UNITS AND CAREFULLY REMAKING THE EXISTING REAR TIMBER FRENCH DOORS WITH SEPARATE SLIMLINE DOUBLE GLAZED UNITS BETWEEN GLAZING BARS; TO NUMBER 46 TEMPLE FORTUNE HILL, LONDON NW11 7XS.

Project Reference: 2406\_46 Temple Fortune Hill

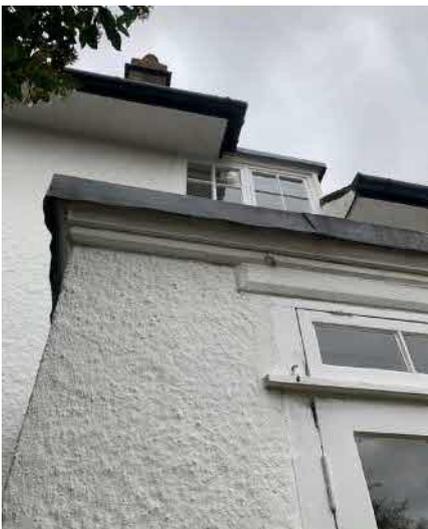
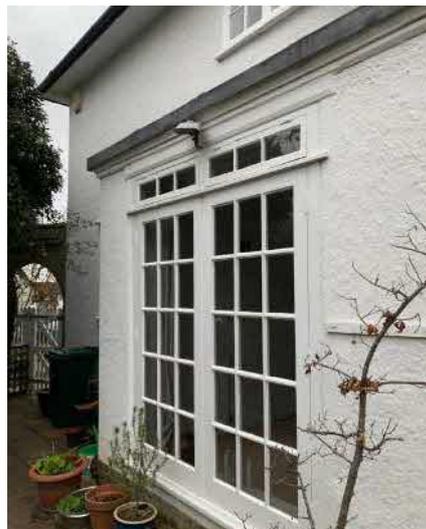
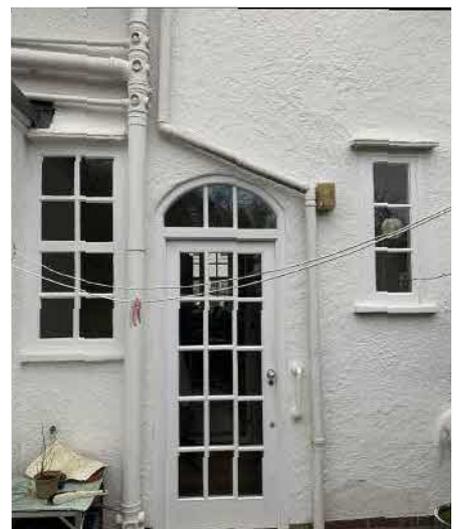
*Top:* View to the rear elevation; *Bottom left:* View to the rear outshot looking up to the bathroom half dormer window; *Bottom centre:* View to the existing French doors; *Bottom right:* View to the existing back door leading to the scullery style porch space with existing cloakroom and washing cupboard behind the small window to the right, and dining room window to the left.

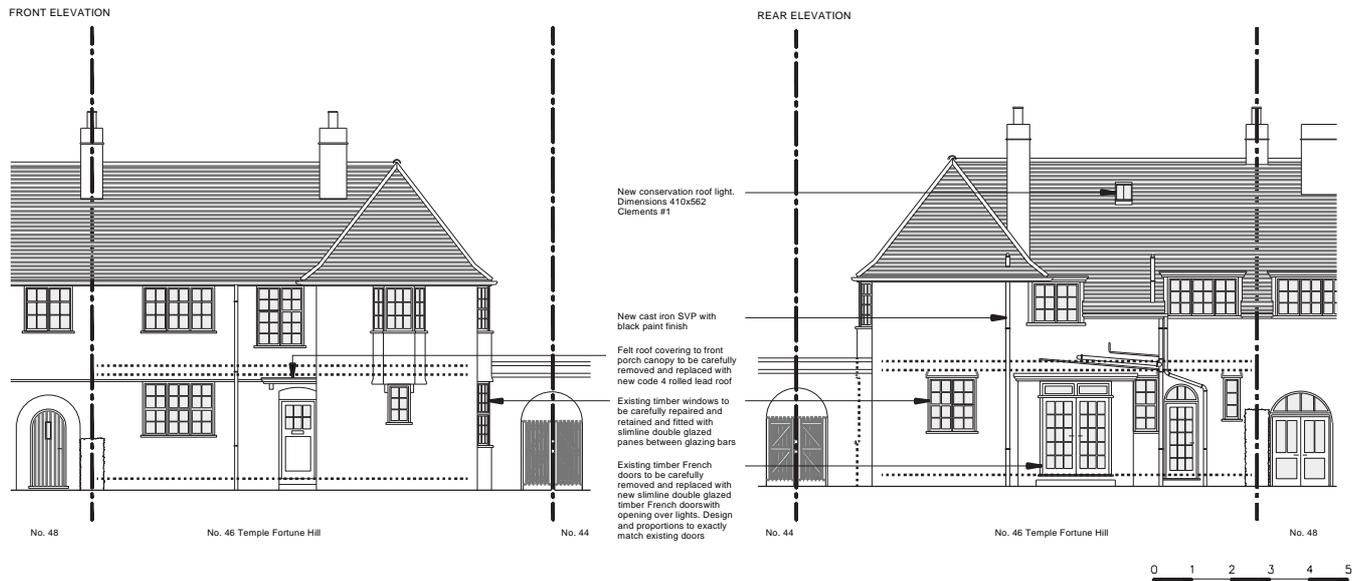
Proposed front and rear elevation drawings showing the new conservation roof light and rear French doors replaced to exactly match the existing doors.

- Structural works to form a habitable porch room in the loft and installation of a small conservation style roof light set at the centre of the rear elevation pitched roof between the first floor half dormer windows.

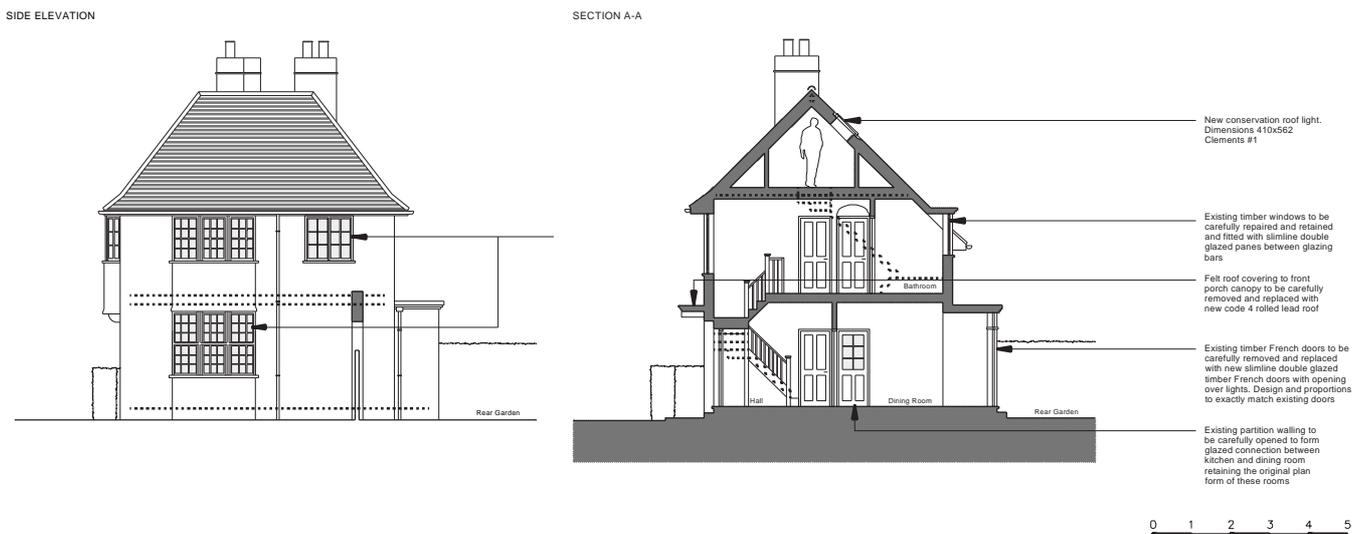
Proposed side elevation and section drawings showing the proposed loft room and new loft staircase.

The works to form the staircase require the addition of a new partition wall in the corner bedroom and construction of a new staircase with winders designed to maximise the limited head height beneath the eaves and minimise impact to the proportions and arrangement of original rooms. Both the wall and staircase largely represent 'addition' to the historic fabric and will be built in such a way that they can be removed in the future to restore the original proportions. The tiled roof will be retained in place throughout the works and where necessary new steel beams will be carefully introduced through small openings which will be replaced with the original tiles as required. The new ensuite bathroom requires the installation of a new door opening which will be made to exactly match the existing original internal doors, and a new cast iron soil vent pipe to the rear elevation. Structural works including the location of new steel beams to strengthen the floor are to be designed to minimise impact to existing fabric, set above the existing ceiling joists and avoiding impact to original chimneys. The two chimney breasts against the party wall at first floor level have been previously removed and require additional support which will be combined with the loft steels.

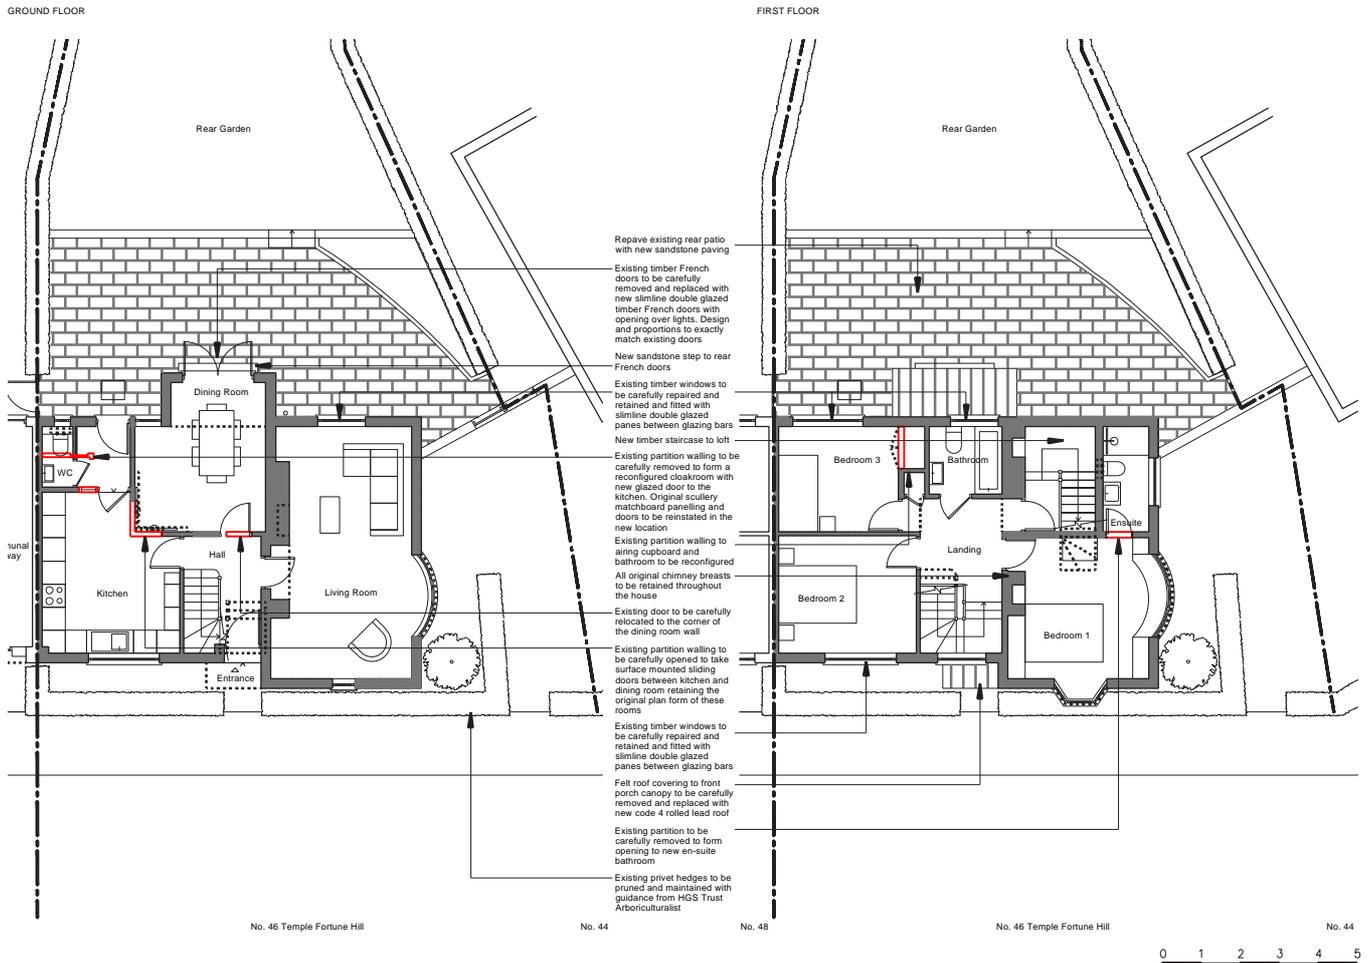
Proposed ground and first floor plans showing the proposed alterations including the installation of the new loft staircase.

- Forming a smaller ground floor cloakroom and larger opening to the porch area by the back door replacing the existing modern glazed timber internal door with a new timber door with glazed over light and , moving back the existing matchboard screen and doors and carefully restoring them as a facing to a new partition wall.

- Forming a corner opening between the kitchen and dining room with new sliding timber doors designed to match the height and proportions of the existing house doors, carefully retaining the plan form of the existing rooms and allowing access and daylight between these spaces. As part of this we are also proposing carefully relocating the existing internal panelled door leading between the entrance hall and dining room to align with the corner of the dining room away from the suggested connection to the kitchen.

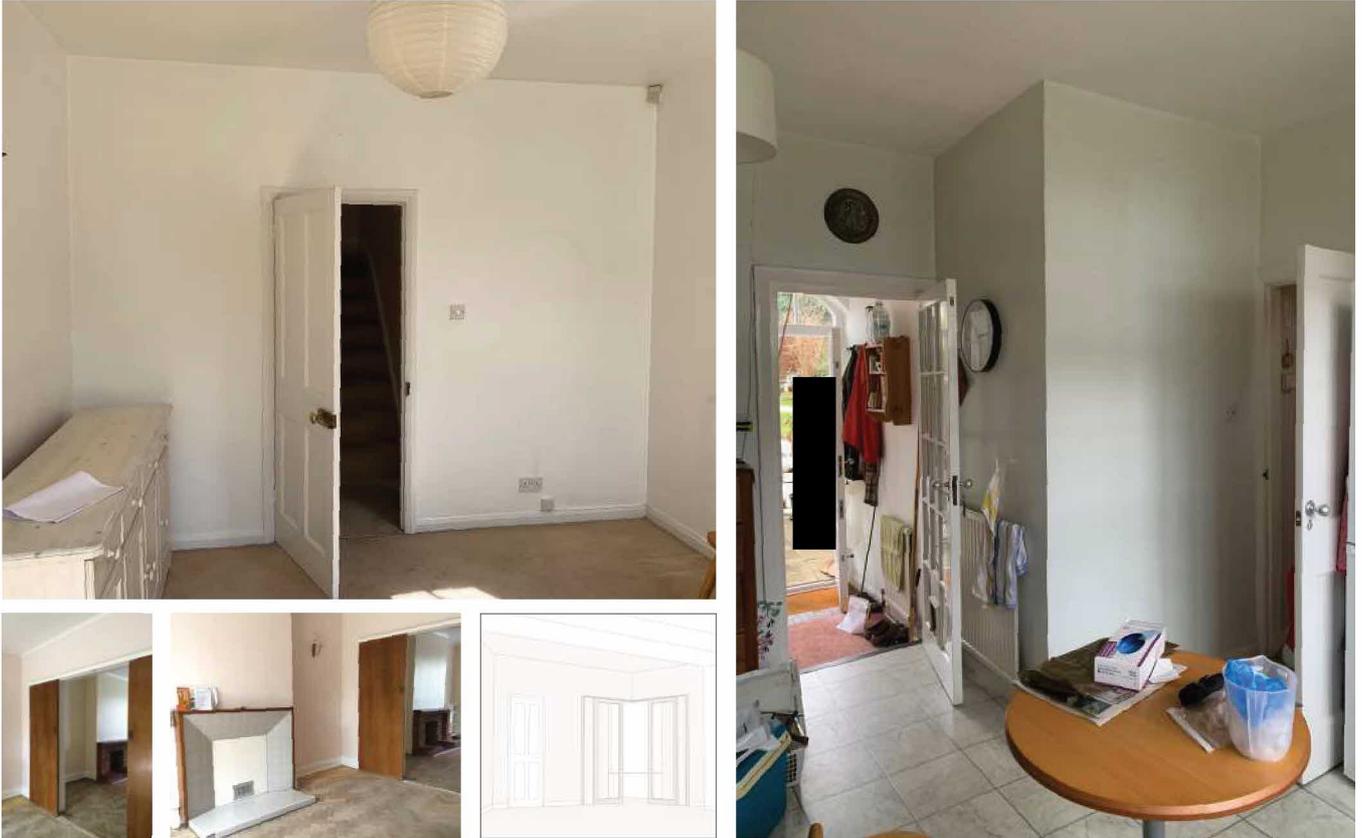
*Top left and right: Views to number 46 Temple Fortune Hill showing the corner wall between the kitchen and dining room;  
Bottom left and centre: The original surface mounted sliding partition doors to the house in Milton Close mentioned here and sketch view to the proposed corner sliding doors.*

The proposed sliding doors will be surface mounted within a timber frame reading as a section of decorative panelling as in the Butler house, retaining the corner when closed and opening to allow light and access directly from the dining room into the kitchen.

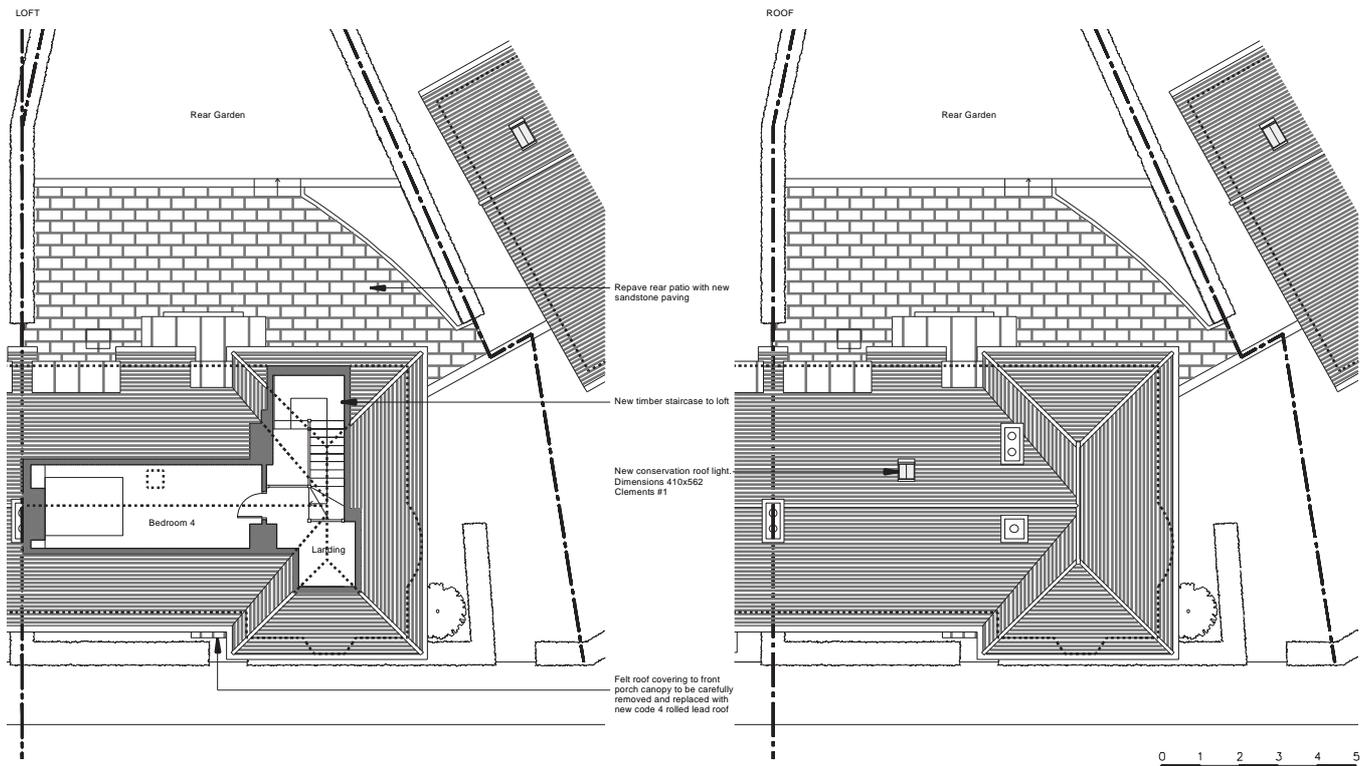
Proposed loft and roof plan drawings showing the arrangement of the staircase and the new conservation roof light.

Positioning the new staircase in the corner room allows the volume of the existing landing to remain uncluttered and the existing arrangement of doors to remain undisturbed. This also allows a single small conservation style roof light placed at the centre of the roof slope to align with the bedroom rather than the stairwell. A similar arrangement has been employed in the matching houses along Temple Fortune Hill. These neighbouring cottages and terraces are designed to vary slightly in response to the meandering street line and topography however form a cohesive set largely following the same pattern and presenting a valid precedent for the layout.

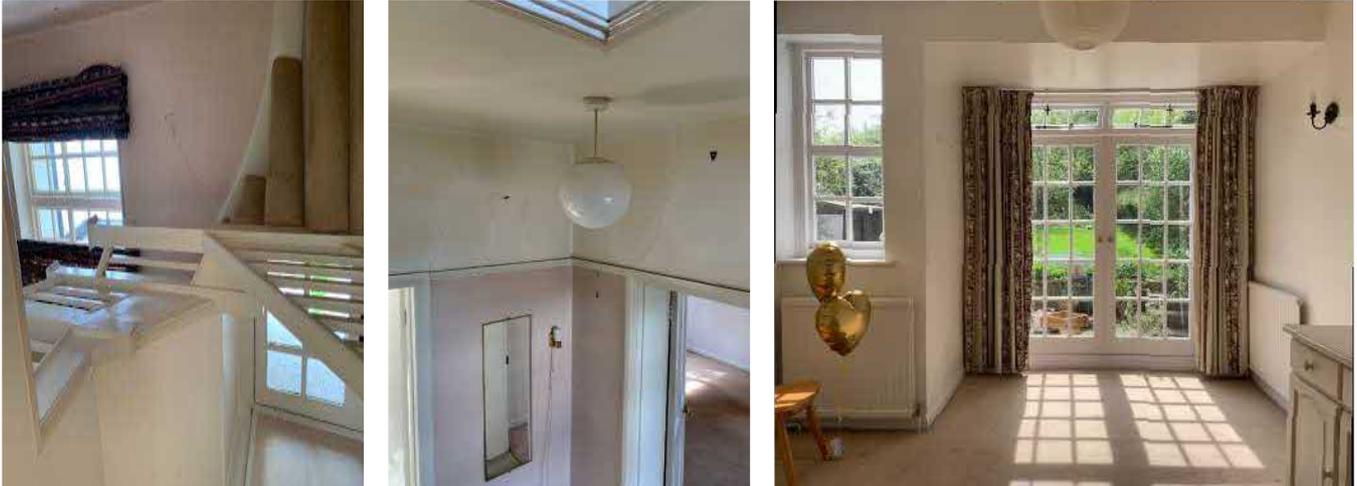
Interior views showing the existing staircase, hallway and dining room. Interior and exterior walls show signs of movement.

Large cracks are evident in the stairwell front wall, at the connections between internal partitions and external walls and around the two storey end elevation bay window which is gradually moving away from the house. Again this appears to have been exasperated by the structural imbalance caused by the historic partial underpinning of the rear elevation walls. The damage has been subject to an analysis and monitoring for the past year and a full structural design is being prepared to remediate these defects. We are working closely with a specialist Structural Engineer to develop the least invasive and most appropriate solution to ensure that the new works both interact well with the existing underpinning and keep disturbance to the existing house to a minimum. A separate application for Listed Building Consent has been submitted for the underpinning works.

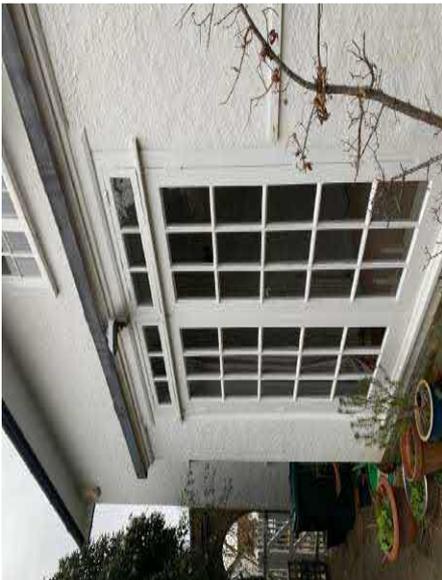
*Top:* View to the rear elevation; *Bottom left:* View to the existing outshot French doors. The doors are fixed shut and badly decayed and it is proposed that these are entirely replaced to match existing; *Bottom right:* View to the rear elevations to the adjoining houses at numbers 48 and 50.

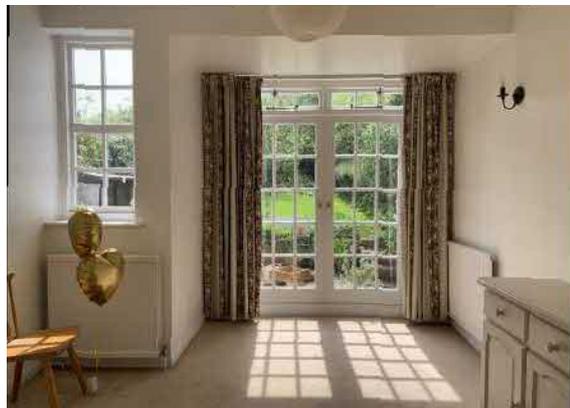
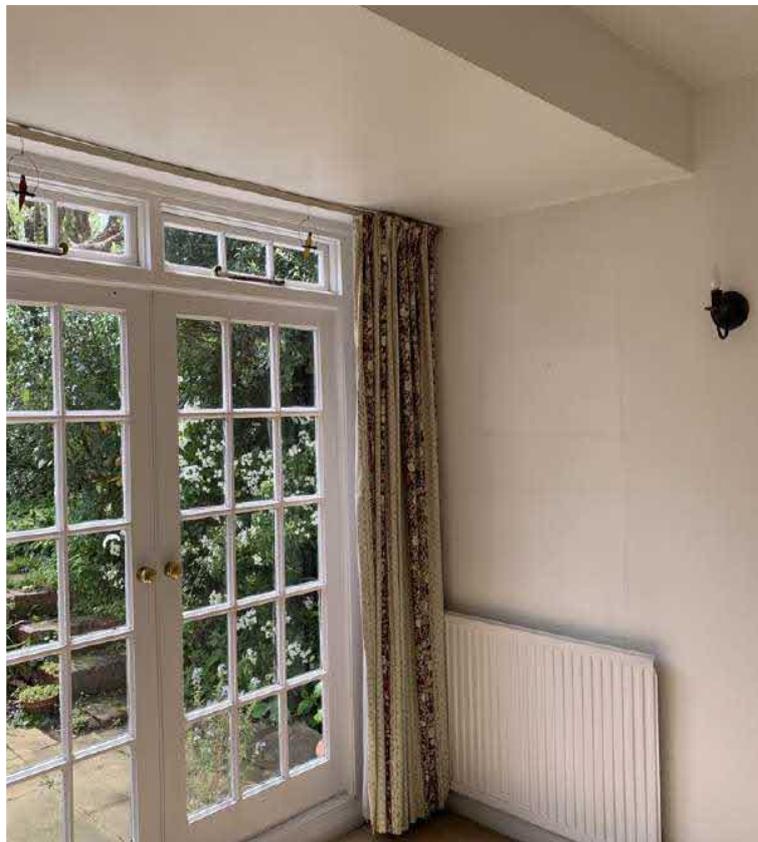
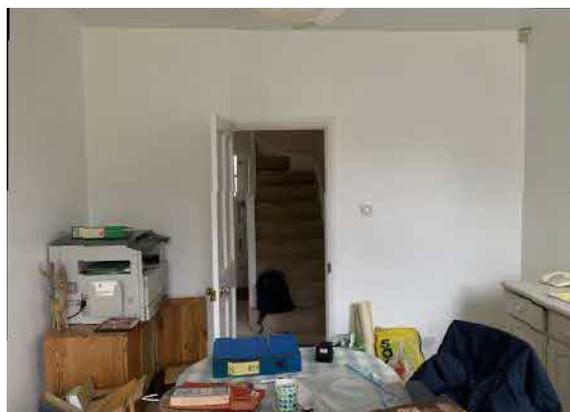
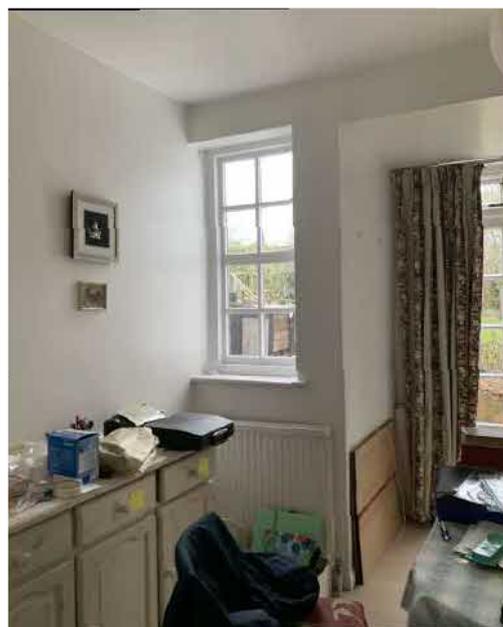
### 10.4 Ground Floor Dining Room

Views to the ground floor dining room showing the existing French doors currently fixed closed and in poor condition.

- Repair and restoration to the existing house fenestration including replacing the existing timber French doors with matching doors and adjusting existing casement window frames and glazing bars to allow slim line double glazed units to be installed to replace the existing glazing;

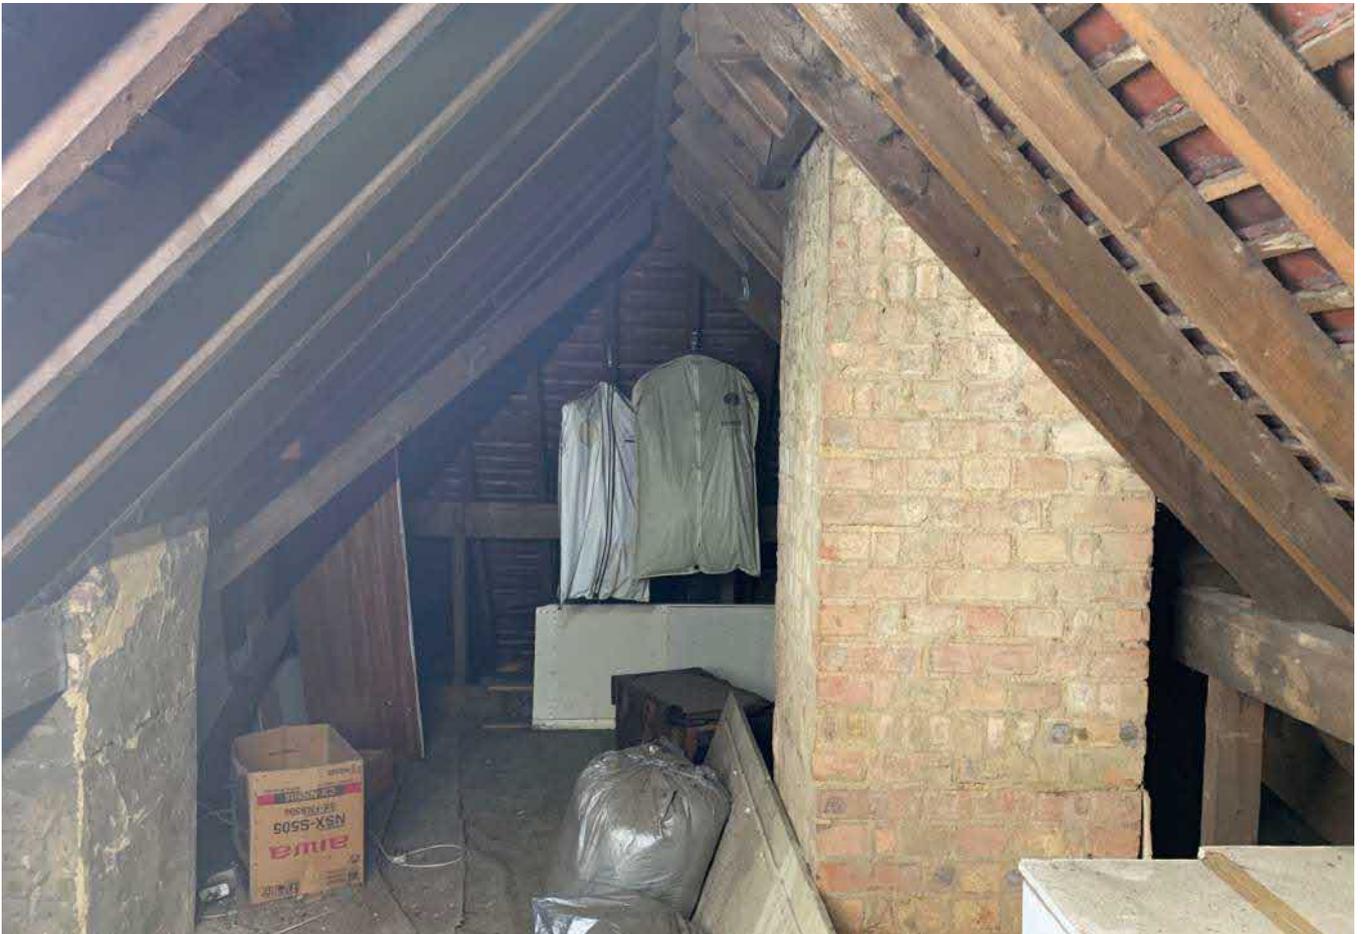
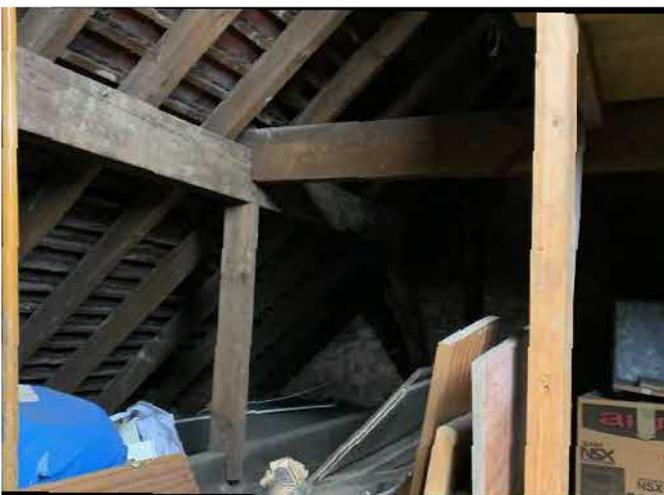
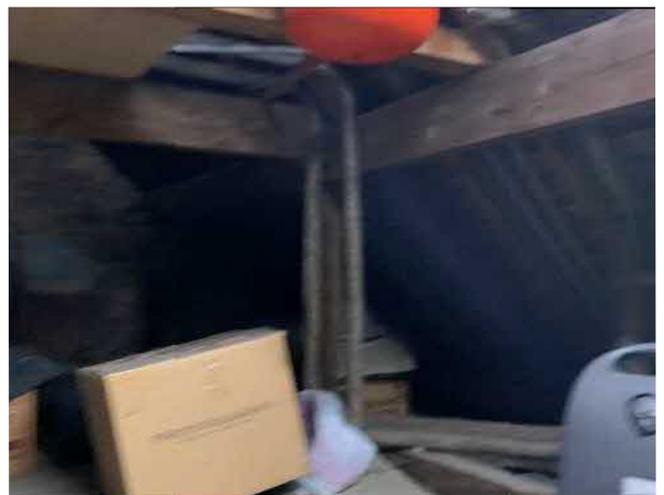
### 10.13 Loft

Views to the existing roof loft space showing the existing chimneys with 2no. located to the centre of the building and 1no. straight run against the party wall.
