## Heritage, Design & Access Statement

Jessops  
Horsham Lane  
Tamerton Foliot  
Plymouth  
PL5 4NP

**Alex Marsh BA (Arch) MRTPI IHBC**  
Solis Planning and Heritage  
Winton  
Cheldon  
Chulmleigh  
Devon  
EX18 7JB

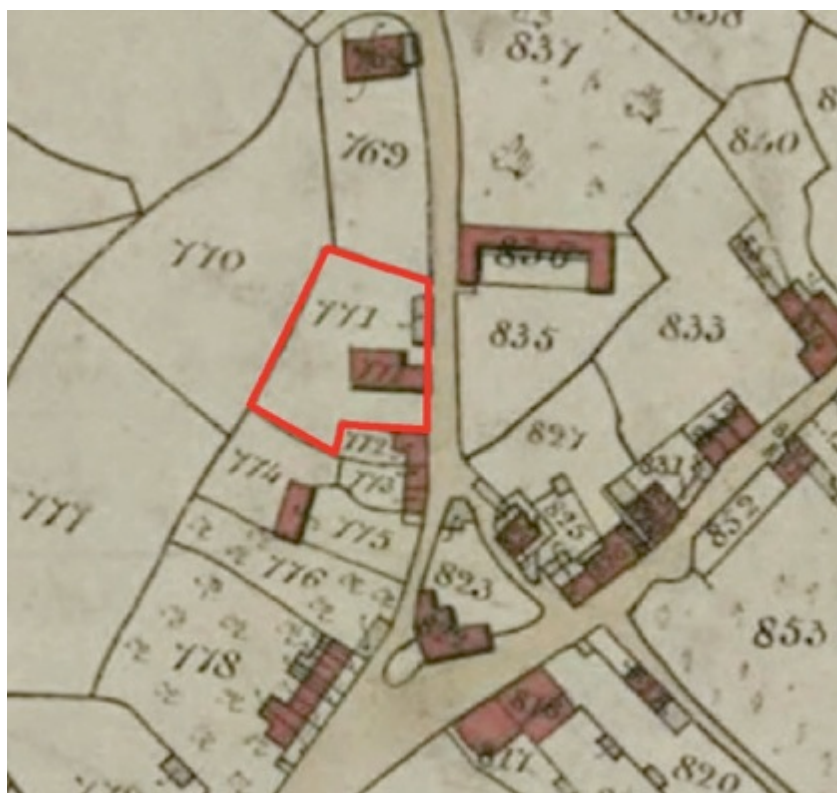
3.1 The 1840 Tithe Map shows the property established in its own gardens with surrounding immediate fields and orchards to the west and north and village properties to south and east. The footprint indicates the rear lean to and a side extension between the main house and Horsham Lane. The stone, timber frame and slate outbuilding to the north that adjoins Horsham Lane is also evident

**1840 Tithe Map Extract (Source: Know Your Place)**

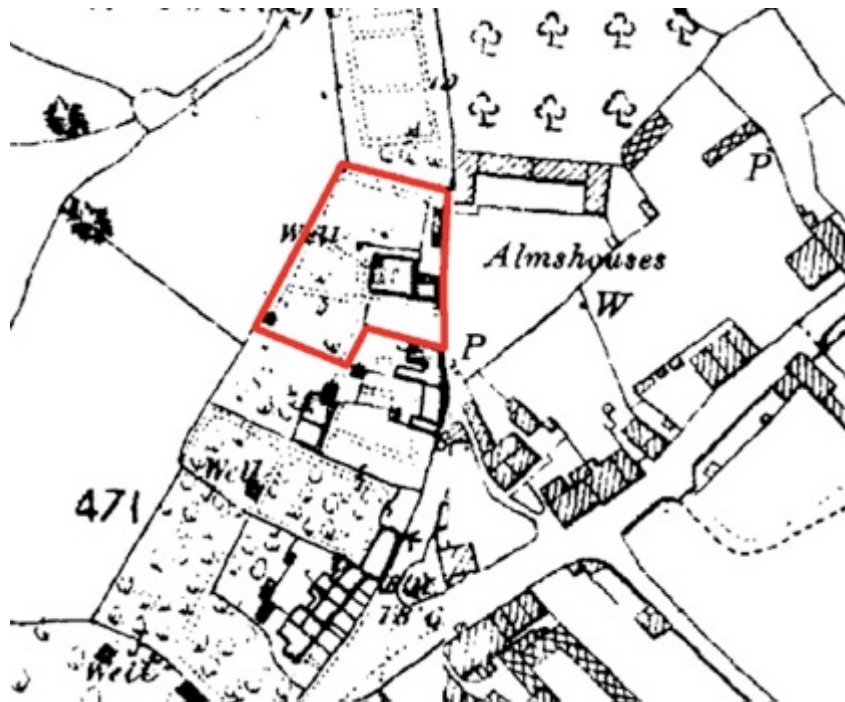
3.2 The 1st Edition OS mapping from 1880 is relatively poor quality but restates the form and siting of the dwelling its outbuilding and a well in the garden.

Map 2 OS 1880 1st Edition Extract (Source: Know Your Place)

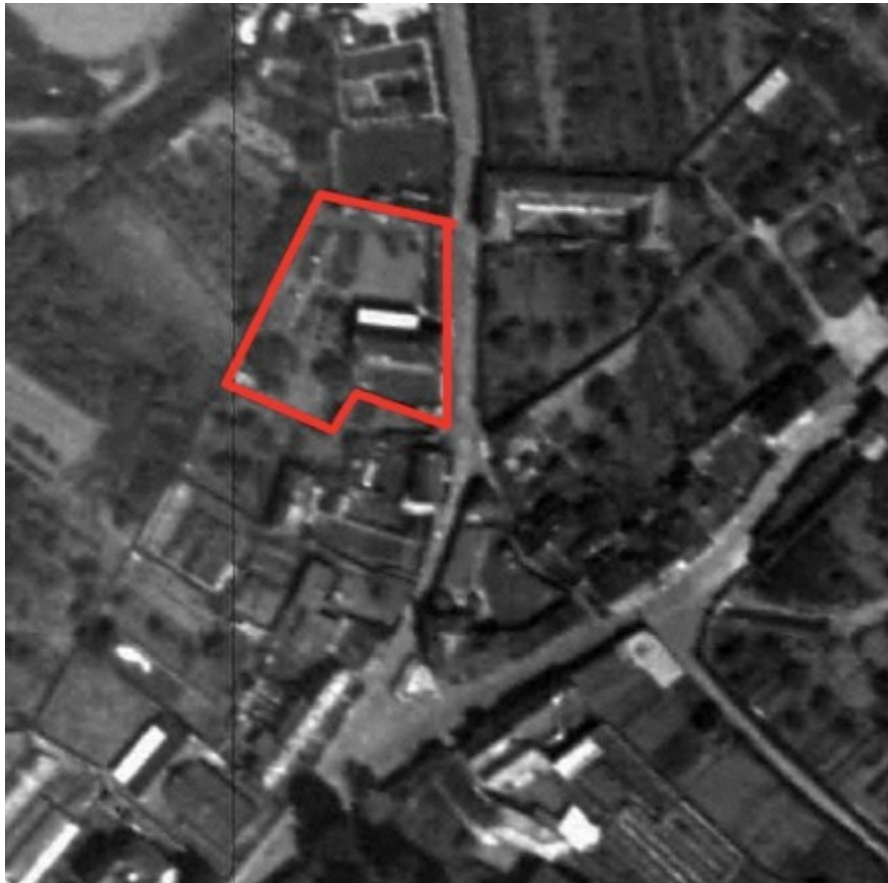
- 3.4 The 1946 aerial photograph provides little of clarity but does identify a reflective flat roof to the rear lean to suggestive that the extension to raised the roof had occurred in the earlier part of the 20th century.

**Map 4 1946 Aerial Photograph (Source: Know Your Place)**

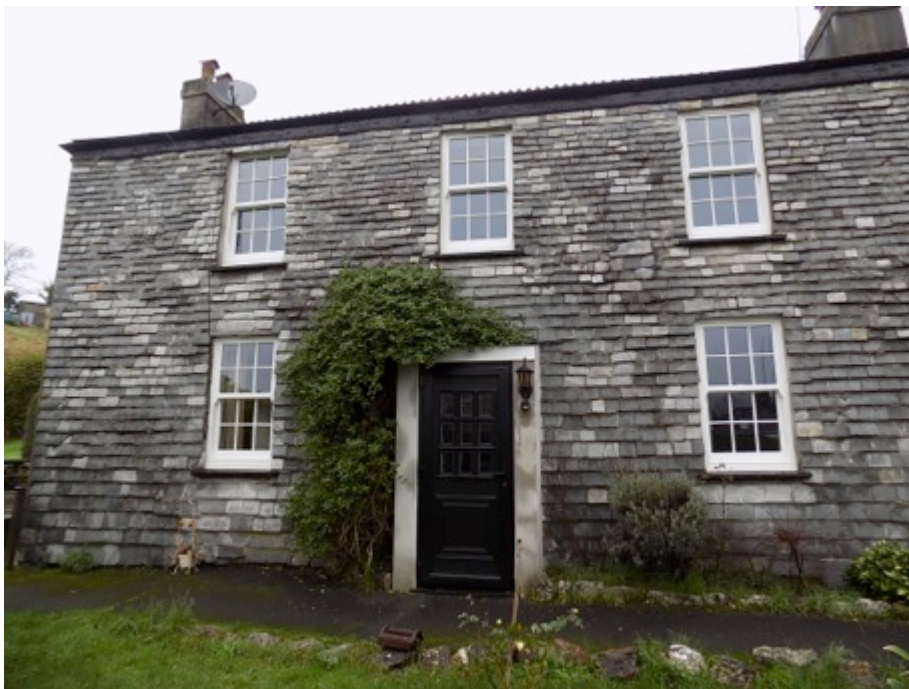
**Pic 1. The primary early C19 south elevation symmetrical frontage and slate hung.**

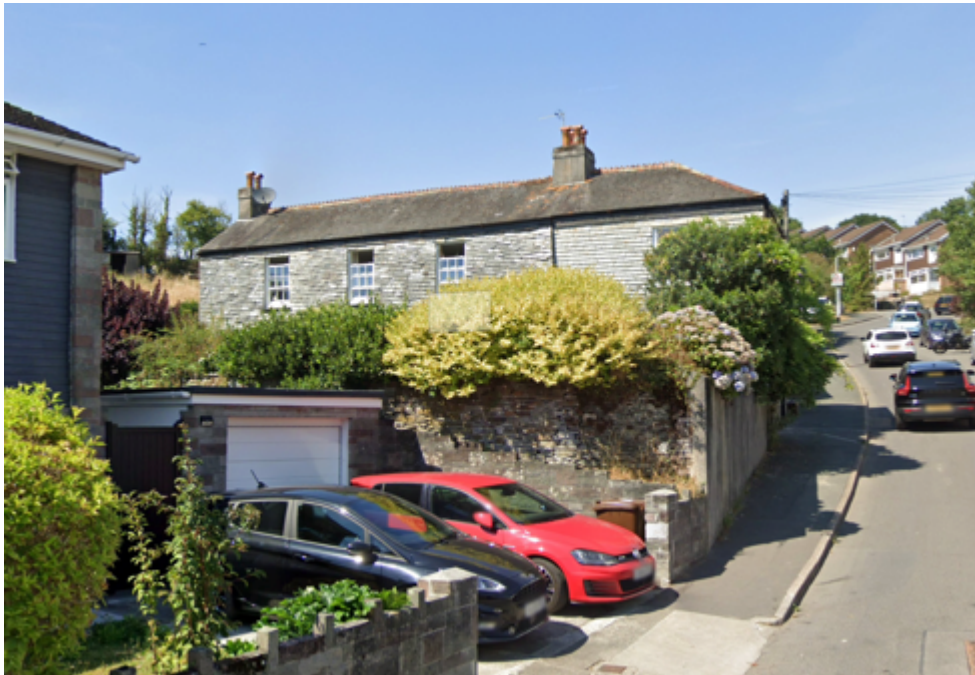
**Pic 2. The south elevation, late C19 extension to right side, slate hanging, hornless 12 pane sashes to C19 main house with 4 pane sash extension**

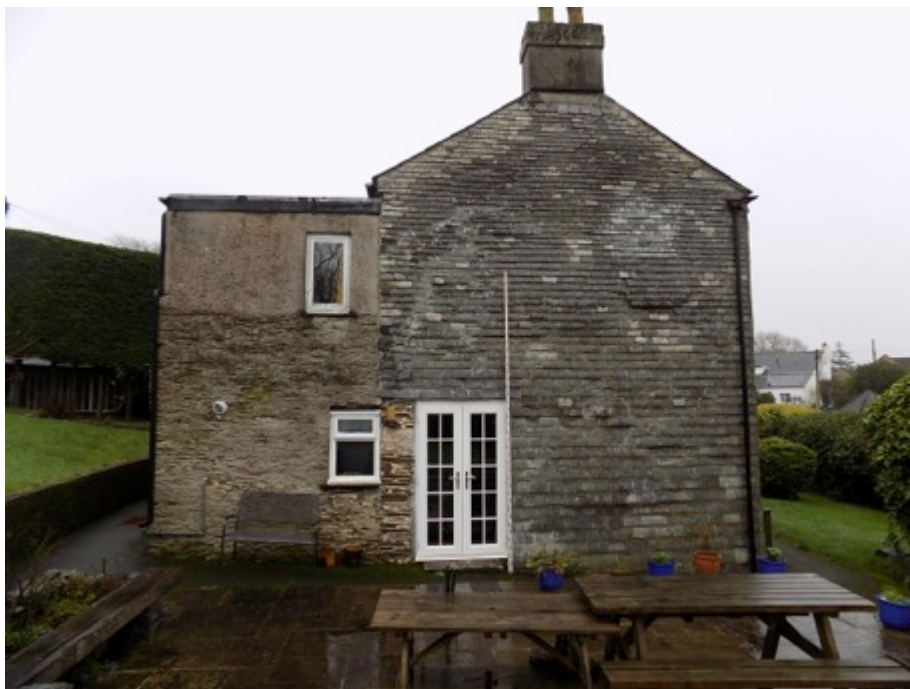
**Pic 3 West gable end slate clad with French Doors and rear extension. To the rear is a two-storey extension with render to the raised section and modern openings.**

7.9 It is proposed to replace three windows to the rear addition. One a side window to the ground floor west side elevation to the new kitchen, this opening will be widened to enable a tripartite timber sliding sash window with slim double glazed units. The existing window is a modern top hung non-traditional form. The first floor bedroom, above the new kitchen window, and the bathroom on the east side windows are both non-traditional timber windows and it is proposed to replace these with slim section aluminium sliding sash windows.

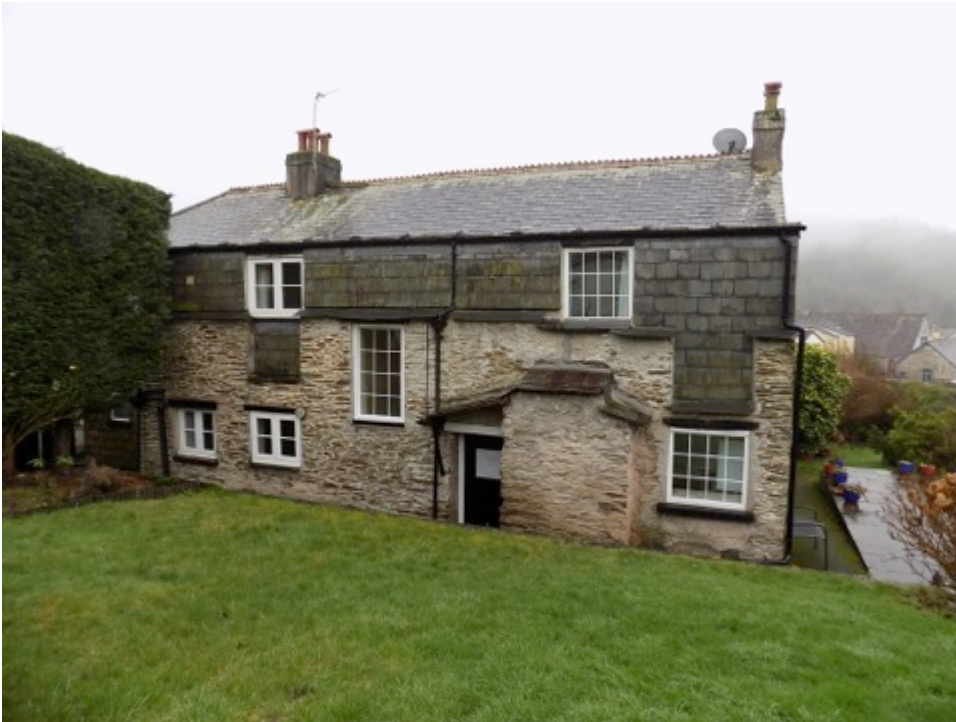
**Pic 4. Extensively altered North (rear) elevation with raised slate clad extension and mix of window openings and forms.**

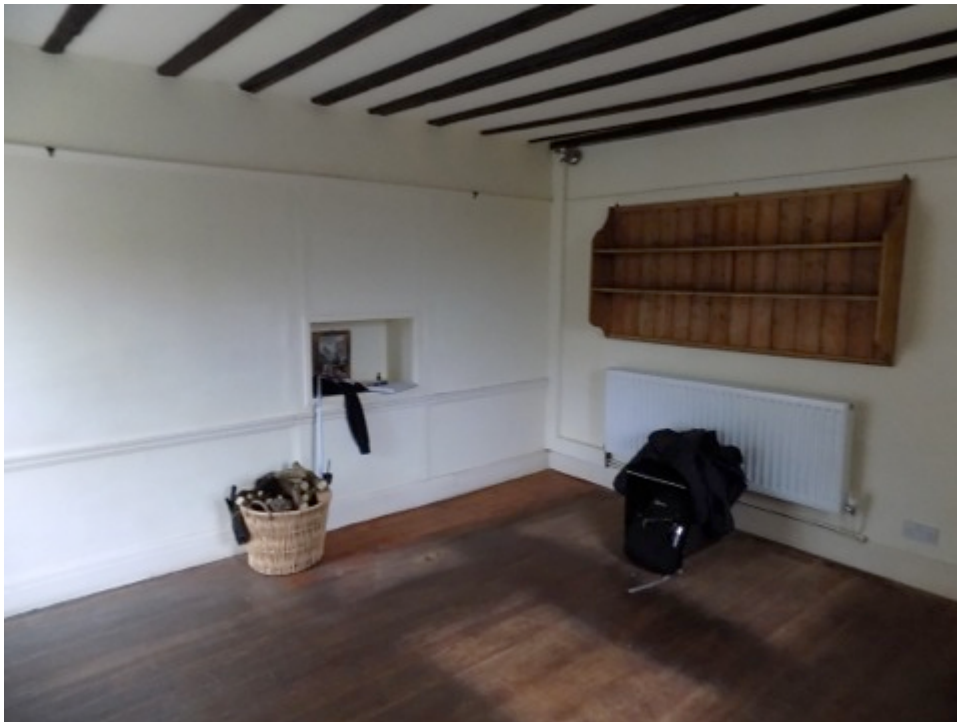
**Pic 5 The evidence of door opening between dining room and rear kitchen.**

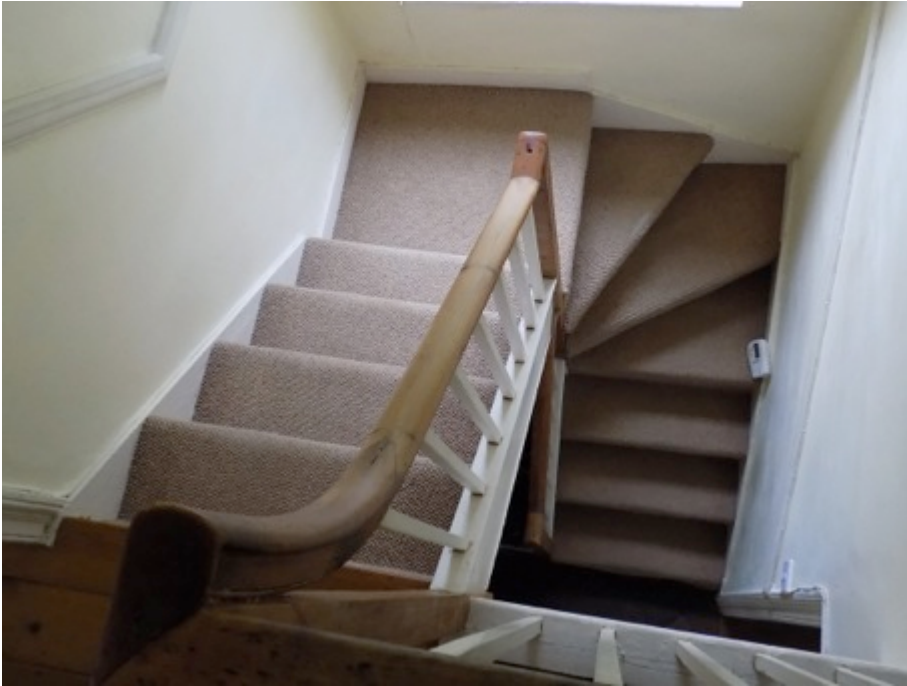
**Pic 6. Existing main staircase, stick balusters and thin continuous handrail**

- 6.2 The existing staircase needs to be replaced. It has been found to be structurally weak and will be replaced in an identical form with new handrail and stick baluster including some/all in metal to improve strength.

- 7.6 In respect to the staircase it is located to the rear of the plan rather than in a prominent position and has the basic features of an early 19th century staircase with stick balusters, although thicker than is the norm and sweeping continuous handrail. It has very plain square section newel posts and lacks the elegance and status expected of a town/village house of this period and may well be a late 19th century replacement. The staircase has structural weakness, it is propped underneath by random cuts of wood, and the treads are sloping downwards. It is proposed to remove the current staircase and replace with a safer new staircase, which replicates the simple form of the existing staircase with timber handrail and stick baluster in metal to assist strength. It was a common feature with the stick balusters staircase of the early 19th century to have at least one or two metal balusters in each flight to provide extra strength (1). This design element would be in keeping with the period and character of the house.

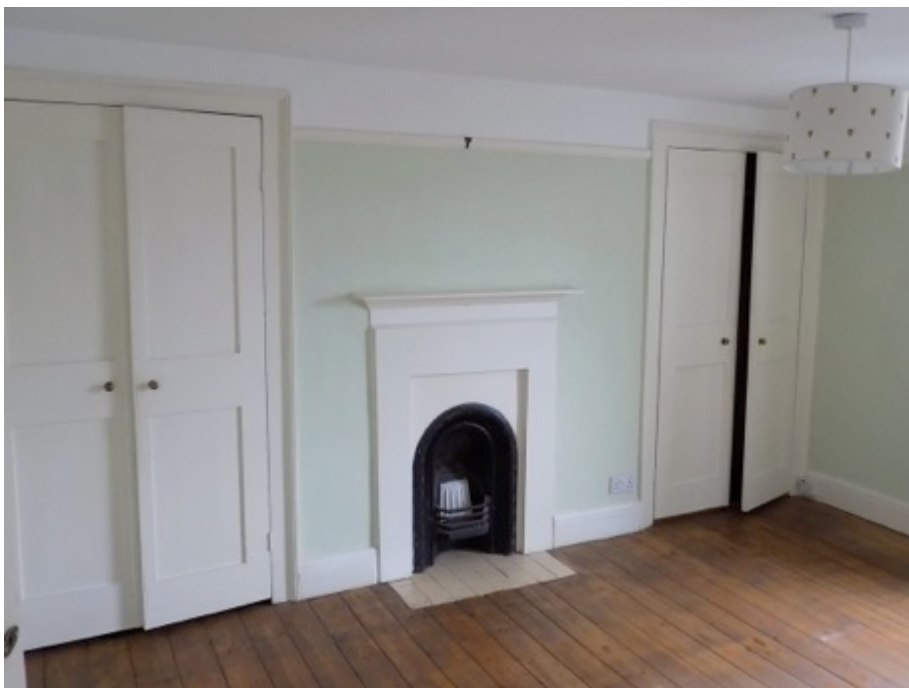
**Pic 7. Middle bedroom with original fireplace and fitted cupboards**
