Phase 1 Desk Study Report
Renton Road, Greenock
Issue No 01 November 2023

CONTROL SHEET**CLIENT:** Clydeway Contracts**PROJECT TITLE:** Renton Road Greenock**PROJECT REFERENCE:** AP2837**STATUS:** Issue 1

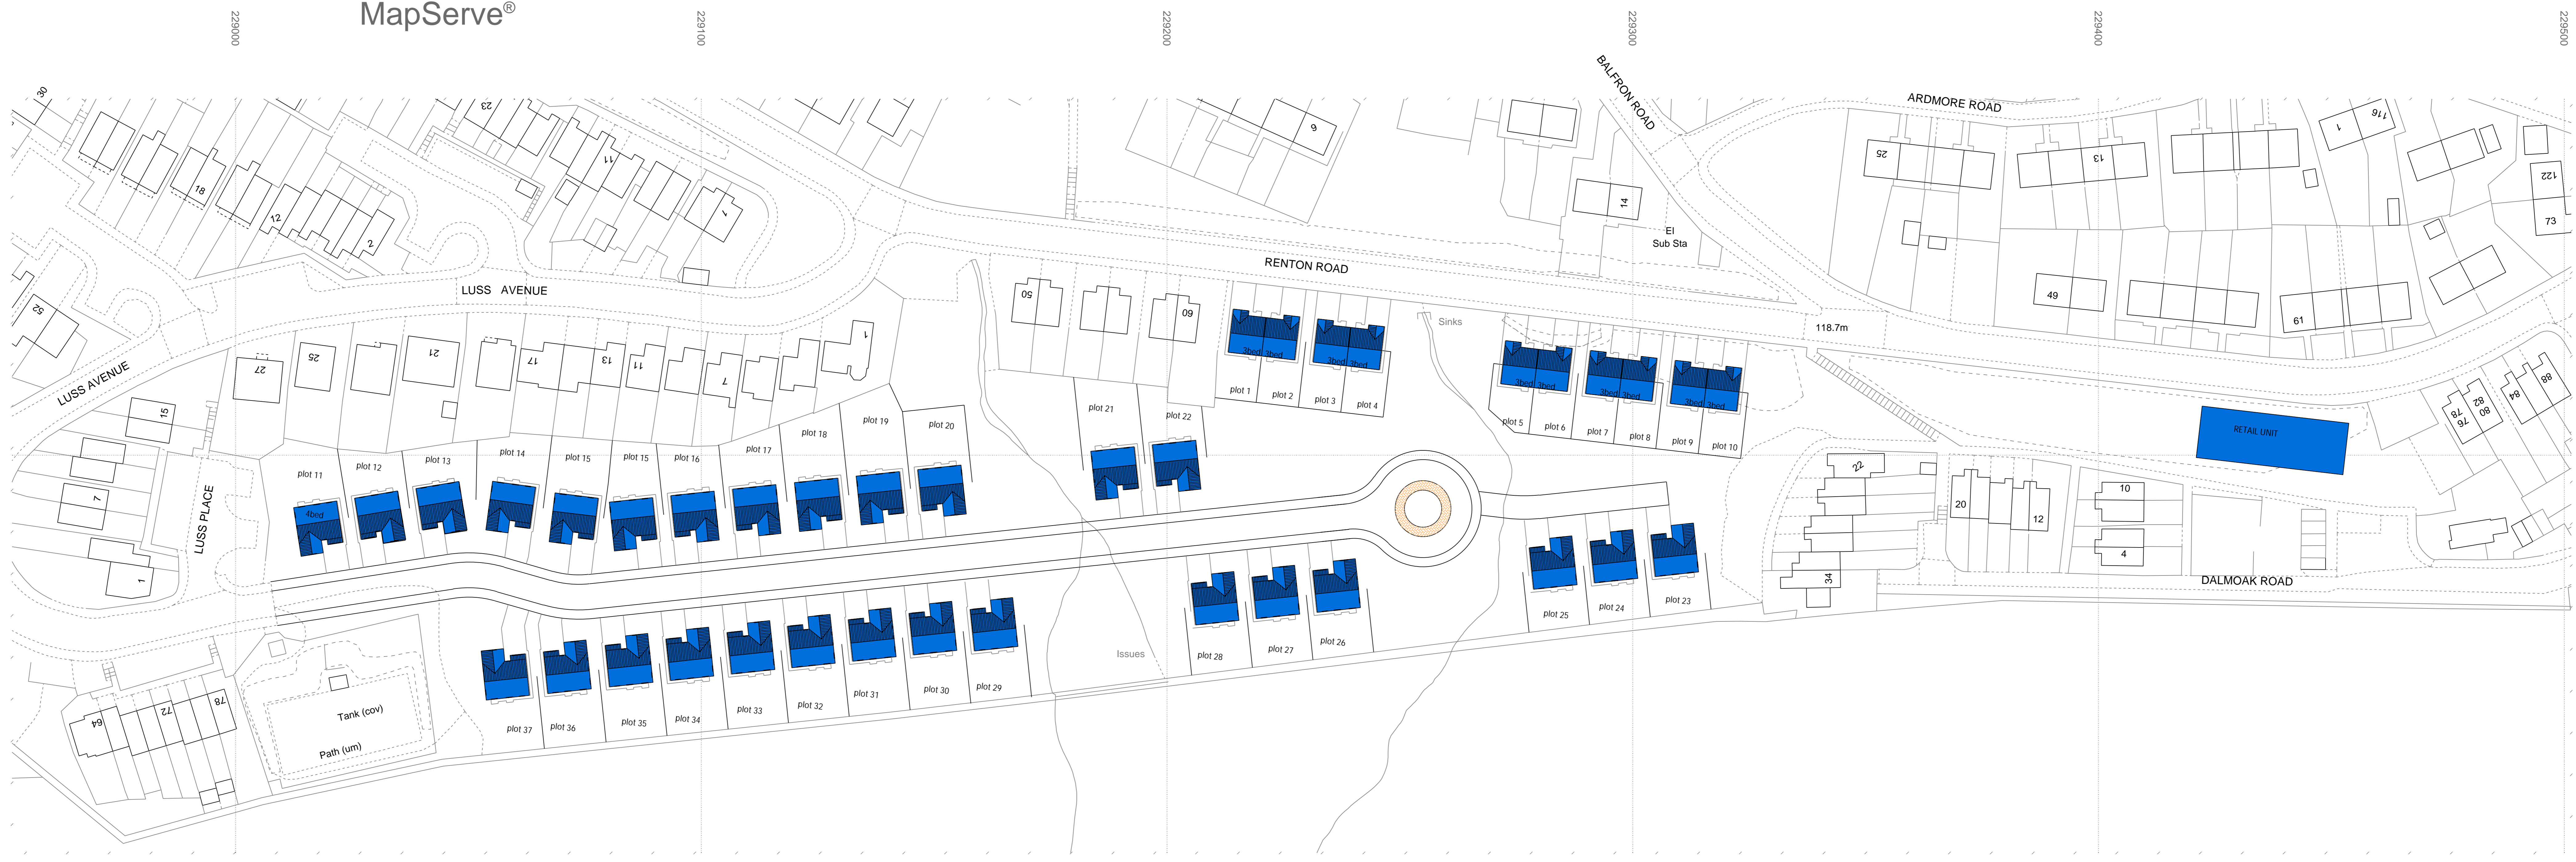
Appendix B: Proposed Development Plan

272 Bath Street Glasgow, G2 4JR Tel: 0141 354 1776 plindsay@modascotland.com www.modascotland.co.uk	project Renton Road Greenock	subject Site Plan 37 Plots
	drawn PL scale 1:500@A0	date Nov 23 drg.no.

The proposed development comprises of new residential developments with associated road access, parking, and soft landscaping along with one commercial development (refer to appendix B for proposed development layout). The areas where there is hardstanding (building footprint, access roads and car parking areas) would break a moderate amount of the potential linkages to human health end users; however potential linkages would not be broken within the areas of soft landscaping.

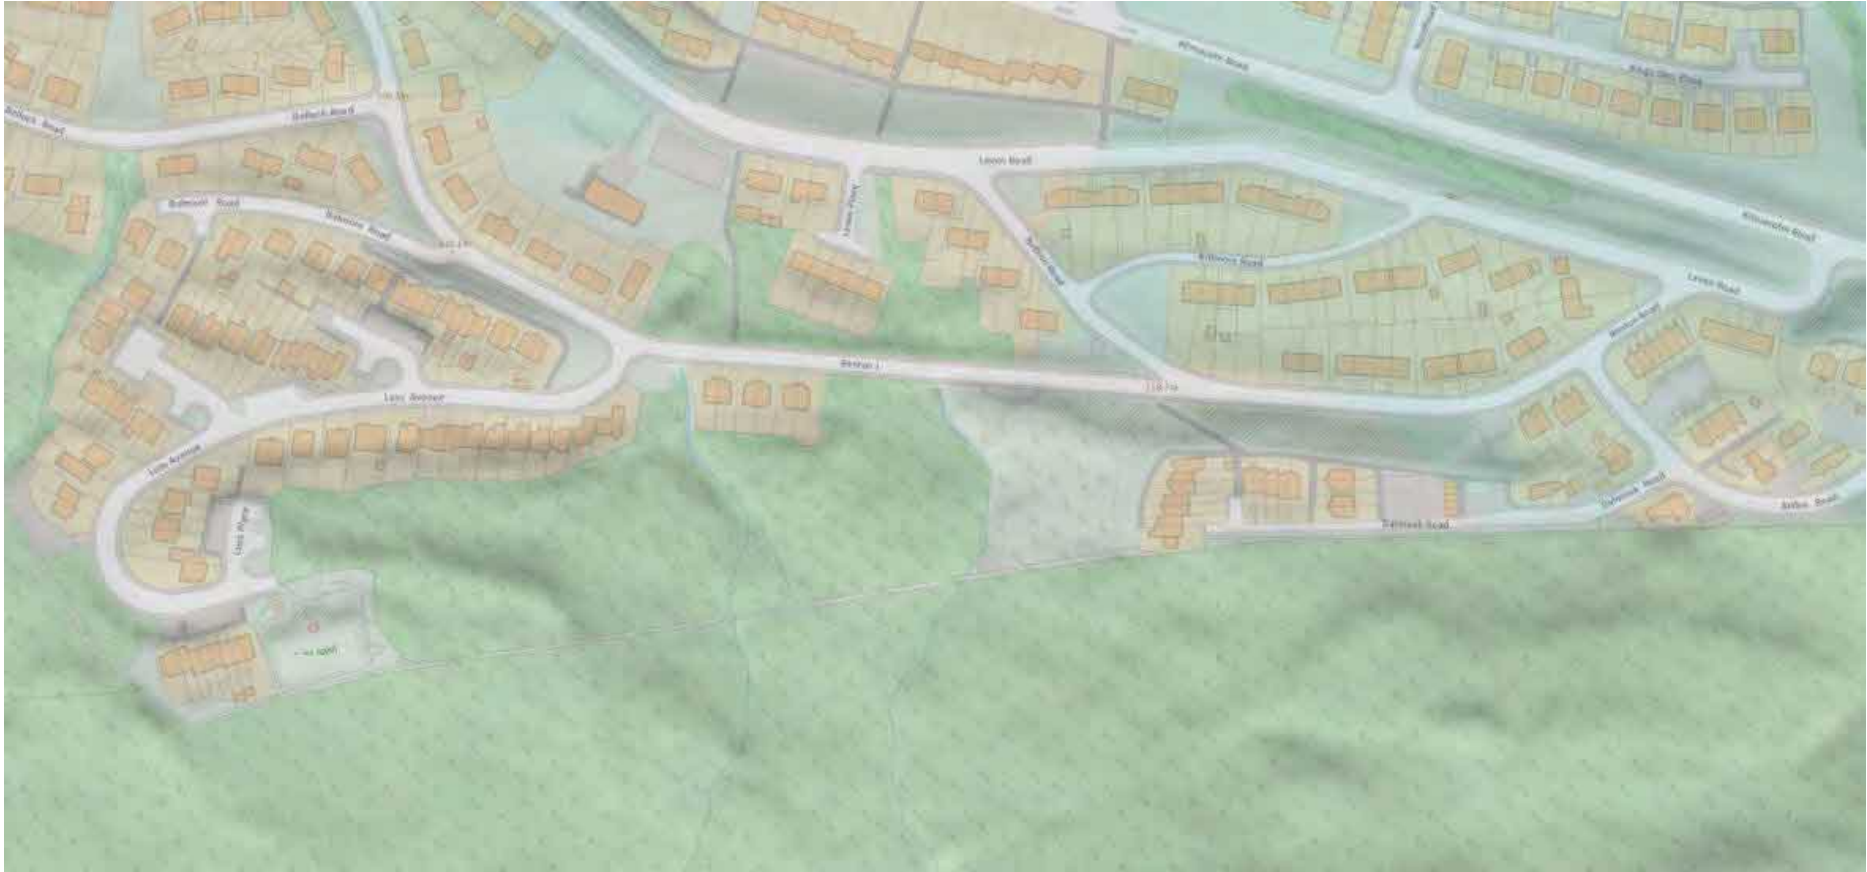
Superficial Geology

Till, Devensian - Diamicton

The British Geological Survey Online Viewer and Geo-Index were utilised to gather information on the geological conditions of the site. The following is a summary of the indicated conditions as interpreted from the above information (refer to Appendix D for BGS Geological Maps).

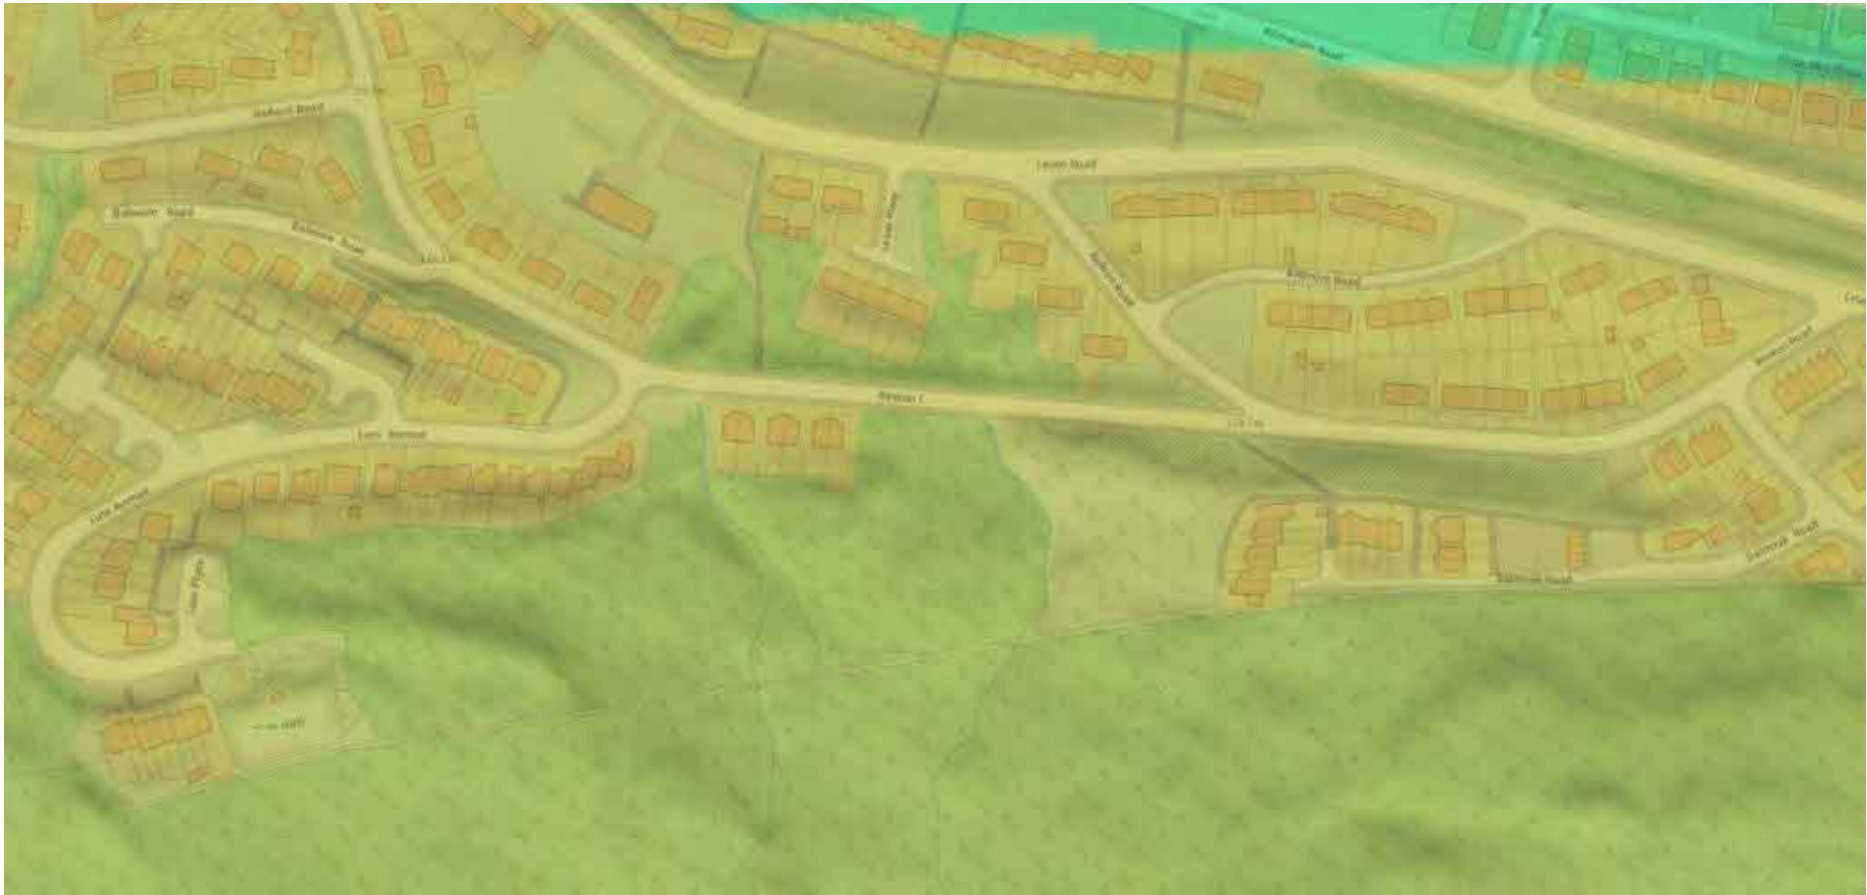
Bedrock Geology

Strathgryfe Lava Member - Mugearite
