2135 - Scarborough Harbour West Pier
Redevelopment

Building 1 Heritage Impact Justification

27 February 2024

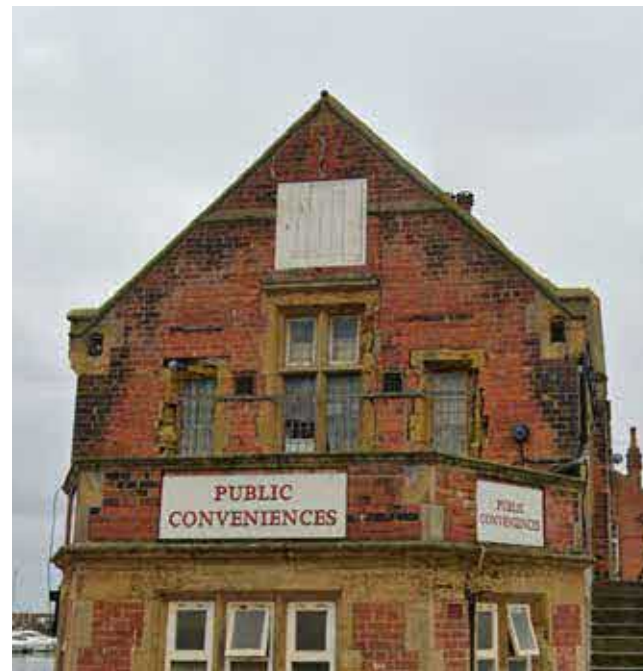
At the first floor level the stone reveals and windows, which are proposed to be repaired and replaced where necessary to match the existing to maintain and re-enhance the character of Building 1, would be obscured and even removed in order to allow for an extension in this location.

Building 1 North West Elevation 1st floor

As can be seen from the "Scarborough Spa Town, Reimagining a Victorian Seaside Resort" document visualisations a small external terrace area has been considered over the single storey part. However, there are challenges with space planning internally in order to gain access to the existing flat roof as well as the less respectful need to punch an opening through the existing brick and stone facade. Significant new structure would be needed to support the potential imposed live loads onto a balcony and, therefore, has been discounted.

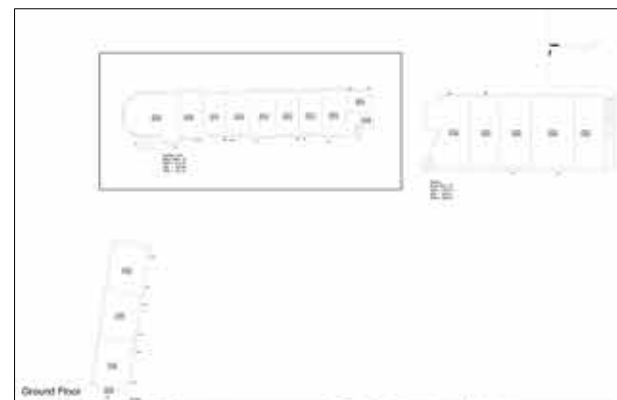
Building 1 - Existing Plan

The ground floor of Building 1 was previously stripped out without much sympathy to the existing building to put the existing public toilets in place. The first floor existing layout does limit the number of units that are lettable due to size and facilities. Currently a number of the cellular units have been unable to be let. By sensitively opening up the spaces the building is more lettable for a variety of uses. Modest openings between the cellular bays at first floor allow for the original building form to be visually read.

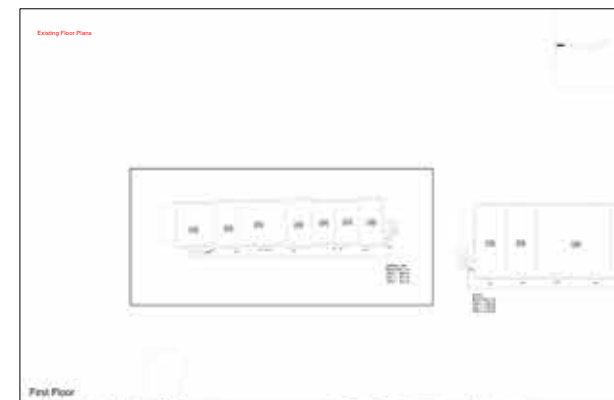
Building 1 - Existing Plan

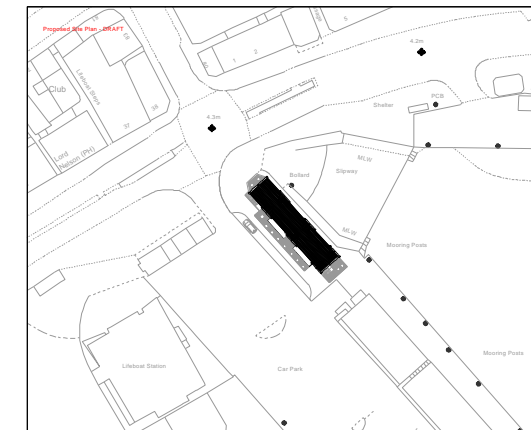
Building 1 - Early Concept Plan

As can be seen from the early concept plans and visuals, prepared by others, below the project has developed considerably with input from Heritage and Conservation, Flood Risk advice, and consultation with potential restaurant operators and the general public to inform the proposed Building 1 and West Pier Redevelopment. Jefferson Sheard Architects have developed a far more sensitive approach to the extension, restoration, and reuse of the heritage asset. For more information please review the supporting documents.

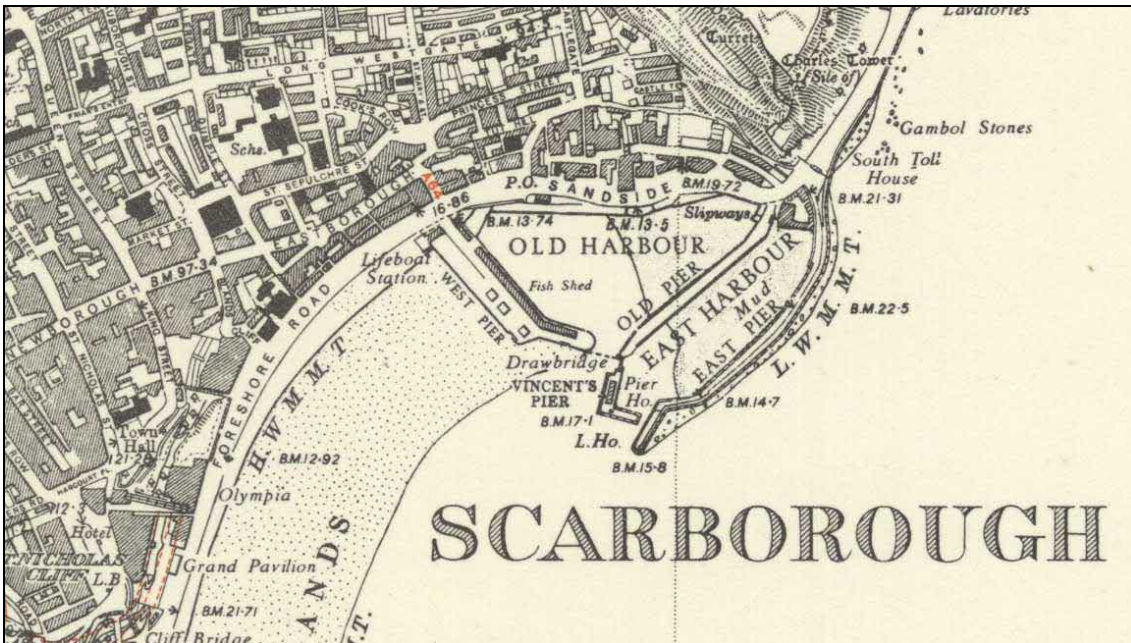
1950 – Building 5 constructed.
