Job Name  
**Knollys & Stephenson Hse**  
Croydon CR0 6SR

Drawing Title  
**Below Ground Drainage Lower Ground Floor**

Drg No **2618 - C - SK033**

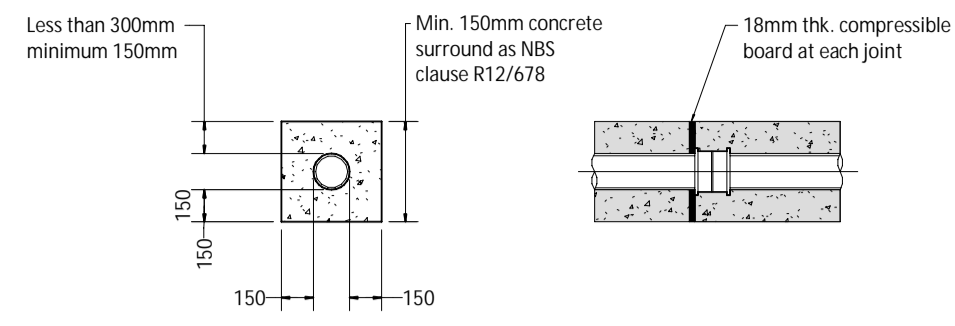
**Typical Bedding detail for cast iron drains when laid with less than 300mm cover (Class Y)**  
1:25

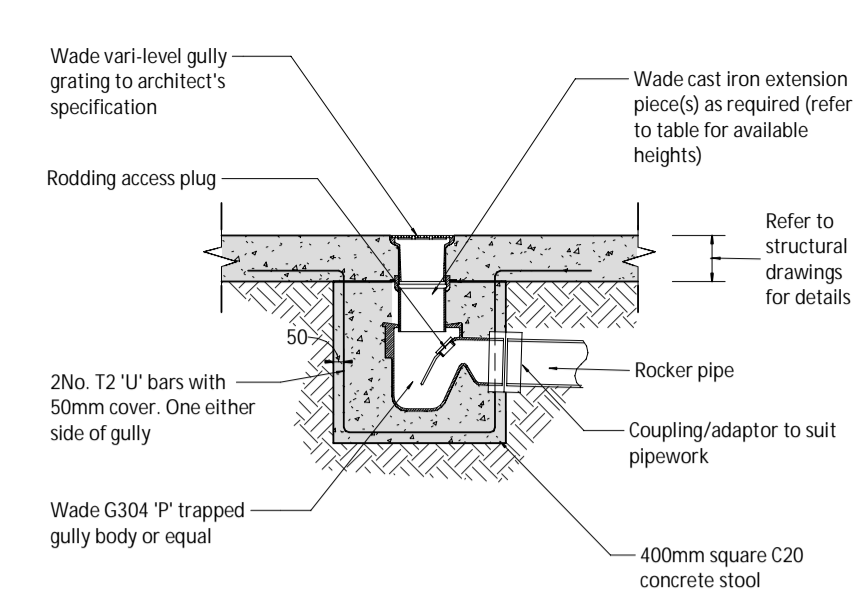
**Typical Internal Floor Gully P Trap**  
1:25
