# BANFF CASTLE COMMUNITY ASSOCIATION

## HERITAGE STATEMENT 2024

## HERITAGE STATEMENT

The following Heritage Statement is in support of the proposed internal alterations as required by the recent Fire Risk Assessment.

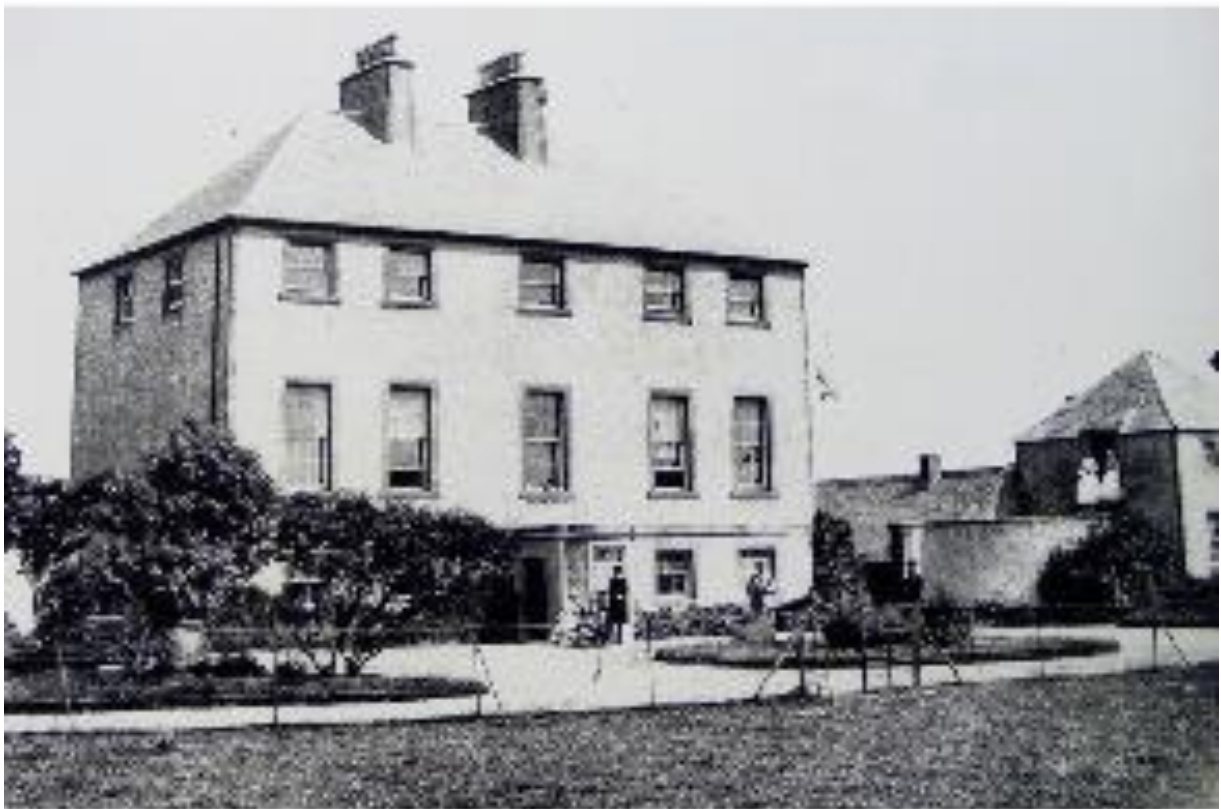
19<sup>th</sup> century photo of Banff Castle courtesy of BCCA

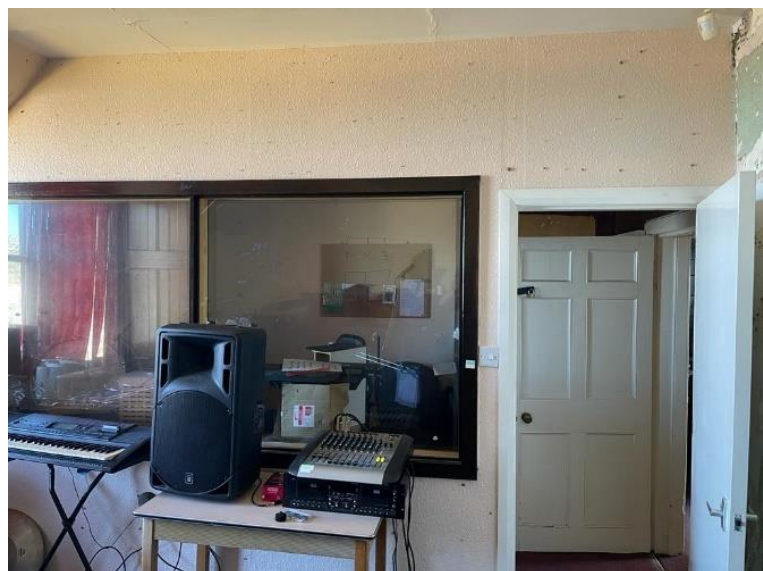
View of the existing first floor Recording Studio

Comprising a main block and rear wing, the 1st floor of the rear wing has been subdivided into several smaller spaces with the main room formerly used by Talking Banffie recording studio.

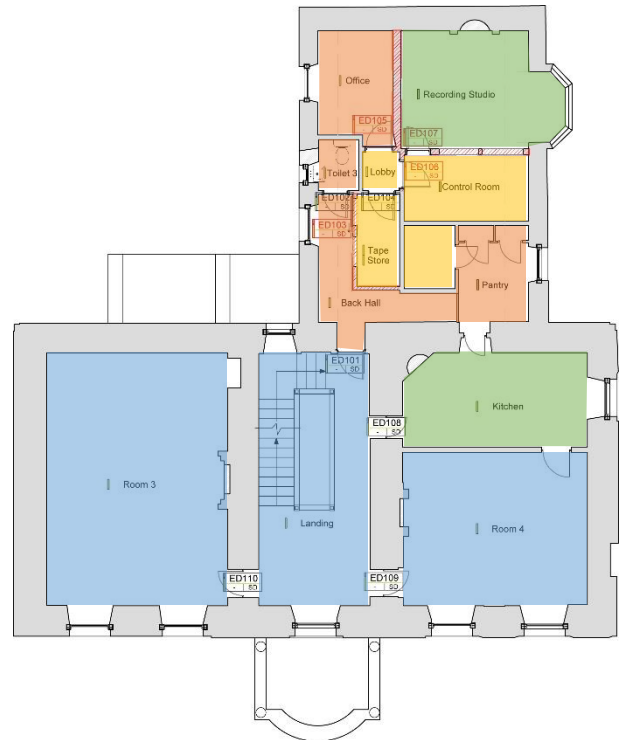
Existing First Floor Plan

- High Significance
- Medium Significance
- Neutral Significance
- Low Significance

Later alterations include the formation of an accessible toilet at ground floor, the formation of a ground floor toilet block to the rear and subdivision of the first floor rear wing to form a recording studio with ancillary storage.

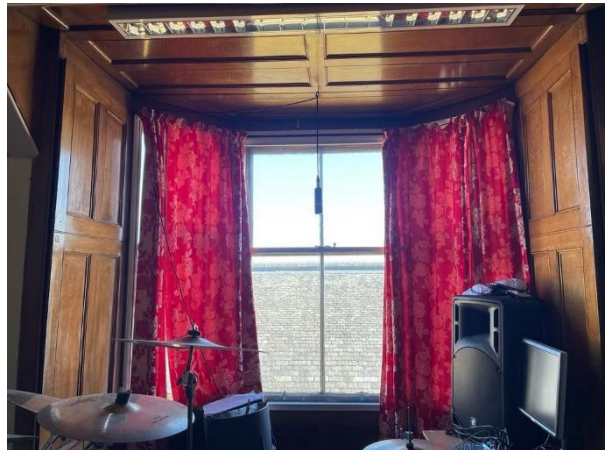
View of rear wing oriel window

The rear wing appears to have been extended in the 19<sup>th</sup> century including the addition of a first floor with east facing oriel window.

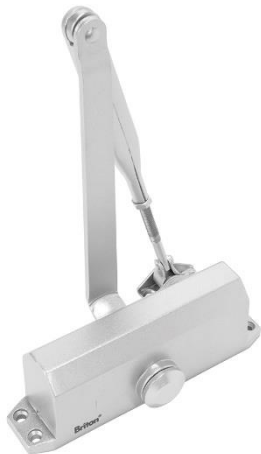
Surface mounted door closer

In terms of the proposed remedial works to the existing panel doors, this will involve surface mounted ironmongery, signage and intumescent smoke seals to minimise any disruption to historic fabric and detailing. Surface application of the upgrades will require screw fixing, but this will avoid checking or rebating into existing timber and can, if ever changed back into a residential property be easily removed and repaired.

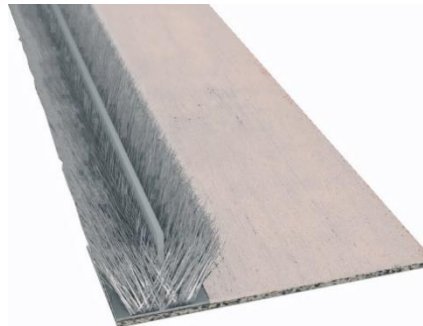
Surface mounted seals

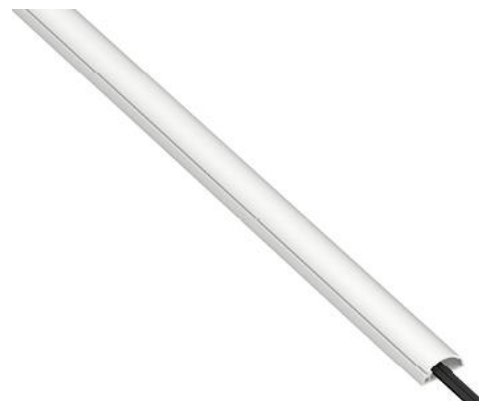
D-Line single core trunking

In terms of the upgrade to the existing fire detection system this will involve routing of new power and pyro cabling. Where possible existing containment routes are to be utilised (since there are limited appliances already installed). Where existing containment is not practical surface mounted trunking is to be used to avoid disruption to existing plaster mouldings. Again, if ever changed back into a residential property this can easily be removed and repaired.
