#### DORMER CONSTRUCTION

CONDITION 3 DISCHARGE APPLICATION DRAWING

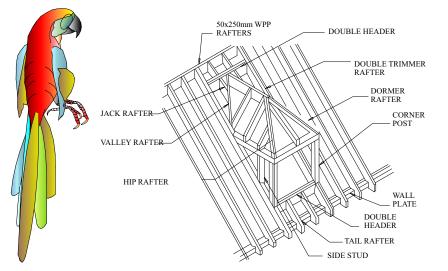
'Clipped' and bedded eaves detail as existing dormers

To achieve minimum U Value of 0.28W/m<sup>2</sup>K

Structure to engineer's details and calculations. Render finish (to comply with BS EN 13914-1:2005) - applied in 3 coats at least 20mm thick to stainless steel render lath. Render should be finished onto an approved render stop. Render lath fixed to vertical 25 x 50mm preservative treated battens to provide vented and drained cavity, fixed to breathable membrane (having a vapour resistance of not more than 0.6 MNs/g) and 12mm thick W.B.P external quality plywood sheathing (or other approved). Ply fixed to treated timber frame studs constructed using 150mm x 50mm head and sole plates and vertical studs (with noggins) at 400mm centres or to structural engineer's details and calculations. Insulation between and over studs 100mm Kingspan Thermawall between TW55 plus VCL and 22mm Gyproc Thermaline Basic plasterboard with 3mm light weight skim of finishing plaster over.

### \*Render to match existing in colour and texture

All junctions to have water tight construction, seal all perimeter joints with tape internally and with silicon sealant externally. Dormer walls built off existing masonry walls to have galvanised mild steel straps placed at 900 centres. Dormer cheeks within 1m of the boundary to be lined externally with 12.5mm Supalux and 12.5mm Gyproc FireLine board internally to achieve 1/2 hour fire resistance from both sides Windows - as specified in JOINERY.001

Construct ceiling using sw joists at 400mm centres, finished internally with 12.5mm plasterboard and min 3mm thistle multi-finish plaster. Provide polythene vapour barrier between insulation and plasterboard. TYVEK breathable roofing felt. 100mm Kingspan Thermawall TW55 between ceiling joists plus VCL and 22mm Gyproc Thermaline Basic plasterboard with 3mm light weight skim of finishing plaster over.

Restraint strapping -100mm x 50mm wall plate strapped down to walls. Ceiling joists and rafters to be strapped to walls and gable walls, straps built into cavity, across at least 3 timbers with noggins. All straps to be 1000 x 30 x 5mm galvanized ved to BSEN 845-1 at 2m c straps or other approved to BSEN 845-1 at 2m centres PITCHED ROOF INSULATION WHERE CEILING FOLLOWS RAFTER LINE
