PROJECT
74-76 HIGH ST, DUNBAR

STATUS
PLANNING/LBC

DRAWING TITLE
PROPOSED ELEVATIONS

DWG. NO.
(02)100

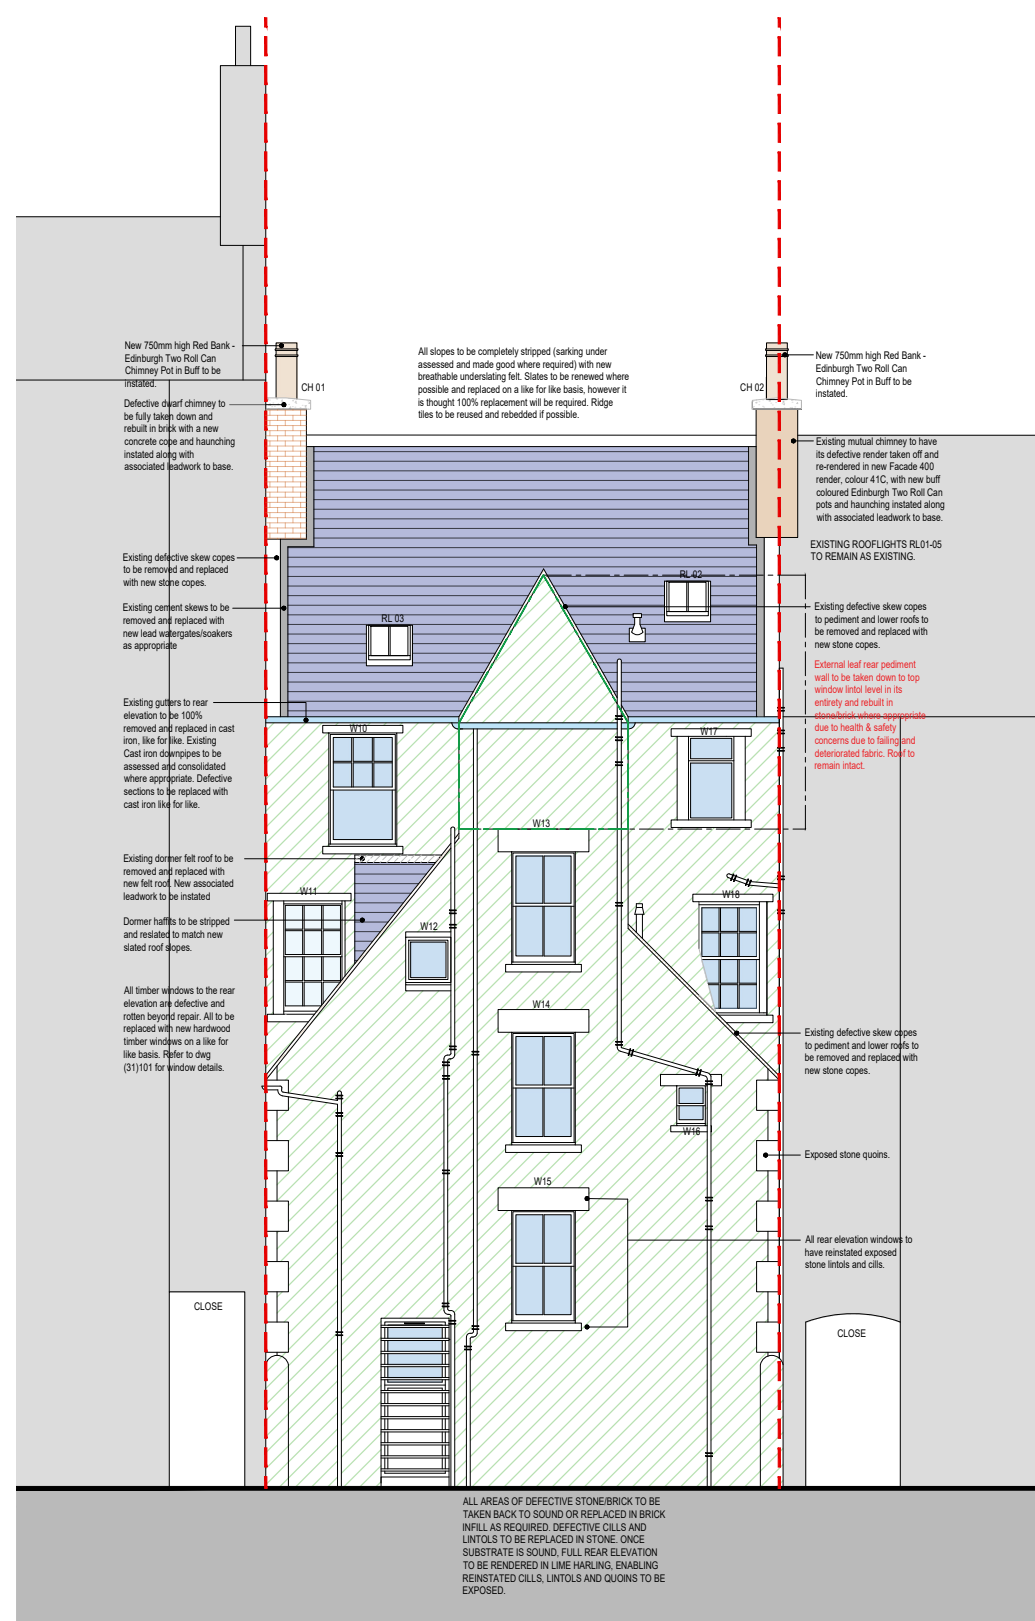
PROPOSED REAR ELEVATION
SCALE BAR 1:100

Are in an extremely poor condition. To the rear the pediment should be taken down to top window lintel level in its entirety and rebuilt. All areas of defective stone/brick to be taken back to sound or replaced in brick infill as required. Defective cills and lintols to be replaced in stone. Once substrate is sound, rear elevation to be rendered in lime harling, enabling cills, lintols and quoins to be exposed. To the front any repairs to the render should be made good and it is recommended this elevation be repainted.
