Document
Design and Access Statement

Project
West Bradley House

West Bradley House Design and Access Statement

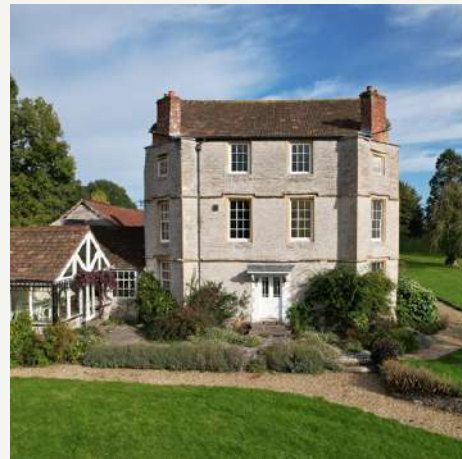
① Main House

Main house comprising of a basement and 3 storeys. Compromised by an ill-considered roof, 1980's porch and numerous internal reconfigurations

- ① The main house is a fine example of a 16th/17 century geometric lodge. However it was completely renovated in 1720s and again almost entirely gutted in the mid 19th century and harm has been caused over the years with the moving of the staircase and replacement of the roof.

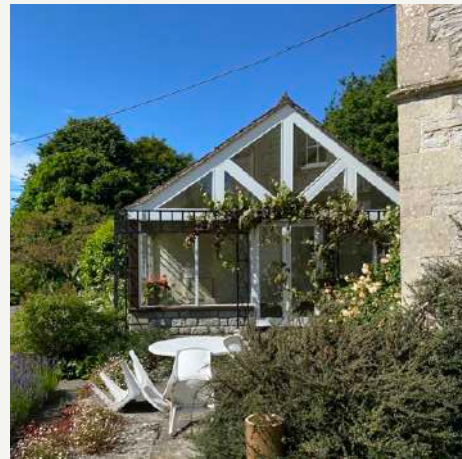
② ③ ④ Extensions

Unsympathetic additions to the house including a sun-room, a poor quality conservatory and a poorly designed covered link to the Apple Barn all harm the heritage asset

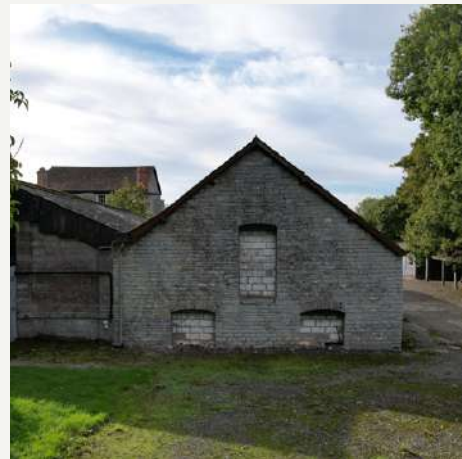
⑤ ⑥ Apple Barn and Concrete barn

1902 Apple barn is a fine example of local stone building with some impressive internal spaces used for cider making. This was built late C19th when cider making changed the house with land to a farm with orchards.

- ④
- ⑤ The Apple Barn (the 1902 cider making barn) is of good quality but its roof is in need of replacement.
- ⑥ The concrete barn to its south is of negative contribution and blocks key views of the house.

- ⑤ The Apple Barn is to be sensitively refurbished and the roof structure is to be replaced as stipulated by the engineers.
- ⑥ The concrete barn to its south is to be removed to improve the views of the main house and expose more of the apple barn.

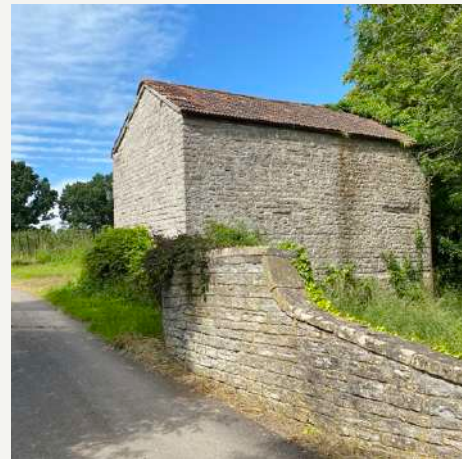
⑦ Little Stone Barn

1902 Stone barn - facing the orchards was used to house a cart and pony to serve the cider industry. The brick infill appears newer than the stone gables.

- ⑦ The little stone Barn is a positive contributor but is in need of major structural intervention.
- ⑧ The dilapidated timber Cart Shed has some character but is in poor condition.

- ⑦ The little stone barn which has a positive impact on the site is to have a new mezzanine and roof new structure to tie the building together.
- ⑧ The existing Cart shed is to be demolished and replaced with a higher quality building of same size and proportion following the rhythm of the existing structural bays.

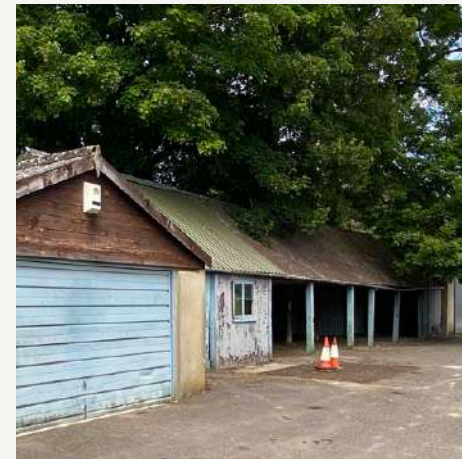
⑧ Cart Shed

Cart Shed - now in a poor state of repair this was a early C20th addition to support the cider industry. The adjoining C20 garage is a poor addition.

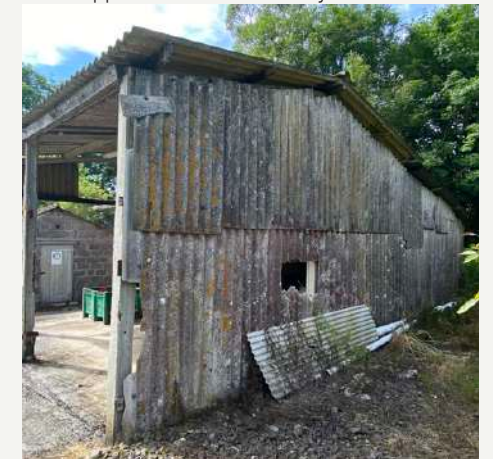
⑨ Agricultural Barns

Modern Barns - a scattering of medium to large steel and concrete framed barns line the rear courtyard. Most are in poor condition and harm the heritage asset. The indicate the expansion of the apple farm and machinery.

- ⑨ The surrounding modern outbuildings are to be demolished and replaced with higher quality ancillary buildings.

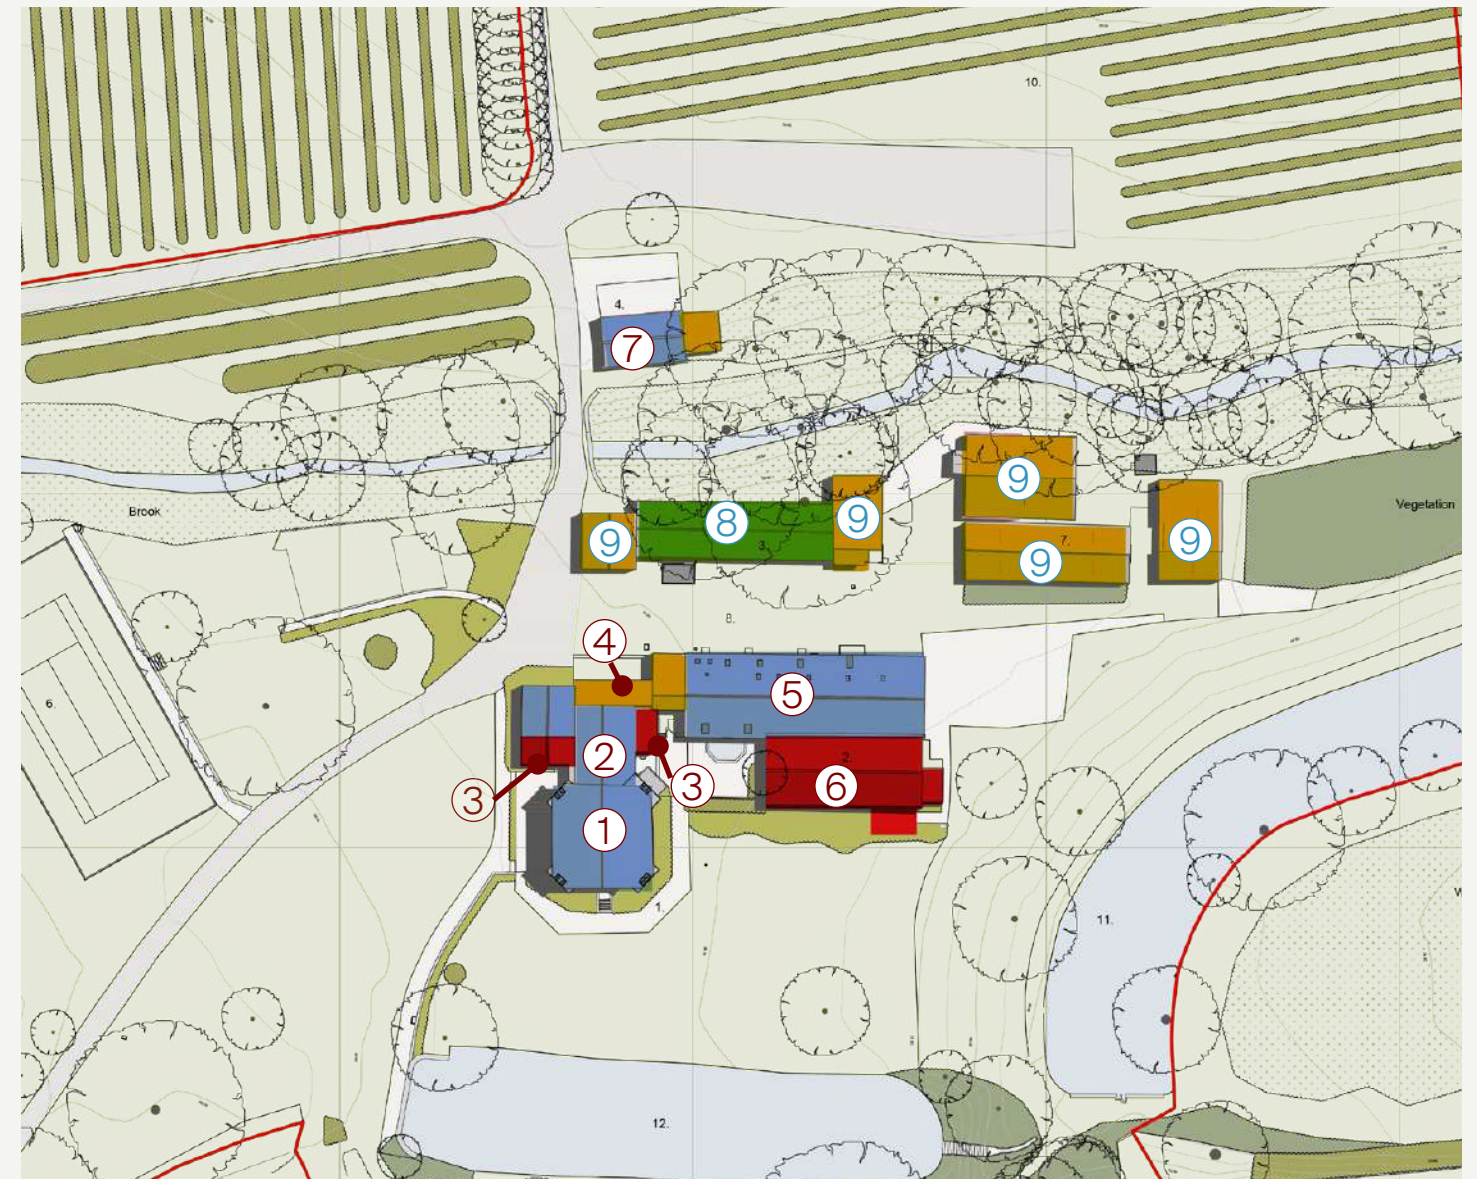
The existing stone bridge is to be repaired as required. Tennis court to be relocated away from the main house and the amount of hard standing reduced.
