5.0 Proposals

6.0 Main House

The refurbishment strategy for the main house has been developed together with Justin Ayton.

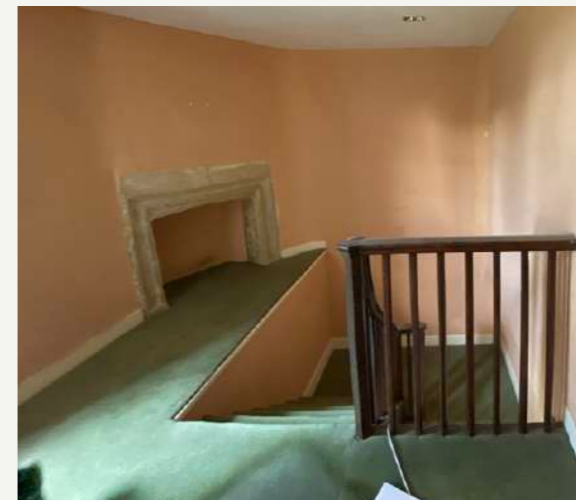
18TH CENTURY WINDOW HEMMED IN BY THE 19 CENTURY LANDING

Its relocation has led to the original very fine, semi-circular headed, early-18th century stair sash to be dissected by the 19th century floor. It has also led to original features being stranded narrow strips of landing. This includes one of only two original fireplaces and one of the few remaining early 18 century corner windows.

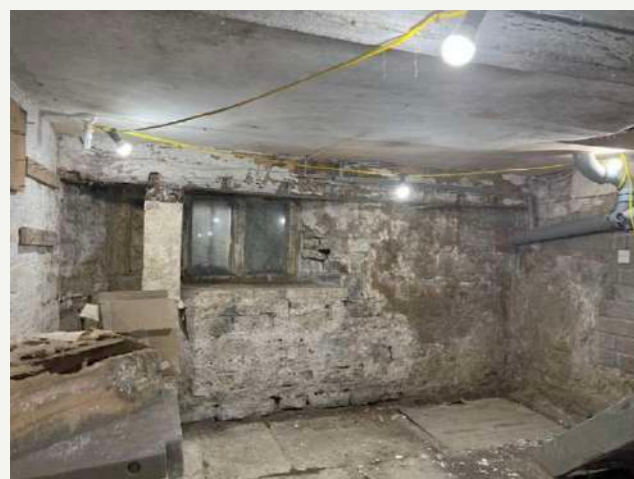
BASEMENT TO BE LEFT IN ITS CURRENT SITUATION

The proposals are for the basement to be preserved in its current form to act as marker of the original age of the building. The later staircase to the basement is to be removed and access will be via the original external stairs.

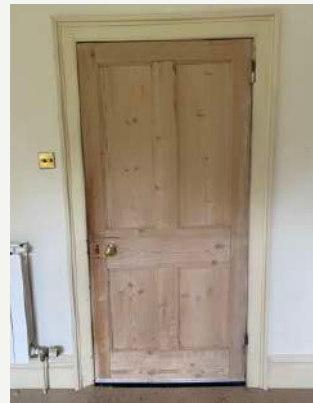
19 CENTURY JOINERY TO BE RETAINED

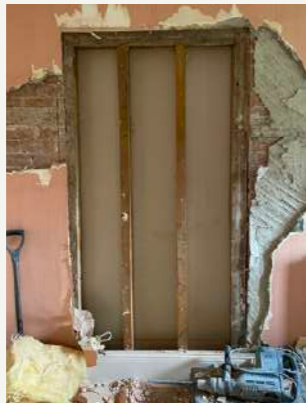
EXISTING OPENING TO BE REINSTATED BETWEEN G1 AND G03

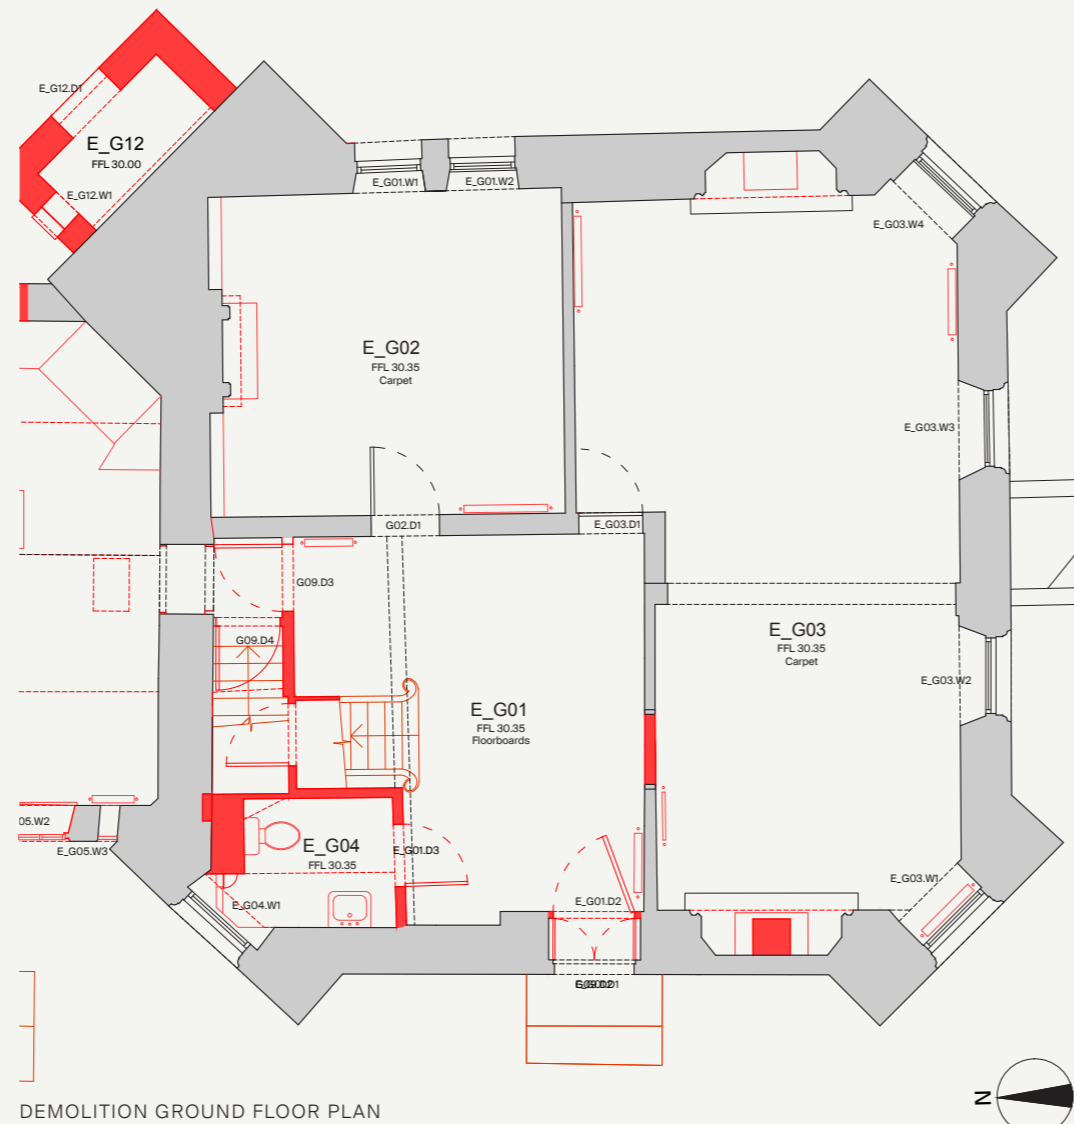
Demolitions

- Remove late C19 timber stairs in non-original location.
- Reinstated hall opening to E_G03.
- E_G02 Remove fireplace. Dismantle chimney surround and hearth.
- Decommission and remove modern wood burner and remove modern masonry plinth to both fireplaces in E_G03.
- Remove C20 internal and external front doorsets.
- Dismantle flagstone steps and set aside to protected location for potential re-use.
- Remove all redundant sanitaryware and modern joinery throughout.

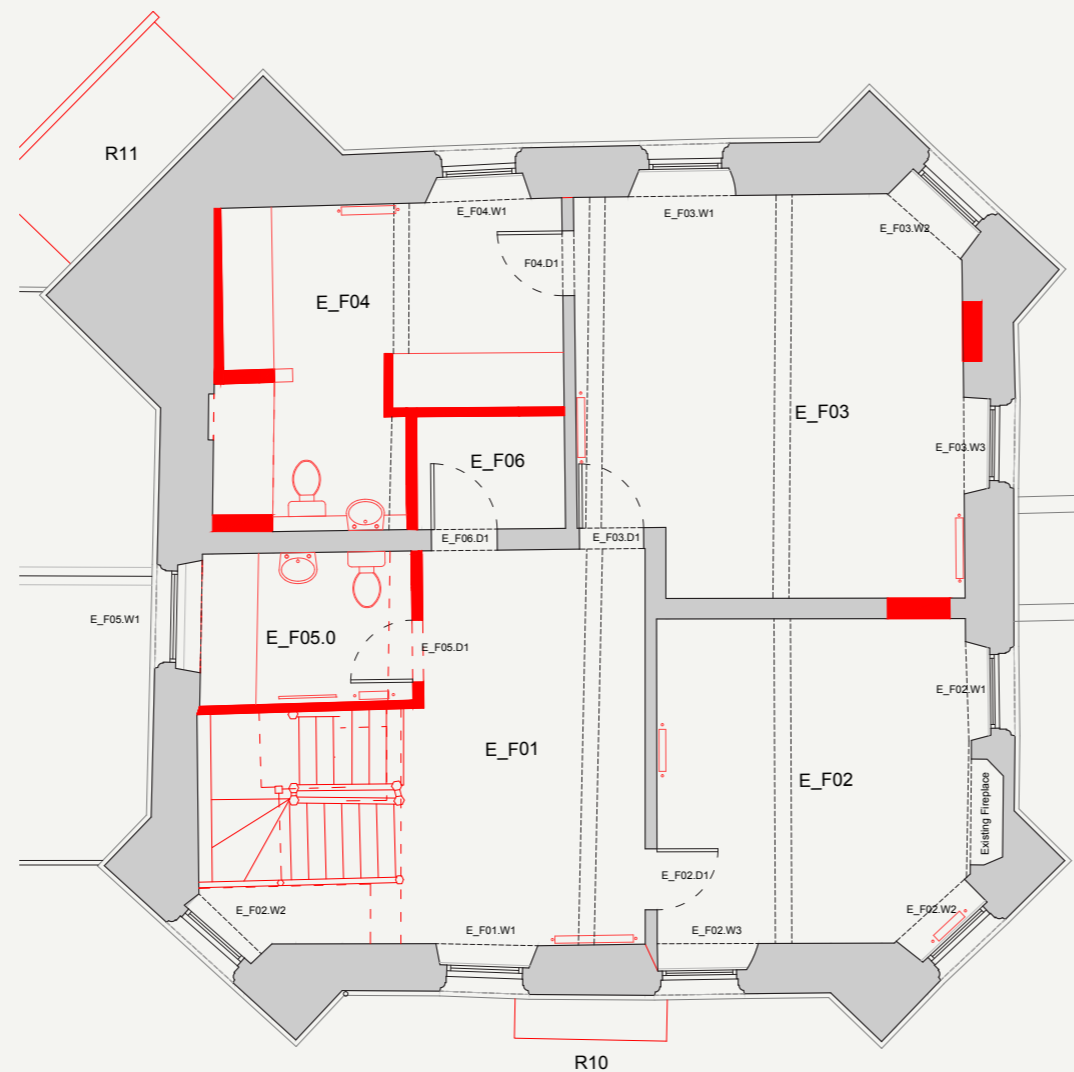
DEMOLITION FIRST FLOOR PLAN

Demolitions

- Remove late C19 timber stairs in non-original location
- Form single door width opening in the wall between E_F02 and E_F03.
- Remove bathroom that intersects window E_F05.W1 and associated partitions. Bathroom door E_F05.D1 to be removed from this location and reused on this floor.
- Remove all modern joinery and redundant sanitaryware and services

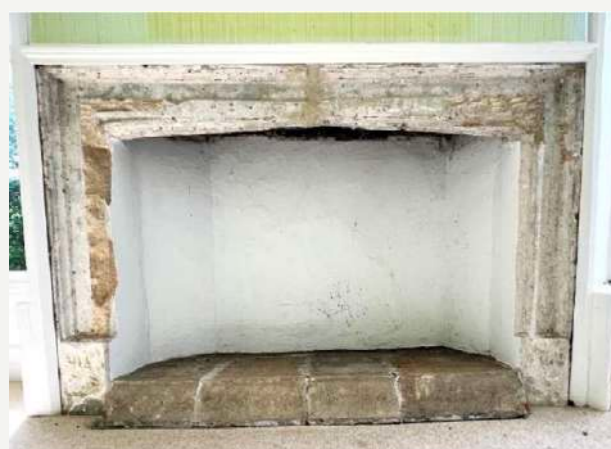
LATE-16TH/EARLY-17TH CENTURY FIREPLACE IN THE SOUTH-WEST ROOM AT FIRST FLOOR TO BE RETAINED - LATER RAISED HEARTH TO BE REMOVED

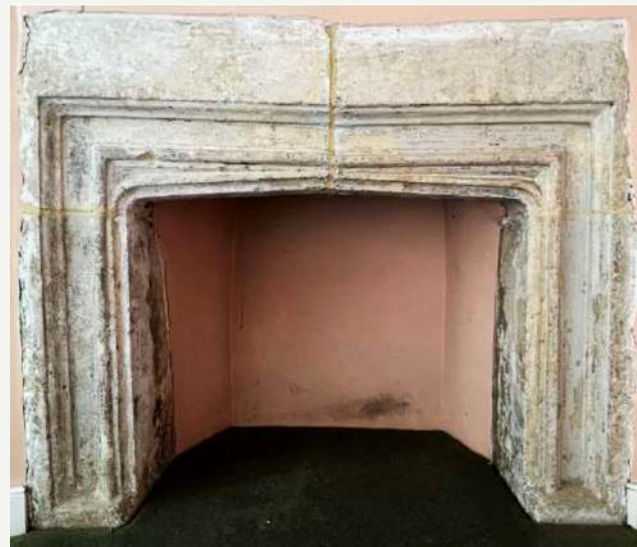
LATE-16TH/EARLY-17TH CENTURY FIREPLACE IN THE NORTH-WEST ORDINAL PROJECTION AT SECOND FLOOR TO BE RETAINED WITHIN THE NEW BATHROOM

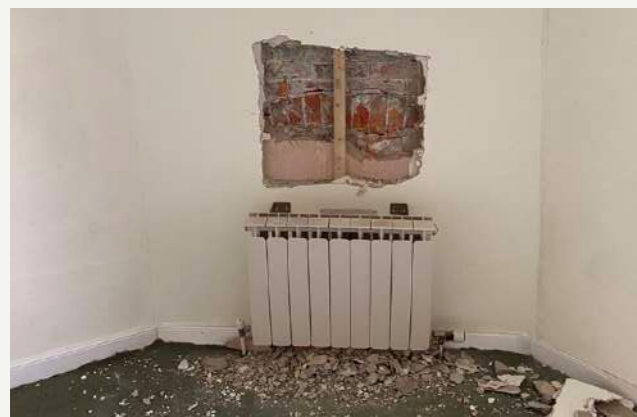
BLOCKED UP FLUES DISCOVERED IN THE CORNER OF EACH OF THE SOUTH BEDROOMS

- Remove late C19 timber stairs in non-original location
- Blocked up flues to have modern red brick infill removed.
- Remove boxing out for modern services.
- Existing bathroom door E_S05.D1 to be retained and reused.
- Remove existing timber roof trusses

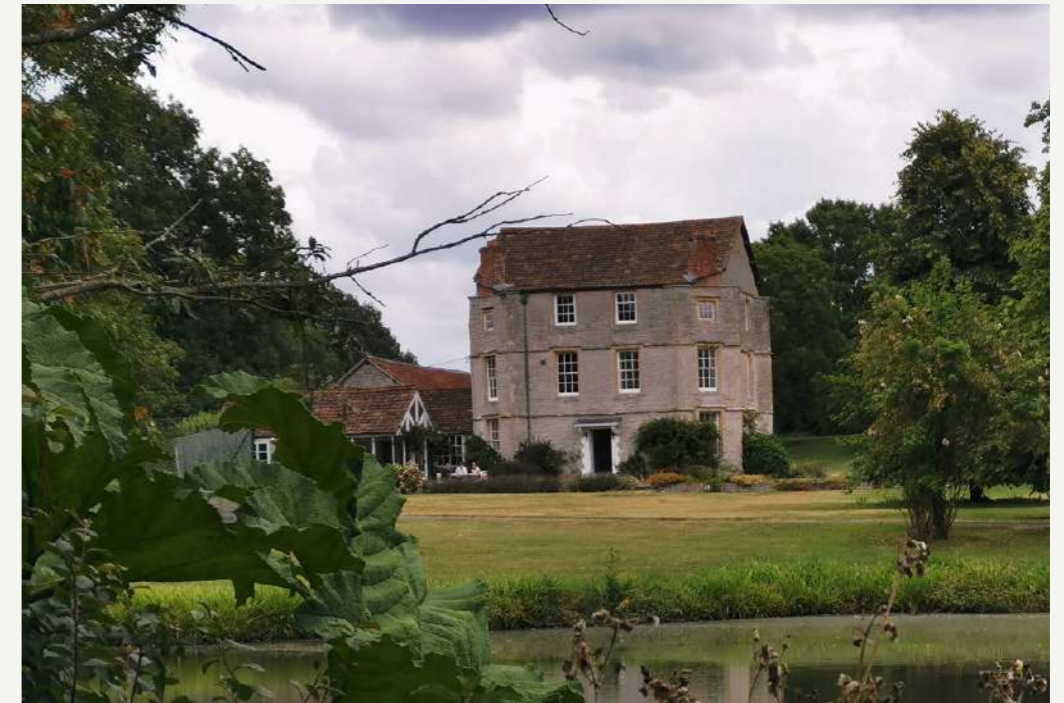
WEST VIEW OF THE HOUSE FROM ACROSS THE BOTTOM POND

The form of the roof, with its massive, blank gables, which give the building an aesthetically harmful, top-heavy feel, & which fails to relate in any meaningful architectural way to the form of the building below, is of little intrinsic aesthetic (fortuitous or architectural) value, & actively harms the aesthetic value of the earlier building.”

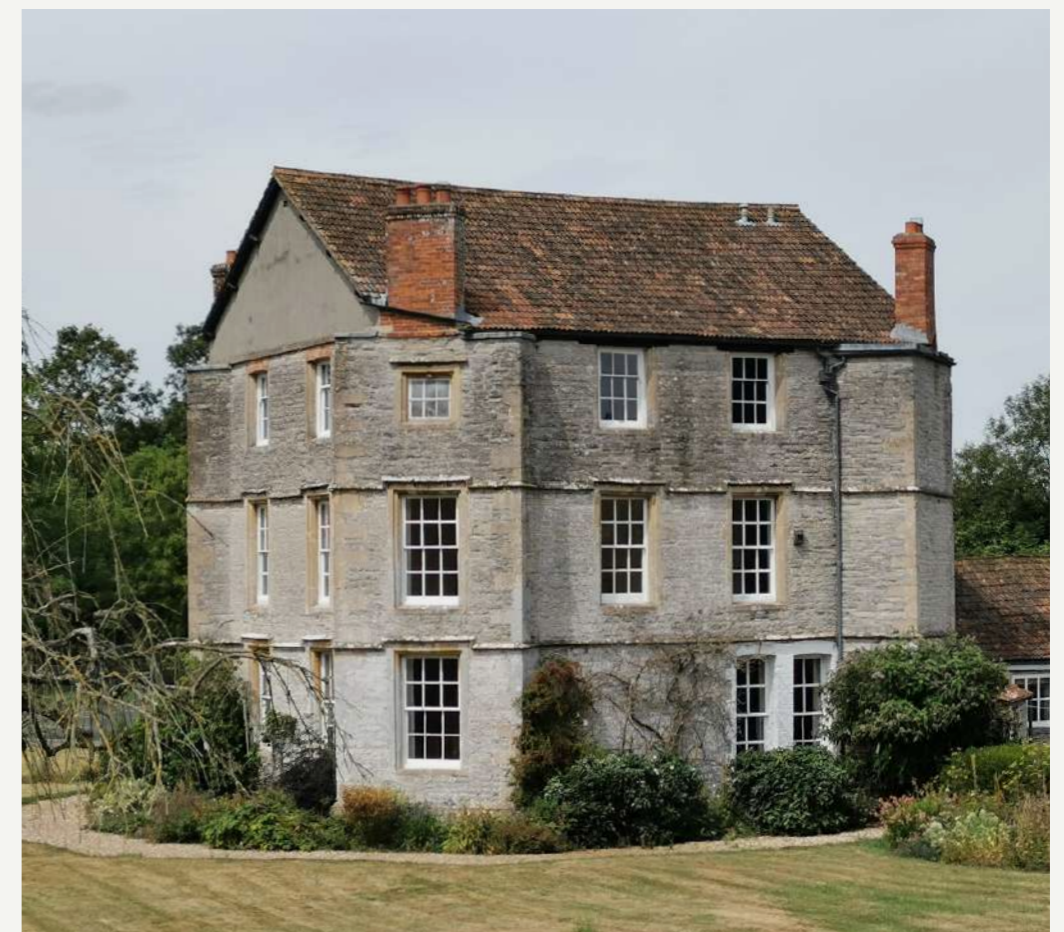
SOUTH EAST VIEW OF THE HOUSE

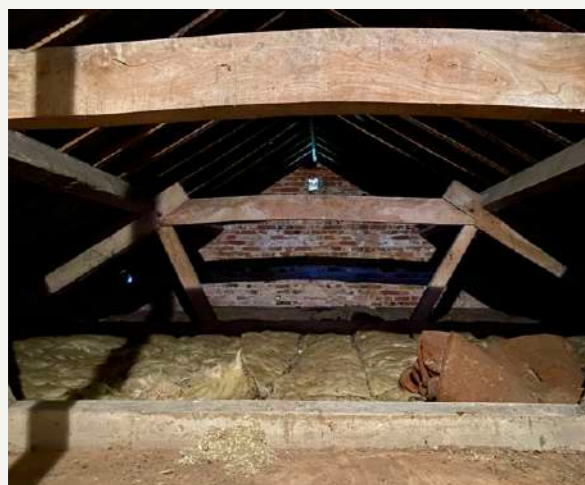
MISSING ROOF RIDGE BEAM RESULTING IN LATERAL THRUST ON THE STONE WALLS

“The roof to the main house has been added at a later stage, it is designed such that thrust is placed laterally into the walls, an undesirable condition long term. Roof pitch structure is a timber roof with no support to the apex and no ridge beam. The timber rafters have signs of damp.

Hairline cracks in the gable end wall suggest that the new masonry gable ends are not properly restrained. The roof should be replaced to avoid long term damage to the stonework that remains.”

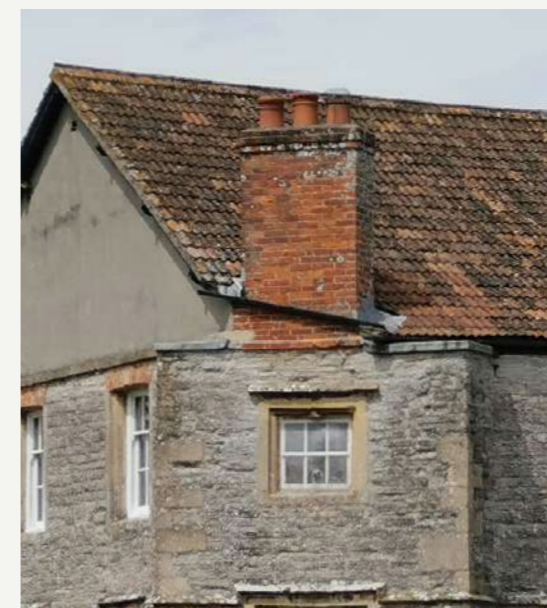
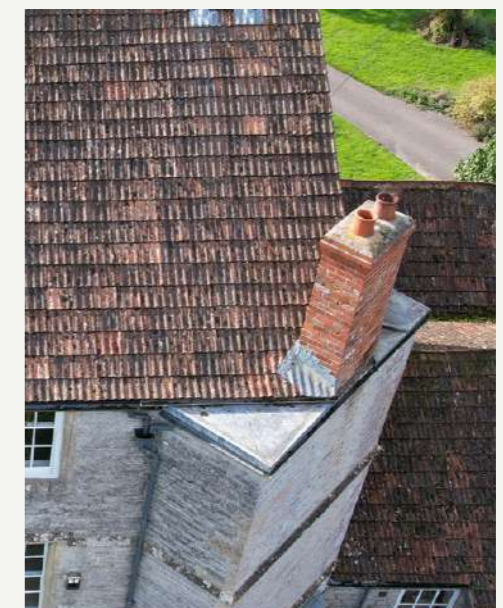
AWKWARD CHIMNEY AND GUTTER JUNCTIONS ARE UNSIGHTLY AND HAVE RESULTED IN WATER INGRESS DAMAGING HISTORIC FABRIC.

As a result of the design rainwater cannot be drained off without excessive guttering and flashings. The current roof solution requires guttering to be awkwardly wrapped around the chimney stacks, cutting diagonally across the stacks and being insufficient to collect and disperse water.

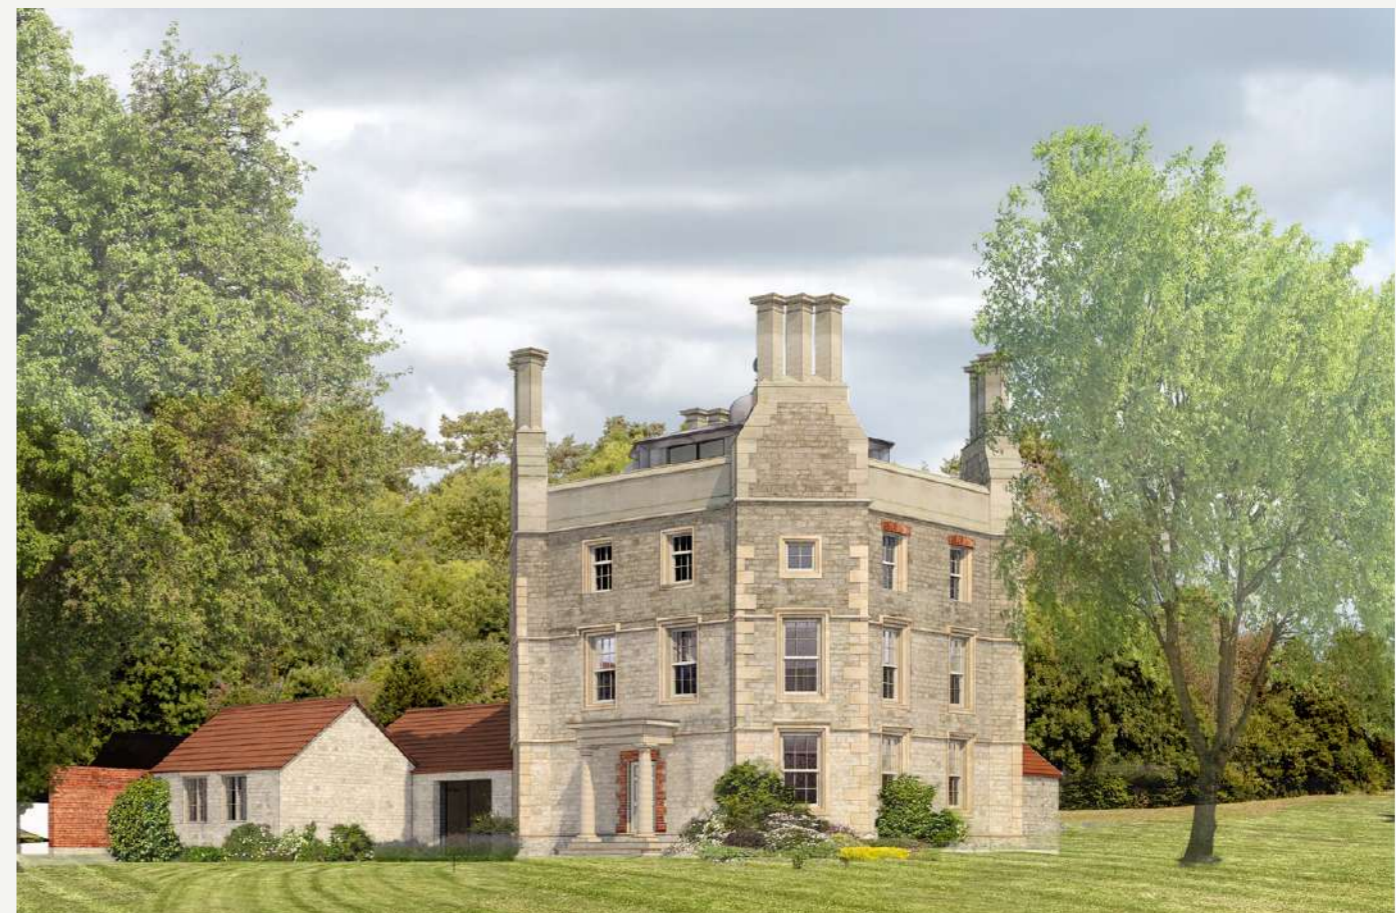
PROPOSED SOUTH WEST VIEW

The proposal is to remove the existing, harmful & over-sized roof structure, & to replace it with a far smaller & more sympathetic roof structure, set back behind reinstated parapets & chimneys. Proposals demonstrates a new fourth chapter in the roof's ongoing history. An overtly contemporary architectural form, which was considered & dismissed, could disjoint the overall appearance of the building, & compete distractingly with the historic elevations below. The intention, therefore, is to follow the examples of architects such as Lutyens & Holden, who took historic forms, but stripped & simplified them to create an honest, but gently & sympathetic homogenous & harmonious appearance.

The parapet would be a dressed stone addition. The triple chimneys draw inspiration both from the typical chimneys of the time, & from the honest expression of the three internal flues within each. The intention is not restoration, but to finish the elevations in a gentle, appropriate manner that whilst contemporary, is not overtly so, but feels simple, unforced & undistracting.

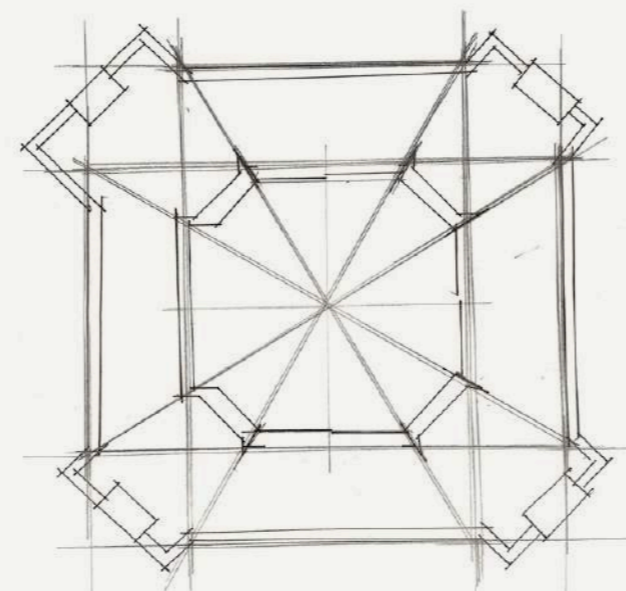
DEVELOPMENT DRAWING SHOWING THE GEOMETRICAL RELATIONSHIP OF THE PAVILION TO THE PARENT BUILDING.

The plan of the house contains a pair of root 3 rectangles forming a cross which define the three regular cardinal elevations (south, east & west); these are also used to define the cardinal & diagonal lines of the prospect room.

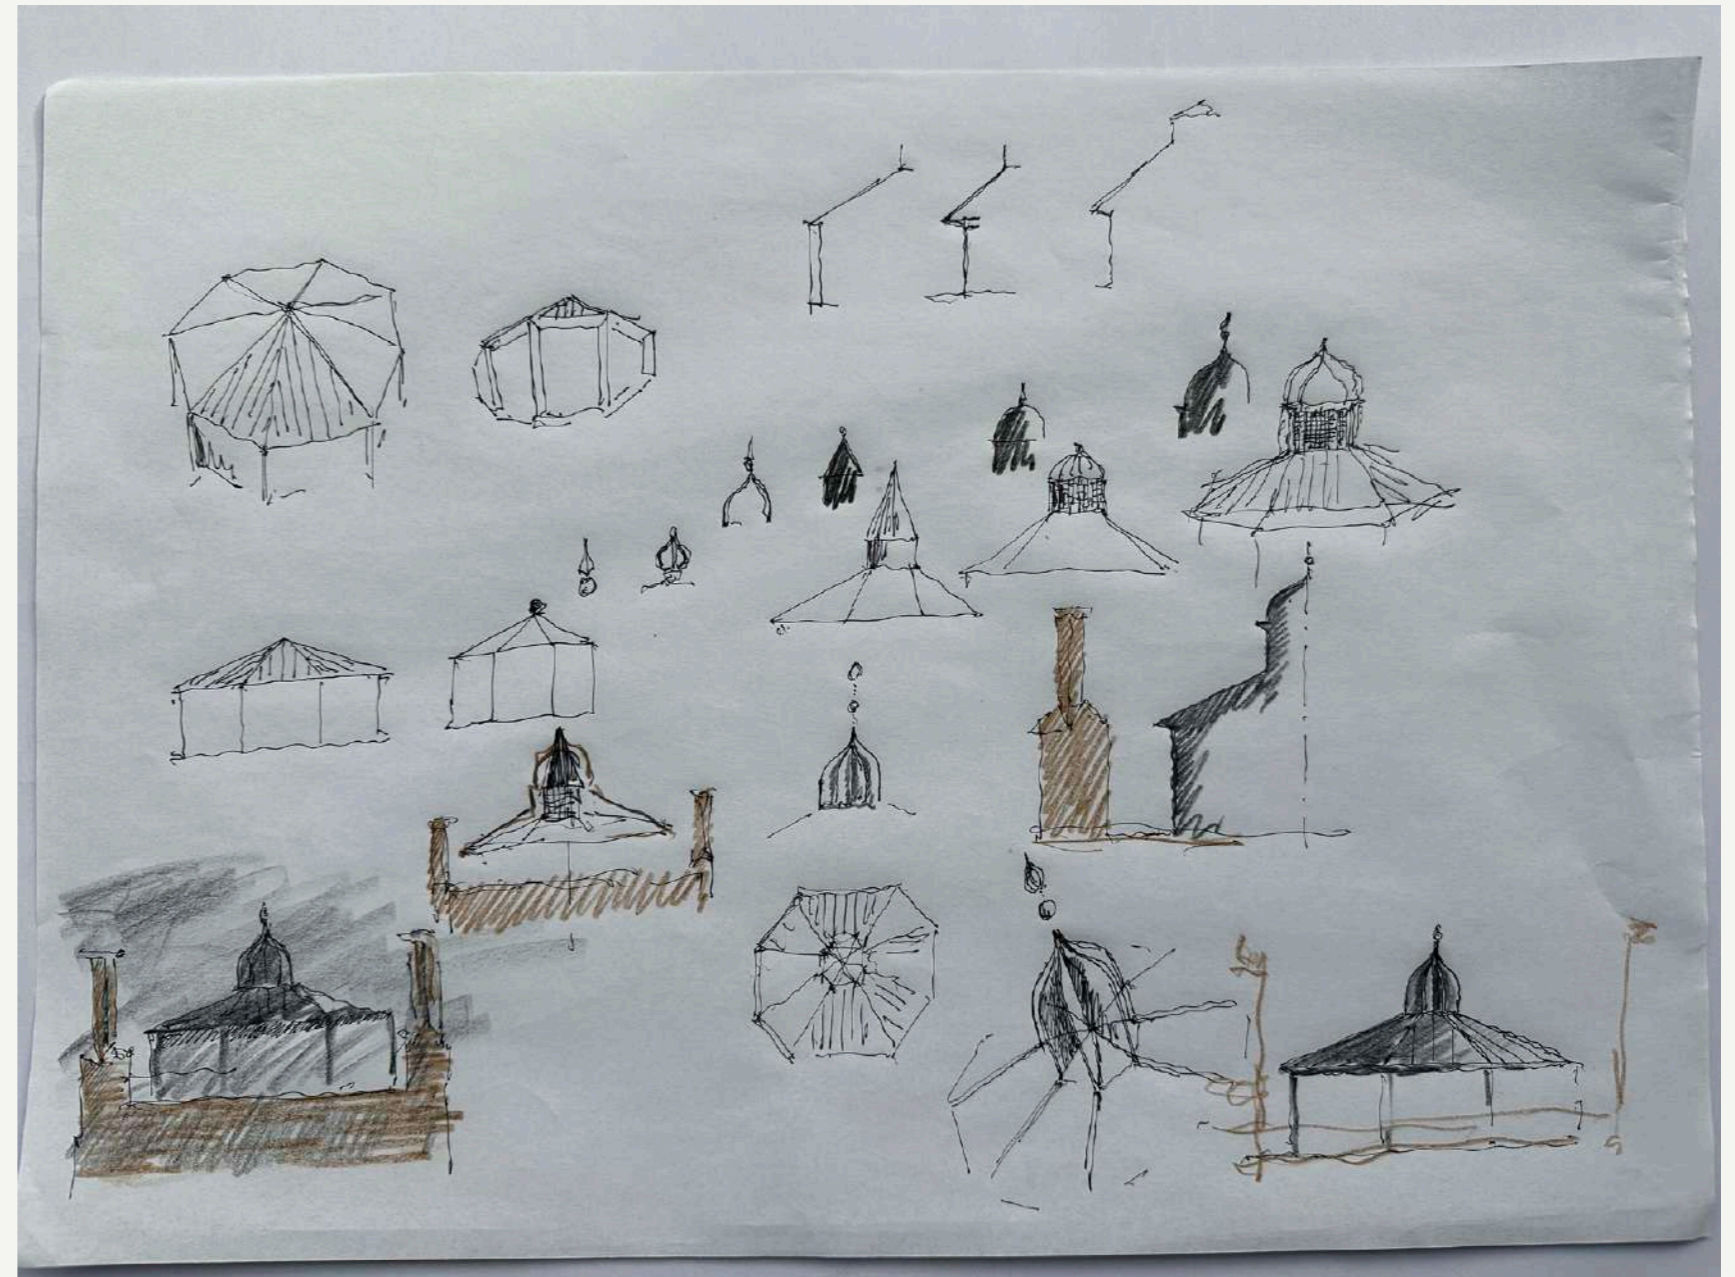
ARCHITECT'S DEVELOPMENT SKETCHES OF THE PAVILION DESIGN CONSIDERING DIFFERENT ROOF PROFILES AND ABSTRACTION

As the new roof was intended to evoke appropriate historic roofs in a sympathetically contemporary way, rather than form a speculative pastiche reconstruction, it is suggested, again taking inspiration for skeletal ogee domes, to 'deconstruct' the ogee to create more abstract silhouette.

The proposal, inspired by these precedents, from the ogee with a skirt of roof around at Nonesuch, to the skeletal ogees, is for the ribs of the roof to rise in the centre to form an abstract silhouette of a raised form & ogee dome at the centre of the prospect room roof.

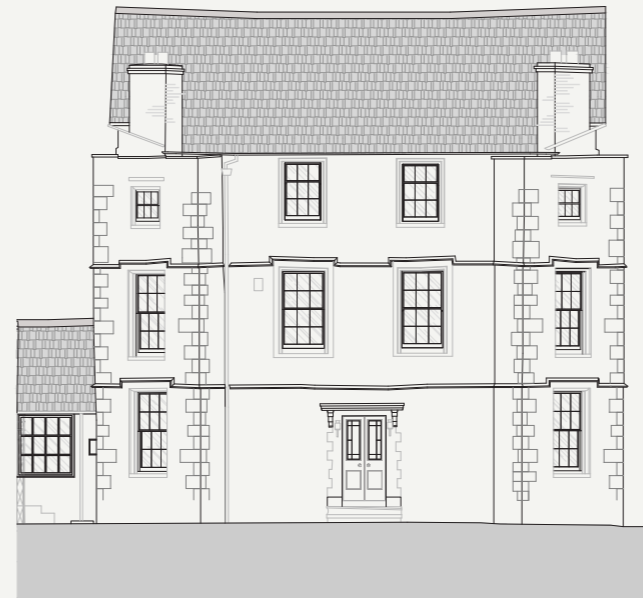
EXISTING WEST ELEVATION

The plan of the building was composed with root 3 proportions. The elevations of the house are entirely composed of root 2 & root 3 proportions. These proportions provide the clue as to the correct height of the roof structure (minus any finial/weather vane).

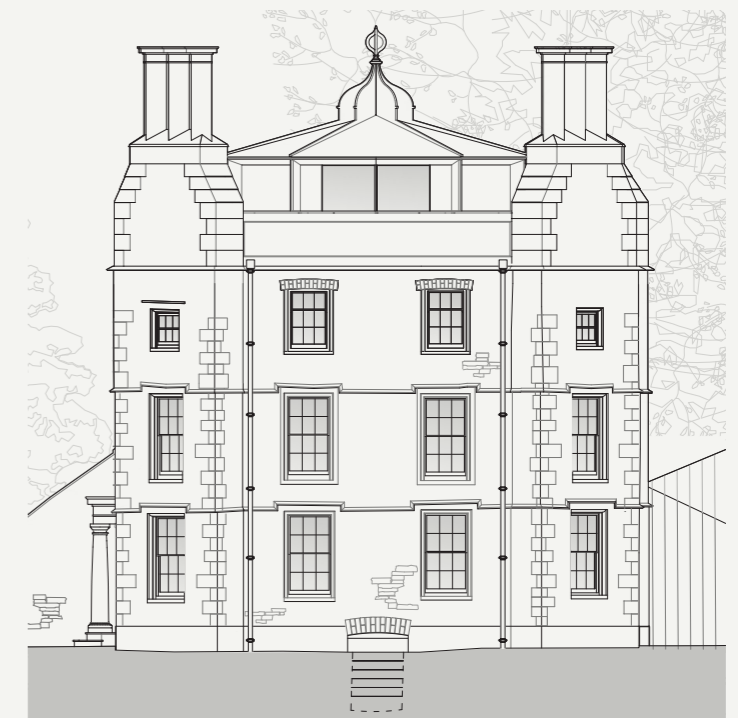
PROPOSED SOUTH ELEVATION

REFER TO SCALE DRAWINGS WITH FULL ANNOTATIONS

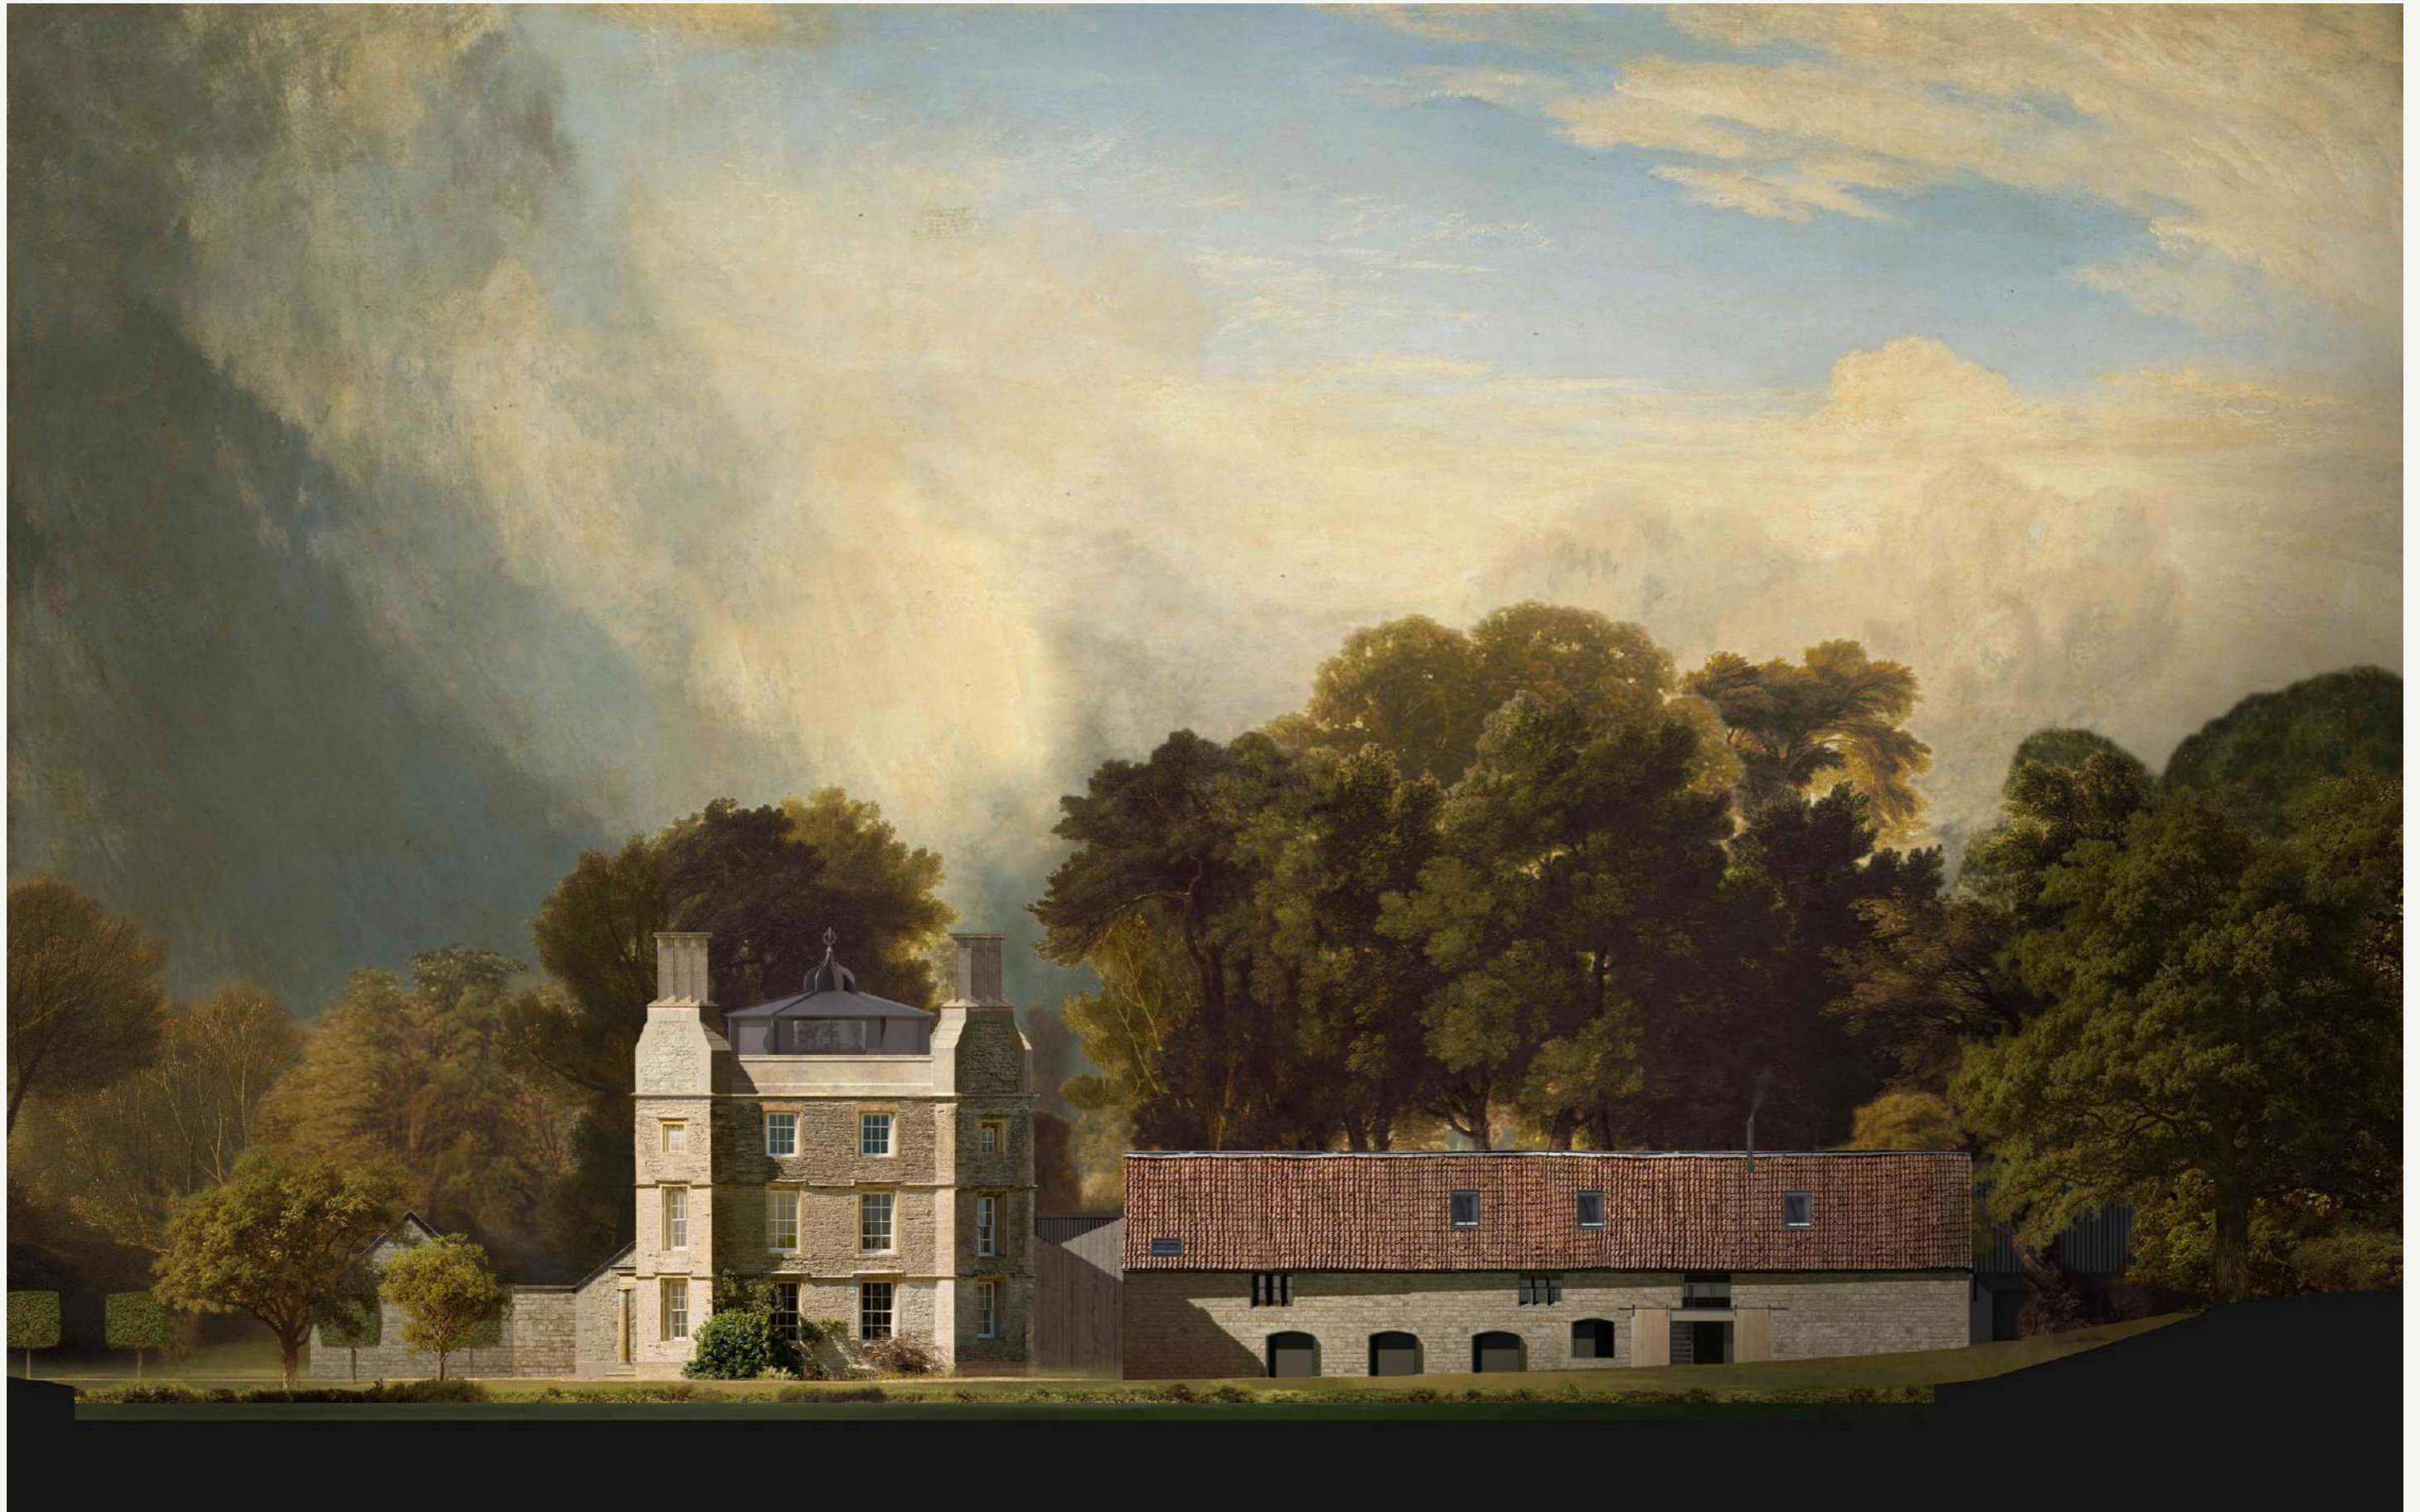
ARTIST'S INTERPRETATION OF THE PROPOSED SOUTH ELEVATION

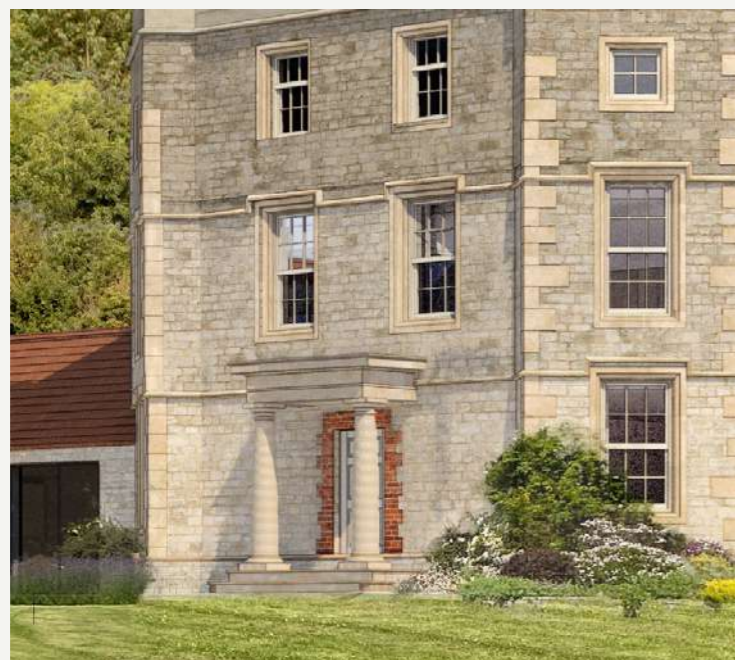
PROPOSED WEST PERSPECTIVE

On the west elevation, it is hoped to add an open porch to both shelter, & better identify the principal entrance.

The proposed porch would be a simple Tuscan porch. The proportions & detailing would be taken directly from John Shute's *The First & Chief Grounds of Architecture*, the first treatise on classical architecture to be written in English, published in London in 1563.

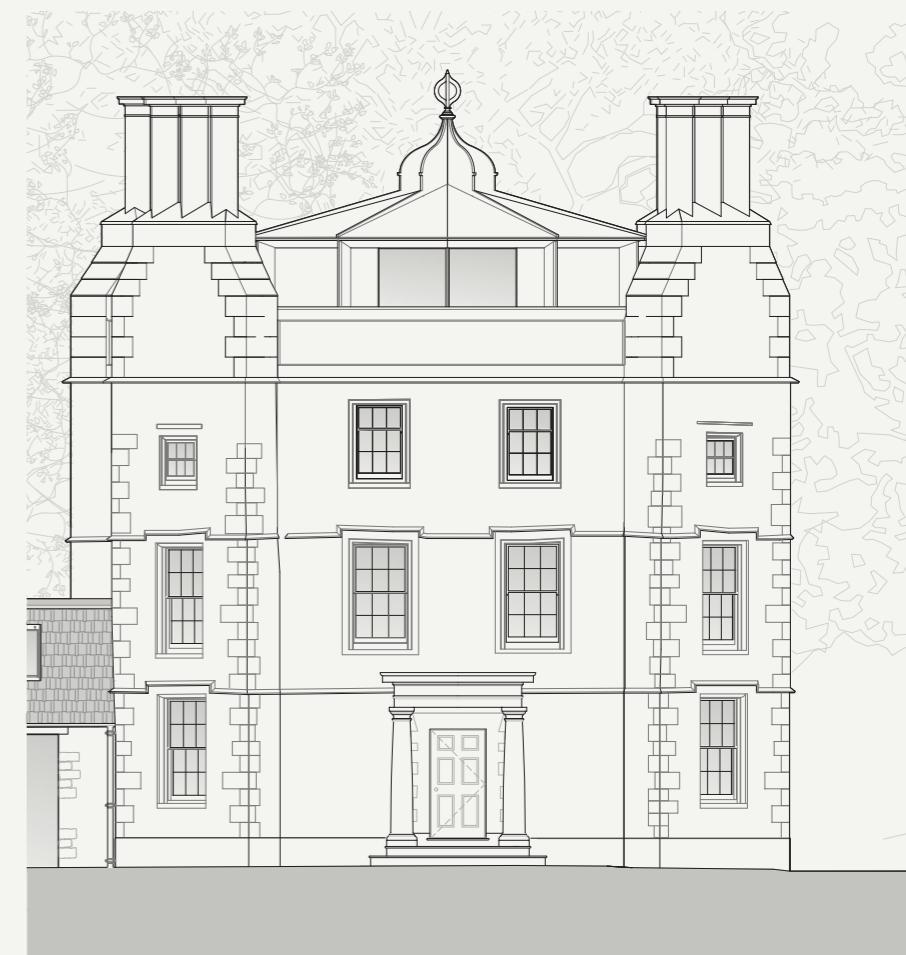
PROPOSED WEST ELEVATION

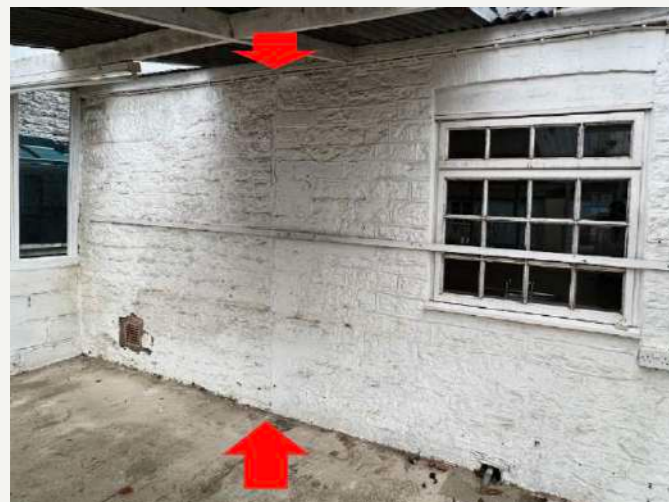
JOINT LINE SHOWING LATER ADDITION OF KITCHEN LEAN TO

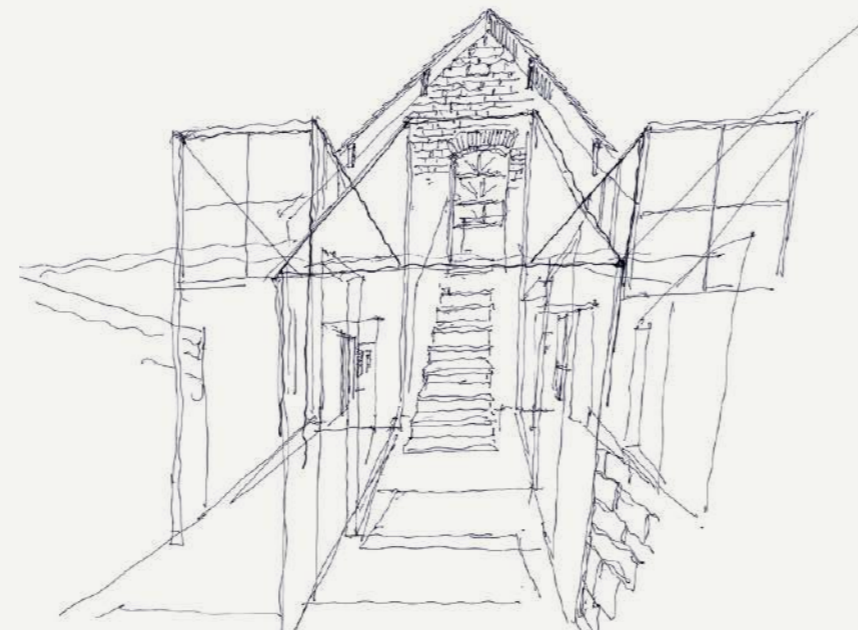
CONCEPT VIEW THE ROOF ANGLES OF THE PROPOSAL RESPOND TO THE THREE OPENINGS IN THE EAST FACADE

The agricultural lean to leading to the apple barn is to be demolished and replaced with a sensitively designed modern link building. The form of the new link is derived from the historic local vernacular of timber enclosures to cider barn staircases. The roof angles of the proposal respond to the three openings in the east facade: 2 lower doors (for barrels) and the upper door (for fruit storage).

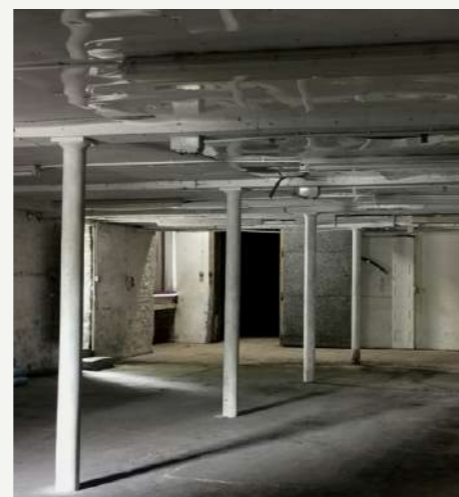
APPLE BARN - GROUND FLOOR WITH STEEL COLUMNS SUPPORTING THE FIRST.

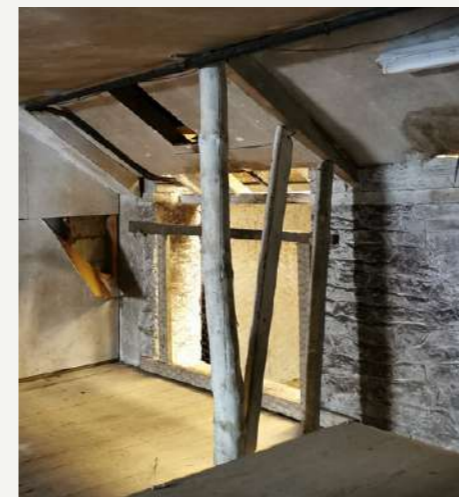
APPLE BARN FIRST FLOOR - TEMPORARY SUPPORTS FOR THE FAILED ROOF

- Modern partitions and temporary truss supports removed.
- Floor structure stripped for strengthening and replacement
- Roof removed for replacement due to structural failings

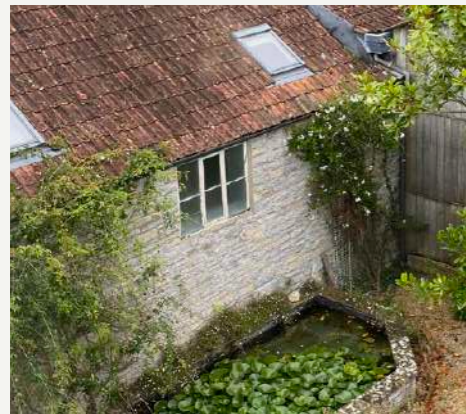
A EXISTING TIMBER CASEMENT WINDOWS IN POOR CONDITION TO BE REPLACED WITH NEW DOUBLE GLAZED TIMBER CASEMENTS IN EXISTING OPENINGS WITH REPLACEMENT TIMBER LINTELS

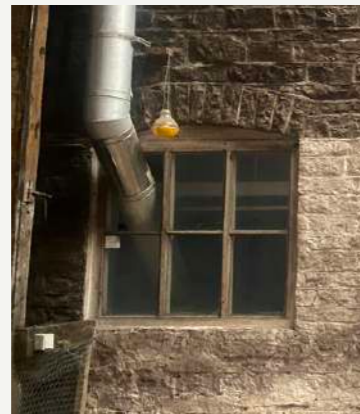
B DAMAGED EXISTING TIMBER CASEMENTS REPLACED WITH NEW TIMBER SILLS WITHIN EXISTING STONE ARCHED LINTELS

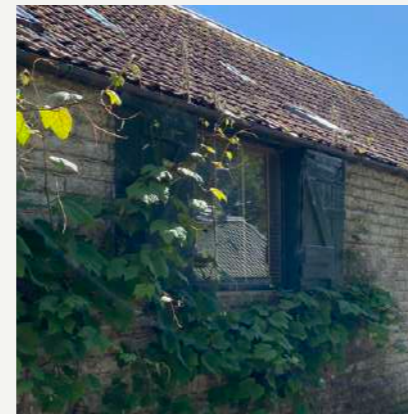
C EXISTING MODERN TIMBER FRAMED WINDOWS TO BE REPLACED WITH NEW CASEMENT WINDOWS

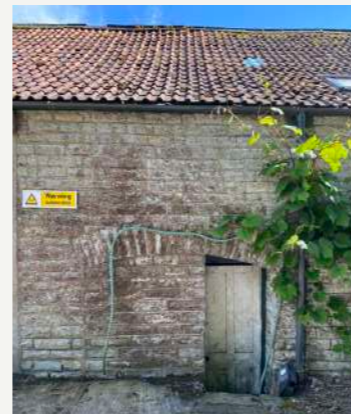
D EXISTING STONE ARCHED OPENING TO BE OPENED UP WITH NEW FIXED GLAZING. THE STEPS ARE CONTEMPORARY WITH THE NEWER DOOR.

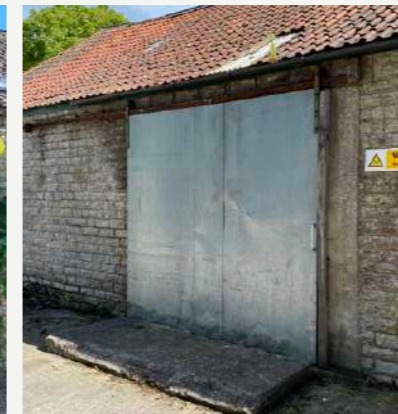
E EXISTING LARGE OPENING TO BE RETAINED, INCLUDING ORIGINAL LINTEL. SILL DROPPED TO MEET INTERNAL FFL, NEW GLAZED INFILL, DOOR AND EXTERNAL SHUTTER.

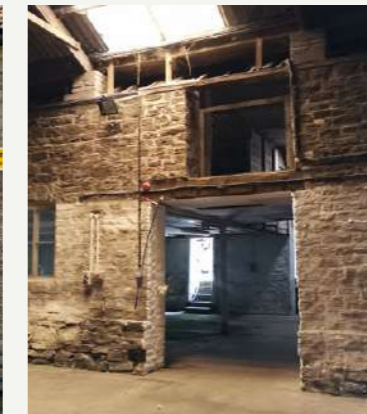
F EXISTING PAIR OF OPENINGS TO BE CONSOLIDATED AS NEW DOUBLE HEIGHT GLAZED OPENING WITH EXTERNAL SHUTTERS
