# Tree Survey Notes - Beech Croft, Church Hill, Patcham BN1 8YE

## 1.0 Introduction:

- 3.1 The details of nine individual trees were recorded, all are located within the site.
- 3.3 The schedule shown on the Tree Survey Plan (ref 1906/39/TS), provides the dimensions of those specimens included in the survey together with an assessment of their condition and life expectancy with specific comments regarding their condition where appropriate. In addition, each tree has been categorised according to its retention value following criteria provided in Table 1 of BS5837.

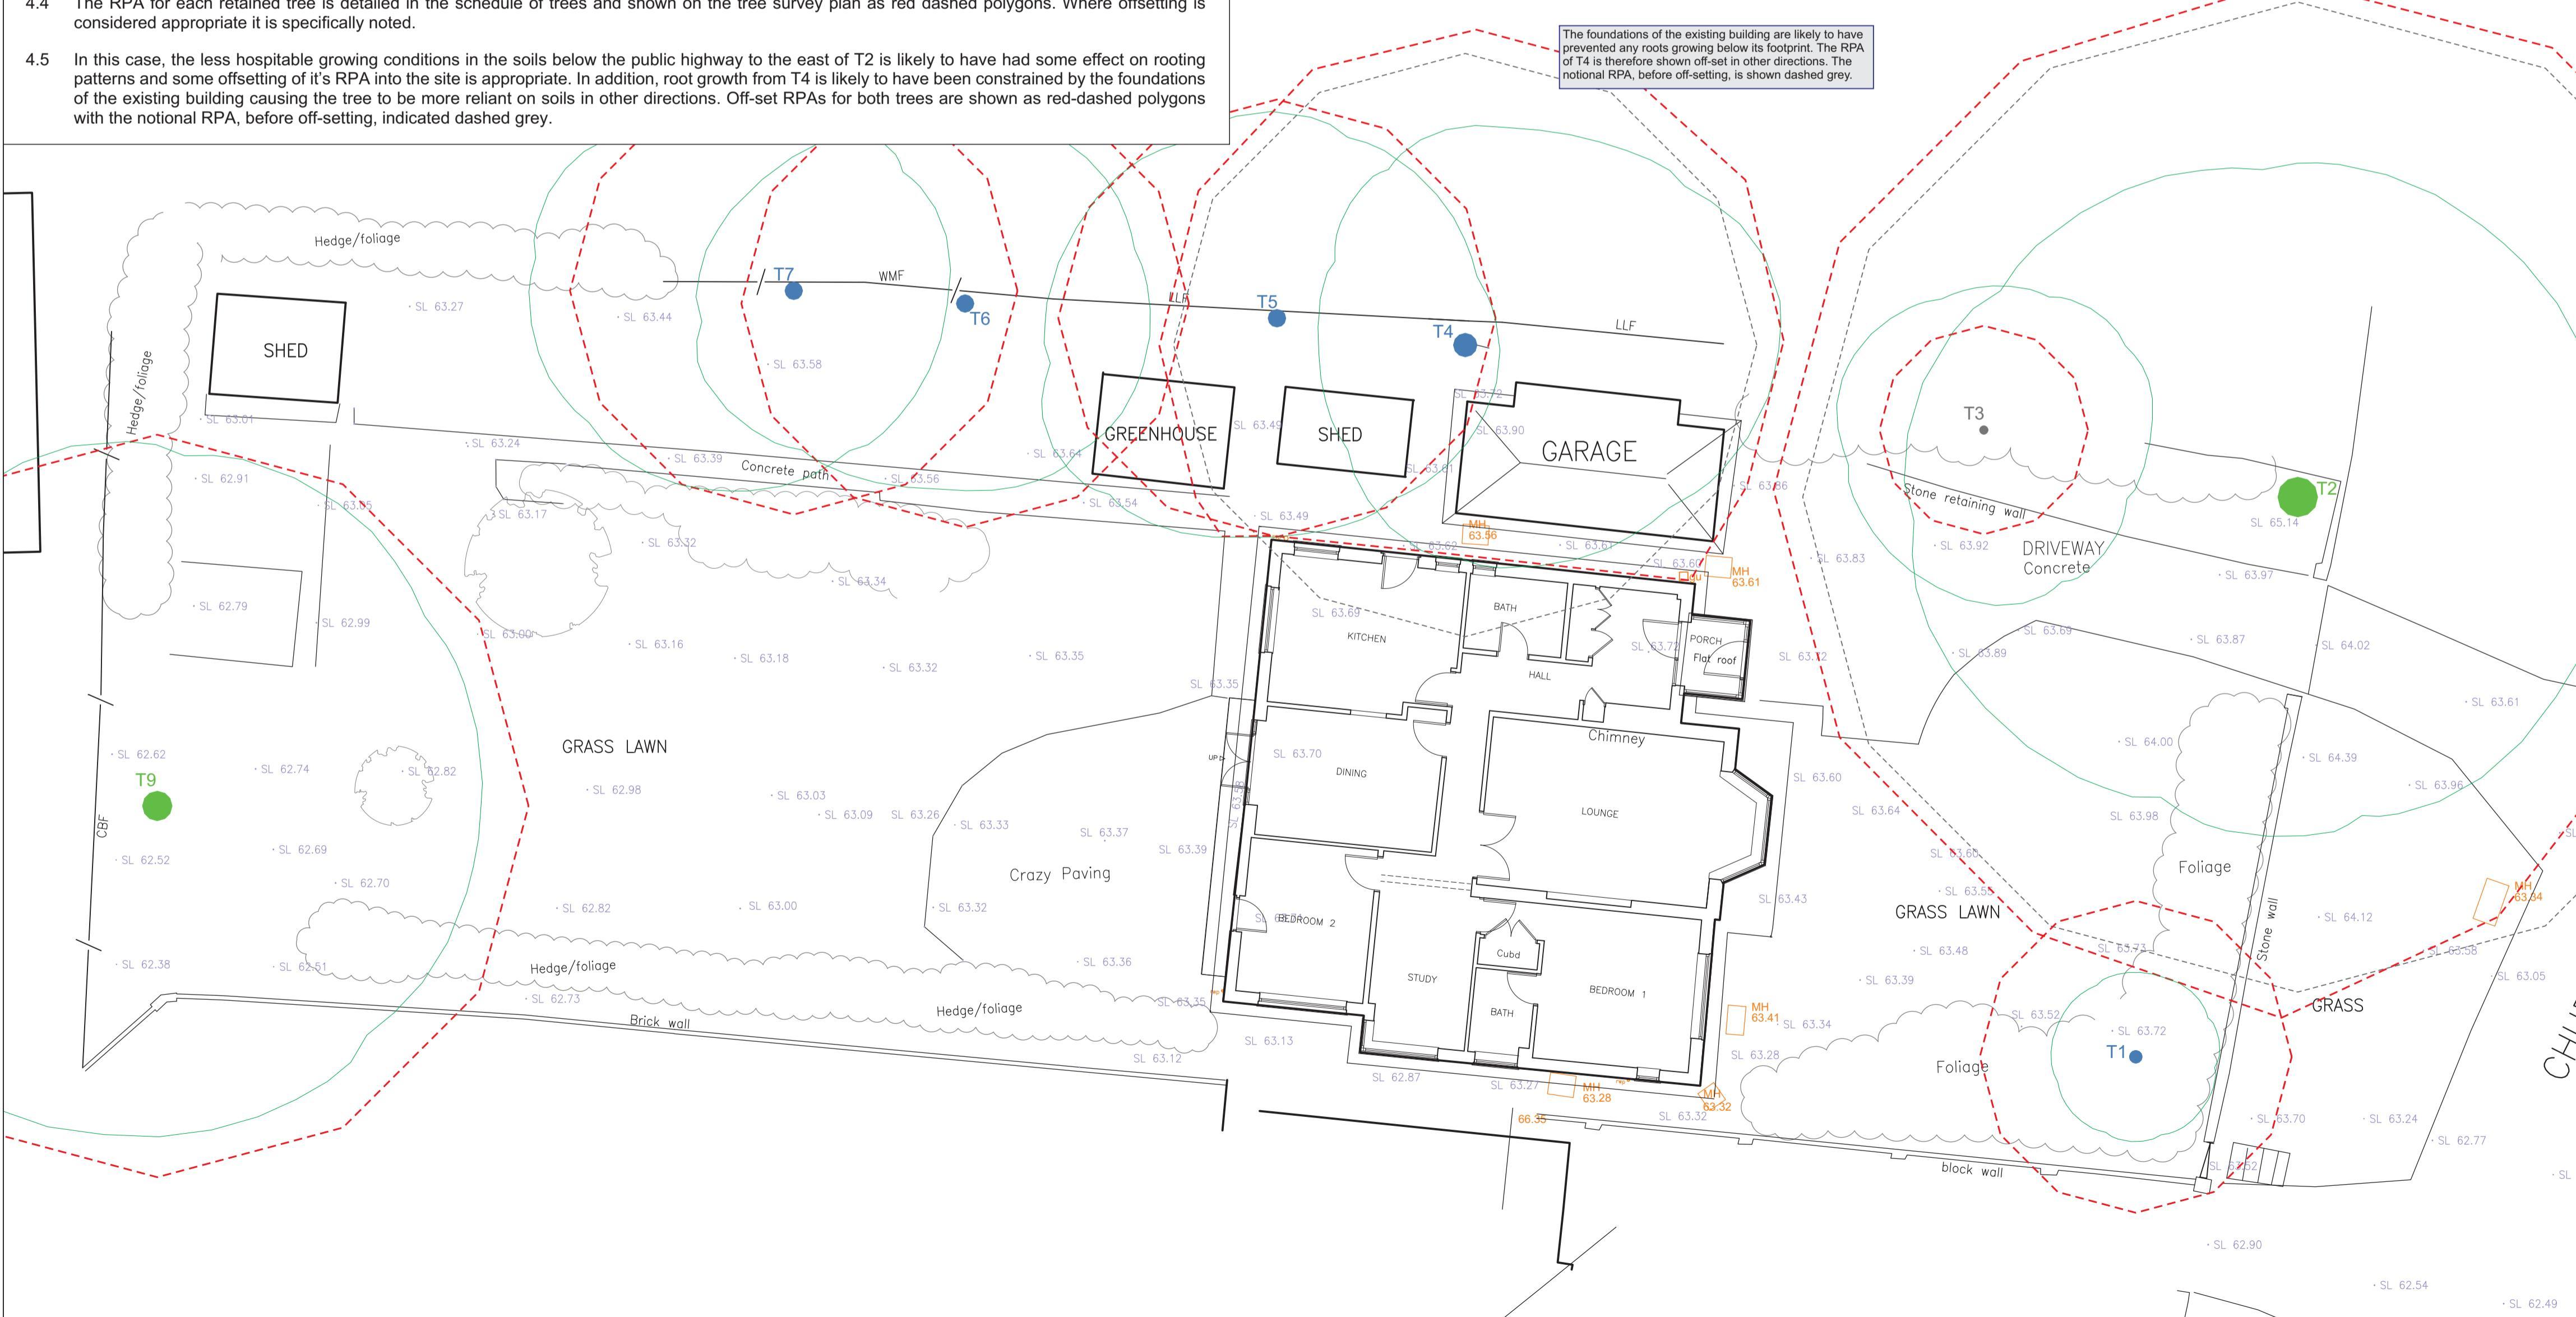
- 4.4 The RPA for each retained tree is detailed in the schedule of trees and shown on the tree survey plan as red dashed polygons. Where offsetting is considered appropriate it is specifically noted.

- with the notional RPA, before off-setting, indicated dashed grey.

Schedule	e of trees																		Key	
No Species	es S	No of tems (	SD* (mm)	lgt N	Cr E	own rad S	ii W	Crn hgt	Age	РС	Comments	Preliminary Recommendations	Life Exp	BS Cat	Sub Cat	RP m	PA RPA 2 Rad	A d		Surveyed tree (T prefix), tree group
T1 Pine		1	300	12 2	2 2	2 2	2	4	EM	Good	Good form		40+	В	1;2	4	1 3.6	5		(G) or significant hedge (H). Colour coded according to BS5837 quality assessment
T2 Beech	1	5	950	14 8	8 8	8 8	9	2	M	Good	Five stems, 480, 460 x2, 400 and 300mm diameter in a clump, stems part fused. Mixture of copper and green beech forming one canopy. Low canopy over	Raise crown to clear	40+	A	1;2	40	)8 11.4	.4		criteria (see Table 1)
T3 Crab A	Apple	1	200	6 4	. 3	.5 4.5	3	3.5	M	Fair	access. High landscape value		10+	С	1	1	8 2.4	1		Root protection area, derived from
T4 Beech		2	560	15 6		7 4.5	4	3	EM	Good	Stems 420 & 370mm diameter. Recently pruned on south side. Part of row		40+	В	1;2	14	2 6.7	7		is specifically noted.

T5 Beech	1	1	420	15 5	5 6	5 4	6	4	EM	Good	adjacent to north boundary Recently pruned on south side. Part of row adjacent to north boundary		40+	В	1;2	8	0 5.0		0.15 SW	Existing underground services
T6 Beech	1	1	430	15 5	; 4	4 4	7	3	EM	Good	Recently pruned on south side. Part of row adjacent to north boundary		40+	В	1;2	8	4 5.2	2	+	
T7 Beech	· · · · · · · · · · · · · · · · · · ·	1	430 300	15 5 12 2	; <u> </u> ;	5 4.5 5 4	5	5	EM FM	Good	Recently pruned on south side. Part of row adjacent to north boundary		40+	B	1;2	8 4	4 5.2 1 3.6	2	57.28	Existing levels
T9 Copper	er Beech	3	715	15 8.	5 8	8 8	8	2	EM	Good	Three stems (460, 400, 370mm diameter) from ground level. Branches in		40+	A	1;2	23	31 8.6	5	Notes	Notes relating to specific arboricultural issues
All dimensions in I	n metres unless othe	erwise stat	ted. Dime	sions of ti	rees gro	owing outs	de the	site may b	pe estim	nated	contact with neighbouring building to rear.
